# Land at White Horse Business Park, Trowbridge, BA14 0XA.

## Castlewood Residential Application

Arboricultural Impact Assessment (AIA)

**Document Reference:** WHBP\_AIA\_PJ\_JP\_v3

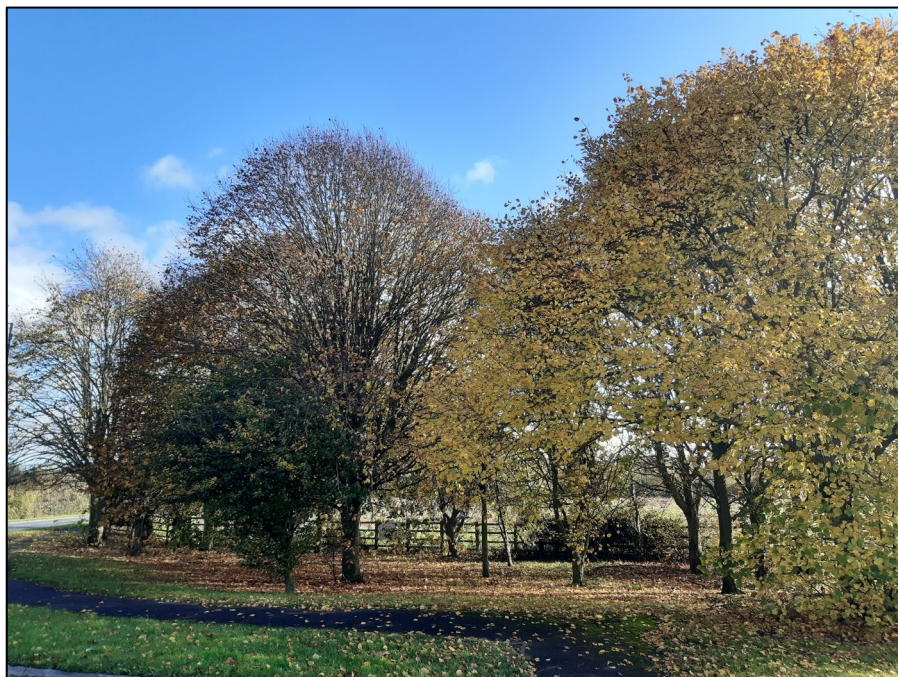
3.1.4 There is a group of trees (T3- G33) to the north west of the site near the roundabout for the A363. The group made up of mixed broadleaves of differing ages and species, predominantly lime trees (*Tilia sp.*) with an understorey of apple trees (*Malus sp.*).

Image 1: Group of trees on northwest corner, near roundabout of A363

- 3.1.6 T6, T26, T31 and T46 have all been recommended for removal. This is to improve the tree stock in the group to the northwest boundary of the site. T3, T4 and T5 have been recommended for a crown lift and cutback to clear the lamp column and achieve a 3m clearance over the footpath.
- 3.1.7 The multiple hedgerows (H34, H40-H43, H47, H48 H51, H54, H66 and H74-H76) are important wildlife corridors and provide essential habitat and navigation channels.

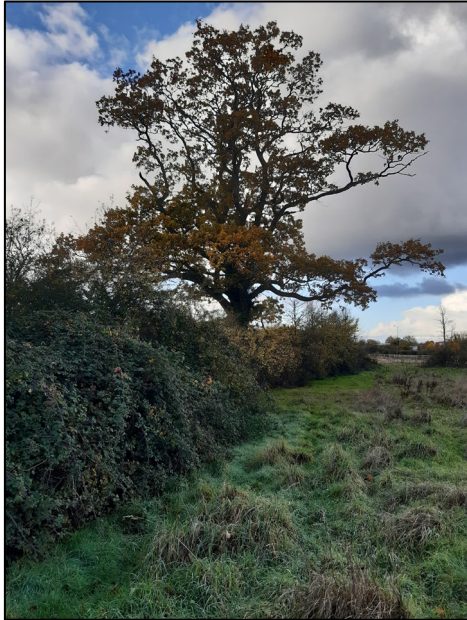
- 3.1.5 T44 is a Category A oak tree (*Quercus robur*) and T45 is a Category B oak with high wildlife value and are the largest trees on site. These two trees are right in the middle of the development and proposed to be retained.

Image 2: T44 Category A oak

- 3.2.4 There is an incursion into the RPA of T44 (Cat A1) for a footpath that links the two side of the development and T45 (Cat B1) for a new tarmac surface. Given the extent of the incursion and the remaining available below ground space for root penetration it is unlikely this incursion will have a significant negative impact on the health and vitality of T44 and T45. It is recommended that any excavation works in these RPAs are carried out under the supervision of an Arboricultural Clerk of Works (ACoW).

5.11.1 There is a footpath proposed in the RPA for T44 but it is only a minor incursion. It is recommended that any excavations are carried out under ACoW supervision and any roots encountered below 25mm are pruned using appropriate sharp cutting tools such as secateurs or loppers.

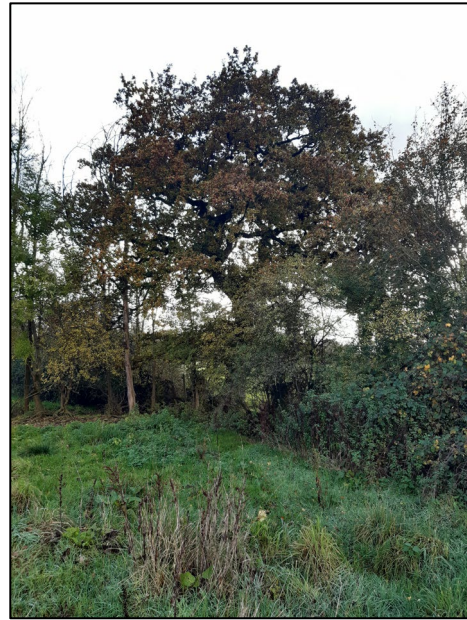
Image 3: T45 Category B oak

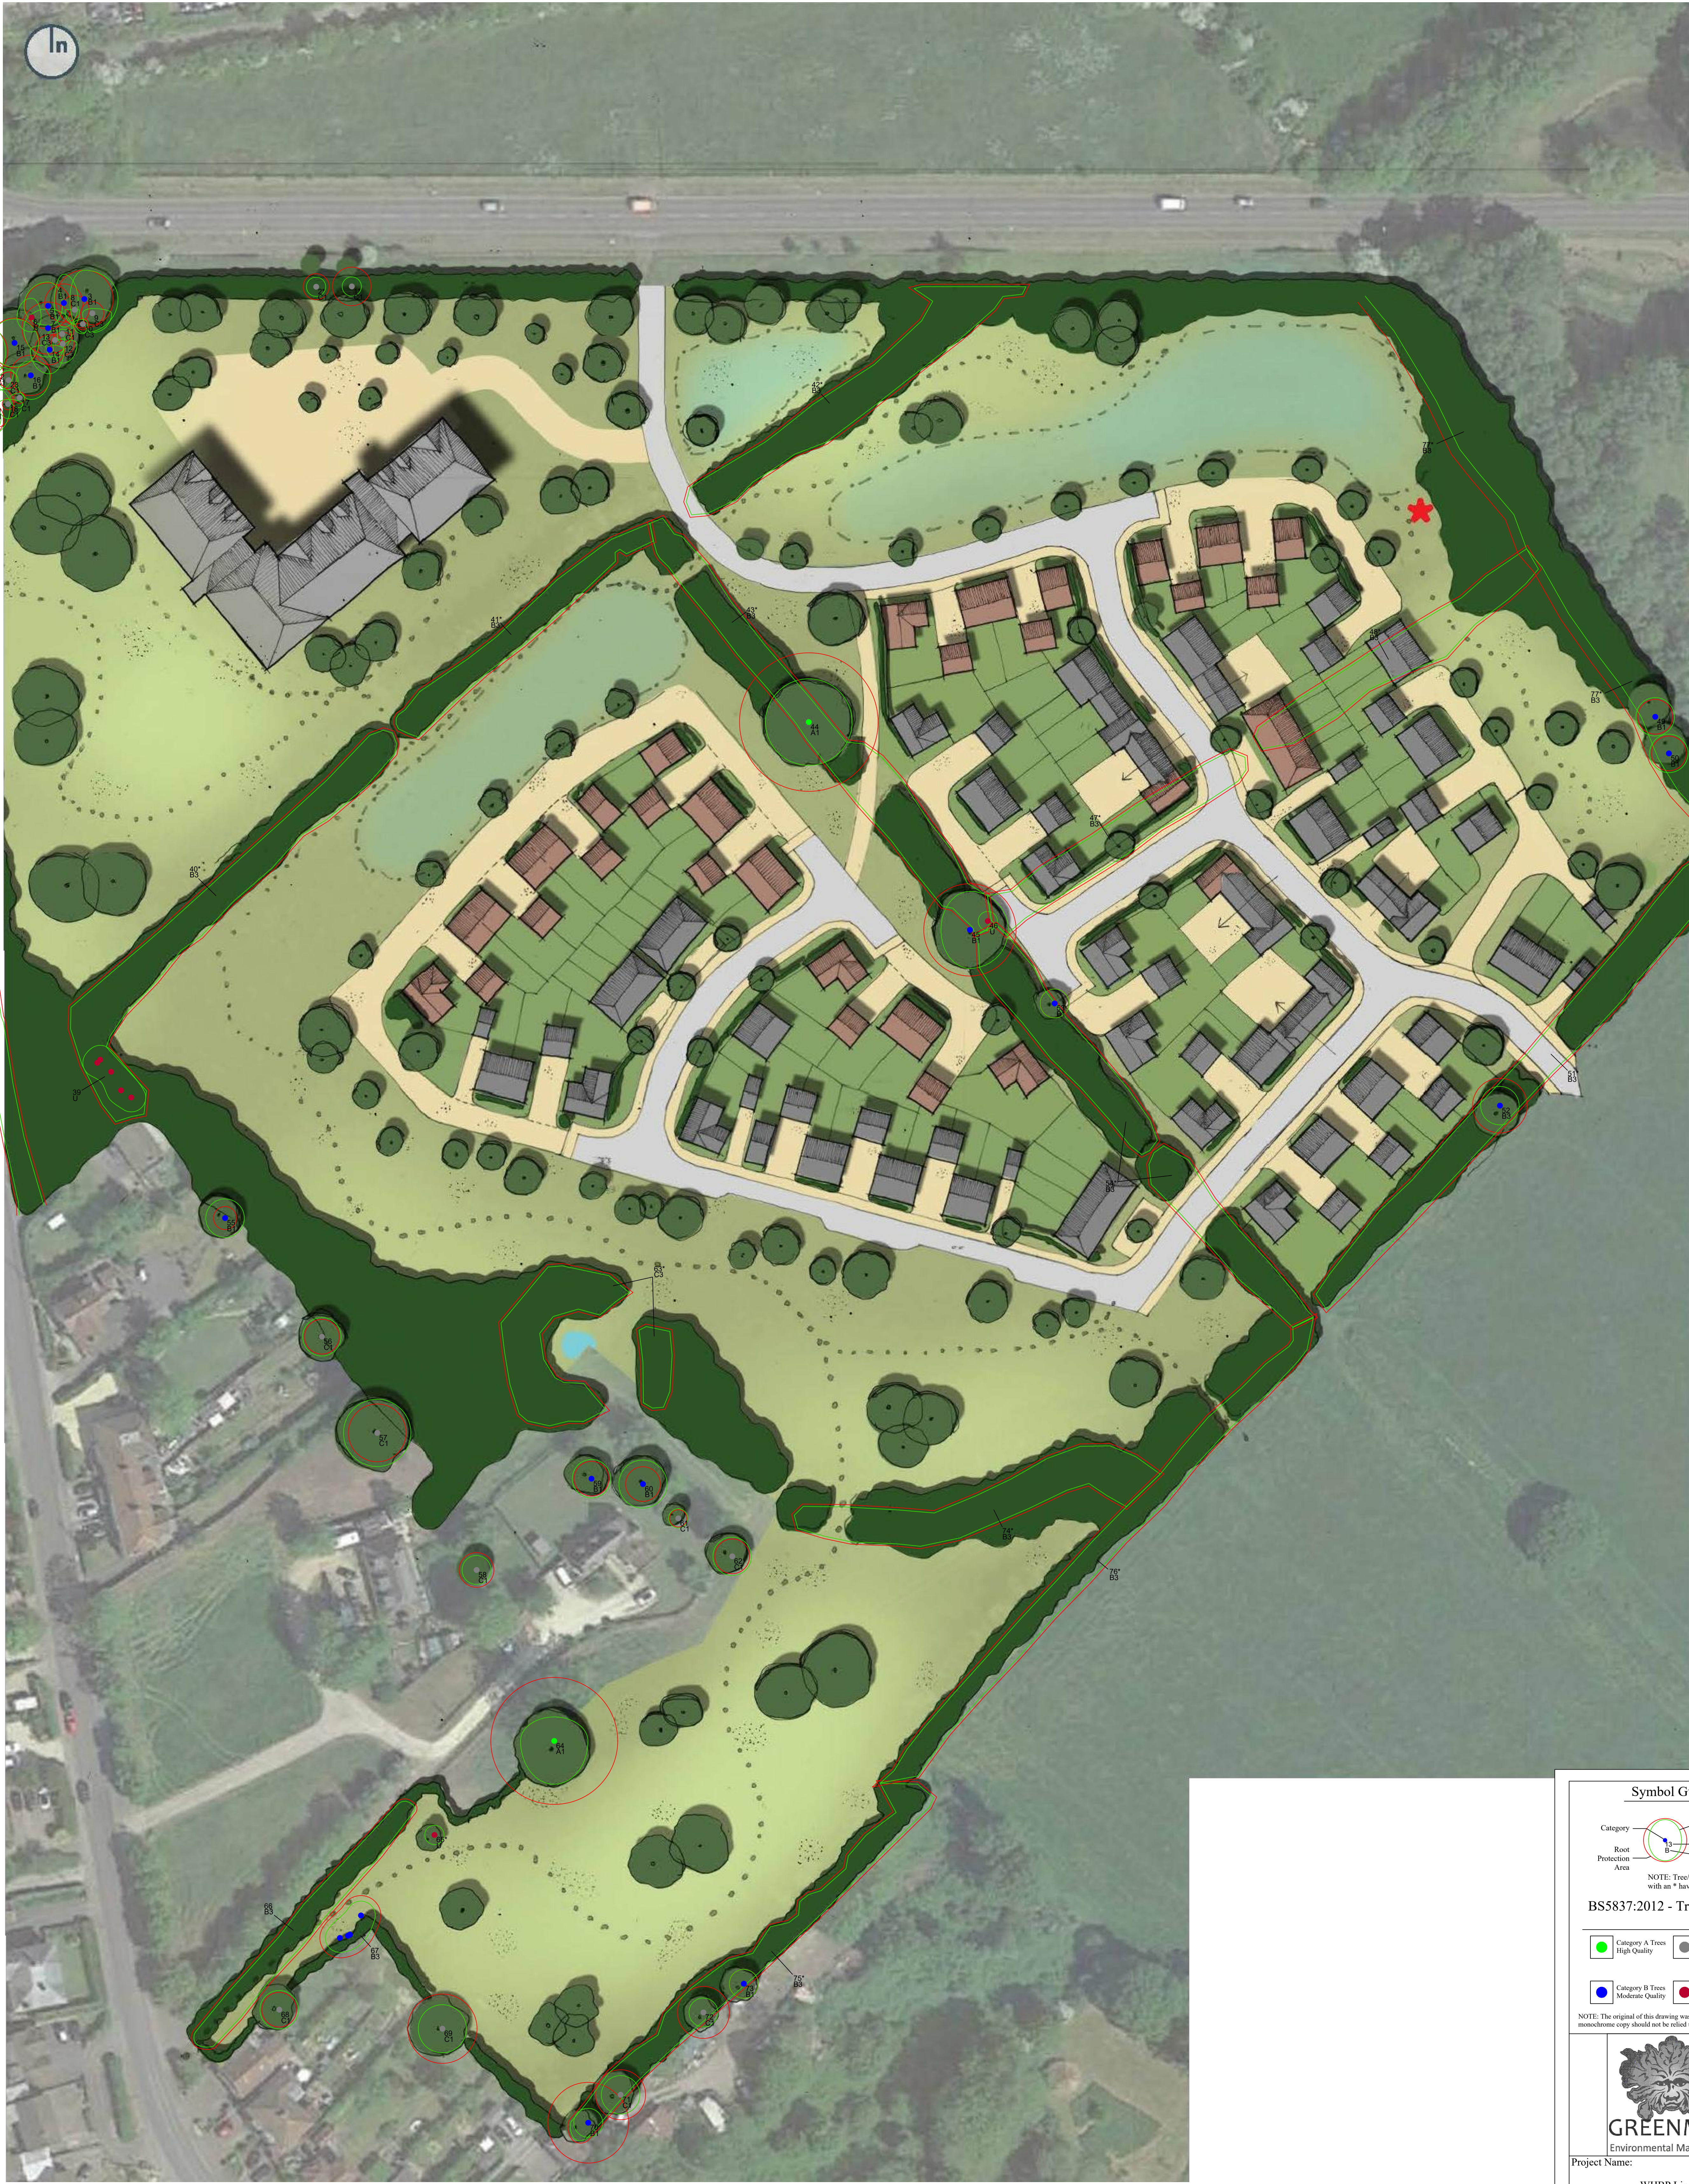
## APPENDIX C: ARBORICULTURAL IMPACT ASSESSMENT

- 3.2.5 H47 and H48 will need to be removed to facilitate this proposal. They are situated in the exact location of new houses and gardens and their retention will not be possible with the current design.

- 3.2.6 H42, H43, H51 and H54 will require the removal of a section of the hedgerow for footpaths and roads (see Appendix C AIA).
