## **Arboricultural Impact Assessment**

A residential development comprising  
49 units, together with associated  
access, parking and landscaping

Land at The Forty  
Cricklade  
SN6 6HW

Survey Date: 3<sup>rd</sup> August 2023  
Report Date: 22<sup>nd</sup> November 2023  
Project no: 2134

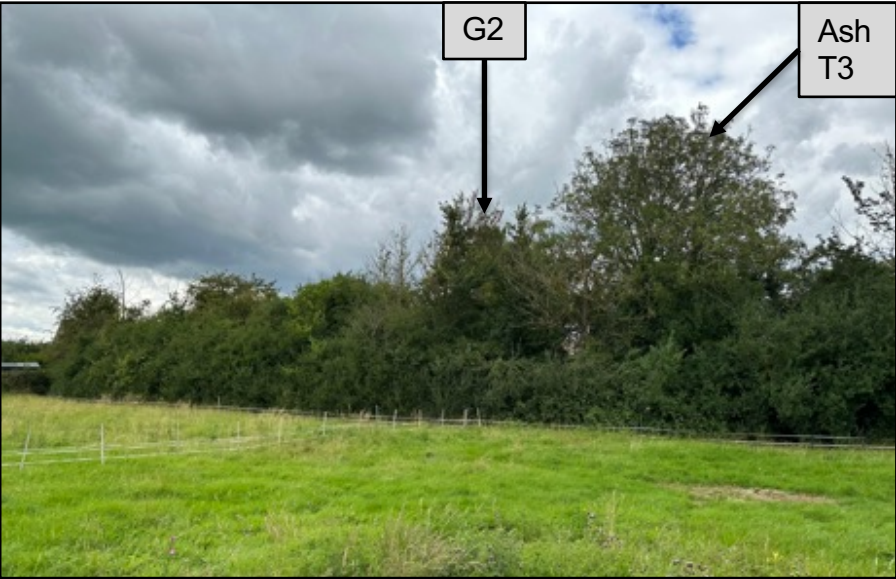
View of hedgerow G2, looking to west from within site. Ash, T3 proposed for removal, together with a section of G2, to allow creation of new site access.

- 6.1** The following trees / tree groups, categorized as per BS 5837 (see Appendix C for details), are proposed for removal:
- Category U – unsuitable for retention: One tree – T3.

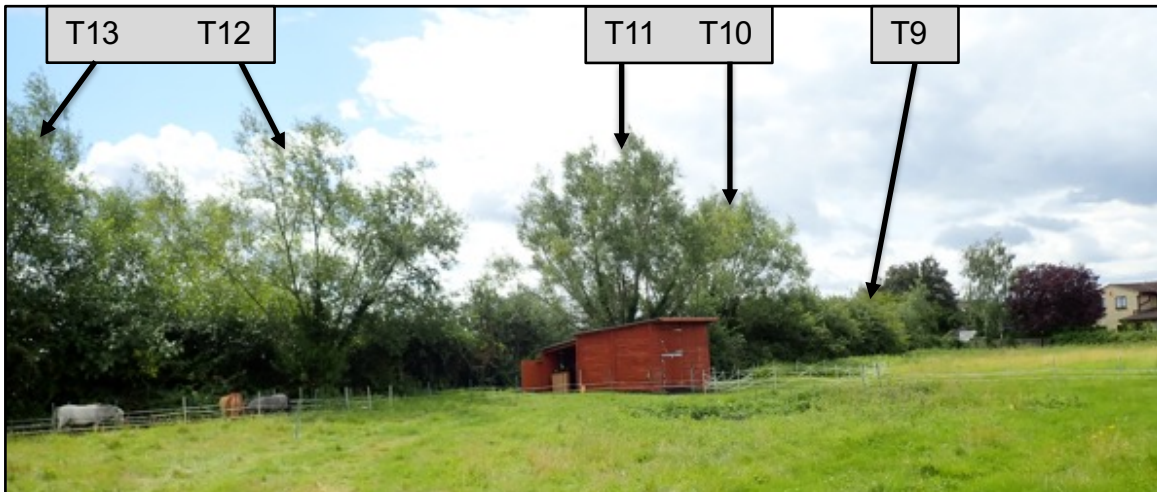
| Tree/<br>Group<br>No. | Species | Height<br>(m) | Stem<br>Diam. at<br>1.5m<br>(mm) | Branch Spread (m) | | | | Canopy<br>Clearance<br>(m) | Age<br>Class | Observations | Management<br>Recommendations | Estimated<br>Remaining<br>Contribution<br>(years) | BS 5837<br>Category<br>Grading | Protect-<br>ion<br>Distance<br>(m) | Root<br>Protect.<br>Area<br>(m2) |
|---|---|---|---|---|---|---|---|---|---|---|---|---|---|---|---|
| T10 | Crack willow | 9.5 | est 1010 | 5.5 | 3.5 | 4 | 5 | 3.5 | Mature | Growing through hedgerow - base not inspected. Two stems - est 600 & 900mm, with larger stem leaning. Further outward leaning stems from base. Previously topped, now with fresh growth but stem attachment points obscured by ivy. | Remove to allow creation of new access. | 10-20 | C3 | 12.1 | 461 |
| T11 | Crack willow | 11.5 | est 1000 | 5.5 | 5 | 8 | 4 | 5.5 | Mature | Growing through hedgerow - base not inspected. Previously topped at approx 2.5m. Decay points in basal stem. At risk from future stem breakout from weak attachment points. | Remove to allow creation of new access. | 10-20 | C3 | 12.0 | 452 |

View of hedgerow G8, with crack willow growing through. T10 and T11 proposed for removal to allow creation of new access for residential development.

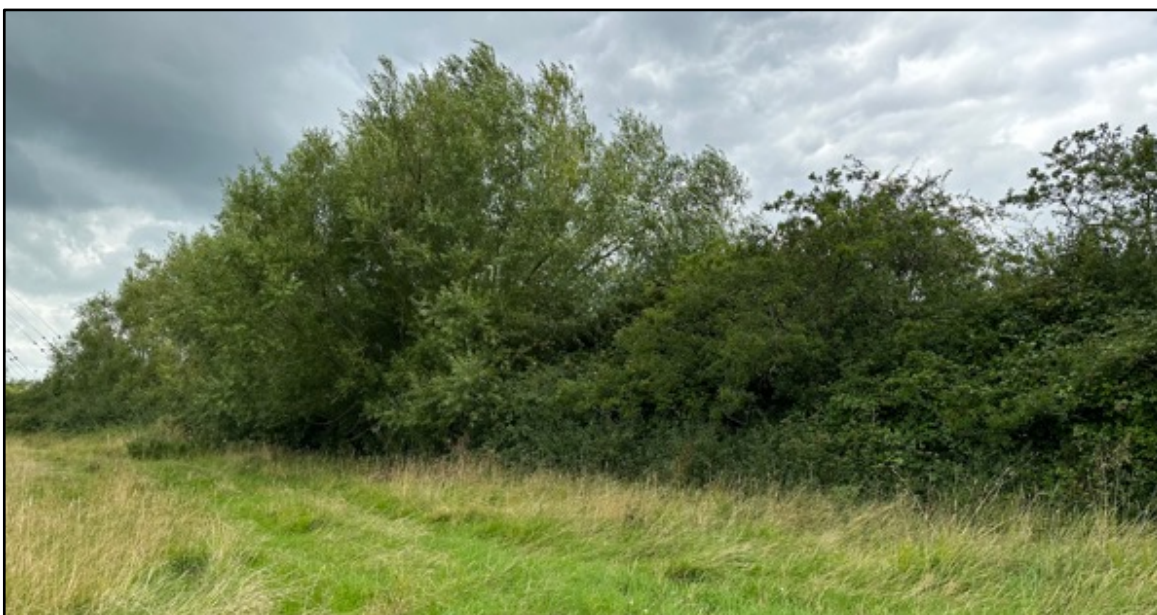
View of hedgerow G8, looking to west, viewed from southern site area, where new dwellings are proposed. Majority of hedgerow is to be retained.

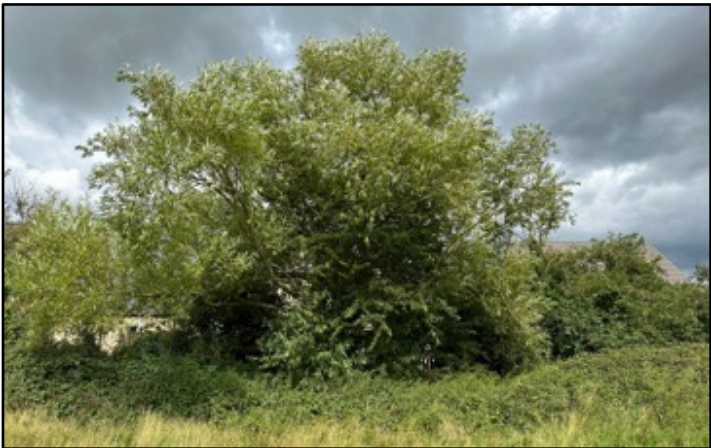
| Tree/<br>Group<br>No. | Species | Height<br>(m) | Stem<br>Diam. at<br>1.5m<br>(mm) | Branch Spread (m) | | | | Canopy<br>Clearance<br>(m) | Age<br>Class | Observations | Management<br>Recommendations | Estimated<br>Remaining<br>Contribution<br>(years) | BS 5837<br>Category<br>Grading | Protect-<br>ion<br>Distance<br>(m) | Root<br>Protect.<br>Area<br>(m2) |
|---|---|---|---|---|---|---|---|---|---|---|---|---|---|---|---|
| T23 | Crack willow | 9 | est 320 | 6 | 6 | 5 | 5.5 | 1.8 | Early mature | In area of dense vegetation - base not inspected. Low lateral to west reduced to long stub at approx 0.7m. | | 20-40 | B2 | 3.8 | 46 |

Bottom right: Crack willow T23.
