**Subject:** FW: PL/2023/09142 MOTO Service Station

For the attention of Olivia Trieste New Material Evidence provided by Linda Pryde 25, Brimble Hill, Wroughton, Wilts SN4 0RQ.

New Evidence

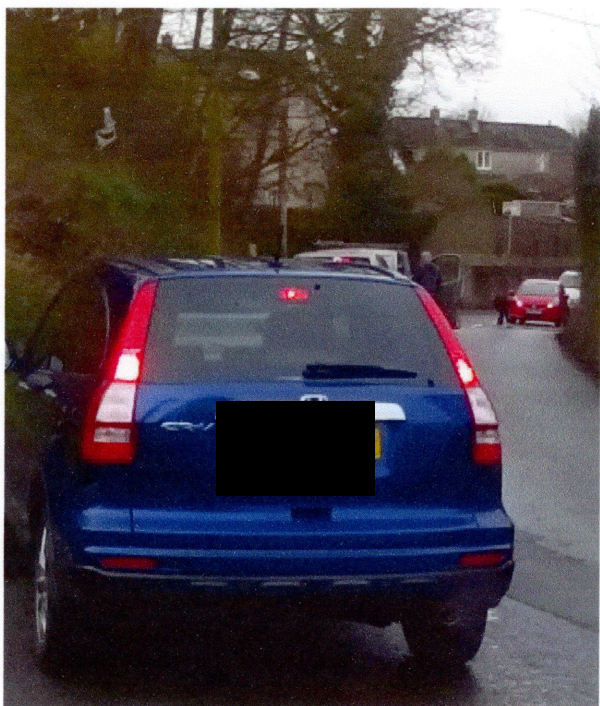
Above Left: Drivers cleaning debris from road. No injuries this time when tree trunk fell from high dry stone wall (above right).

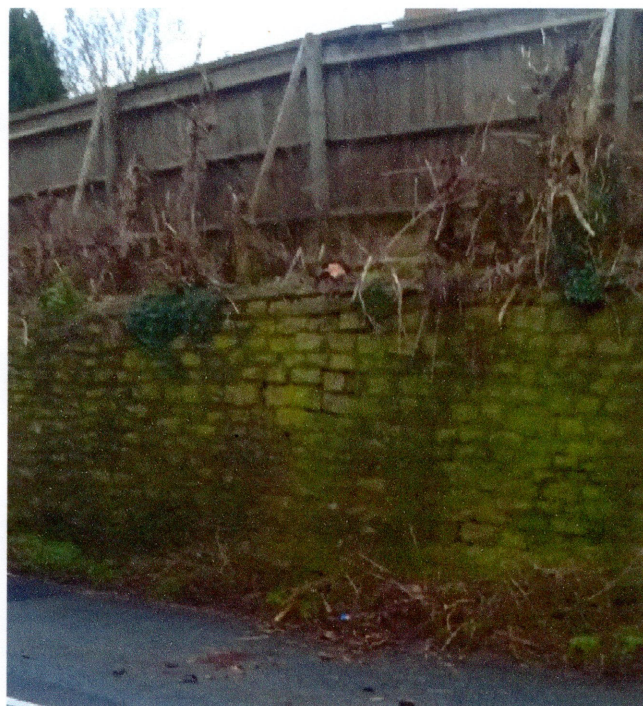
Above Right. Side effect on road with severe camber. The top of a large vehicle can lean up to 25cm (approx 10inches). Drivers need to 'choose position' to ensure it will not collide with buildings, other vehicles or street furniture. NOTE you can see from the end of trunk that the tree was alive. The road is too narrow for driver to choose position of lorry therefore has to cause damage. SOURCE Safediving for Life, partner of DVSA.

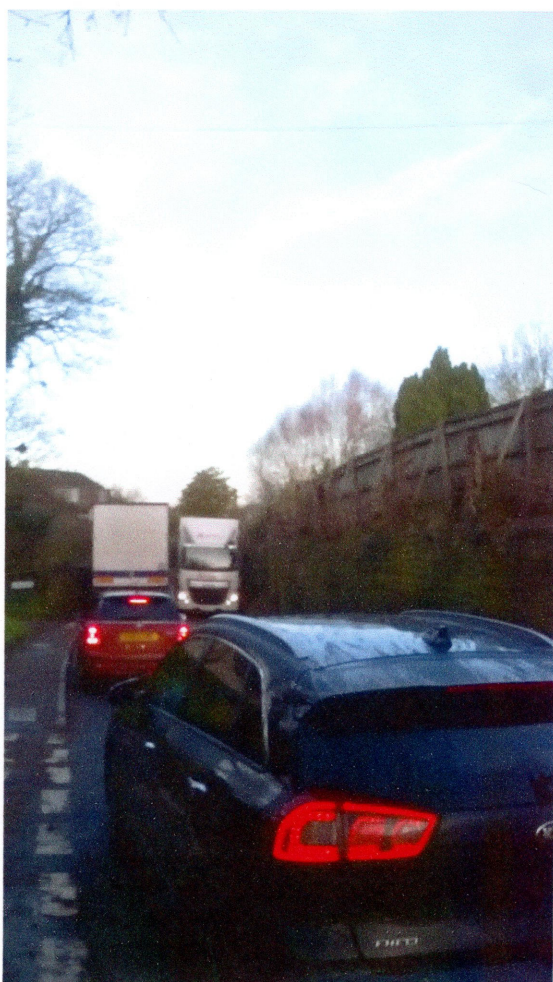
Left: Shows that HGVS do not have recommend passing width.

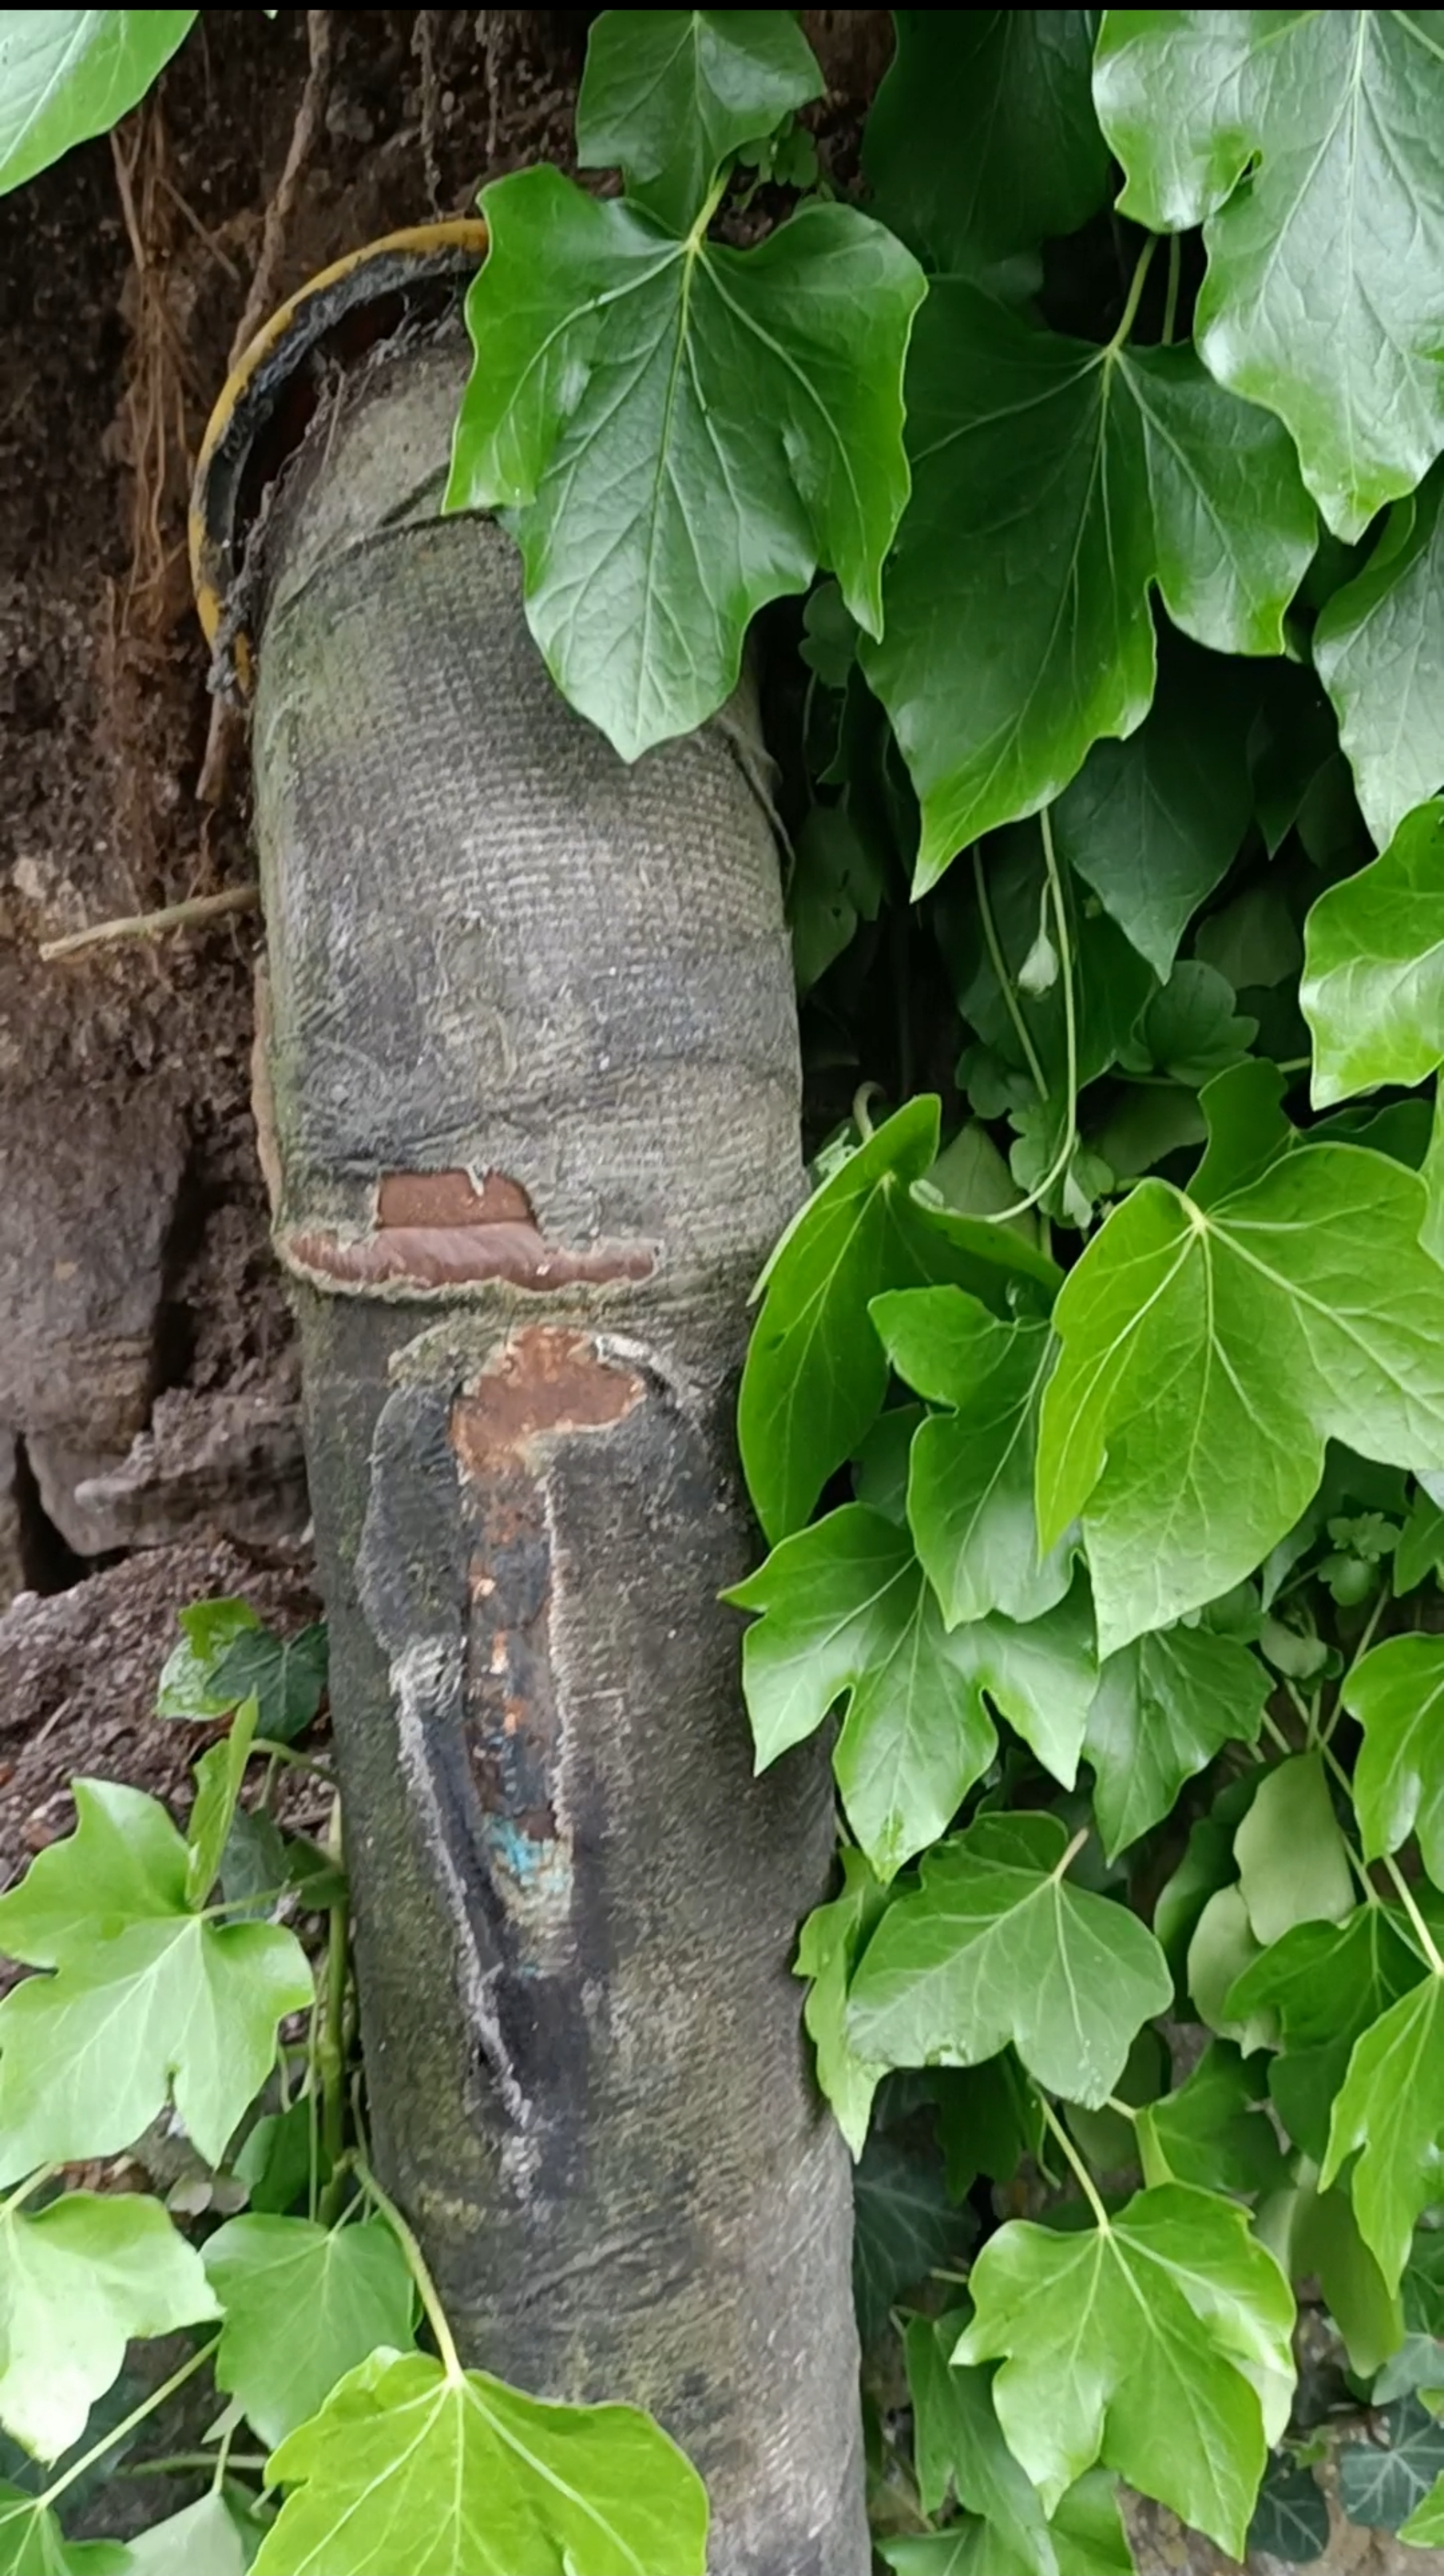
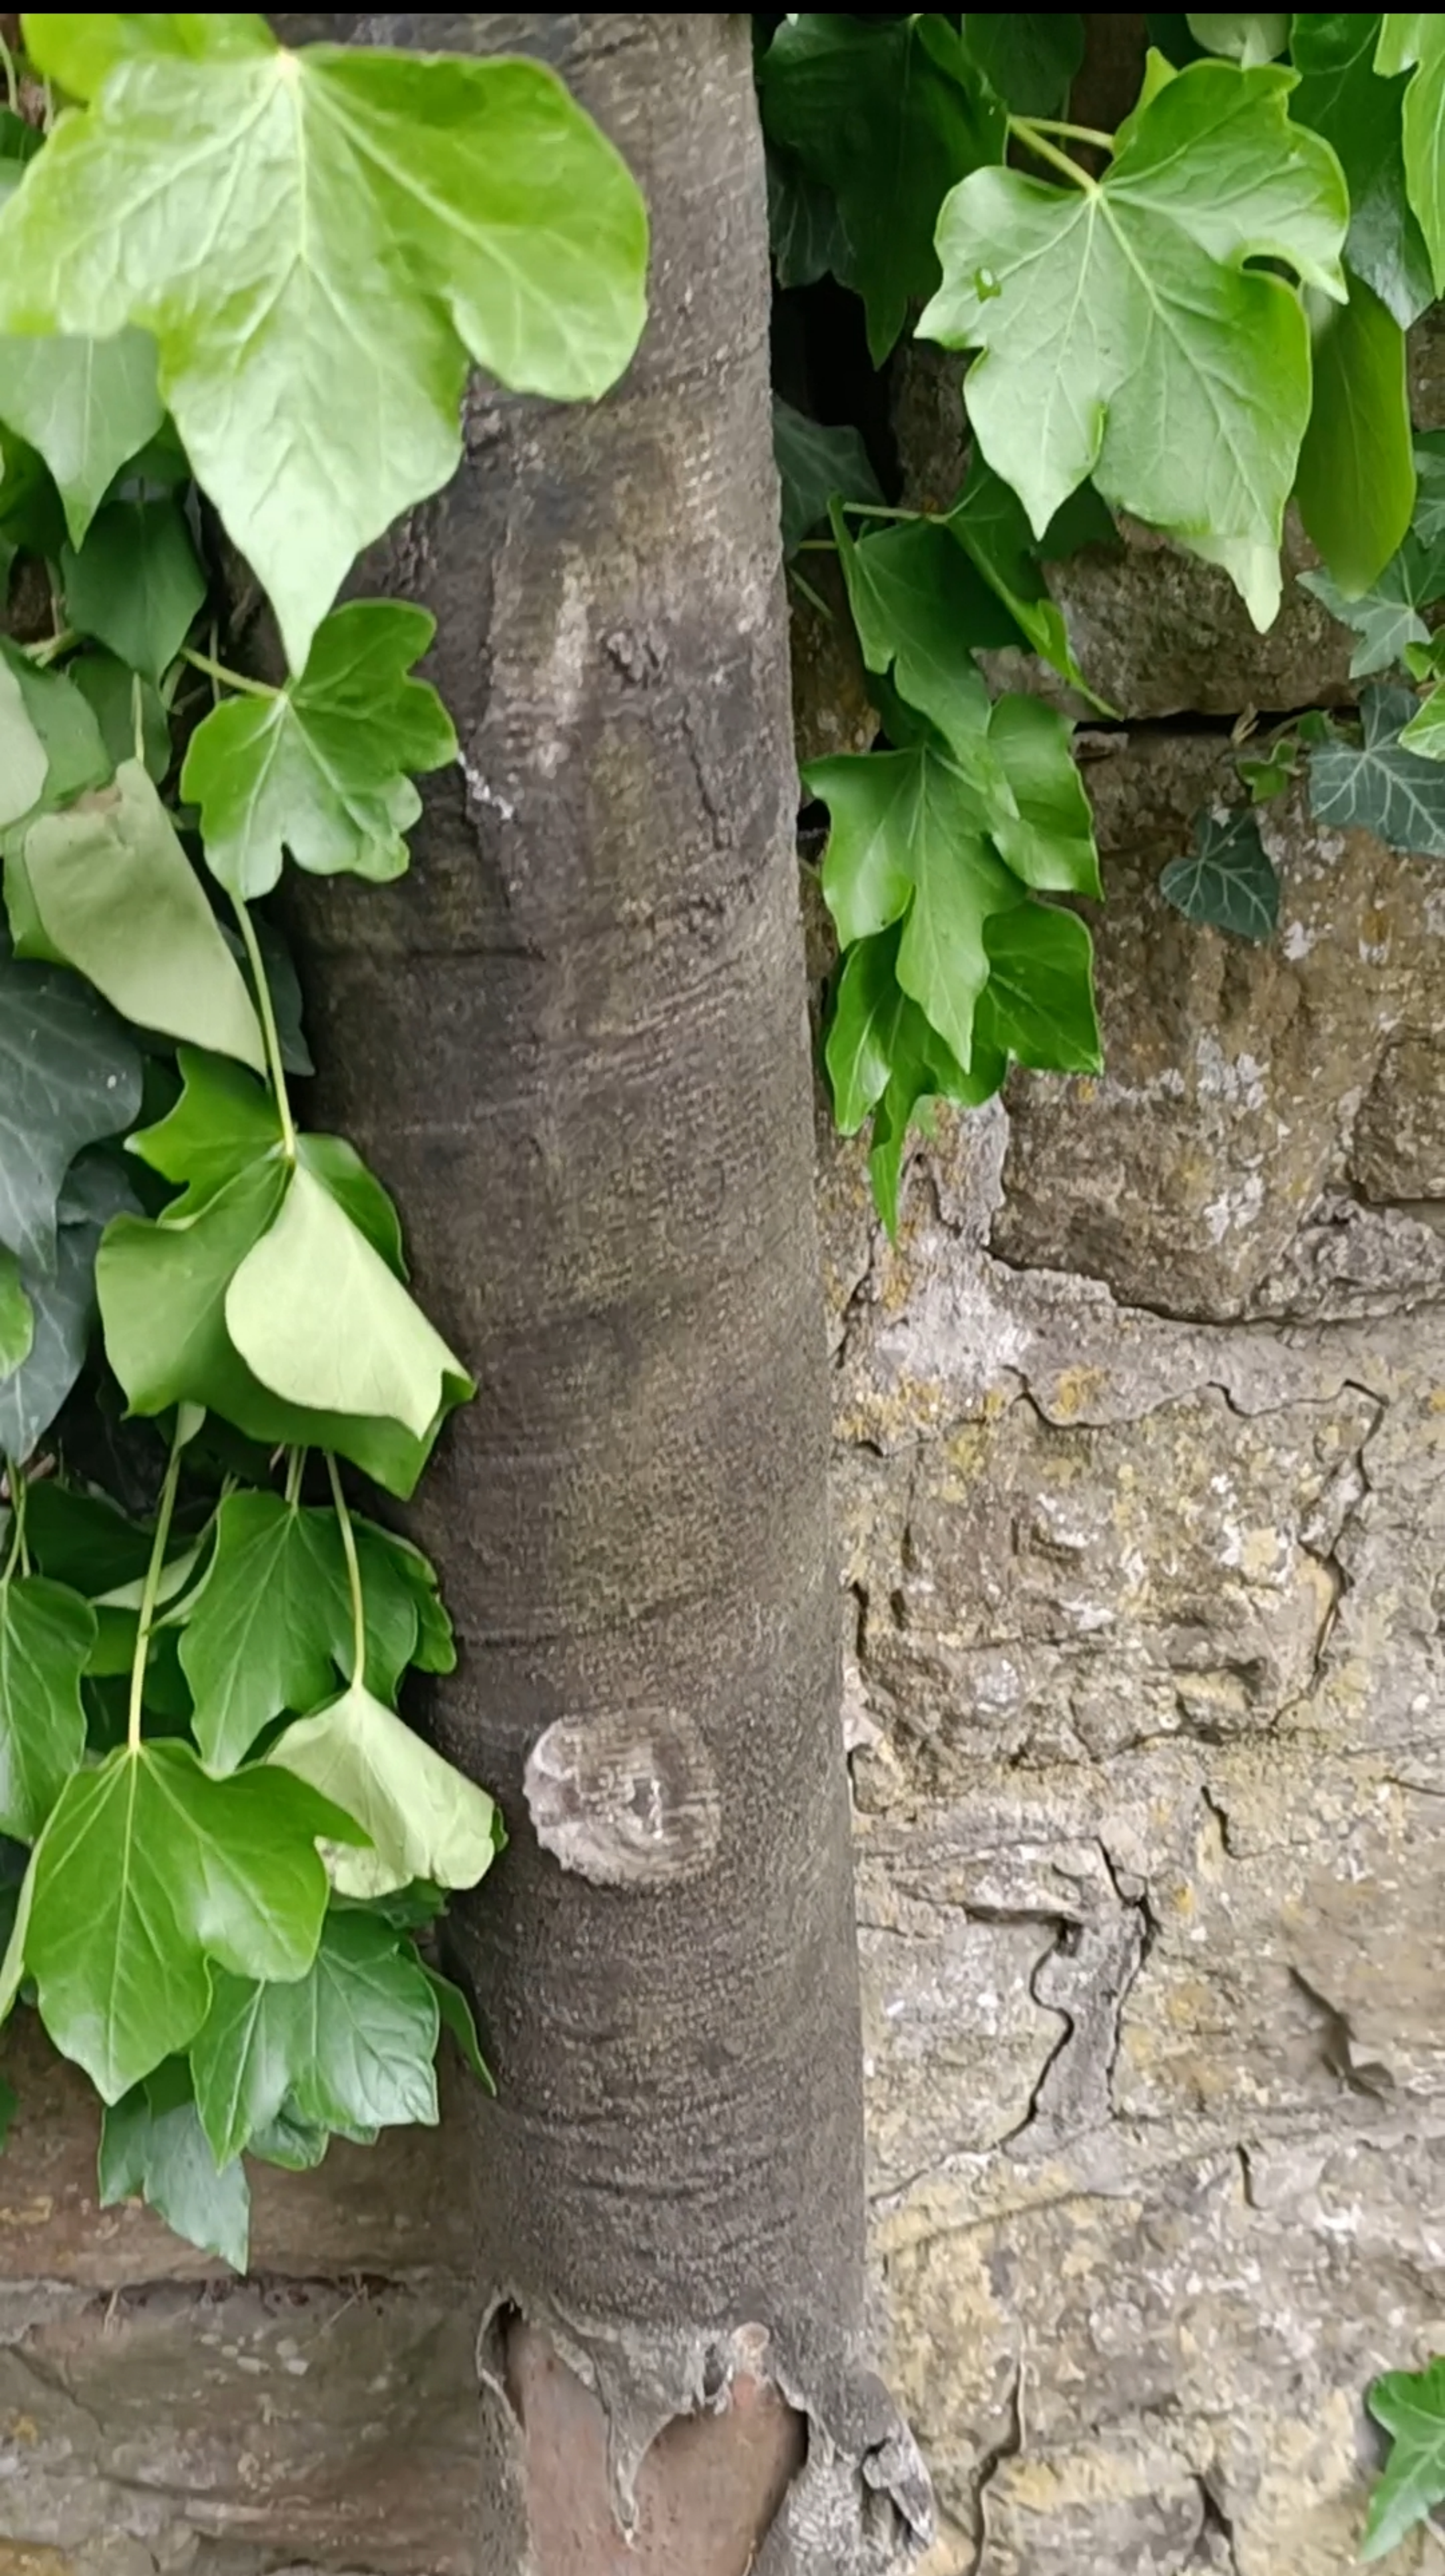
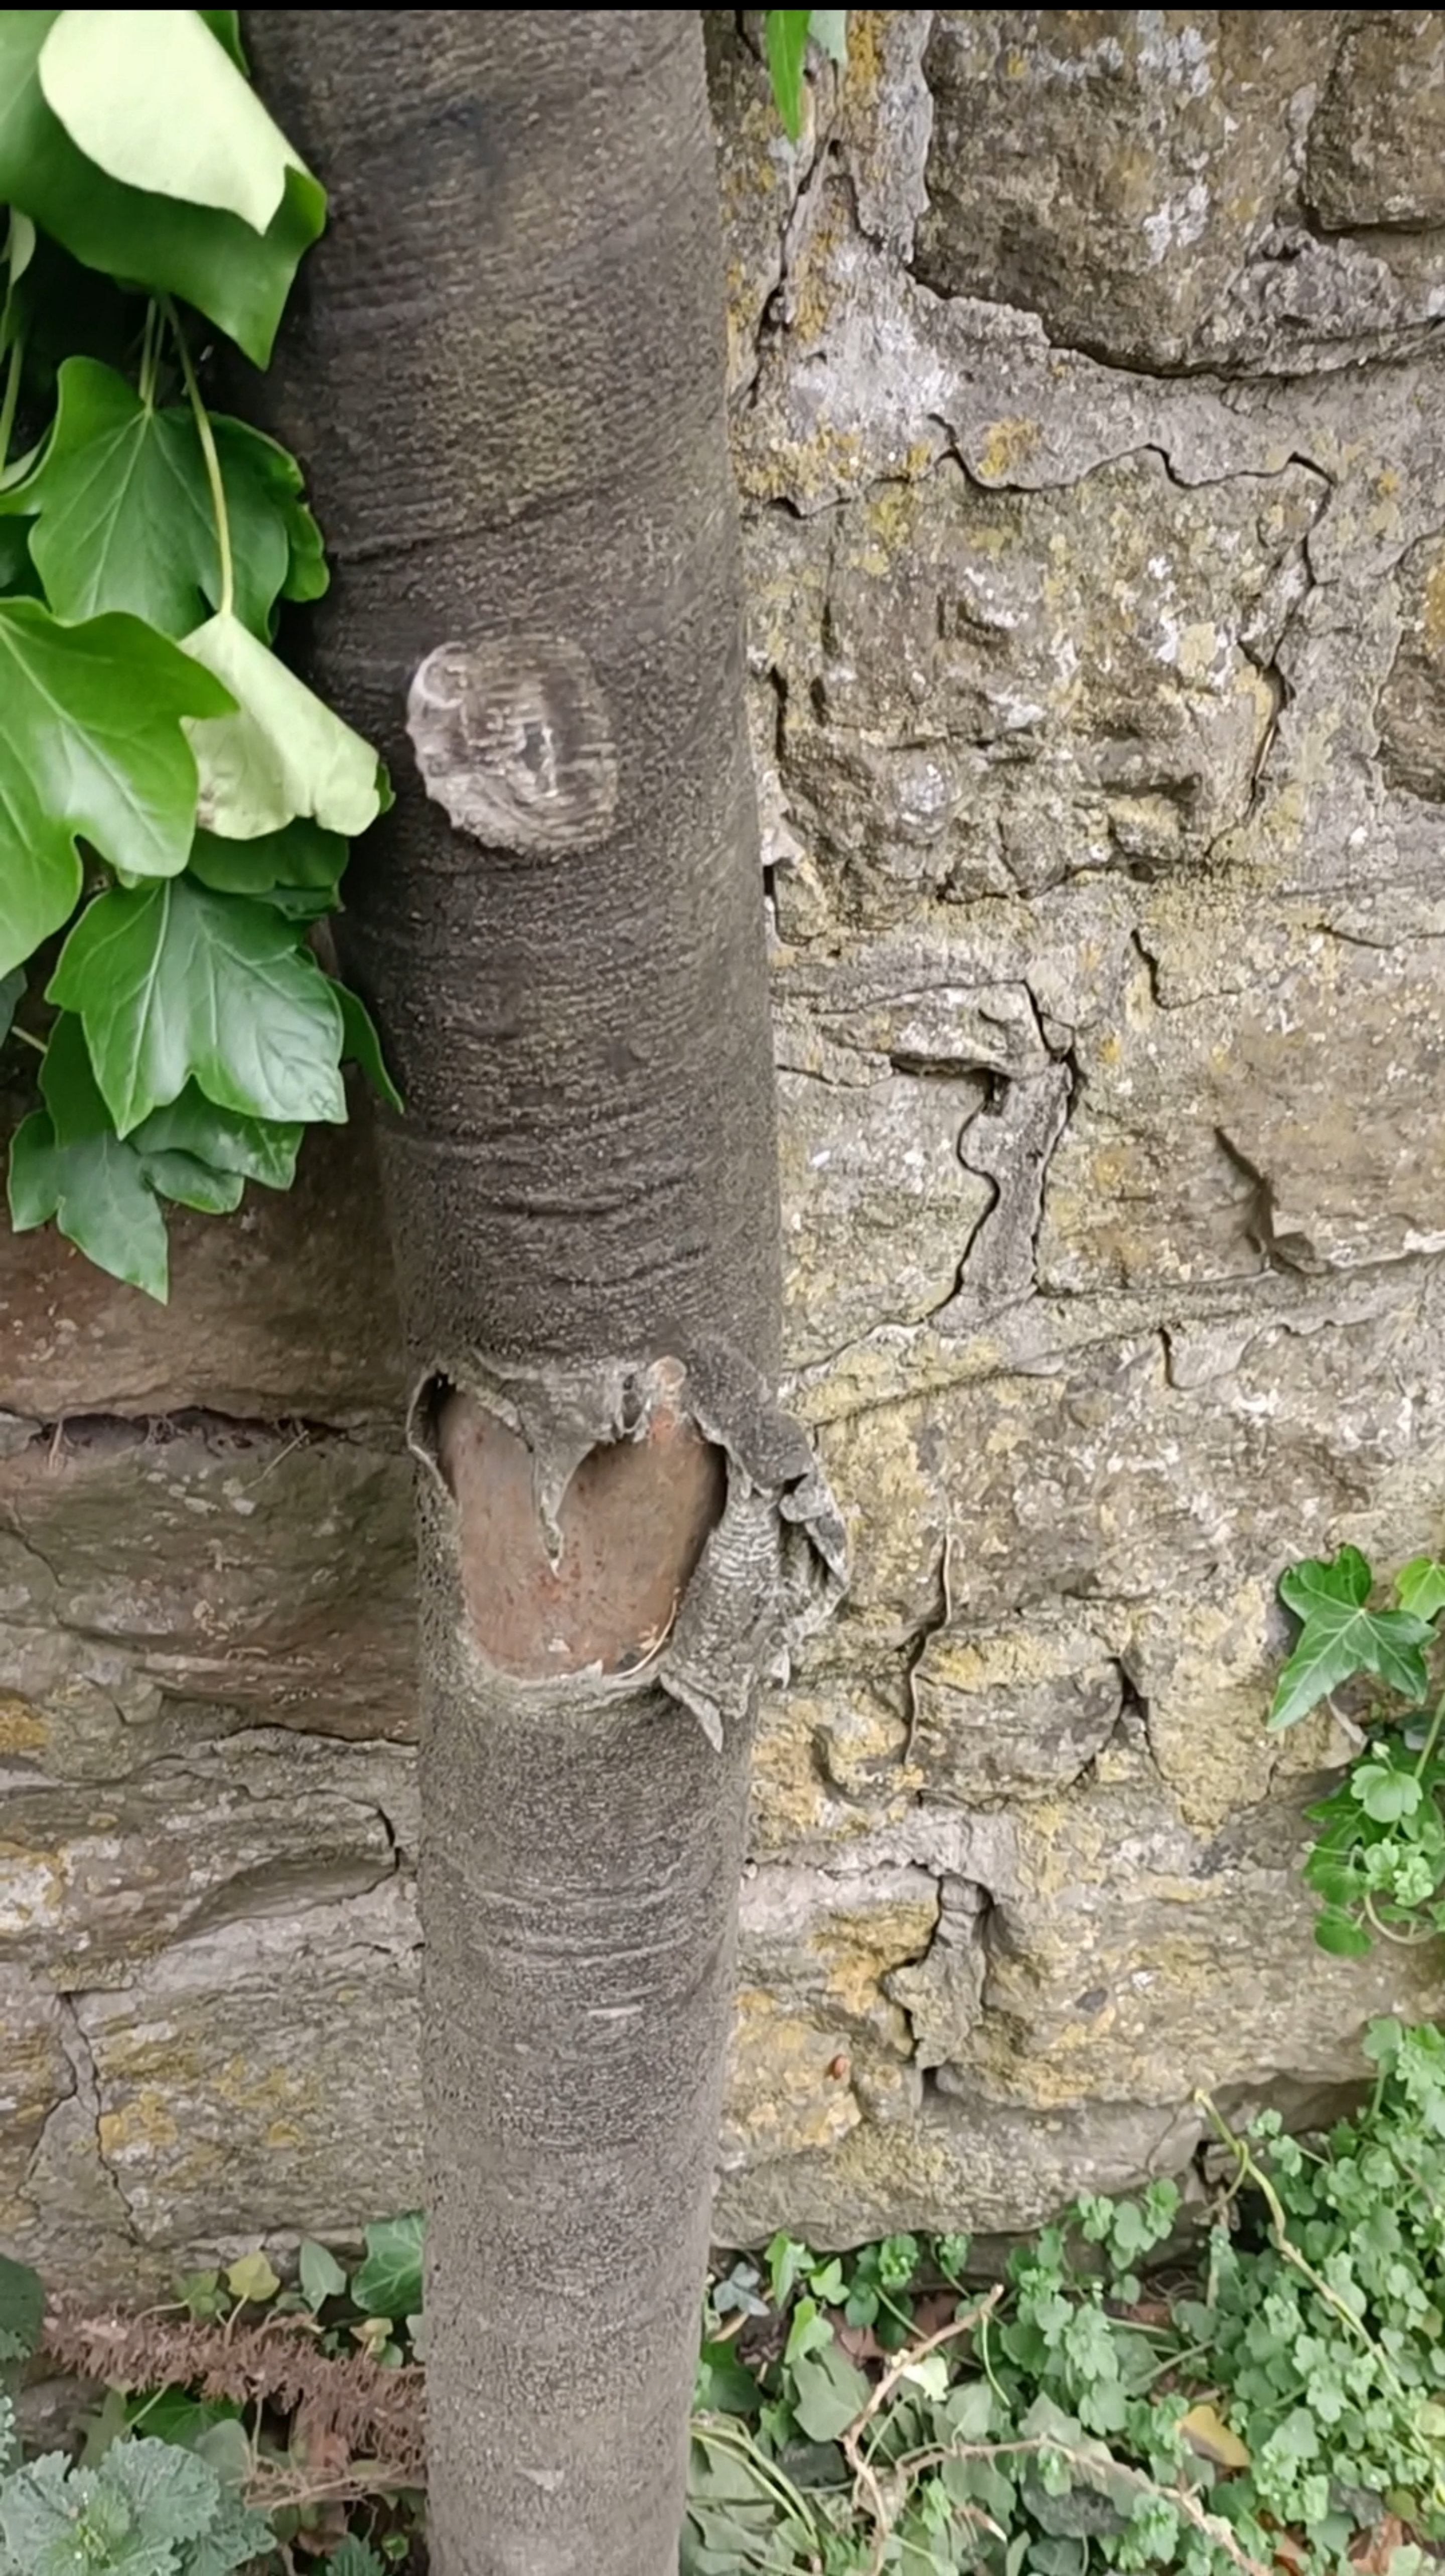
Omitted from the report due to the unknown danger at the time it was composed, is the damage to a live gas pipe. The damage done to the pipe being hit numerous times. Due to the narrowness of the unsuitable use by heavy goods vehicles and even larger agricultural machinery. (Please see photographs below). The volume of LGVs vehicles are forced to mount the pavement, in order to navigate passed each other. Contrary to the Highway Code Code February 2002 that offers protection to non motorised vehicles. There is an abundance of evidence supporting the fact that the unsuitable large vehicles have repeatedly damaged the historic walls. A large section of wall has recently collapsed on Marlborough Road after being struck by an LGV due to the confinement of the road. Said vehicles are caged in on either side by high drystone walls. This also adds to the build up of carcinogenic pollutants.
