# LAND EAST OF SOUTHAMPTON ROAD, ALDERBURY

## Arboricultural Impact Assessment

JSL4528\_770  
Land northeast of  
Southampton Rd, Alderbury  
Arboricultural Impact  
Assessment  
Rev B  
Dec 2024

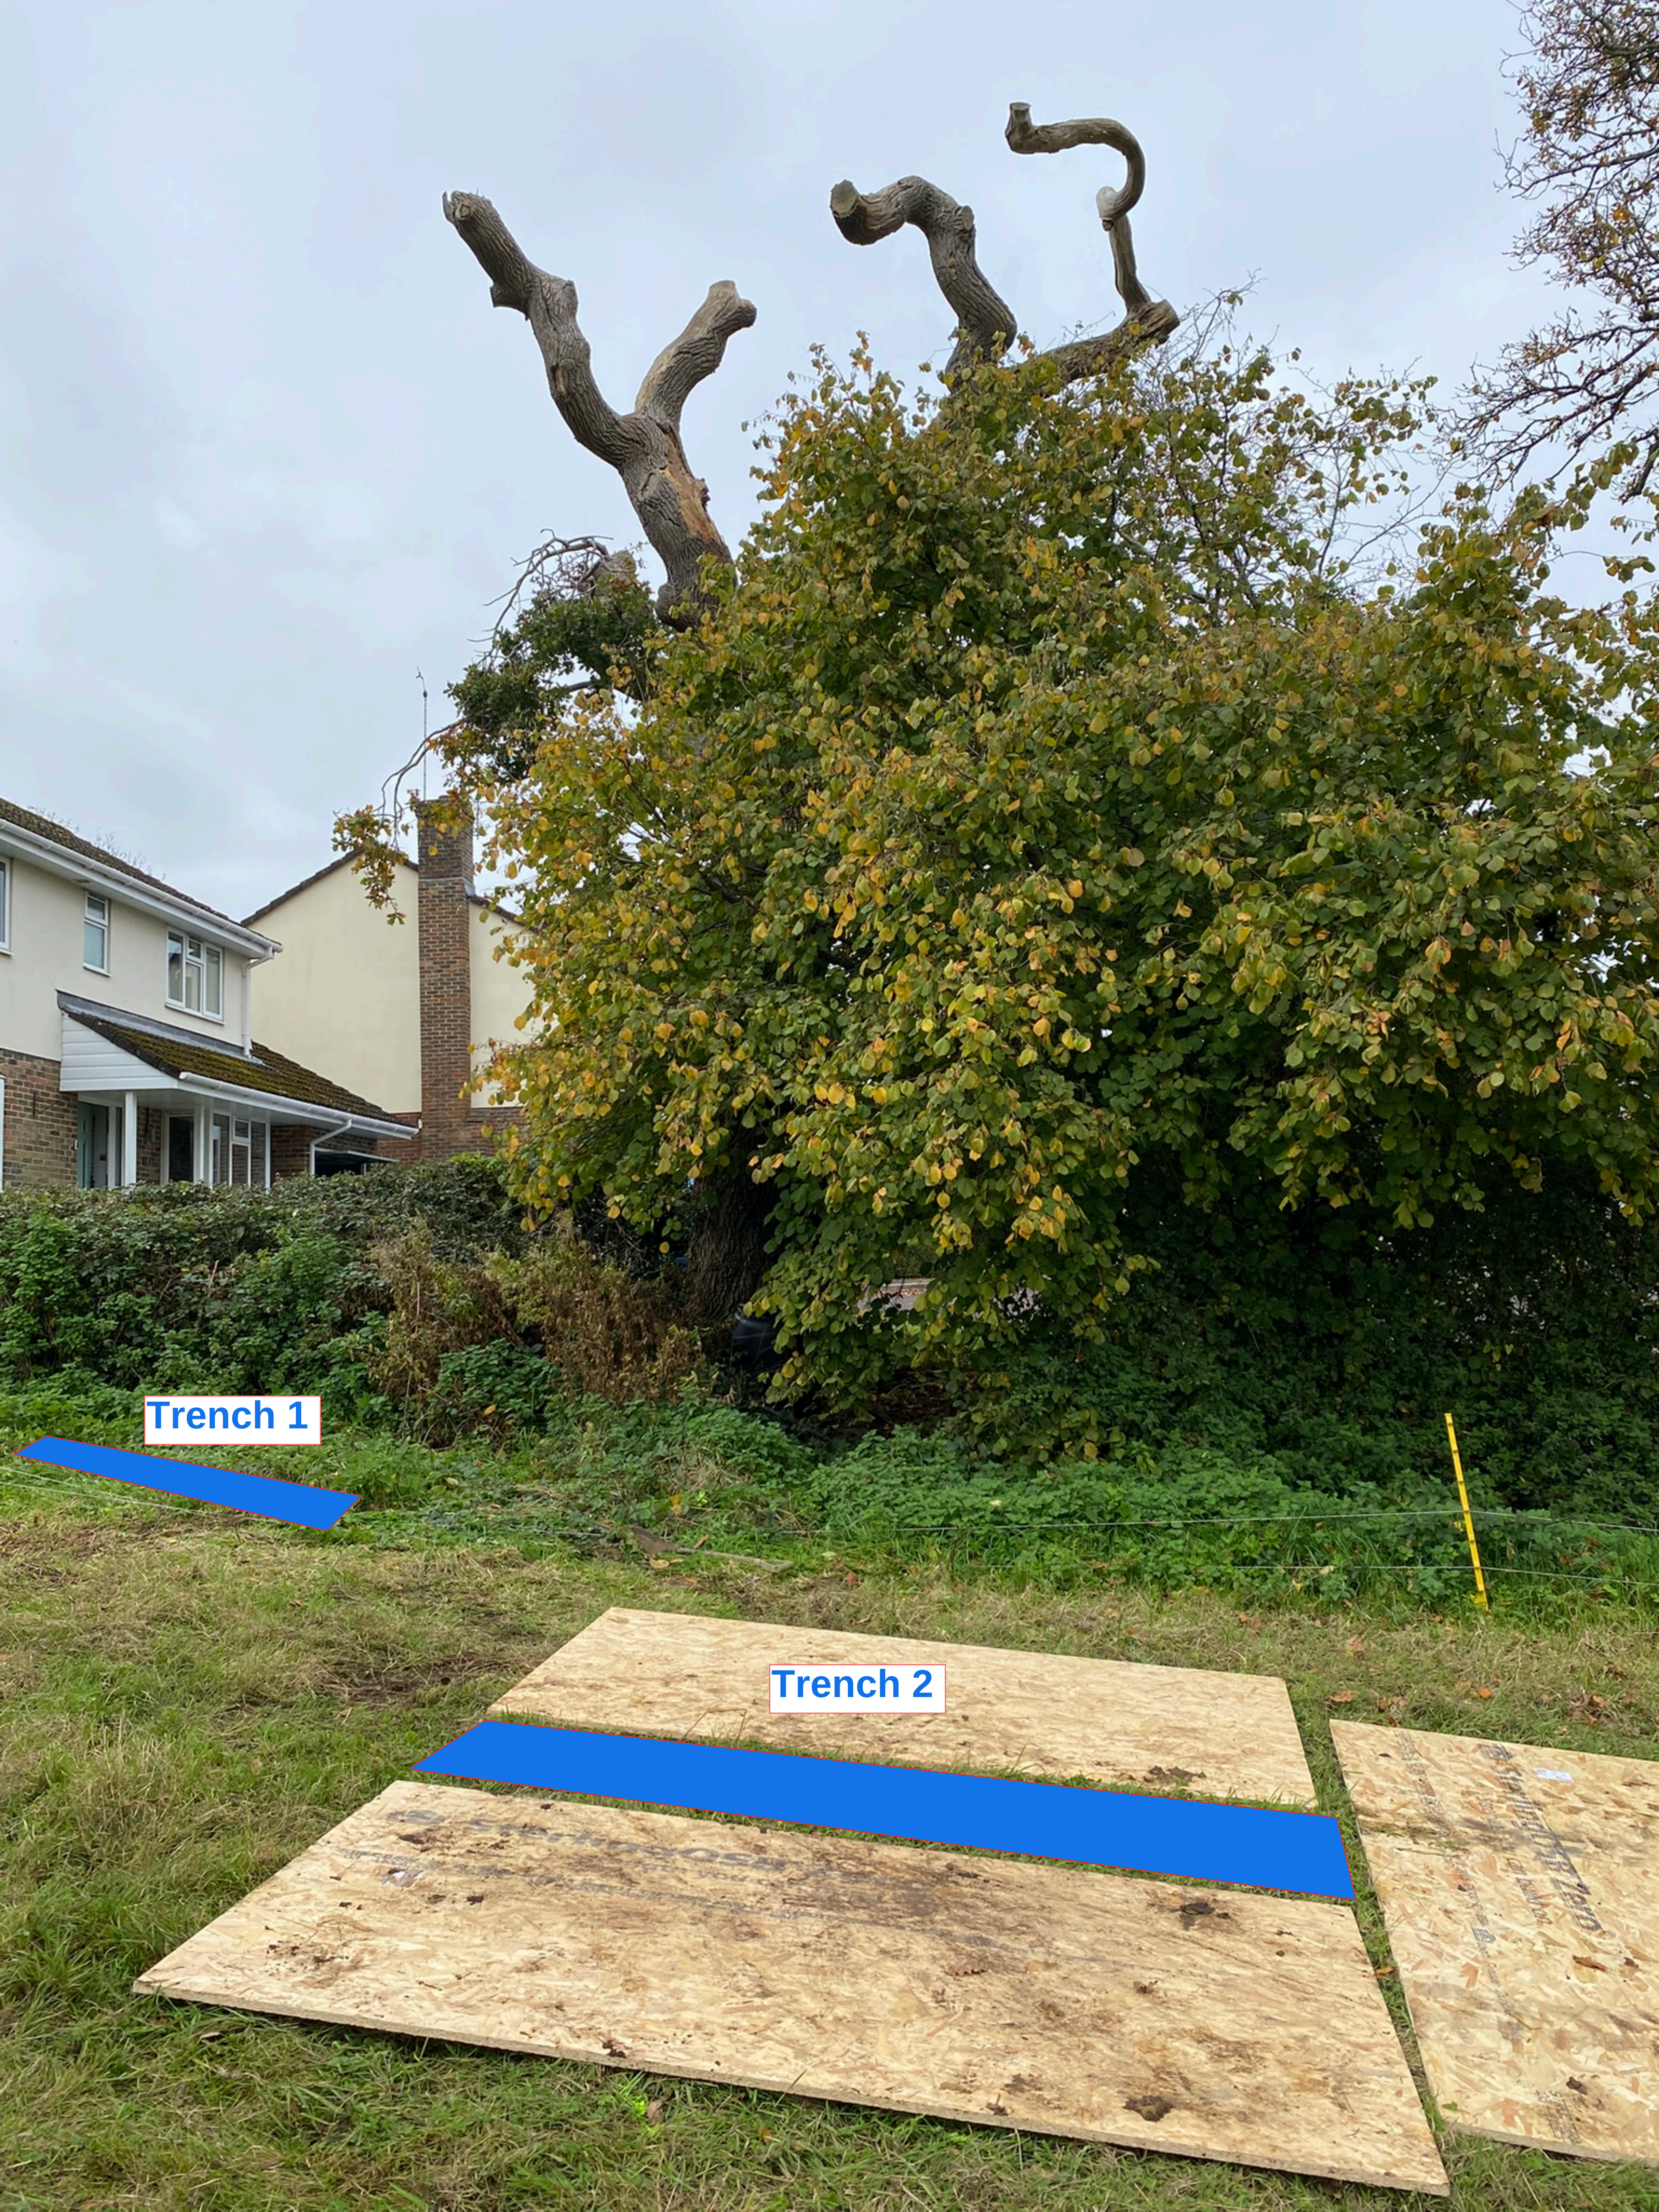
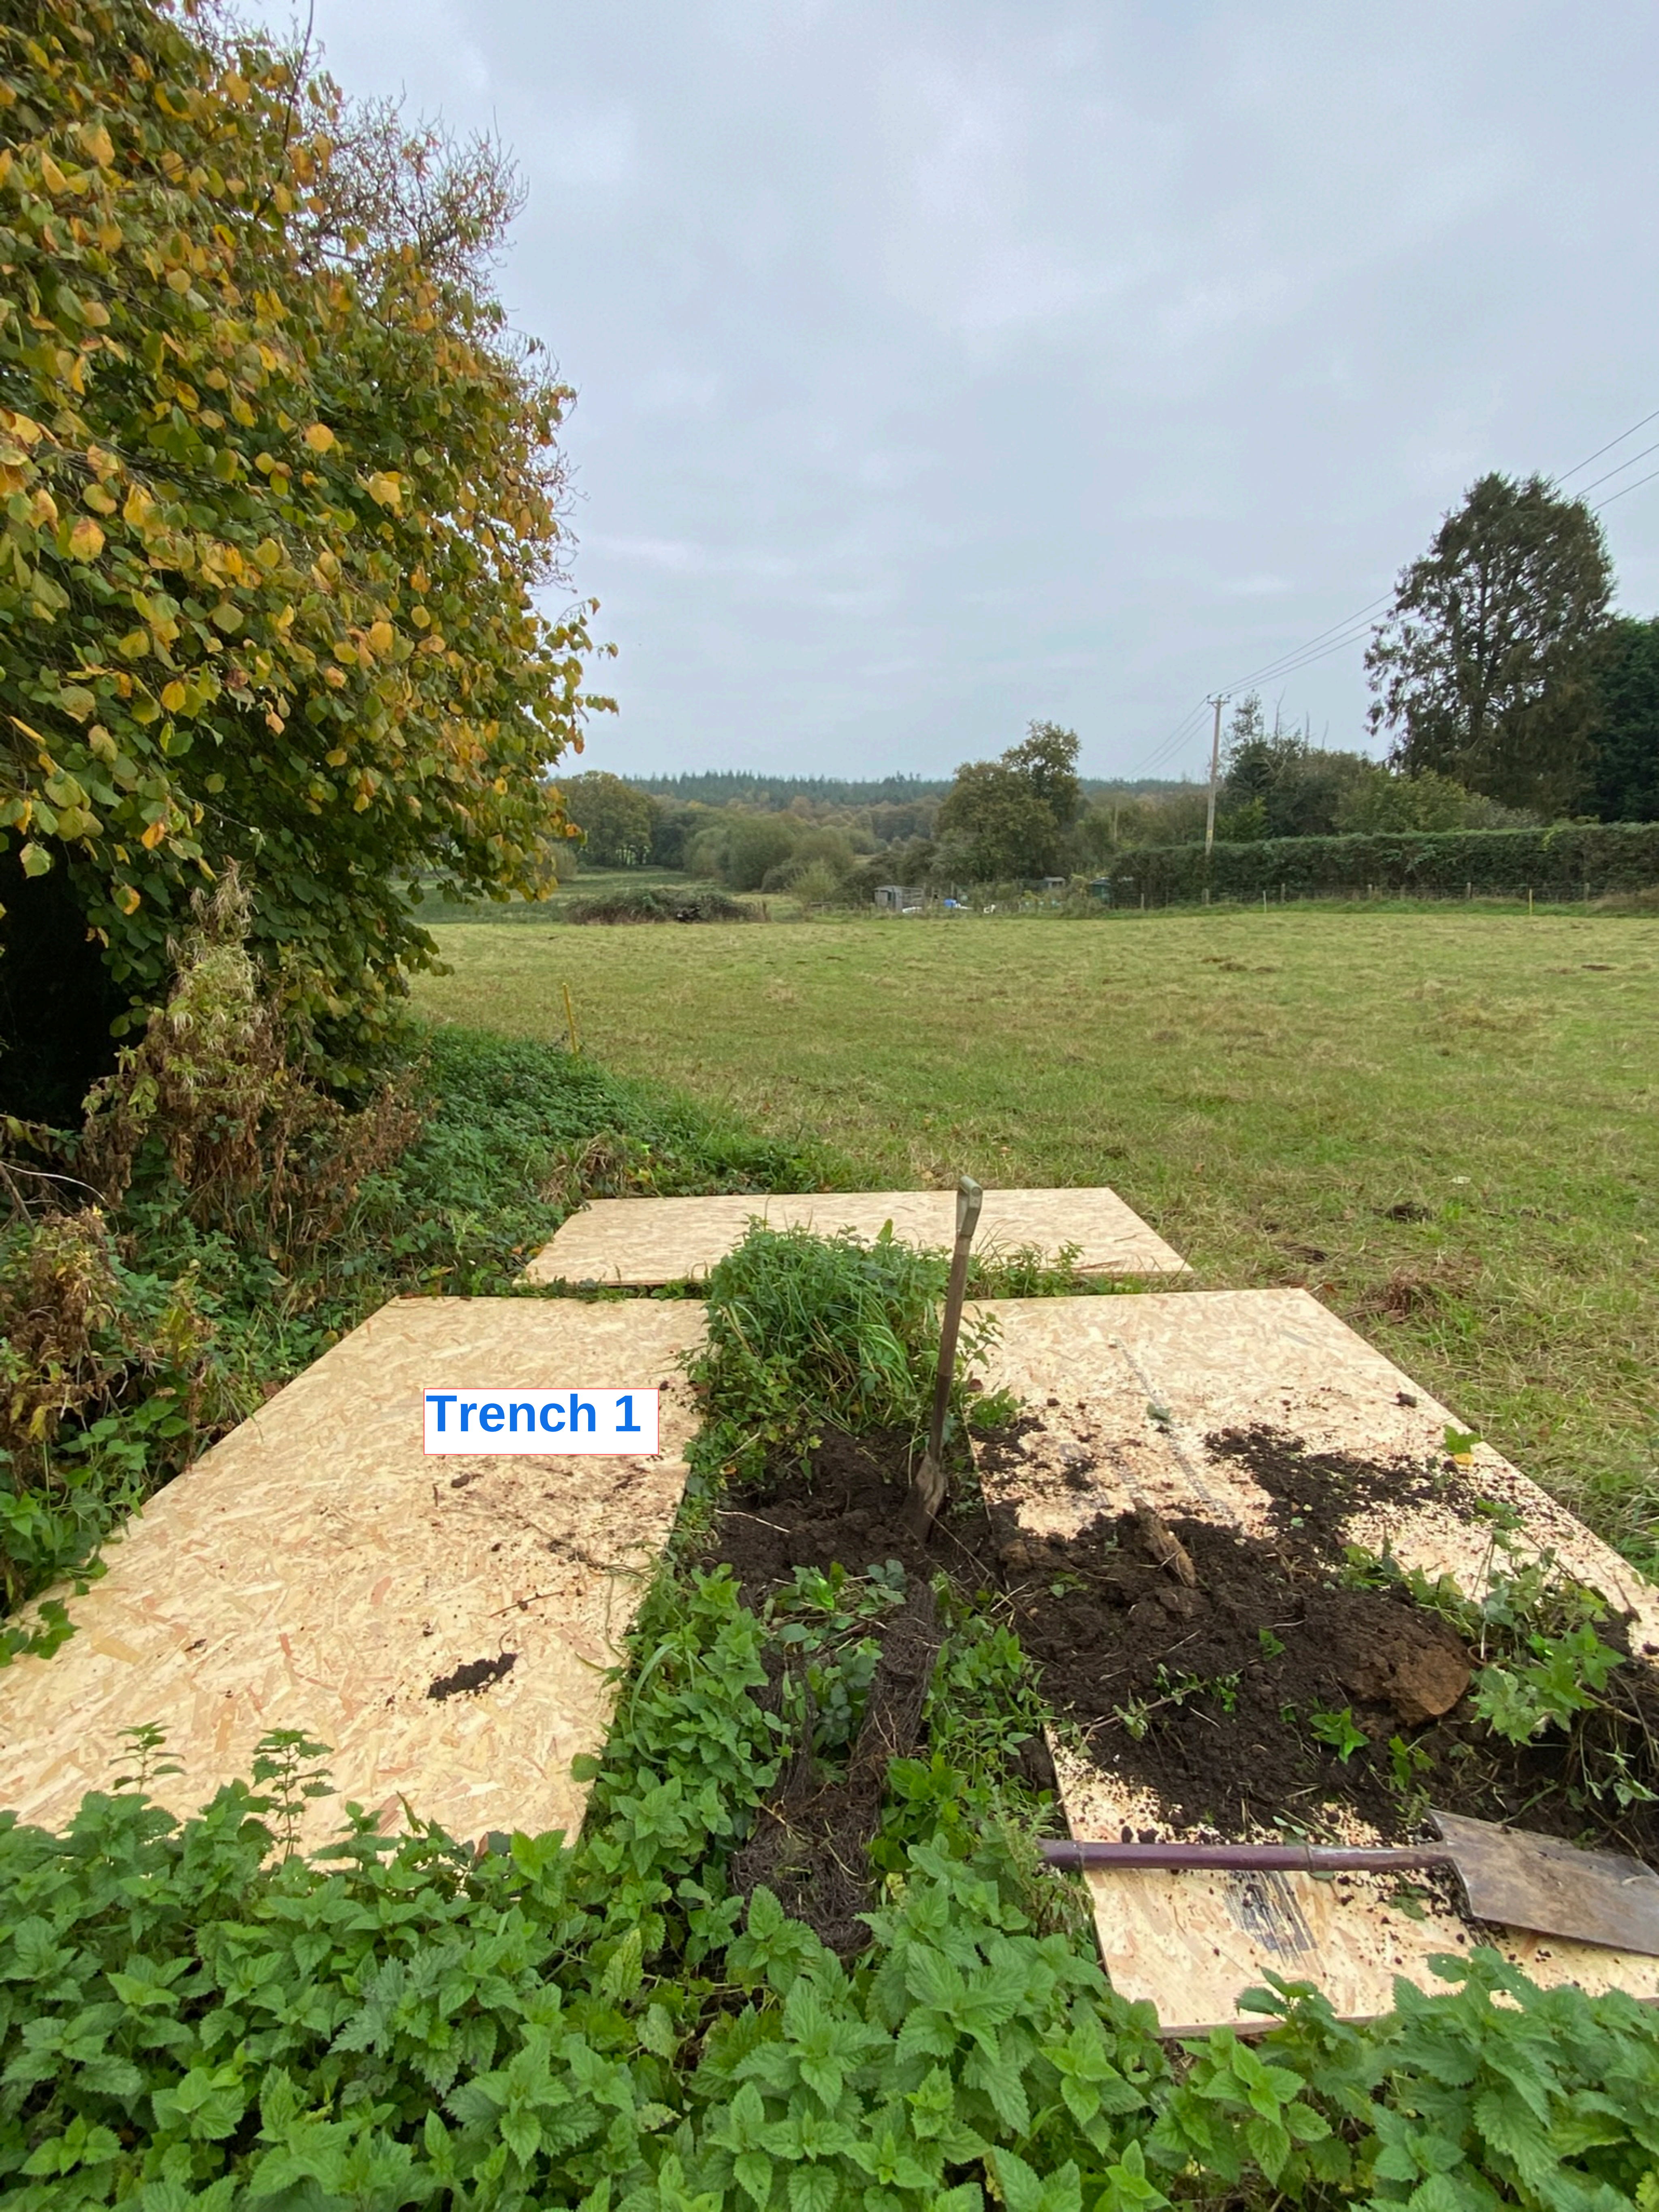
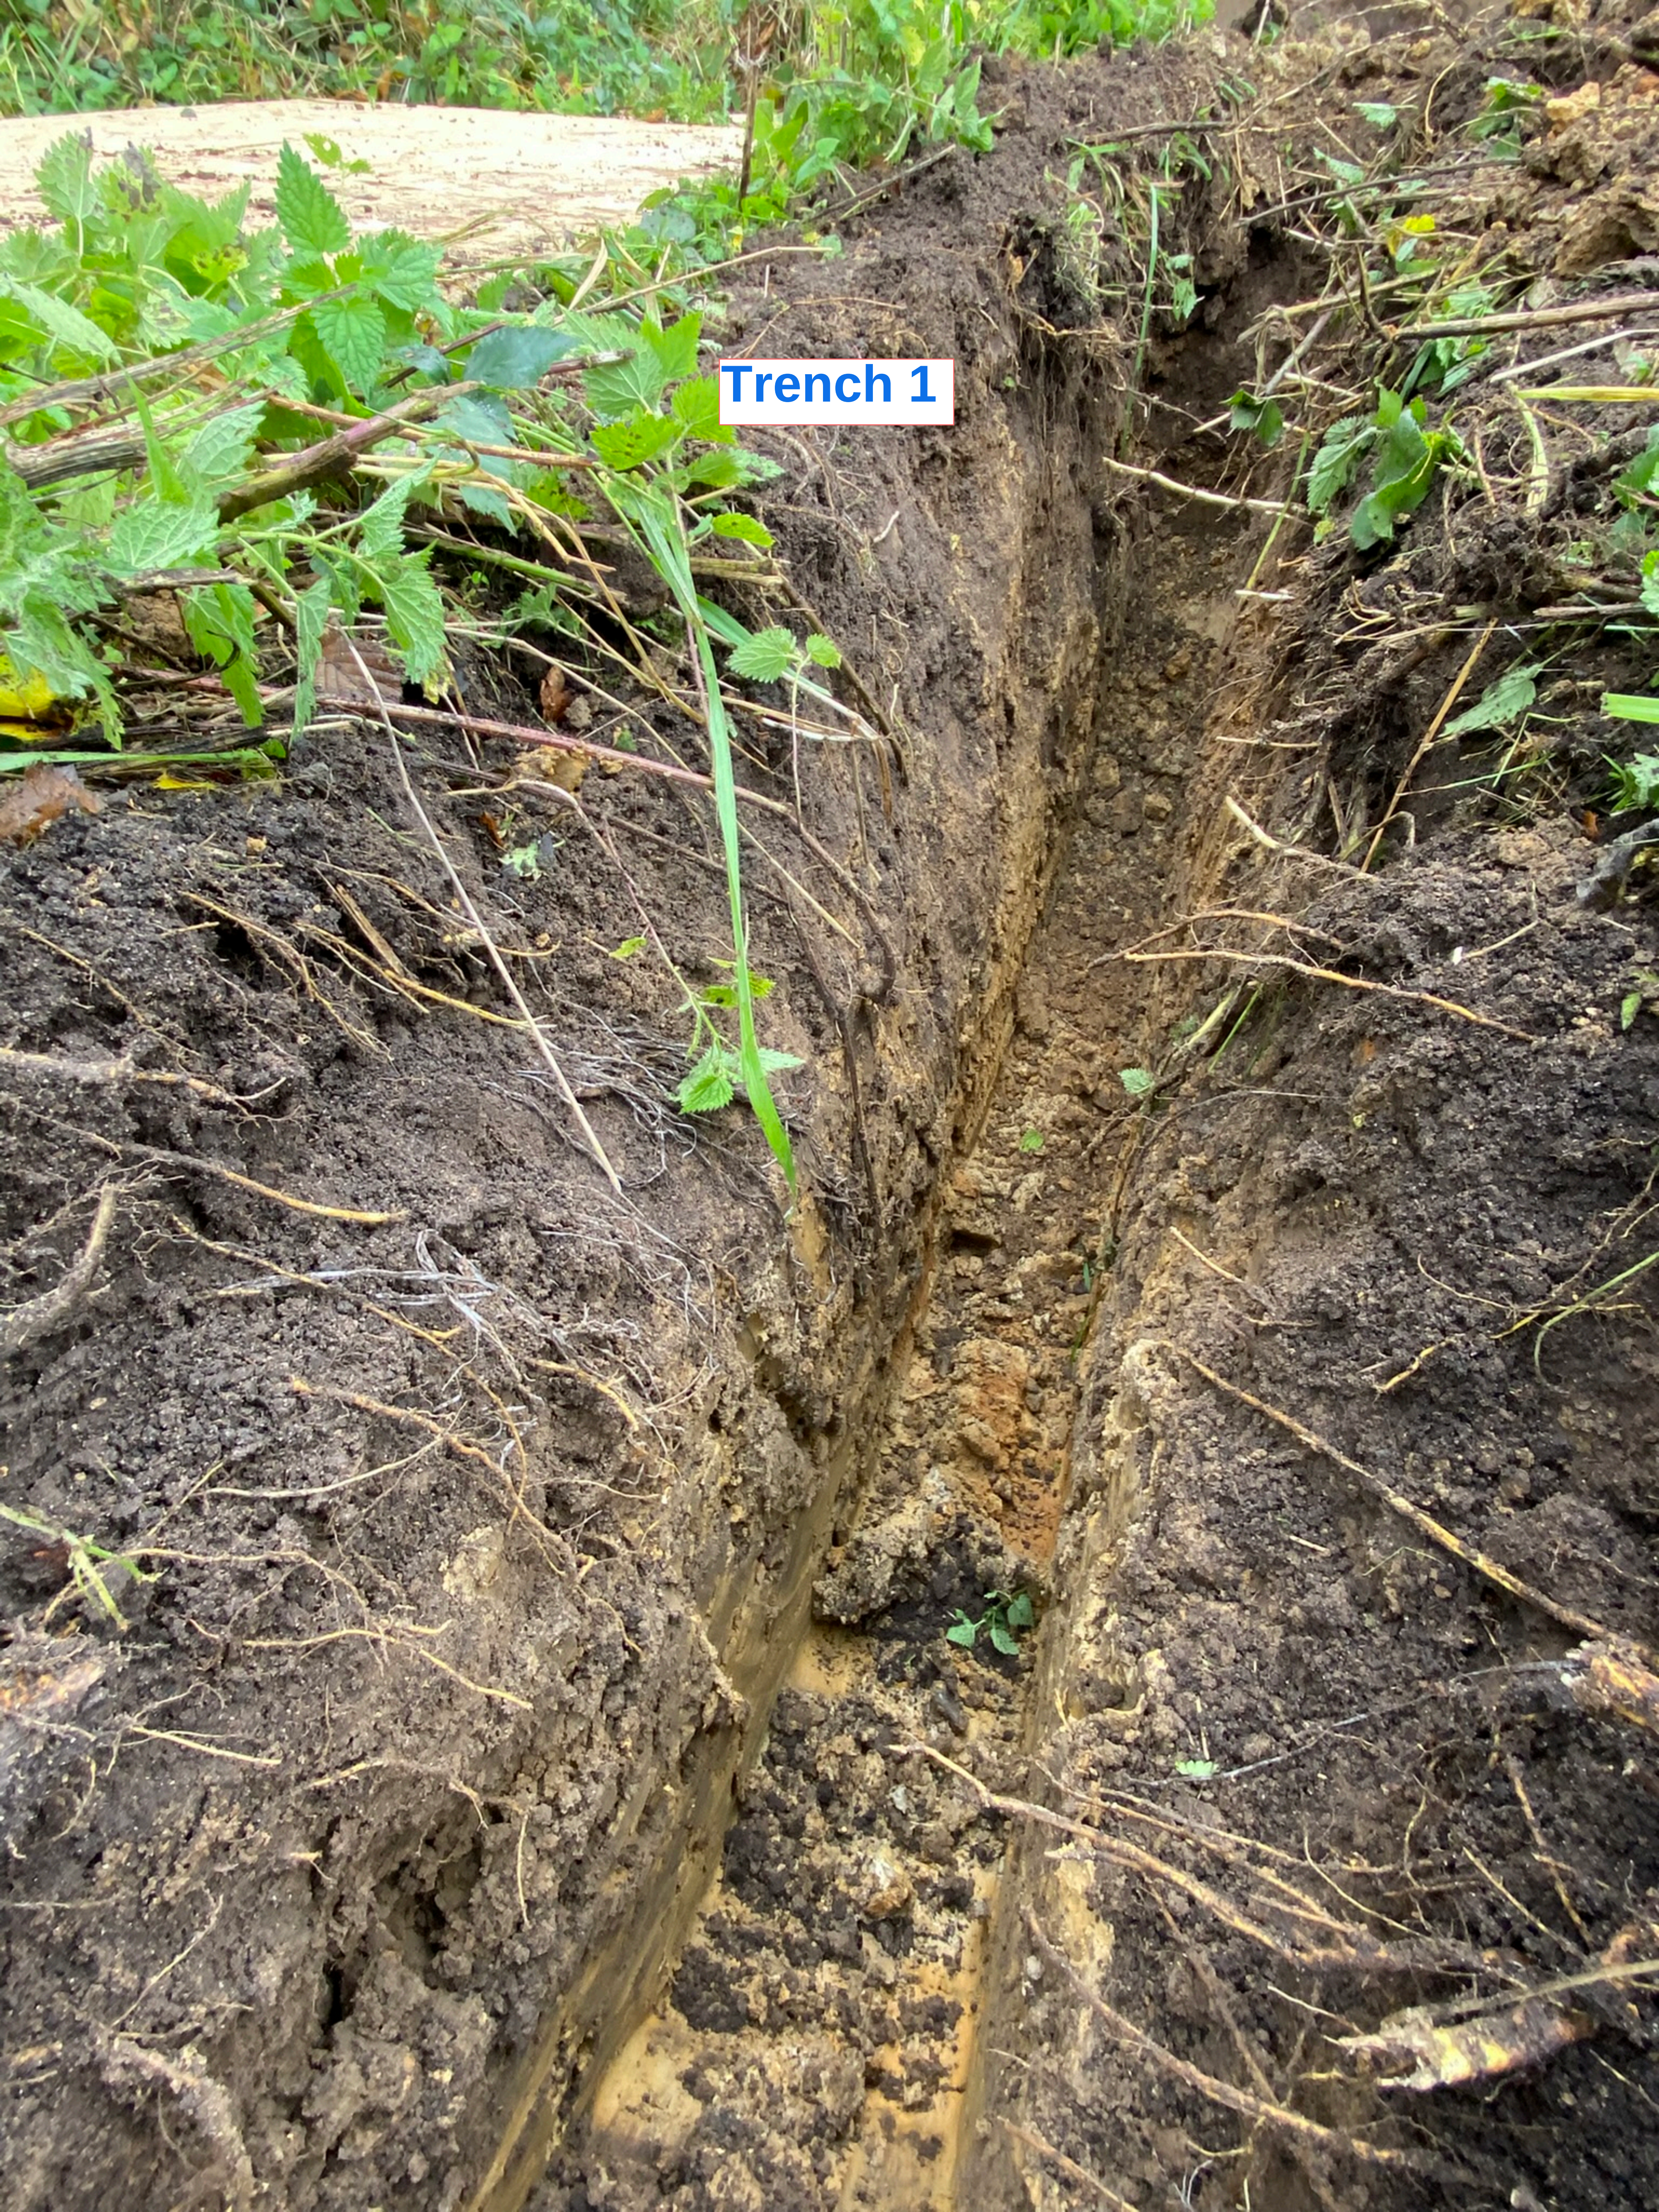
Trench 1

| Alderbury Rd | Type | Impact m2 | RPA | Percentage | Level |
|---|---|---|---|---|---|
| <p>T1 is in a significantly compromised condition, with its actual rooting area likely much smaller than the British Standard guidance. Two trial trenches, approximately 2m long and 800mm deep, were excavated under arboricultural supervision at the edge of the proposed road. No evidence of small or large roots was found in either trench. This supports the prediction that T1's root system has declined over many years, mirroring the tree's overall decline.</p> <p>Furthermore, the tree is practically dead, with only a few small live branches remaining. The root system required to support such minimal live growth is negligible. Another consideration is the impact of the excavation required to construct the road and whether it will affect the tree's structural integrity. The results from the trial trenches indicate that no loss of structural integrity is expected from the road construction. Please see appendix A for further detail.</p> | | | | | |

- 5.15 As highlighted in the Table of Proposed Impact – no roots of any significance were uncovered during the excavation. As such, the position of the road is unlikely to have any significant impact on the structural and/or physiological conditions of the tree.
