## Land at Biddestone Lane, Yatton Keynell, SN14 7BA

### Arboricultural Report containing:

*Prepared by:*  
**Deb Randall BSc TechArborA**  
**Arboricultural Consultant**  
**May 2024**

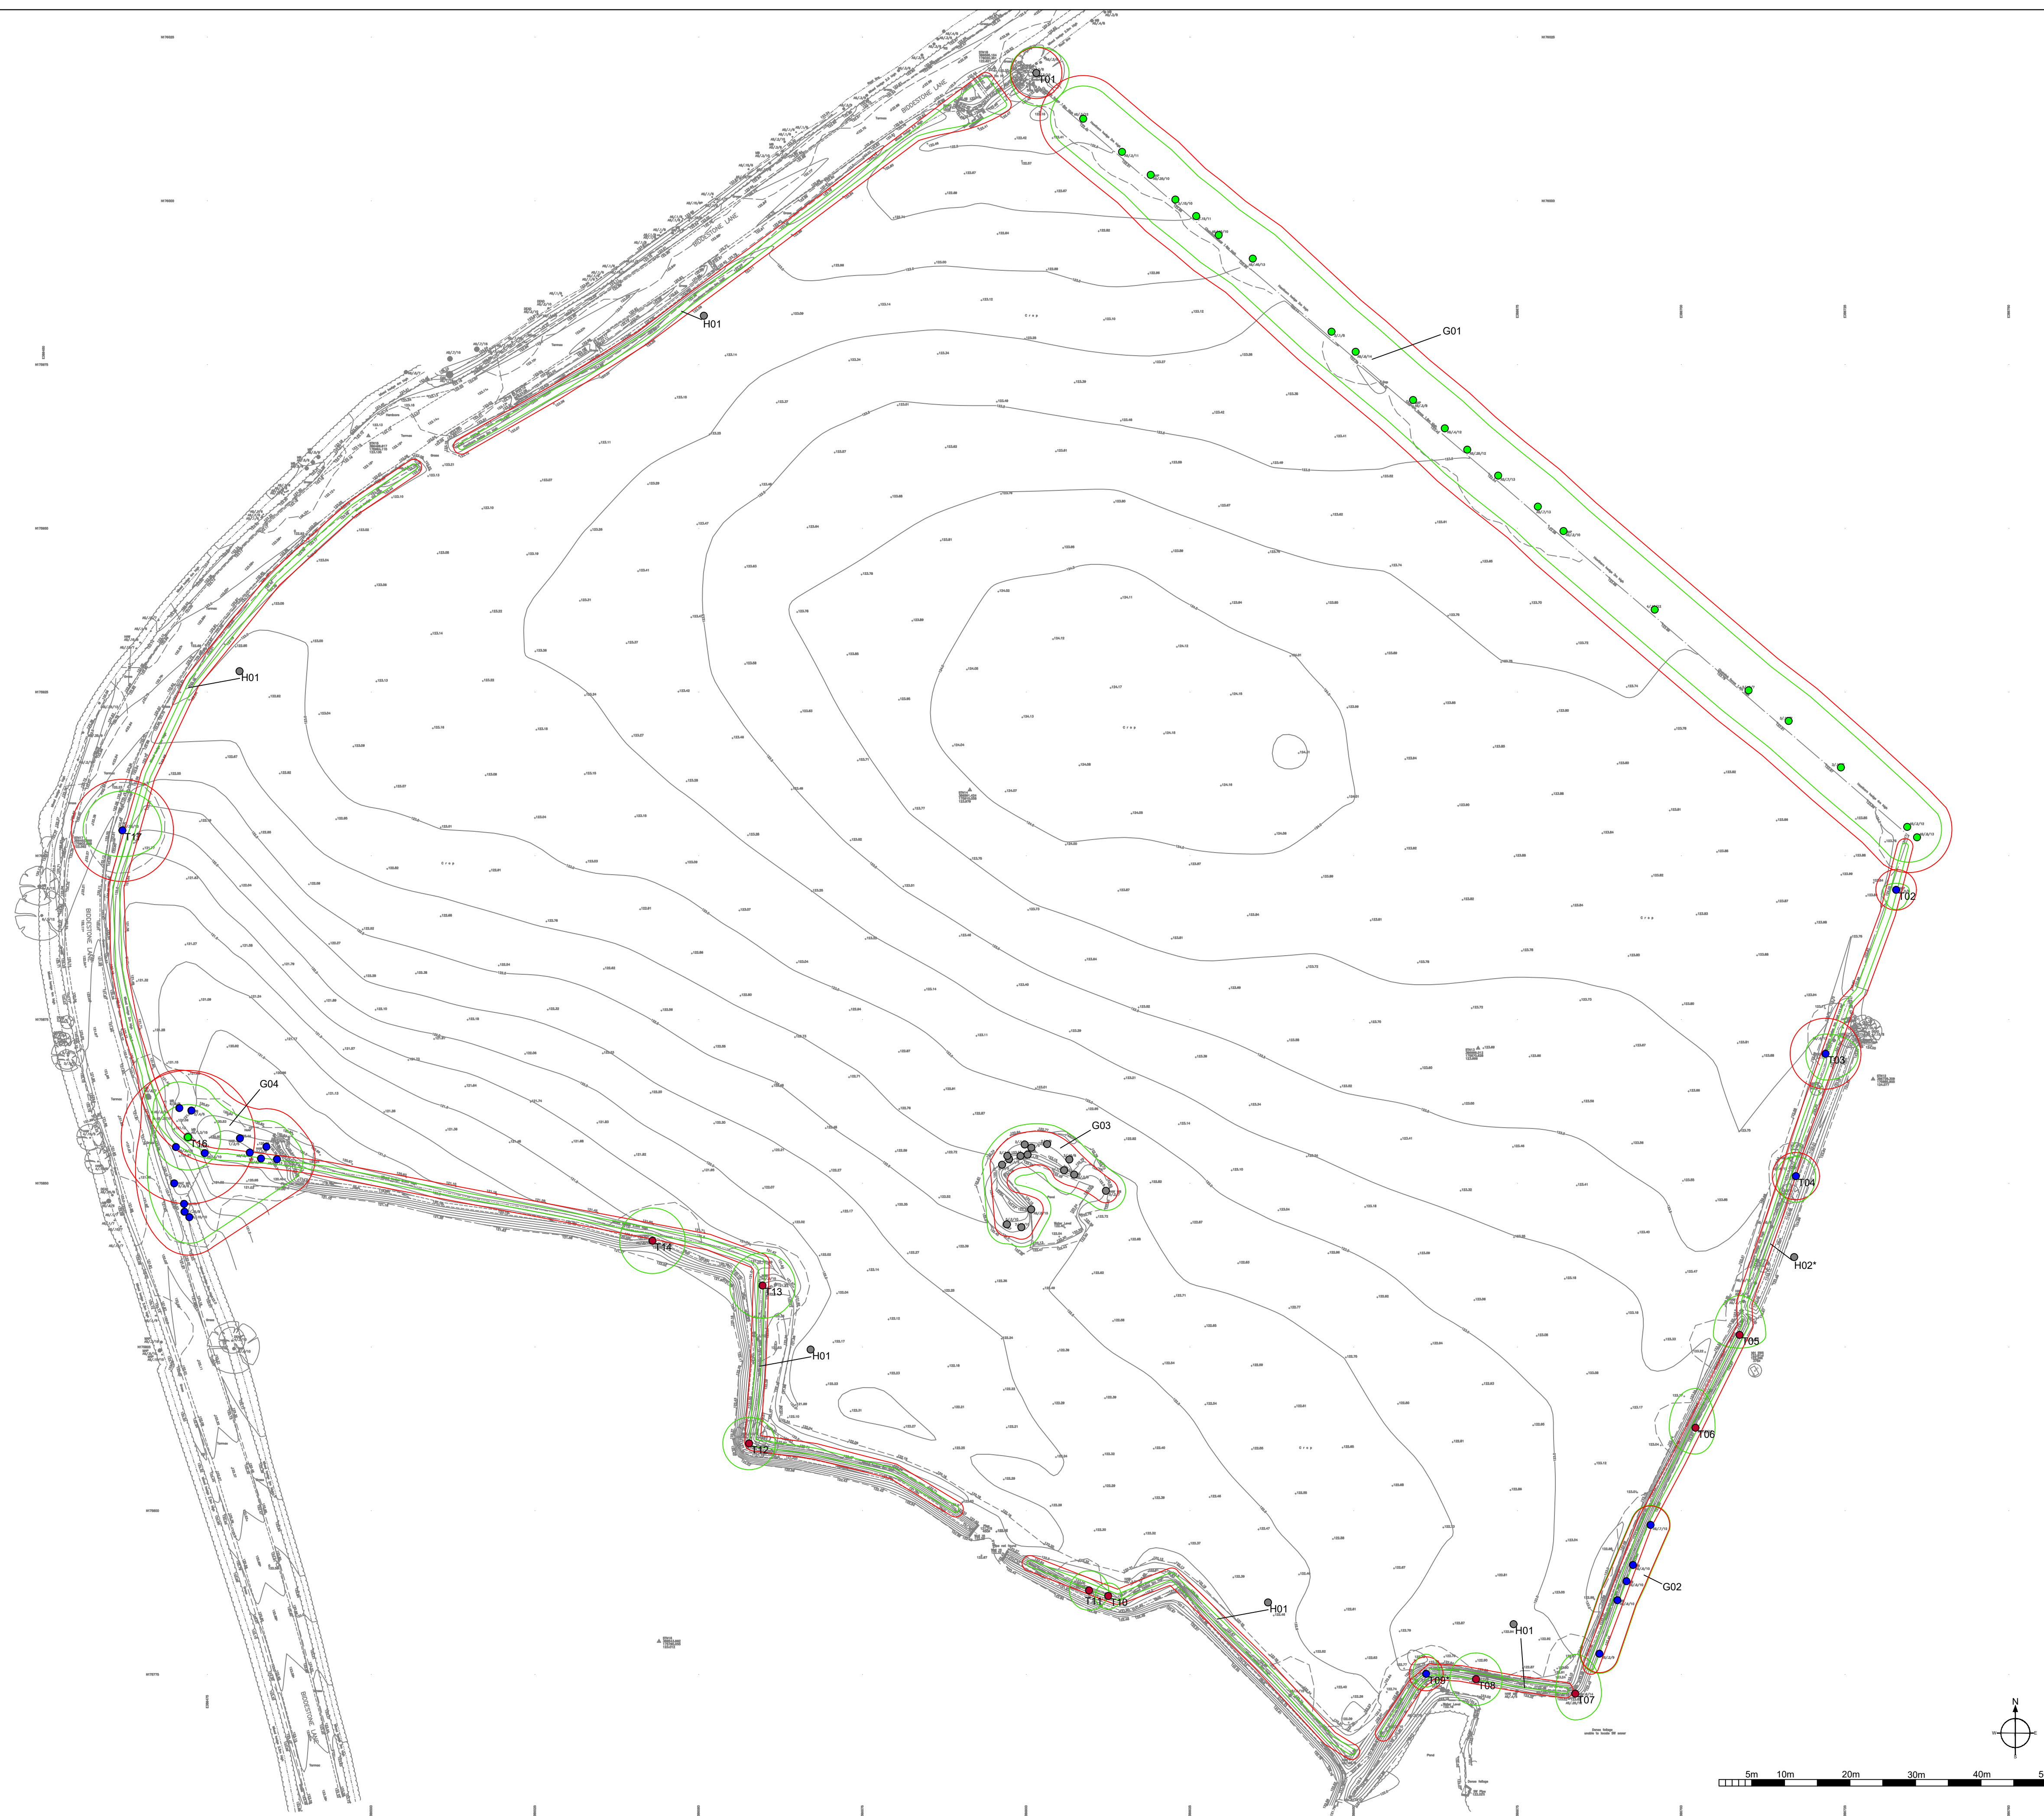
| Drawing Number: 240516-YAT-TCP-DB | May 2024 |

- 5.1 The site is currently an agricultural field bordered by mixed species hedgerows on all sides. G01 at the north end of the site borders the adjacent playing fields and is considered to be a significant hedgerow for containing many species and high-quality trees. T16 was found to be an ancient Field Maple growing in the southwest corner of the site within a group of trees.

- 5.2 It was found that the majority of the trees are mature Ash trees growing out of the hedgerows. On inspection, it was found that all the surveyed Ash trees are infected by Ash dieback disease (*Hymenoscyphus fraxineus*). This was evident by the density and condition of the foliage, and the dieback within the canopy. Ash dieback disease destroys the tree's phloem and xylem, which results in the tree being unable to move water and nutrients around its structure. This lack of water and nutrient movement will cause the branches of the tree to fail and the tree to 'die back'.

- 5.4 The latest evidence nationwide and from local tree surgery teams, is that infected trees can decline rapidly becoming structurally unsound in a matter of months. It is therefore considered that the Ash trees have a very short useful life expectancy and should not be considered as a constraint to the approved development.

- 5.5 Seventeen trees, four groups of trees, and two hedgerows were surveyed. Of the trees surveyed, one tree and one group of trees was categorised **A**, five trees and two groups of trees were categorised **B**, nine trees were categorised **U**, the remaining trees, groups and hedgerows were categorised **C**. The trees were assessed and graded in accordance with the Cascading Chart of Tree Quality Assessment contained within BS5837:2012.

- 6.3 The Tree Constraints Plan shows the Root Protection Areas (RPAs) for the individual trees identified in the tree schedule tables. This represents the minimum area in m<sup>2</sup> which ideally should be left undisturbed around each tree were it to be retained. The TCP also shows a representation of the crown spread of each tree measured in four cardinal directions. The RPA has been calculated in accordance with Section 4.6 of BS5837:2012 Trees in relation to design, demolition and construction – Recommendations.
