## HUNDRED ACRES FARM, SOPWORTH SN14 6PP

### BAT TECHNICAL NOTE –29<sup>TH</sup> APRIL 2025

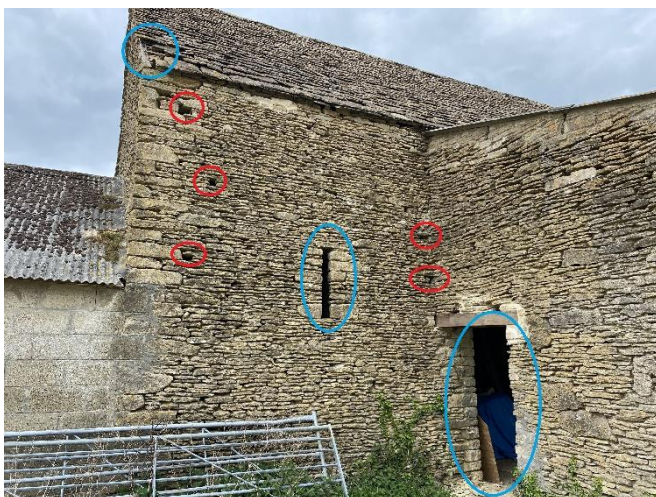
**Photograph 1:** Southern side of the building.

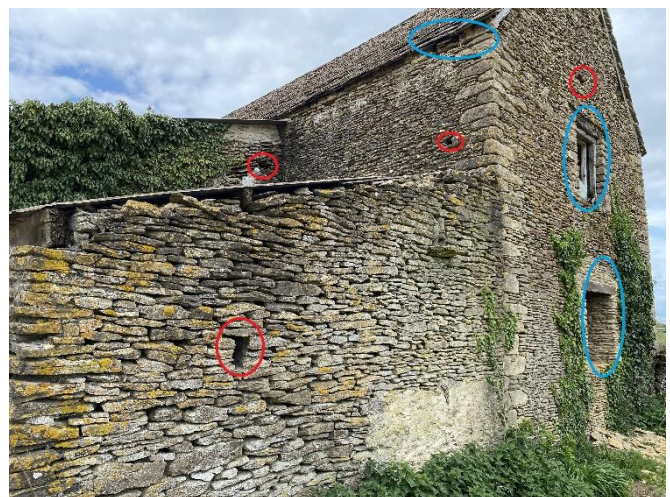
**Photograph 2:** Eastern side of the building.

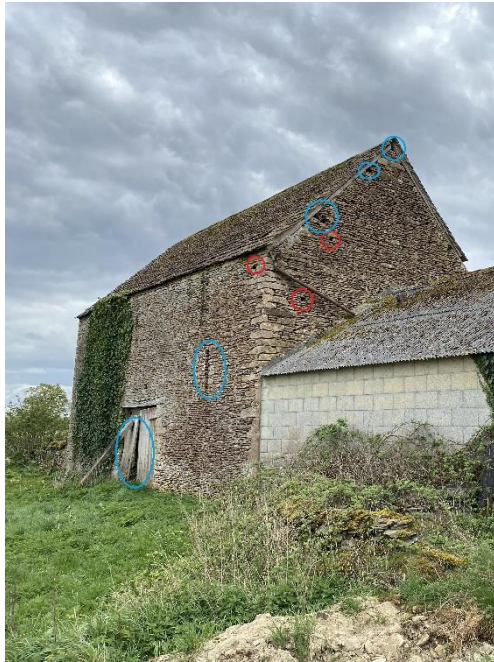
**Photograph 3:** Northern side of the building.

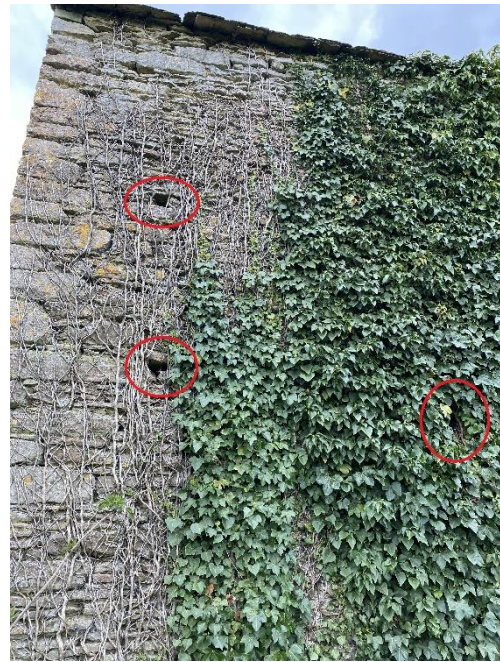
**Photograph 4:** Dense Ivy and PRFs on northern wall.

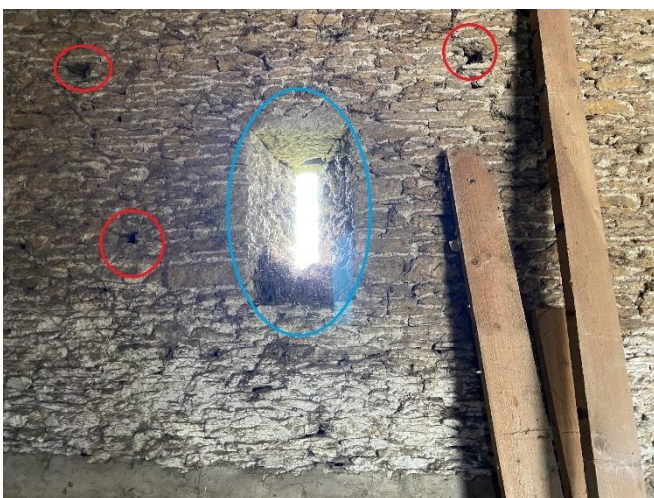
**Photograph 5:** Internal features on northern wall.

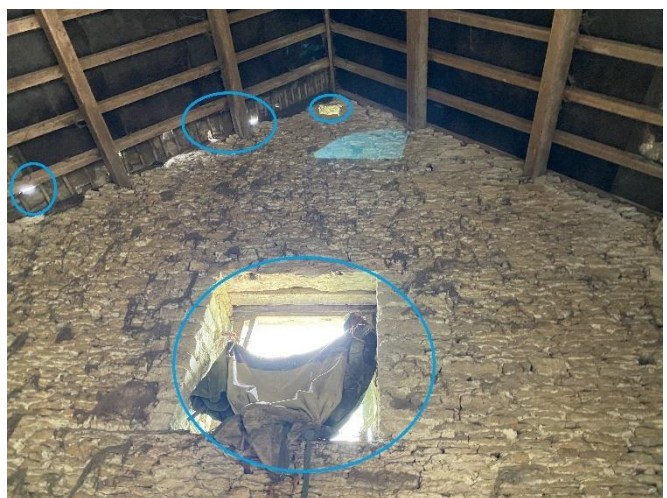
**Photograph 6:** Internal access points eastern wall.

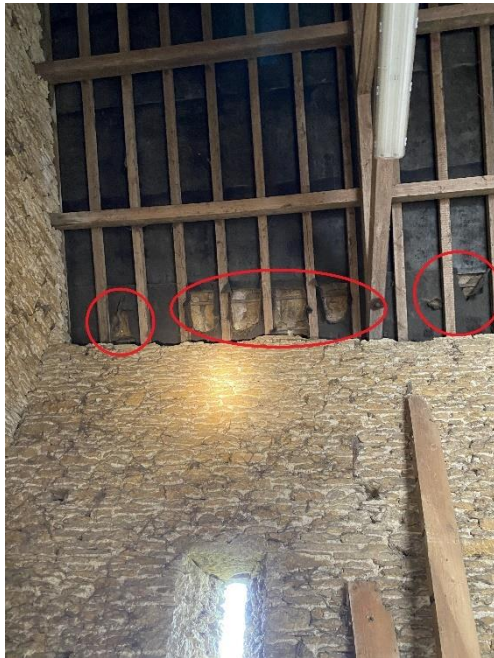
**Photograph 7:** Internal roof PRFs.

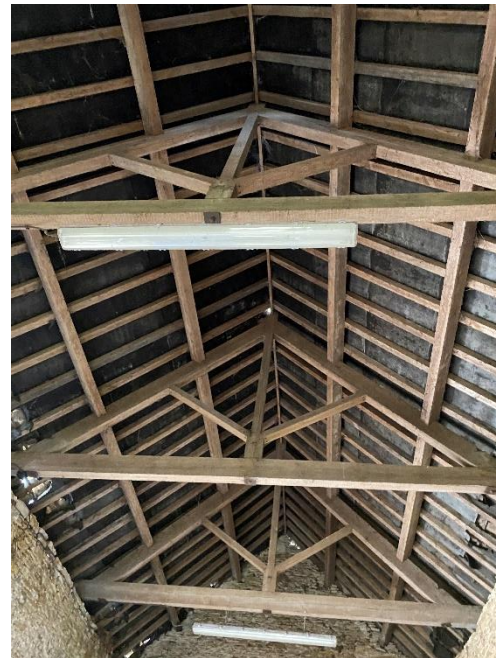
**Photograph 8:** Internal wooden beams.
