# Flaxlands Solar Farm

## Otter and Water Vole Survey Report

Ampyr Solar Europe

October 2024

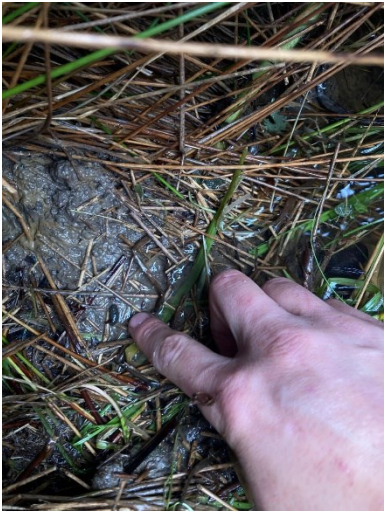
A single dropping with characteristics of water vole (see Photograph 1, Appendix B) was identified during the September survey observed within vegetation at P2 along with a pile of feeding remains which due to their proximity to the dropping are likely water vole. The dropping was not subject to DNA analysis, identification was determined using professional judgement.

| <p><b>Photograph 1</b> – Dropping with characteristics of water vole observed on bank of P2.</p> | <p><b>Photograph 2</b> – Burrow with characteristics of water vole observed within bank of W2.</p> |

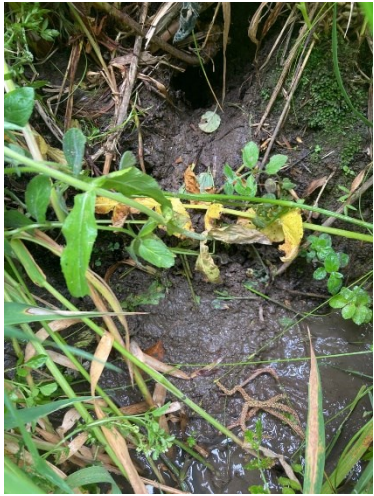
A small mammal burrow with characteristics of water vole, being the correct shape and size, was recorded during the July survey along W2 which drains into P2 (See Photograph 2, Appendix B). The burrow was not observed during the September survey due to the presence of debris caused by recent flailing of a nearby hedgerow impairing the surveyors view of W2.

W2, where the burrow was observed, provides suitable burrowing and foraging habitat for water vole and as such it was categorised as Good.

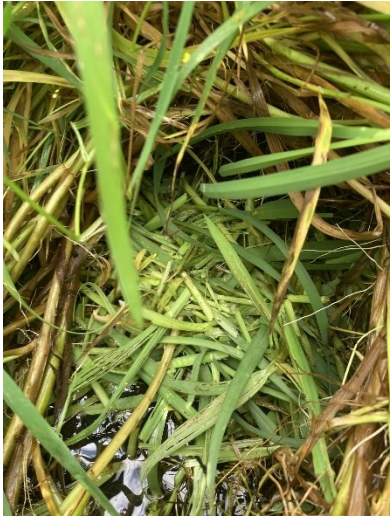
| <p><b>Photograph 3</b> –Feeding remains with characteristics of water vole. Observed within W1.</p> | <p><b>Photograph 4</b> – Small mammal feeding remains present along W1, uncharacteristic of water vole due to their size.</p> |

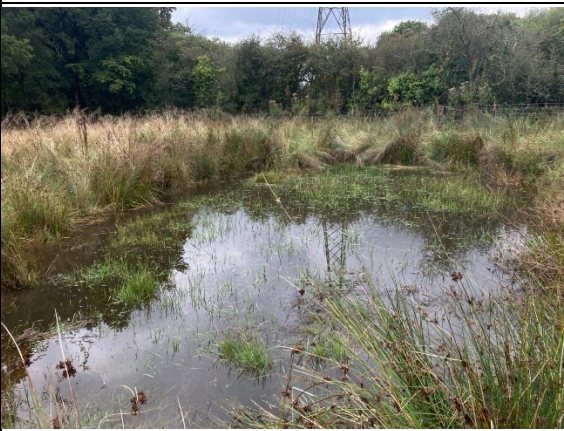
| <p><b>Photograph 5</b> – View facing north at P2.</p> | <p><b>Photograph 6</b> – View facing east at P7. Pond offers Good suitability for water vole.</p> |
