## Appendix D Site Walkover Plan and Photographs

| <b>Project:</b> | Flaxlands Solar Farm | <b>Date:</b> 11/11/2024 |
| <b>Job Number:</b> | 60727989 | <b>Undertaken by:</b> LR |
| <b>Site Location:</b> | Wootton Bassett, Swindon | |

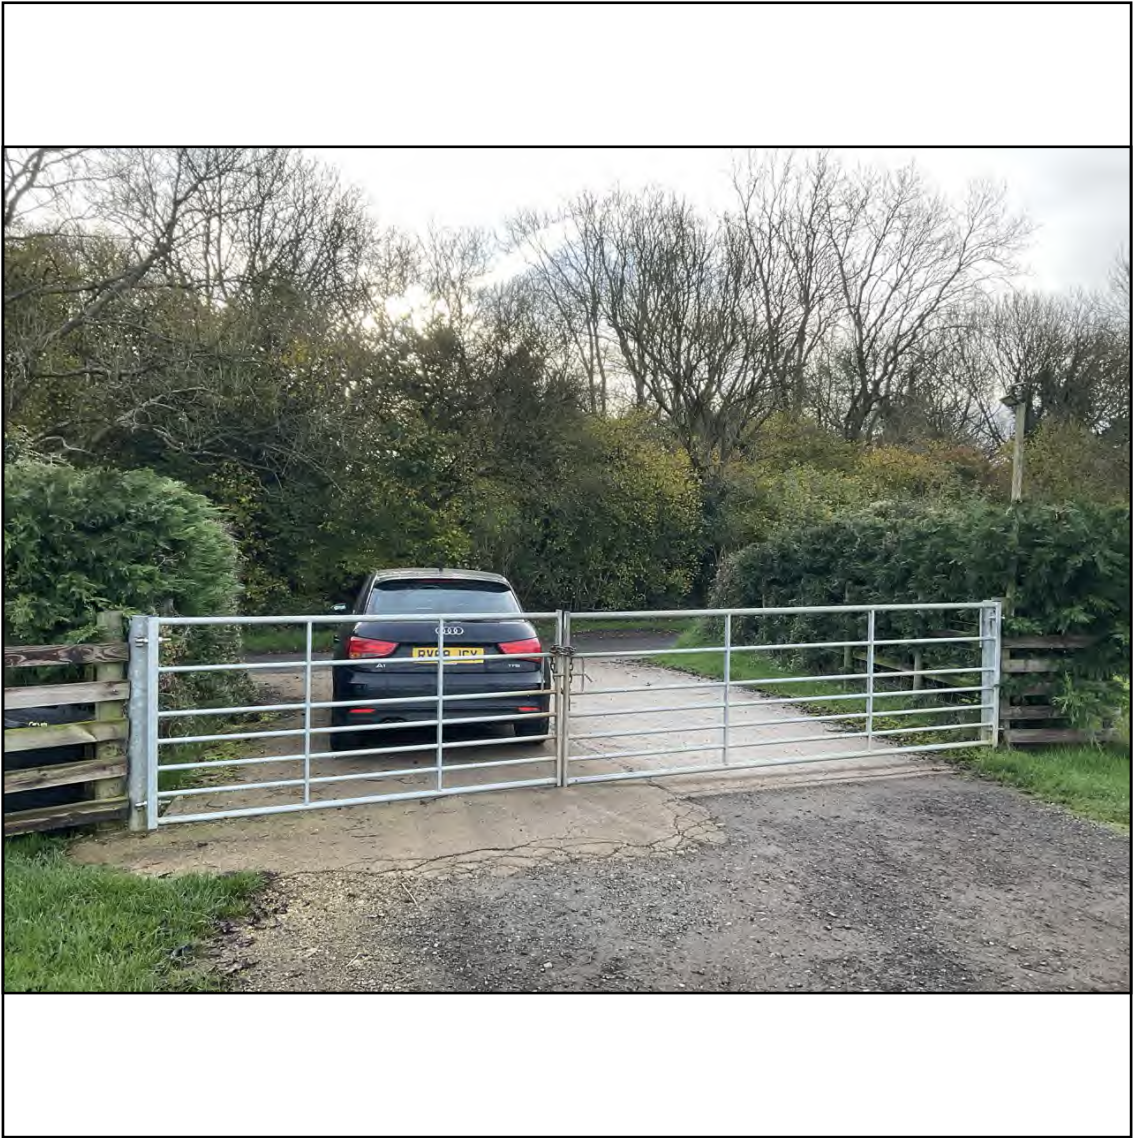
| OBJECTID : | 1 |

| Feature Description : | Site access through double gate |

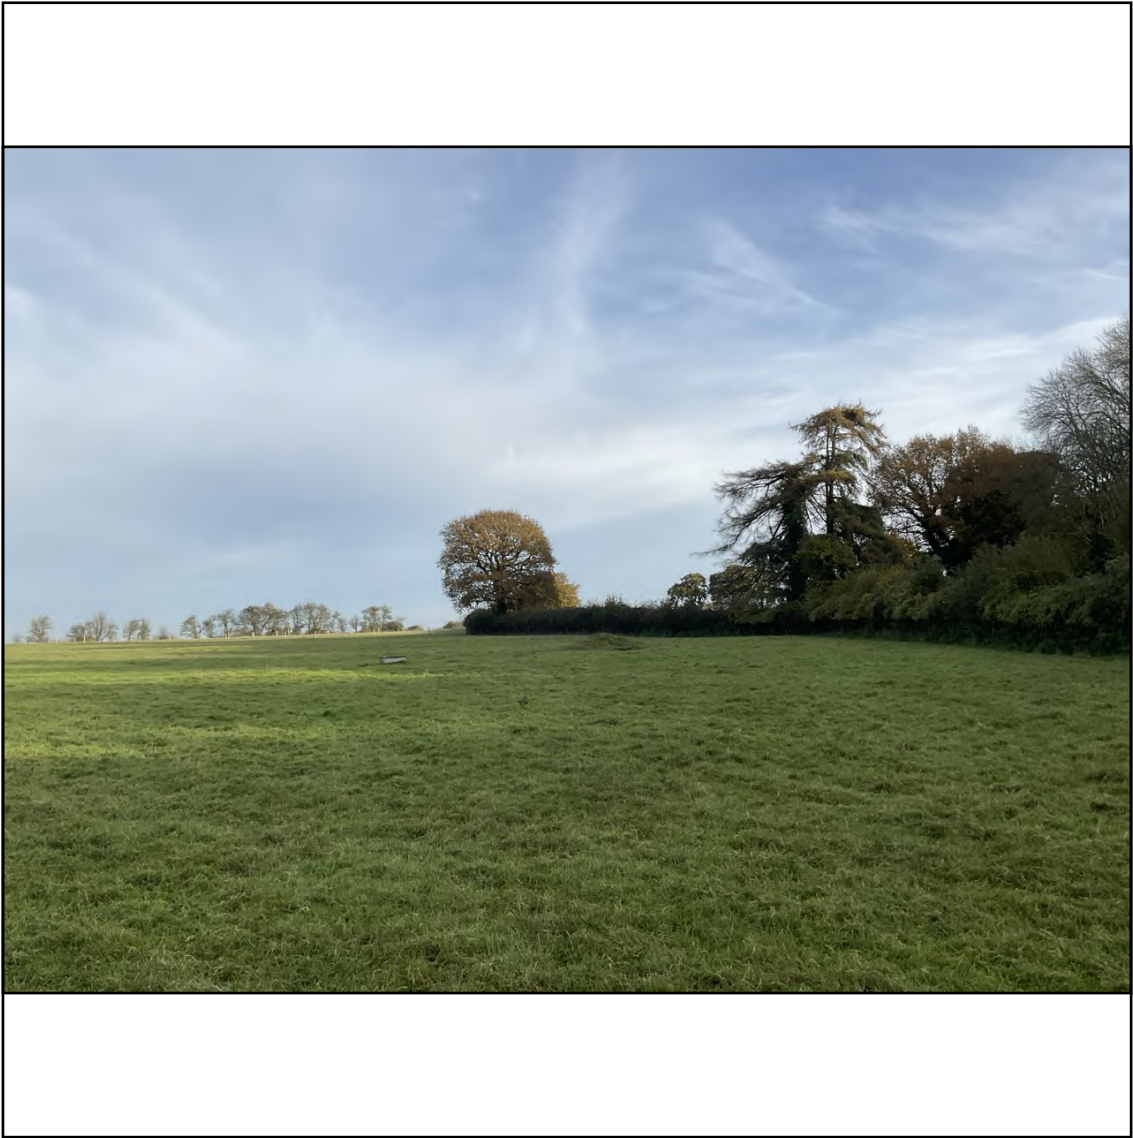
| OBJECTID : | 2 |

| Feature Description : | Raised mound of ground potentially infilled |

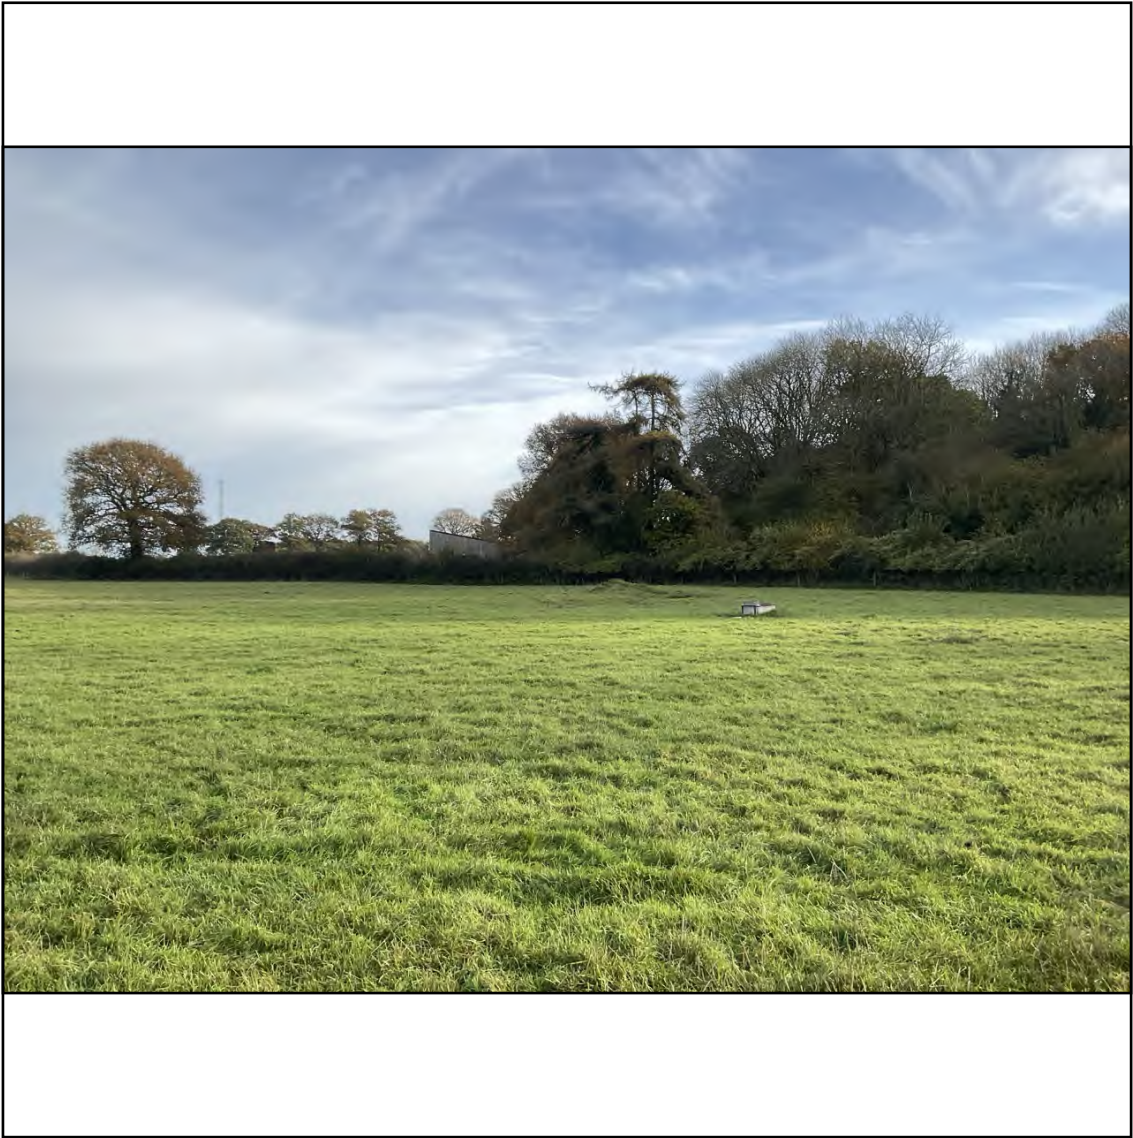
| OBJECTID : | 4 |

| Feature Description : | Raised mound |

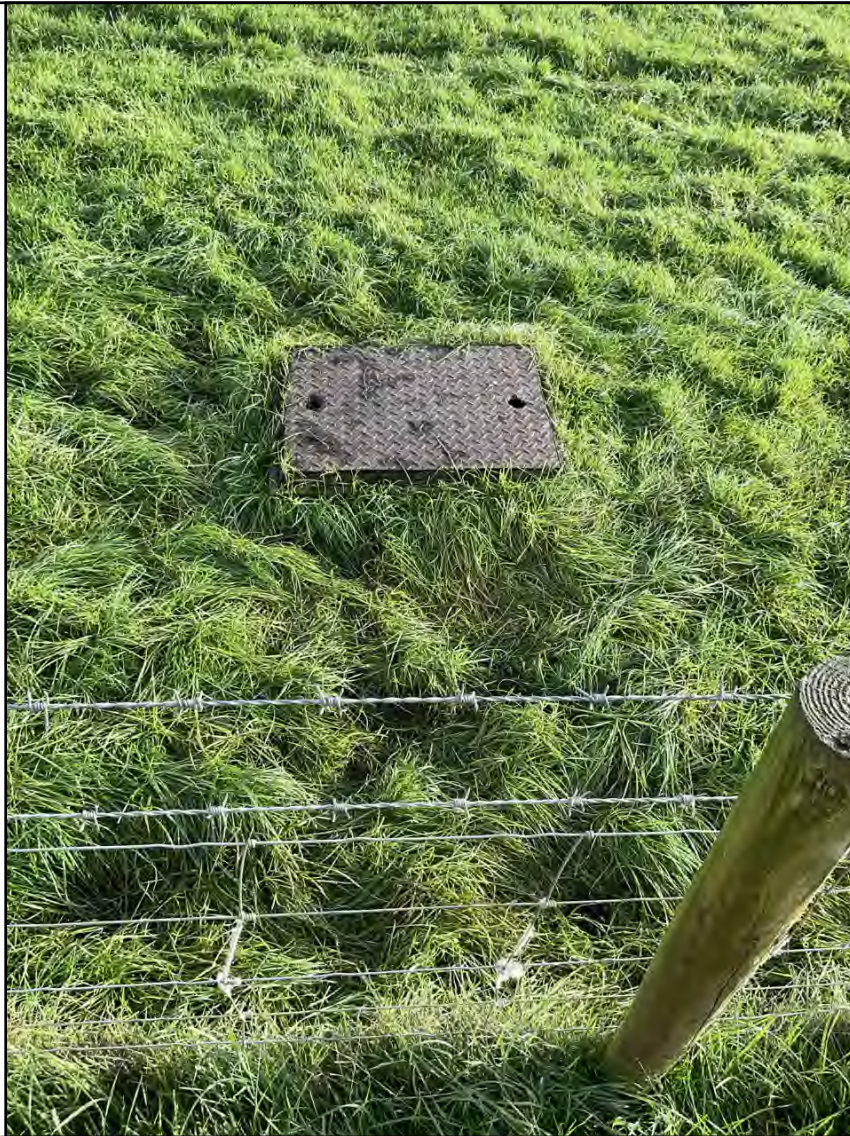
| OBJECTID : | 7 |

| Feature Description : | Drain cover |

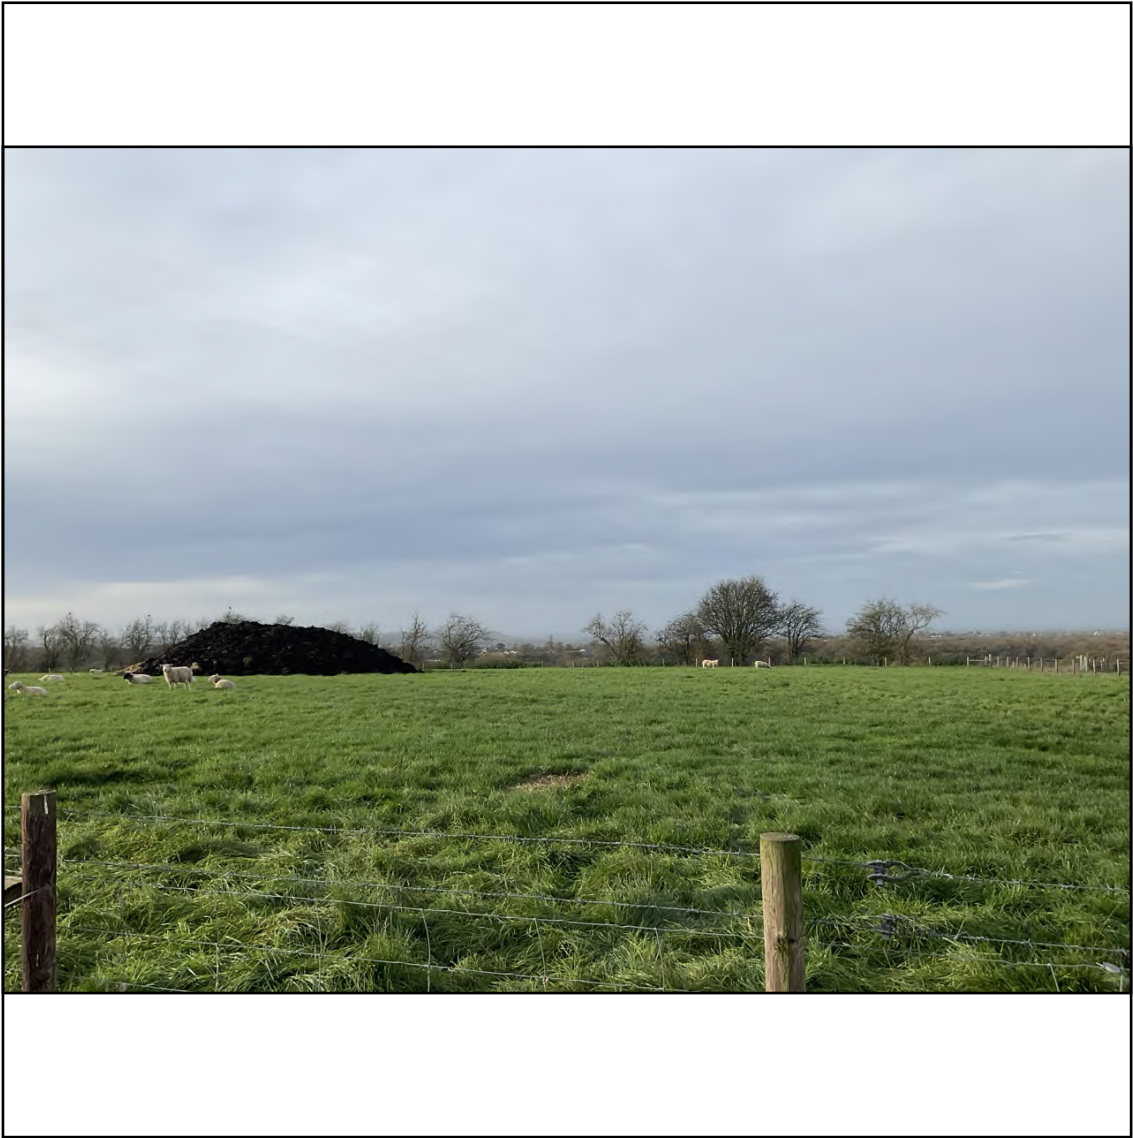
| OBJECTID : | 8 |

| Feature Description : | Muck heap |

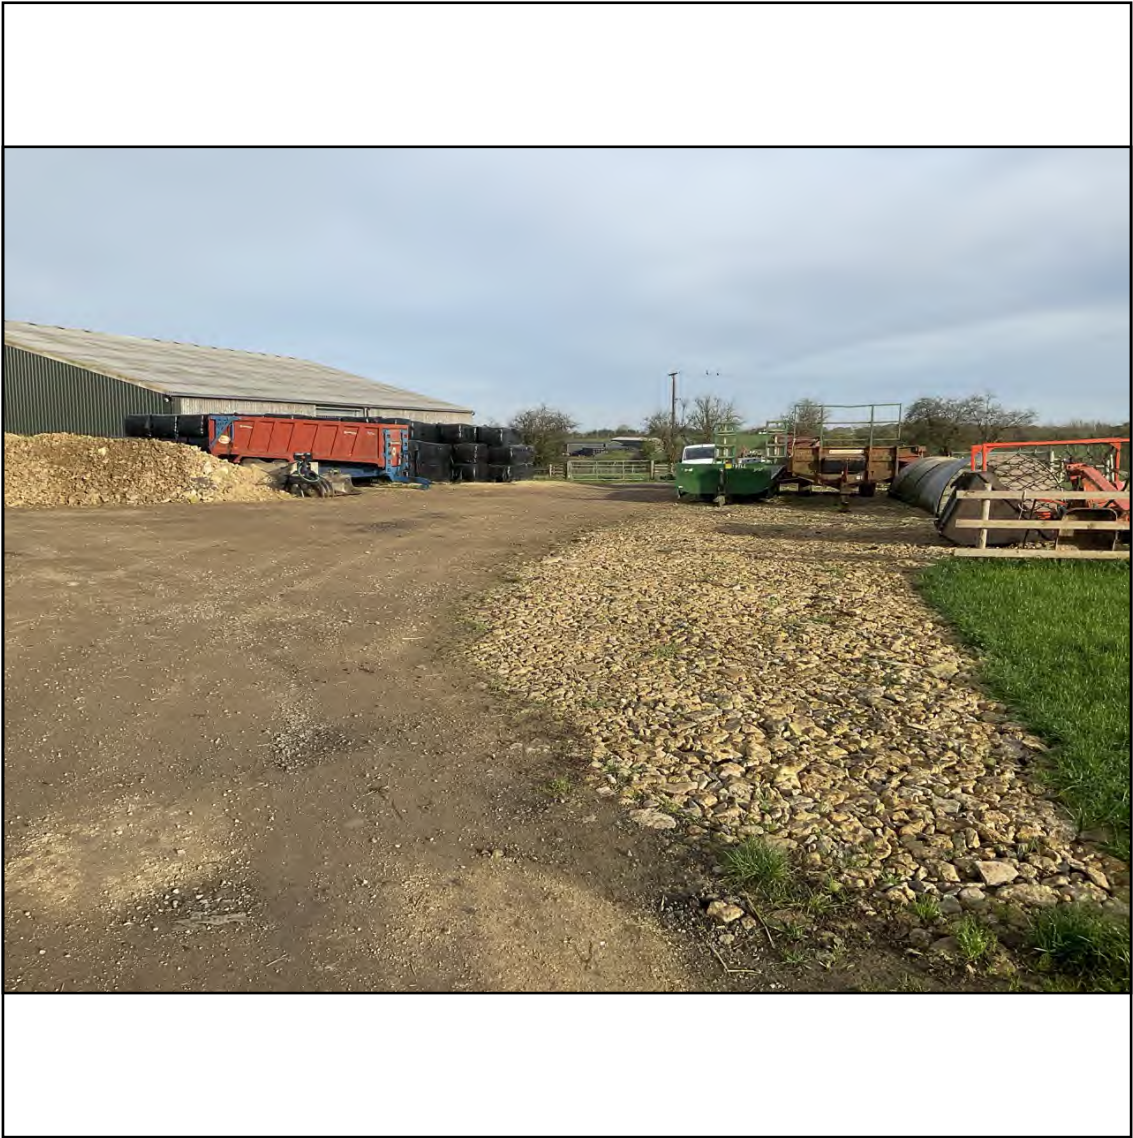
| OBJECTID : | 9 |

| Feature Description : | Hard rubble at farm |

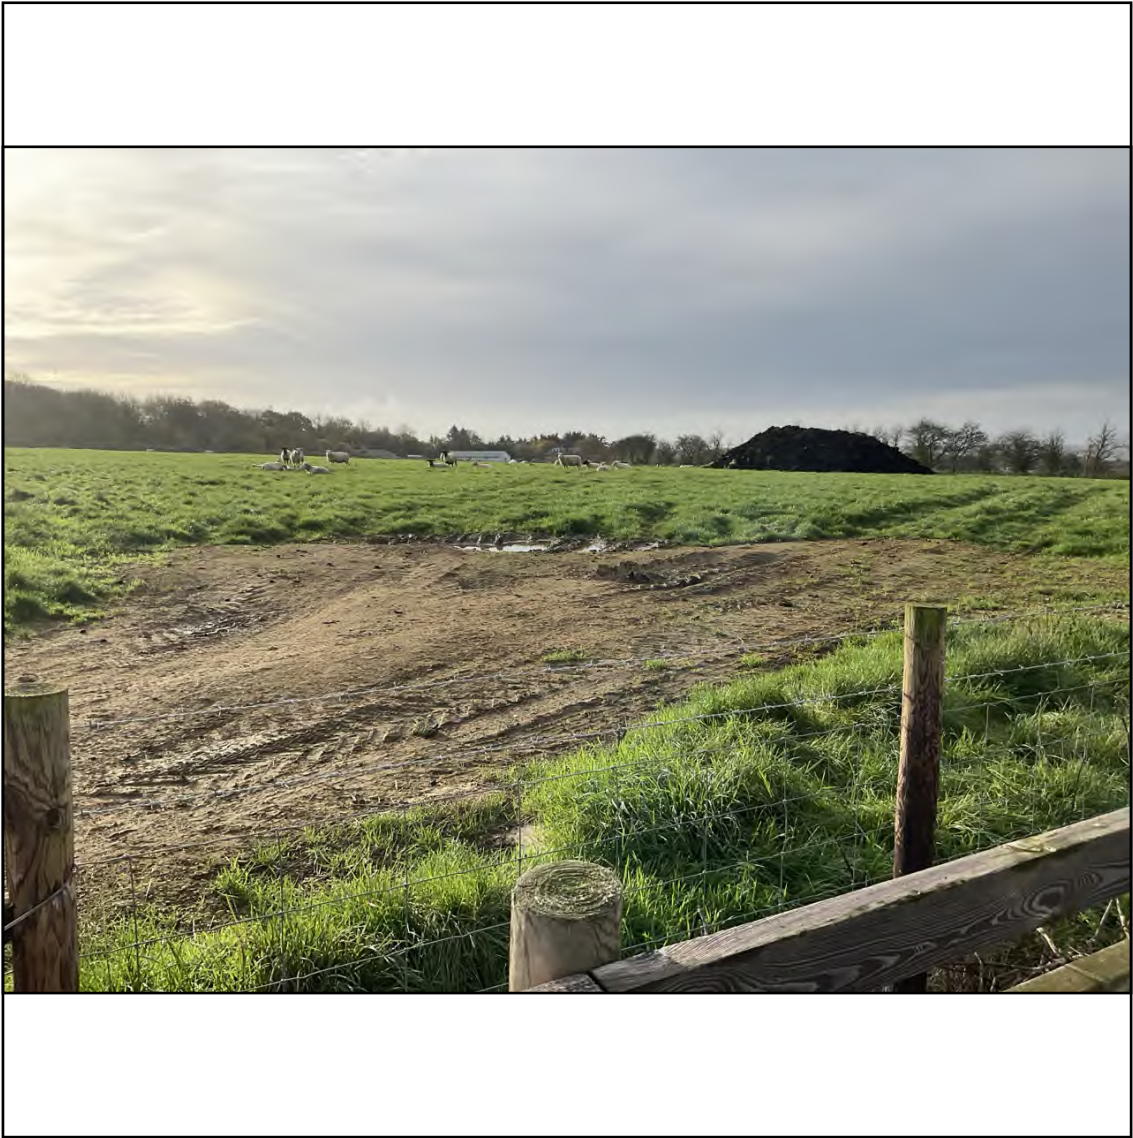
| OBJECTID : | 10 |

| Feature Description : | Standing water from vehicles |

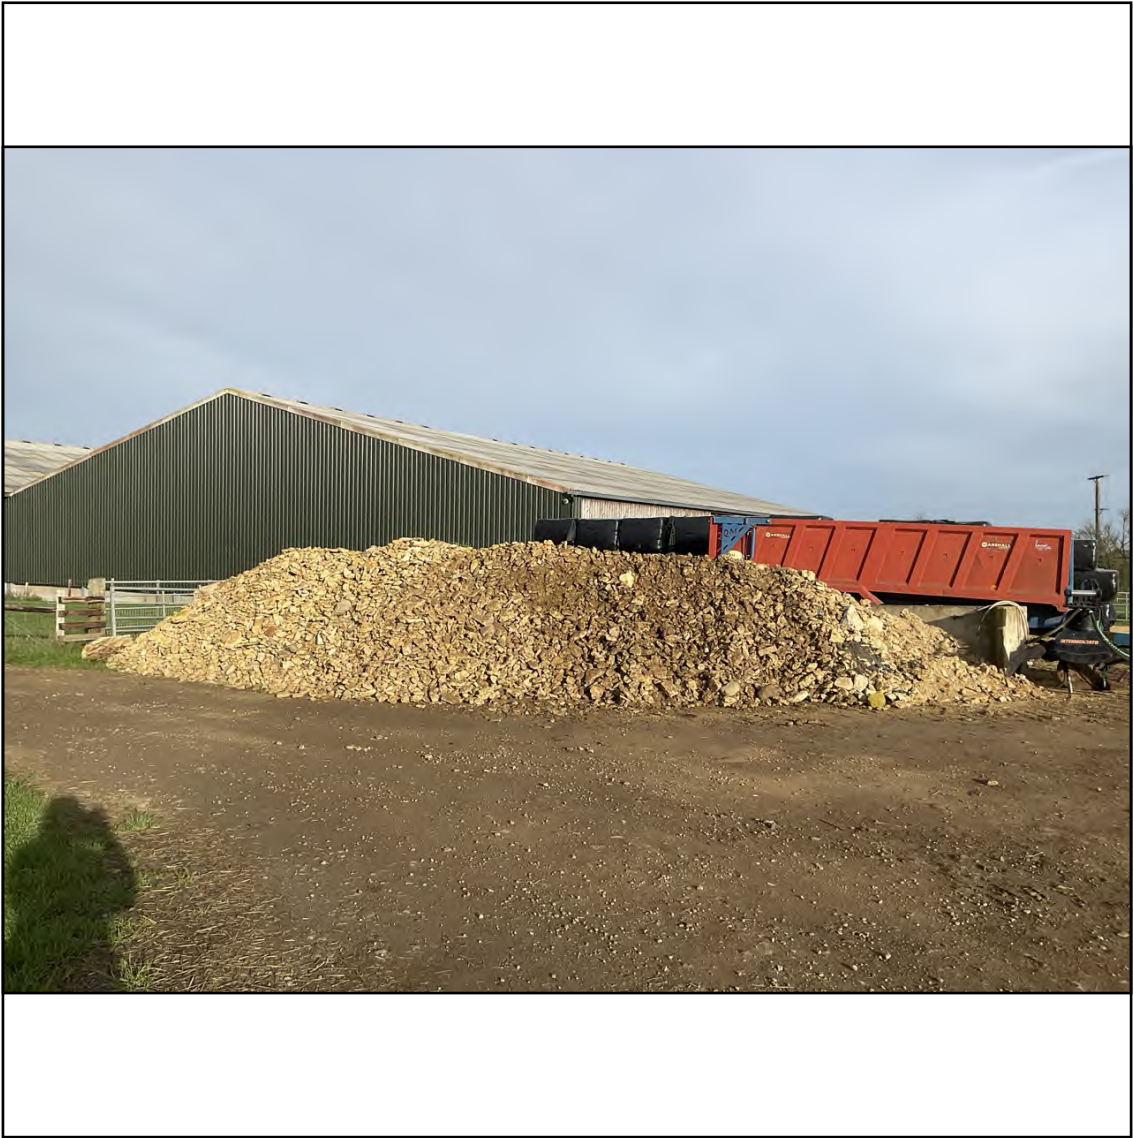
| OBJECTID : | 11 |

| Feature Description : | Stockpile |

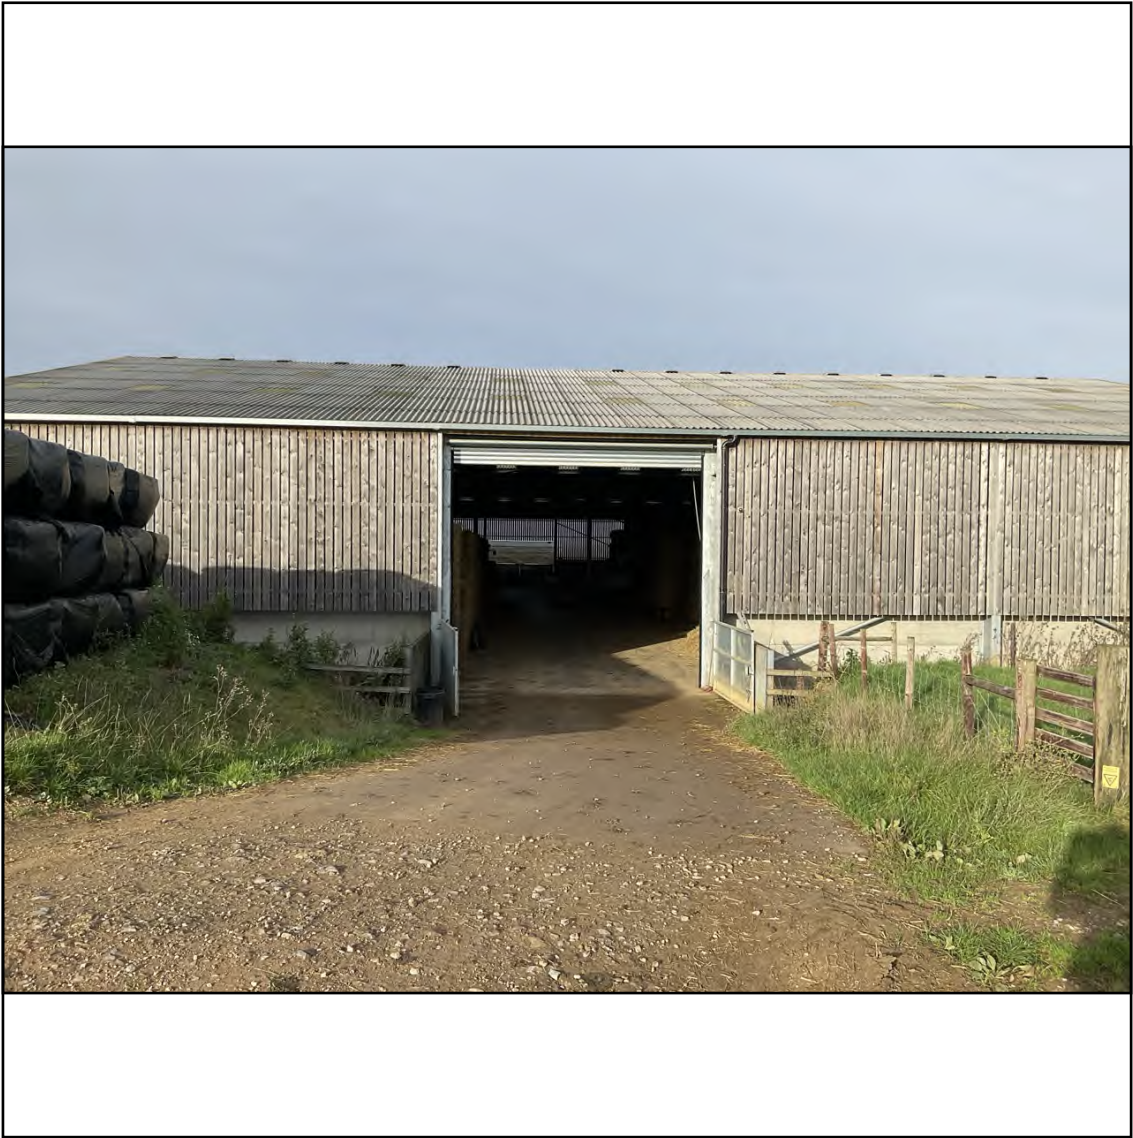
| OBJECTID : | 12 |

| Feature Description : | Existing shed, not entered some vehicles stored in addition to hat |

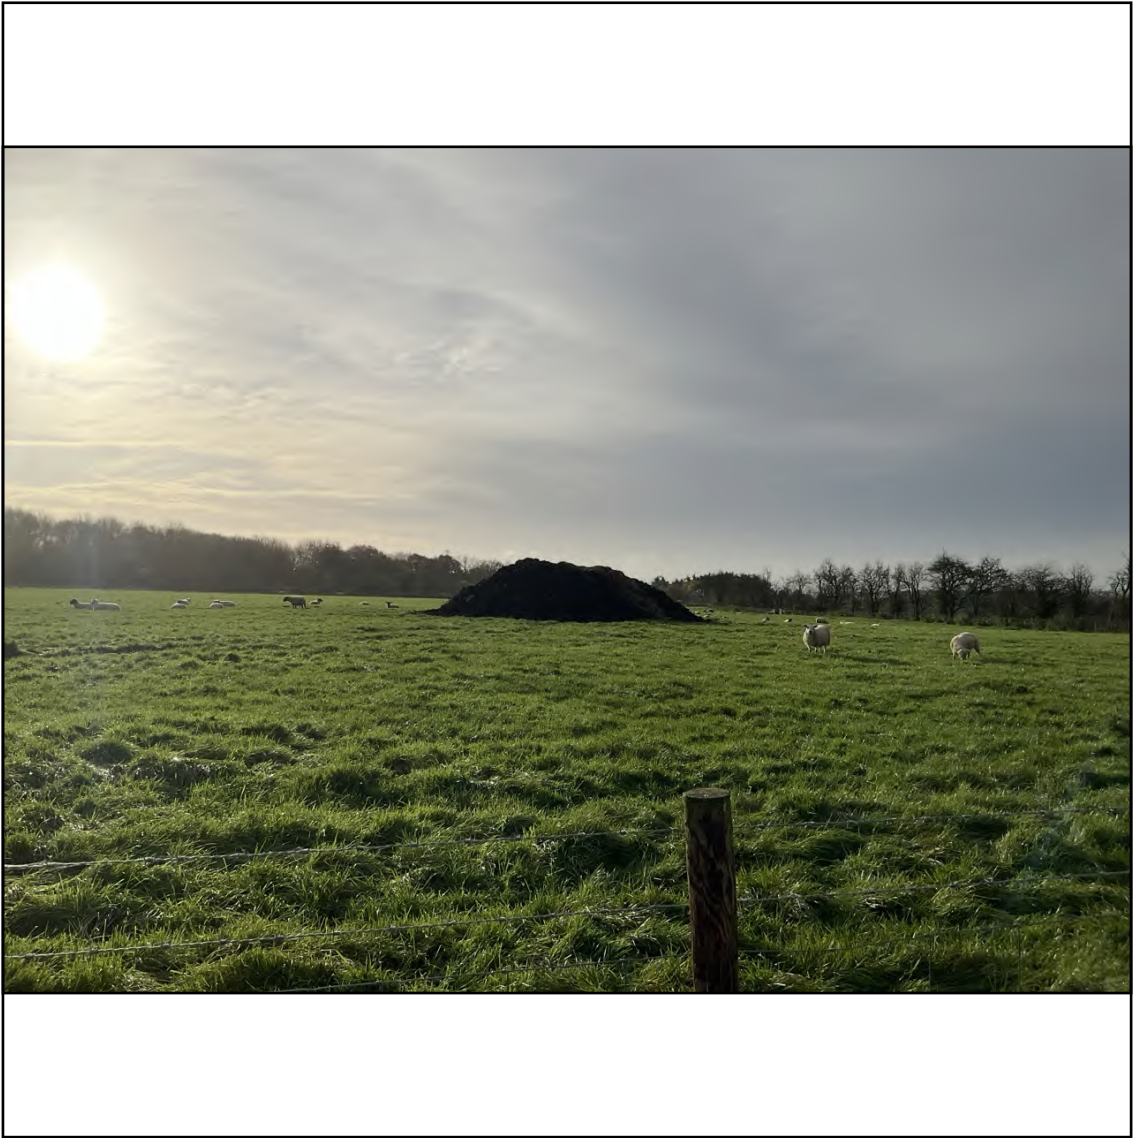
| OBJECTID : | 13 |

| Feature Description : | Muck heap |

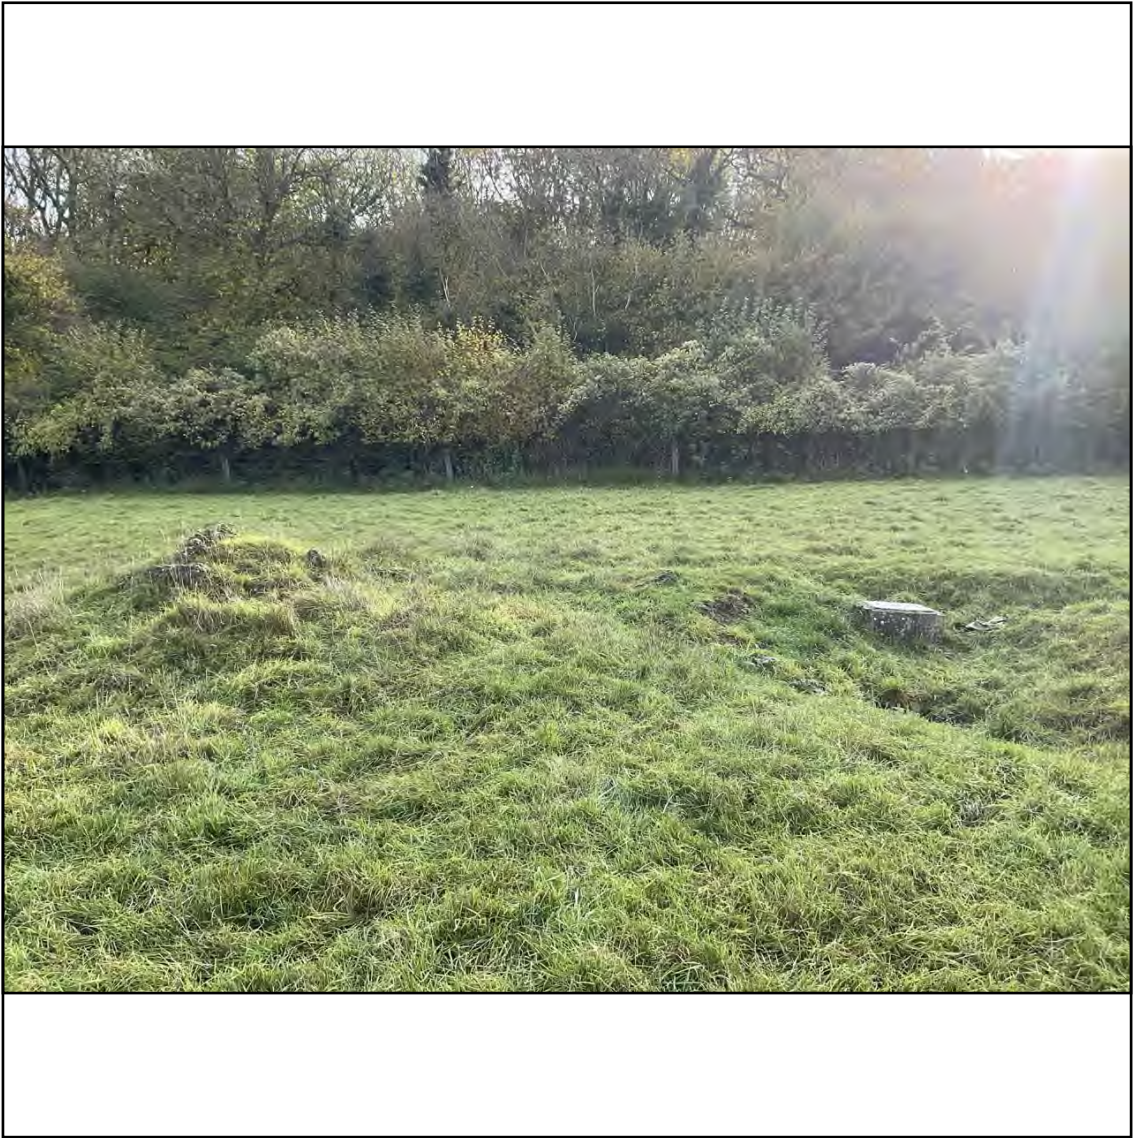
| OBJECTID : | 14 |

| Feature Description : | Mound of rubble covered in grass from drain excavation adjacent |

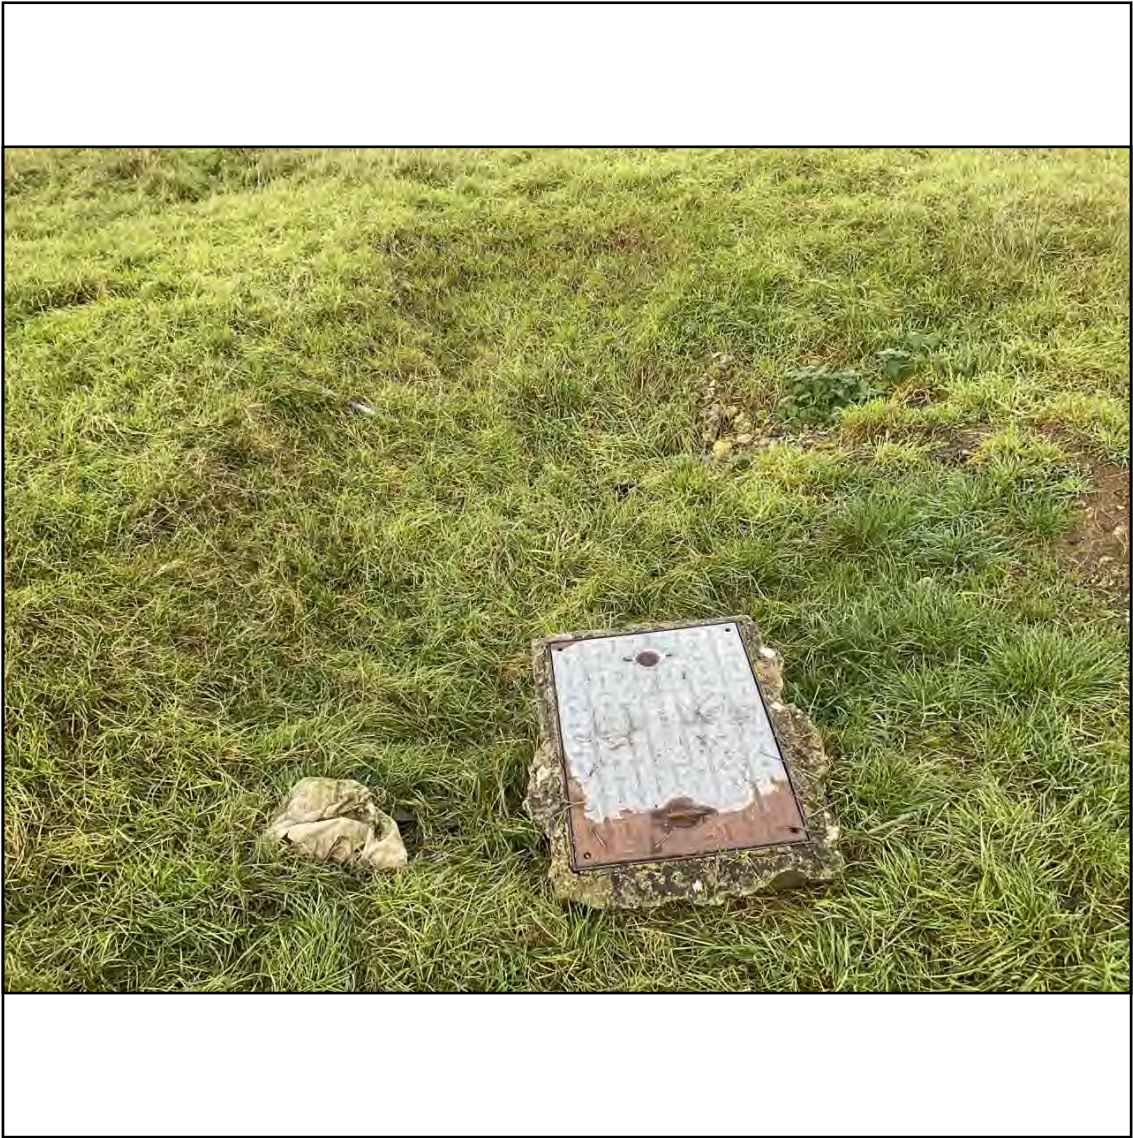
| OBJECTID : | 15 |

| Feature Description : | Excavation approx 3m x 2m x 0.8m |

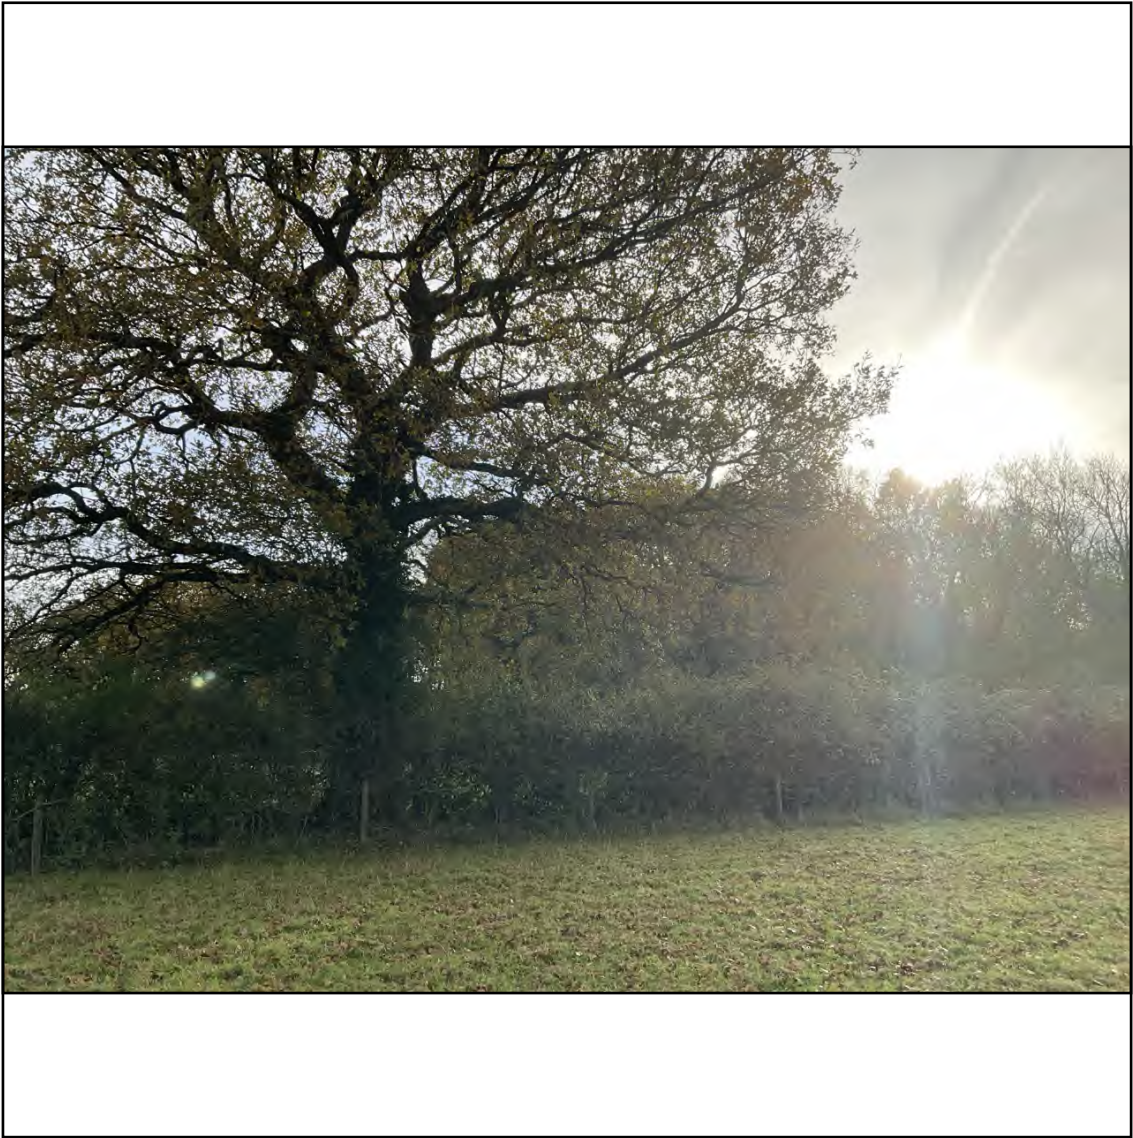
| OBJECTID : | 16 |

| Feature Description : | Mature oak tree on boundary and general views across site |

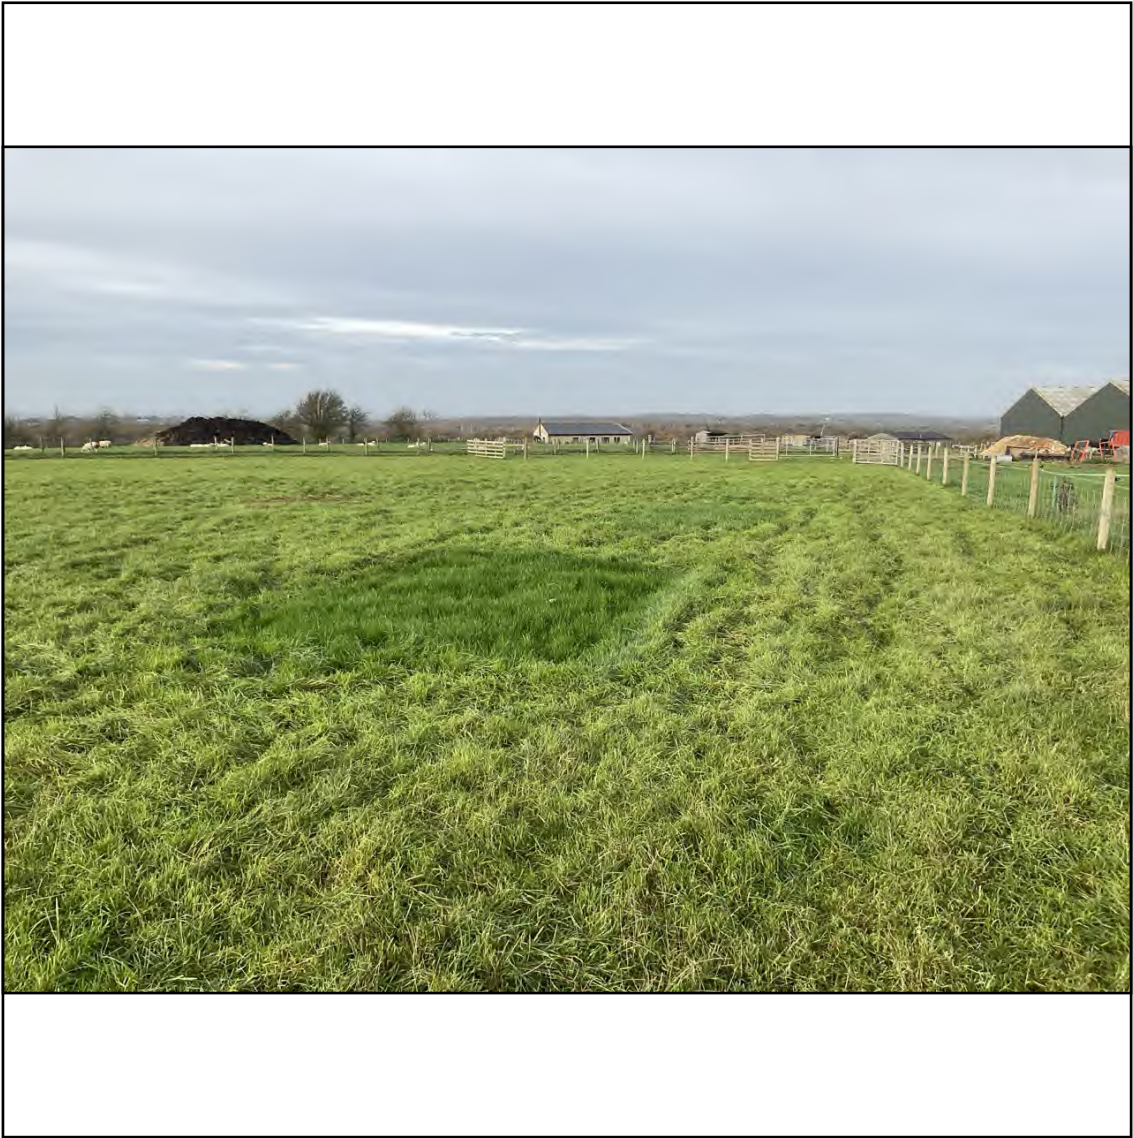
| OBJECTID : | 17 |

| Feature Description : | Area of previous structure? |

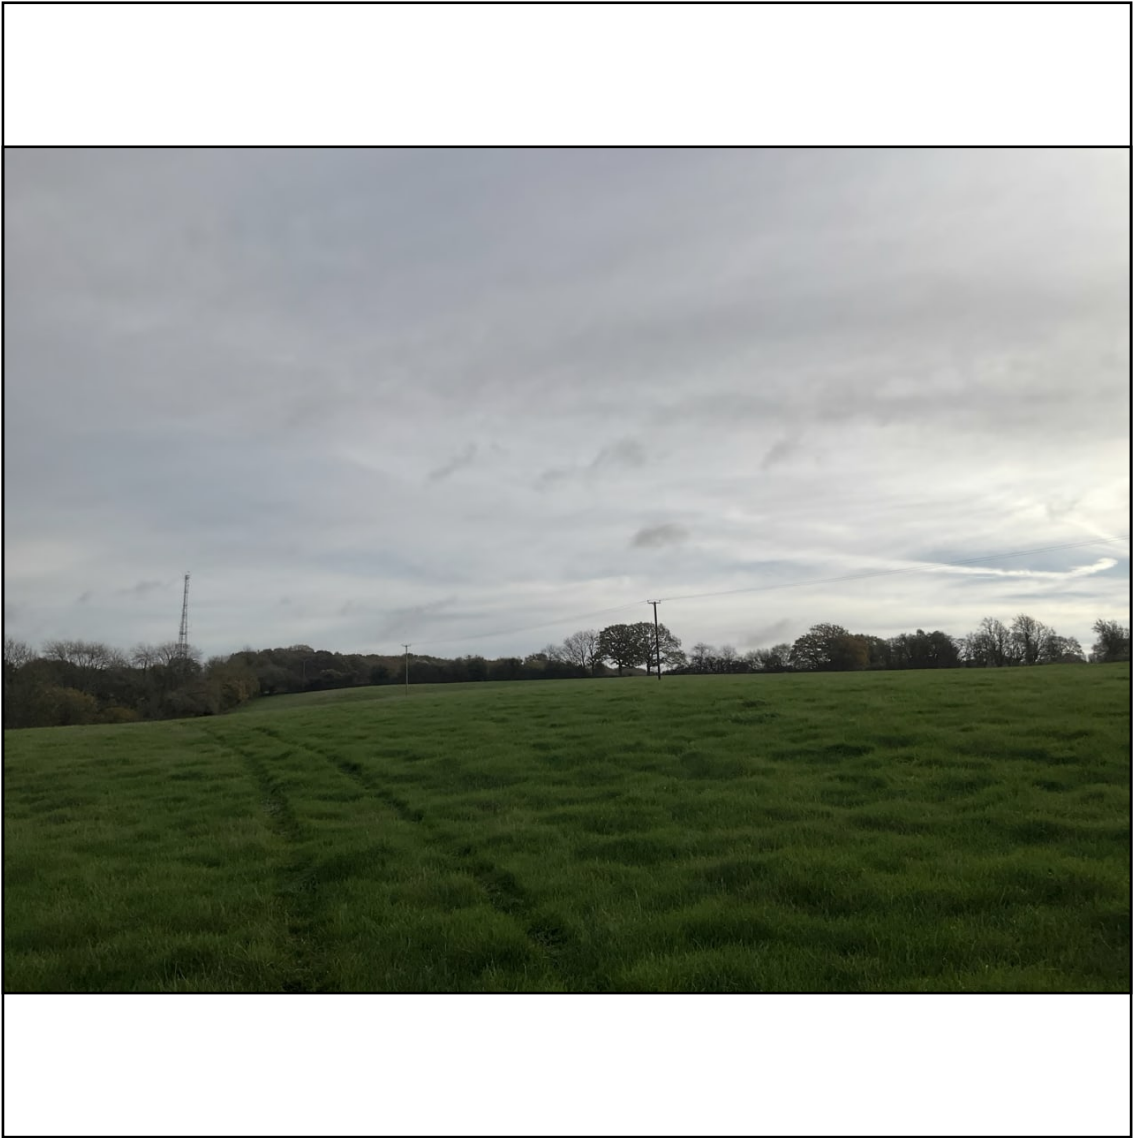
| OBJECTID : | 20 |

| Feature Description : | Electric overhead lines |

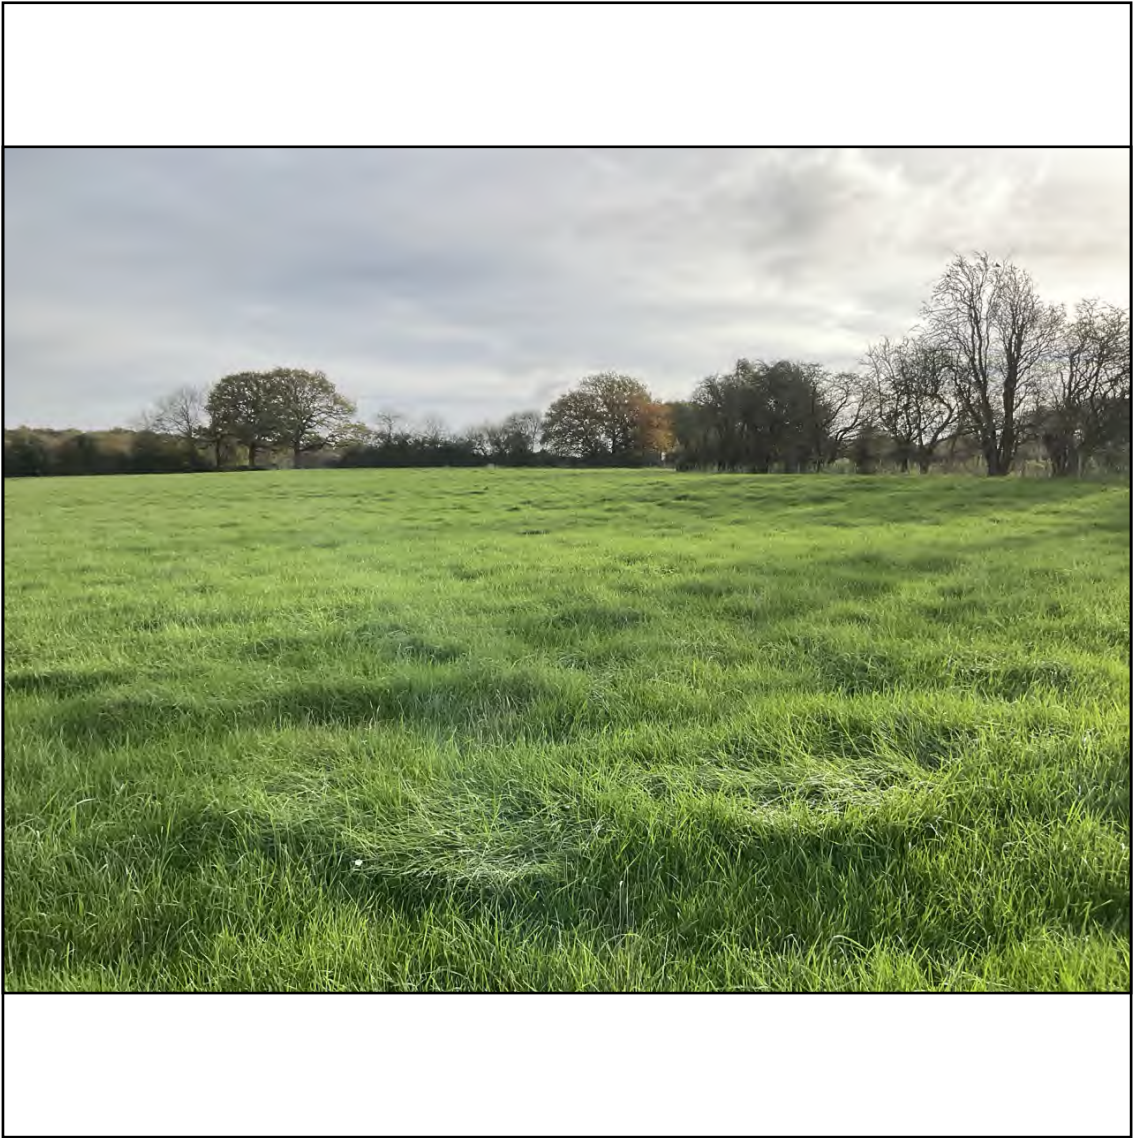
| OBJECTID : | 22 |

| Feature Description : | Undulating/ hummocky ground |

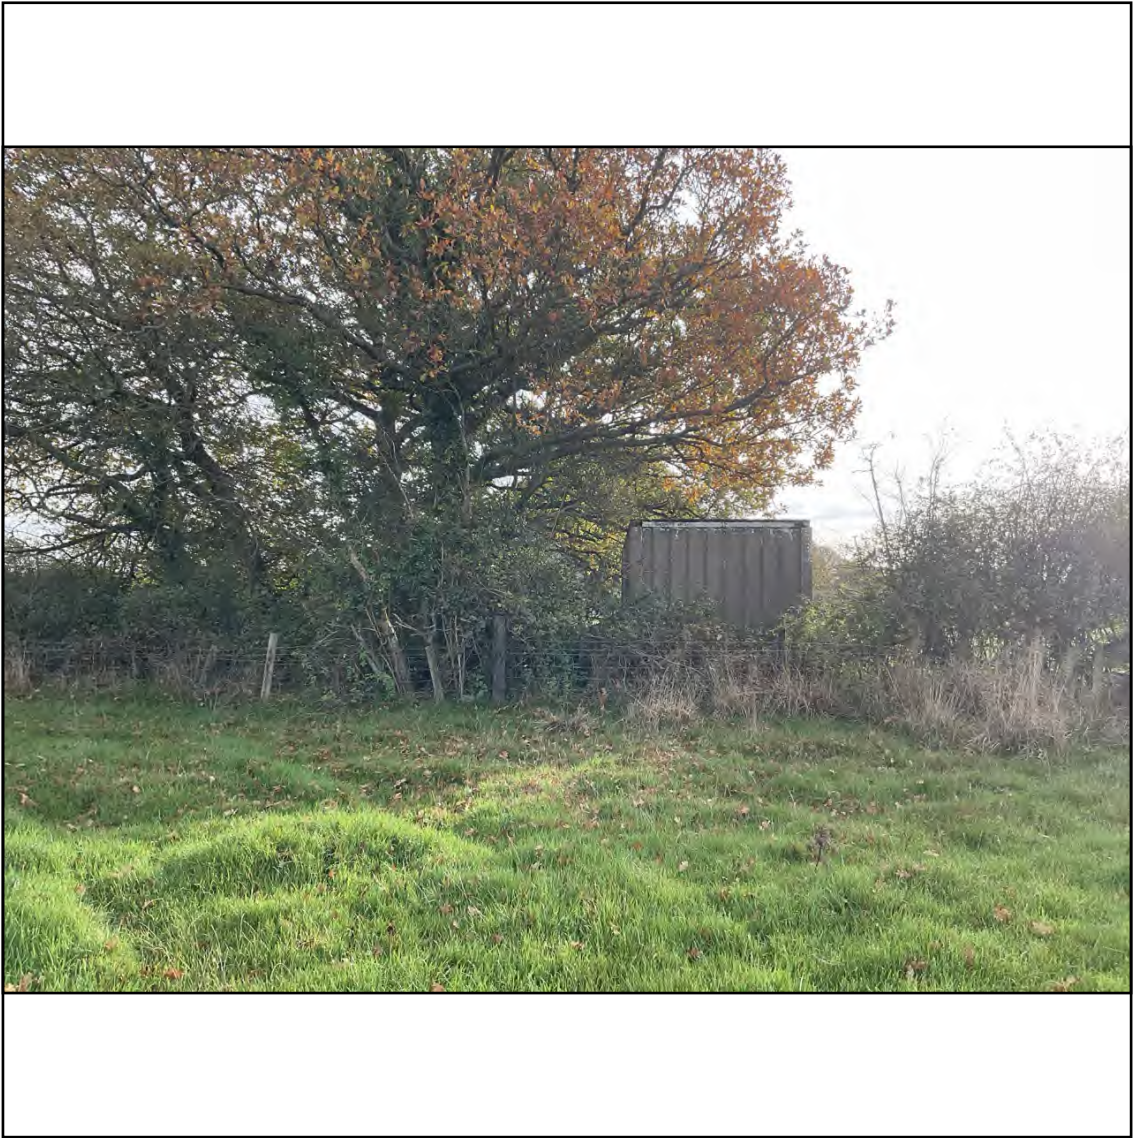
| OBJECTID : | 23 |

| Feature Description : | Storage box in site boundary |

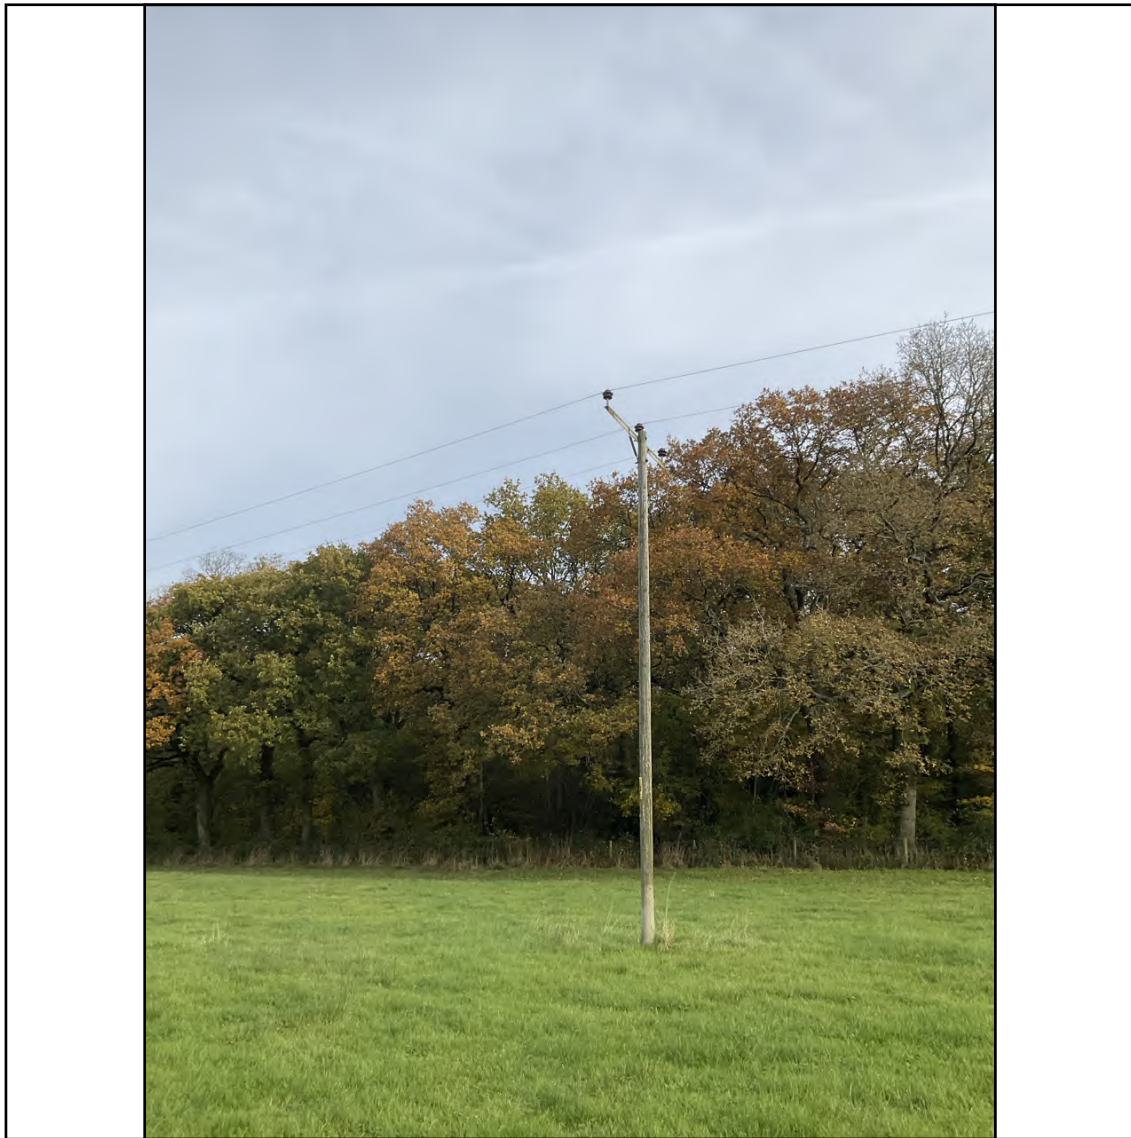
| Feature Description : | Electric overhead lines |
