## Appendix D Site Walkover Plan and Photographs

| <b>Project:</b> | Flaxlands Solar Farm | <b>Date:</b> 11/11/2024 |
| <b>Job Number:</b> | 60727989 | <b>Undertaken by:</b> LR |
| <b>Site Location:</b> | Wootton Bassett, Swindon | |

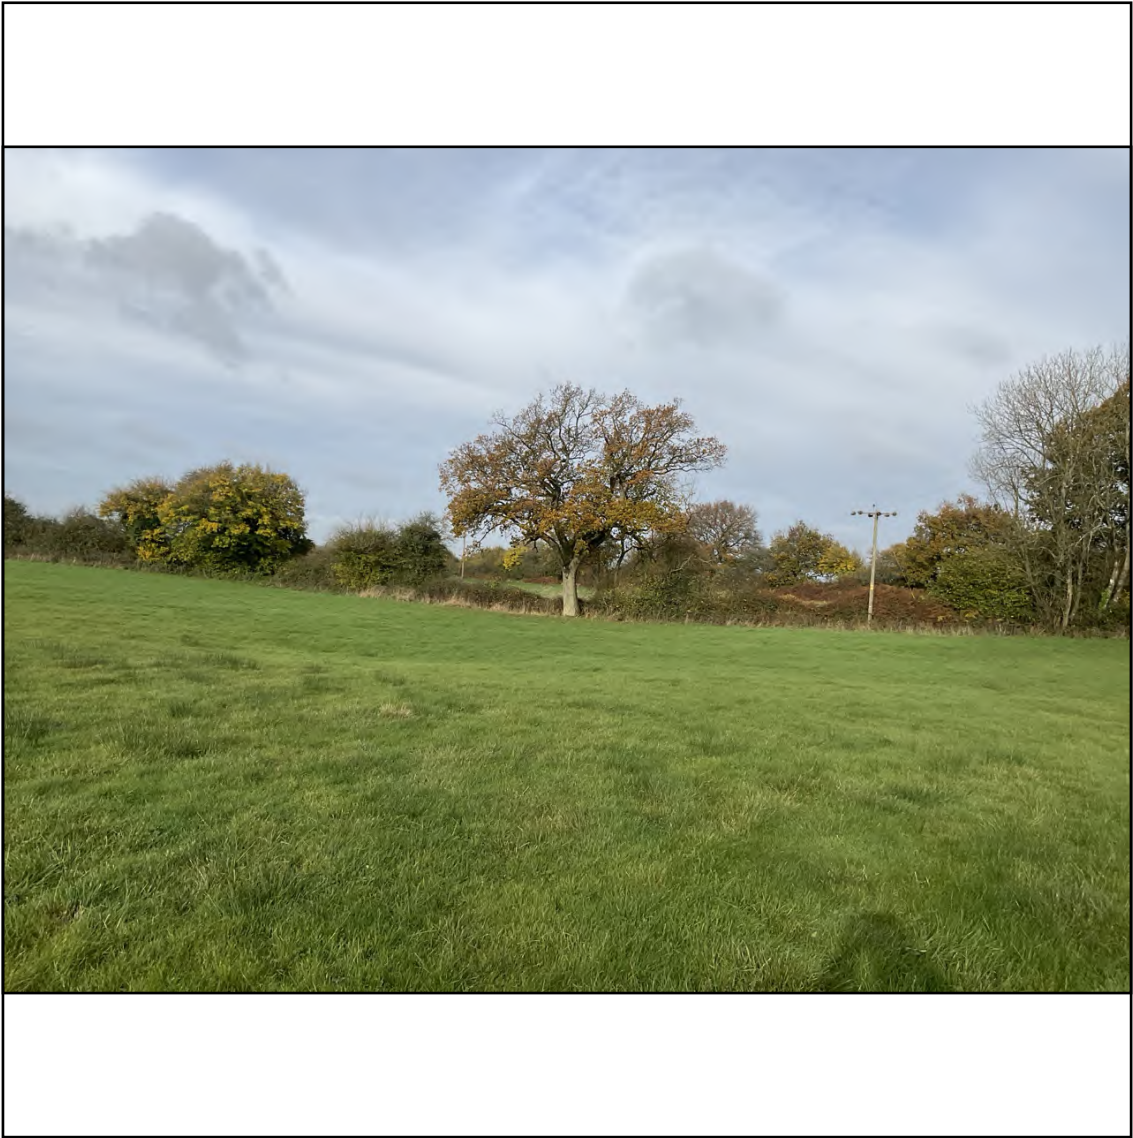
| Feature Description : | Sloping topography into depression approx 5mx5m |

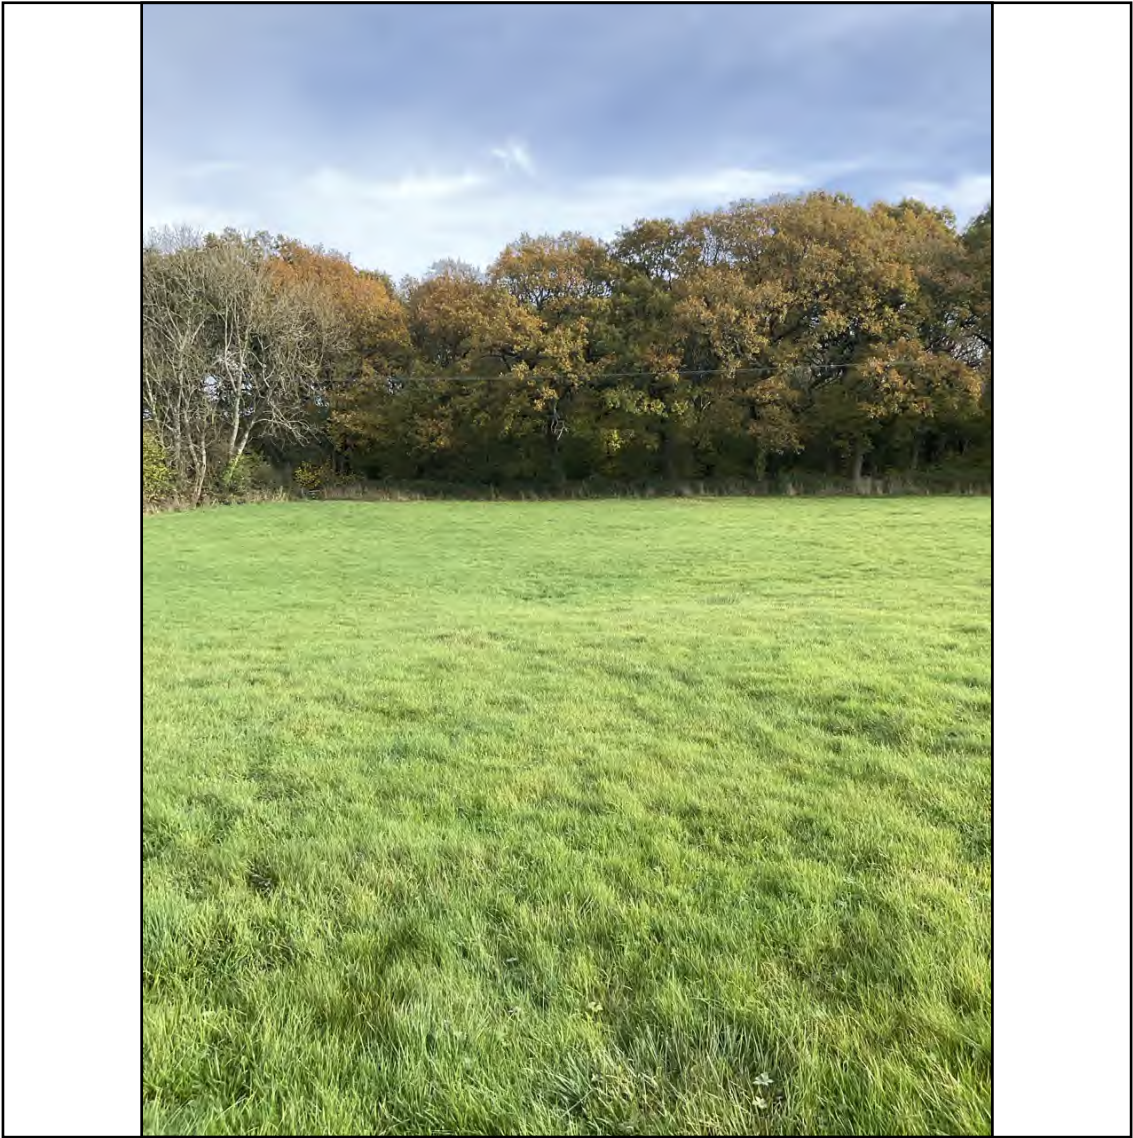
| Feature Description : | Area showing slight depression in the ground surface approximately 15m diameter potential dissolution feature |

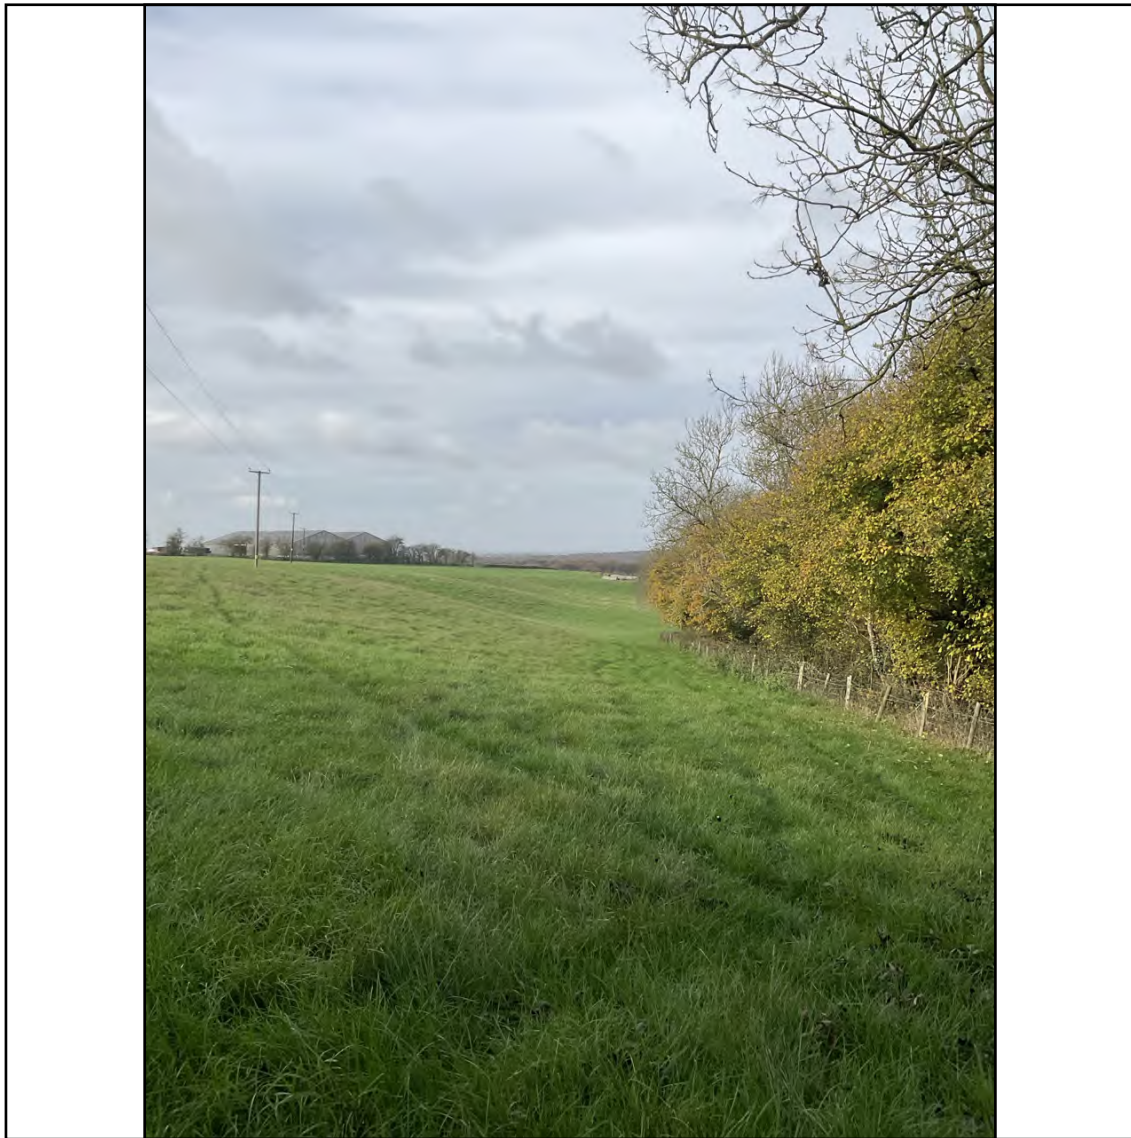
| Feature Description : | Undulating change in slope |

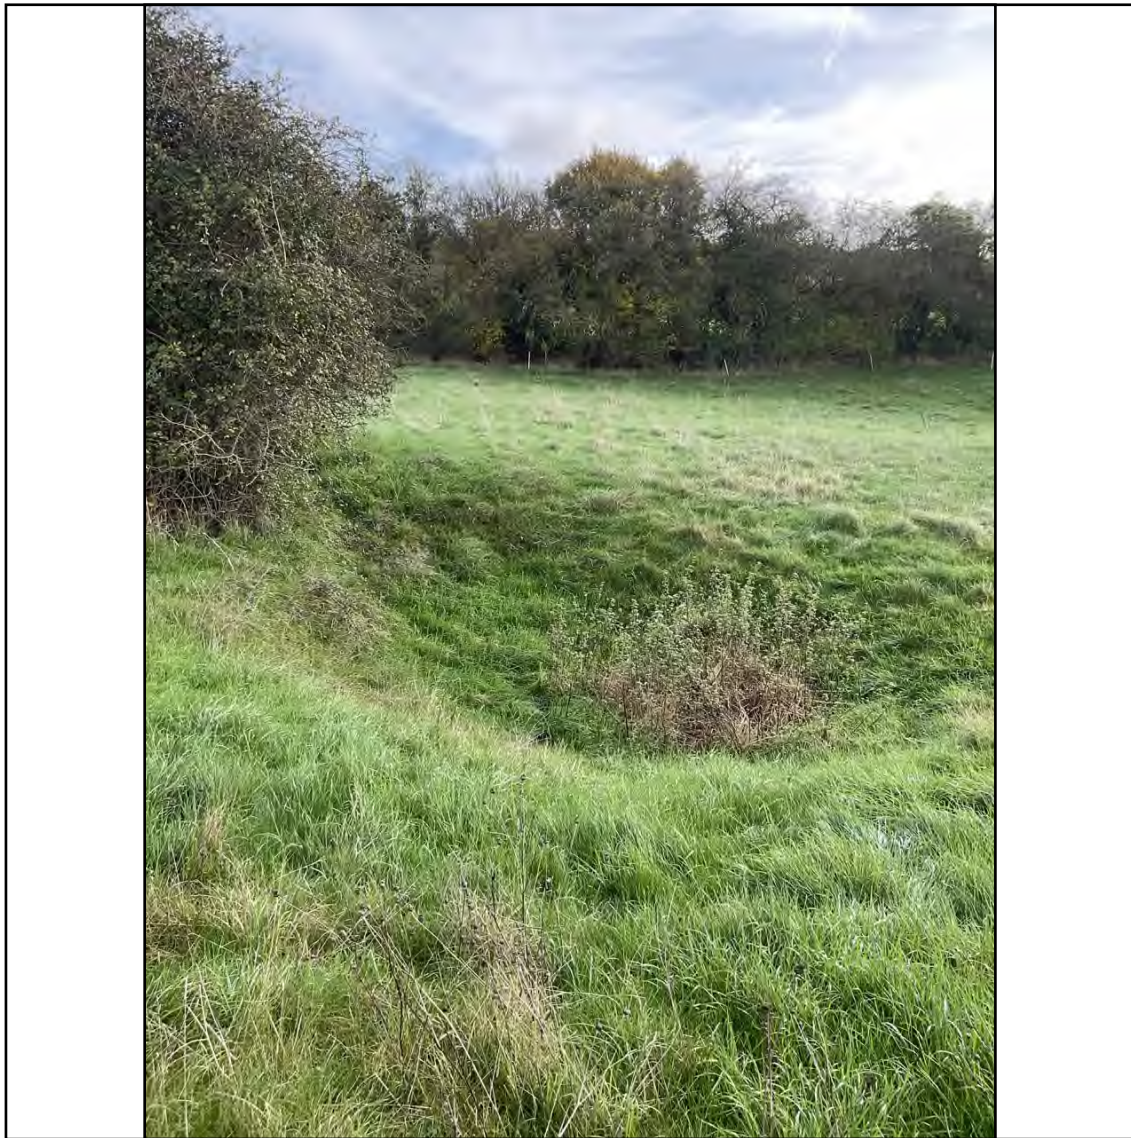
| Feature Description : | Potential dissolution feature approximately 5m in diameter |

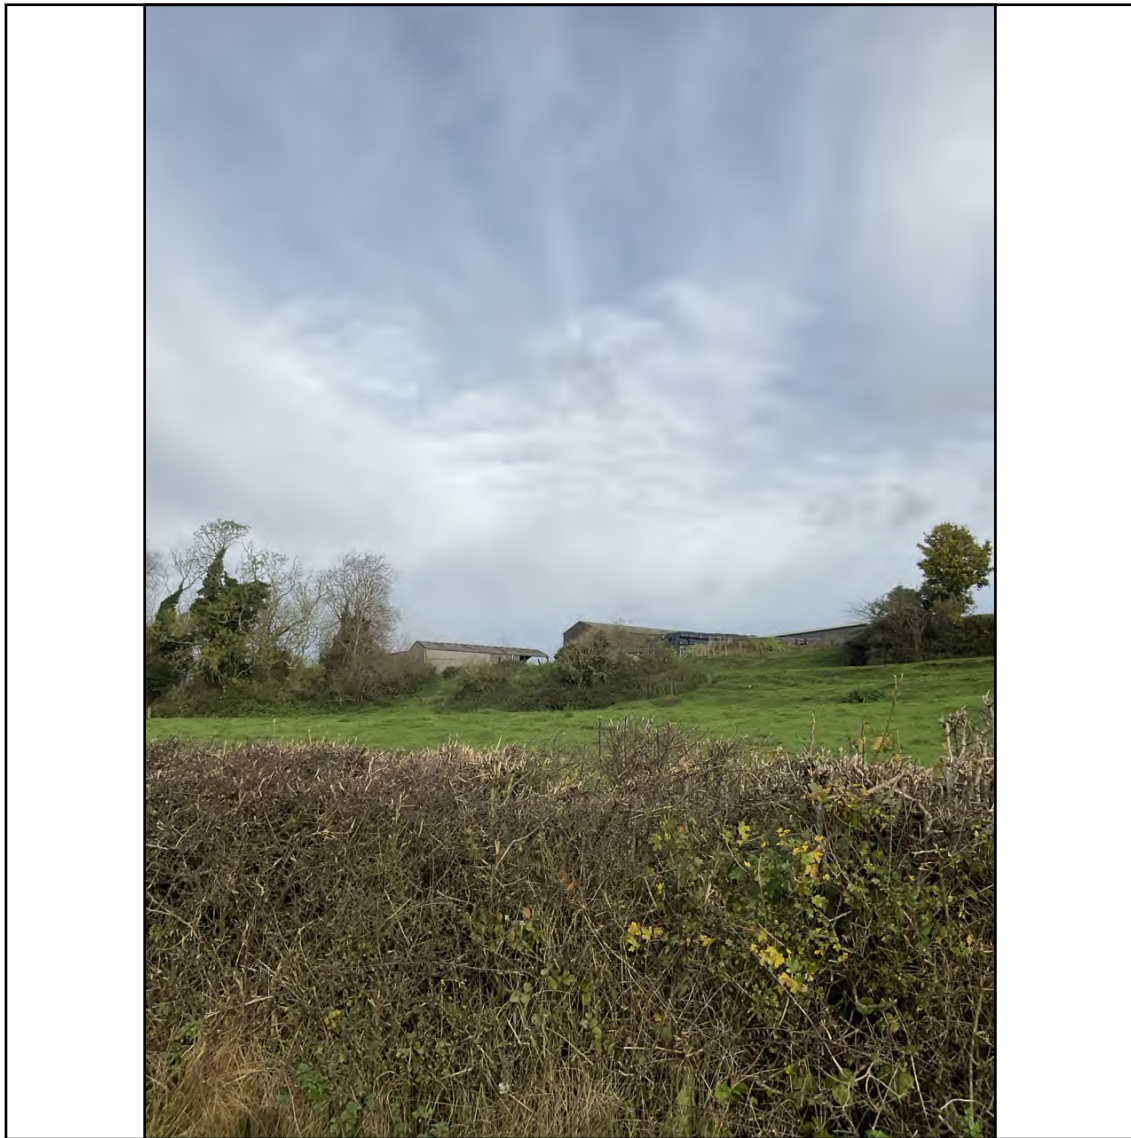
| Feature Description : | Landslip offsite |

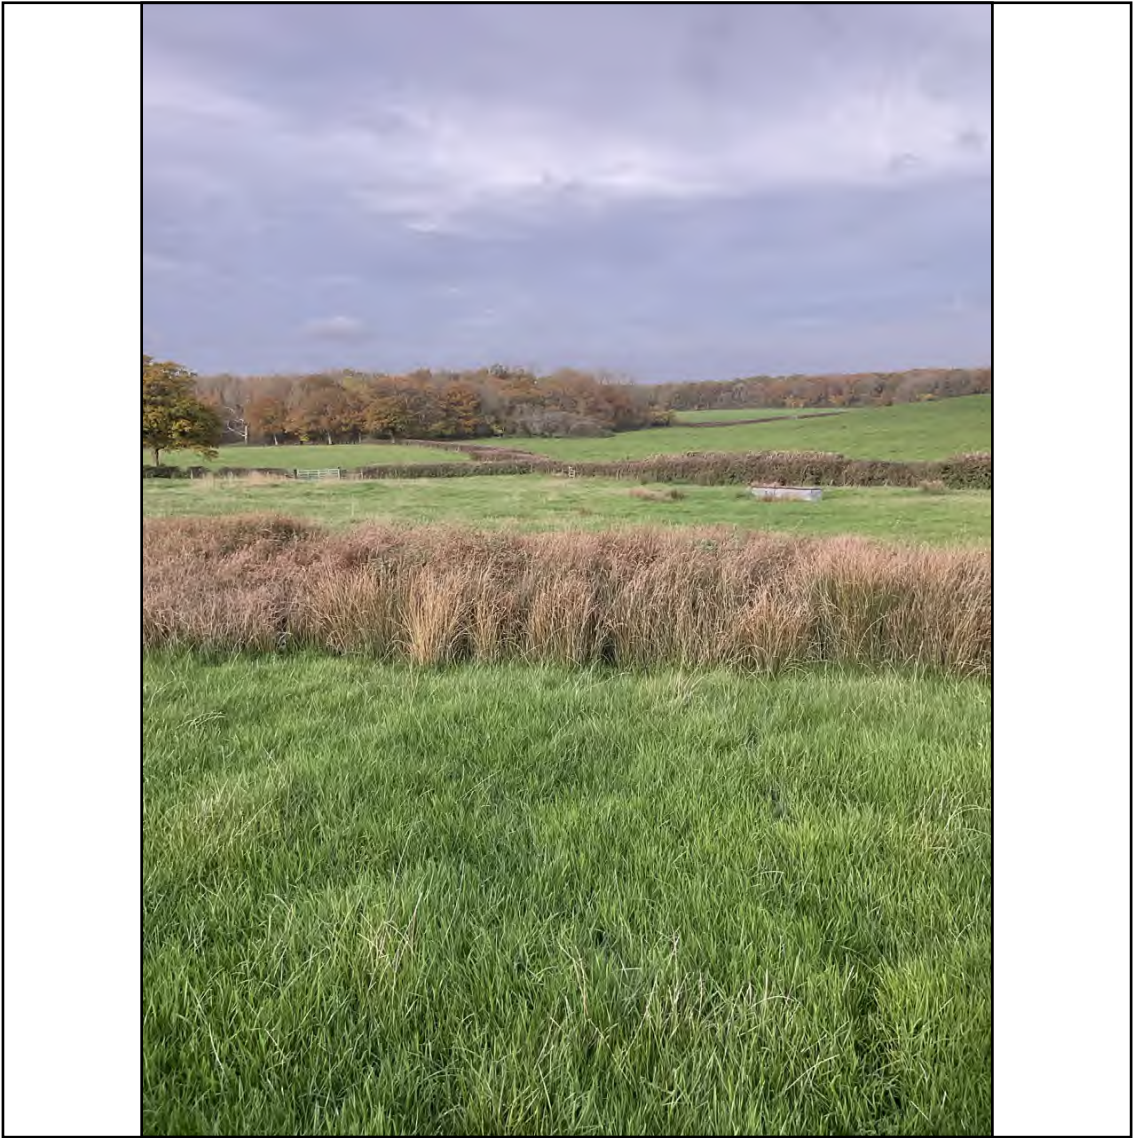
| Feature Description : | Potential instability |

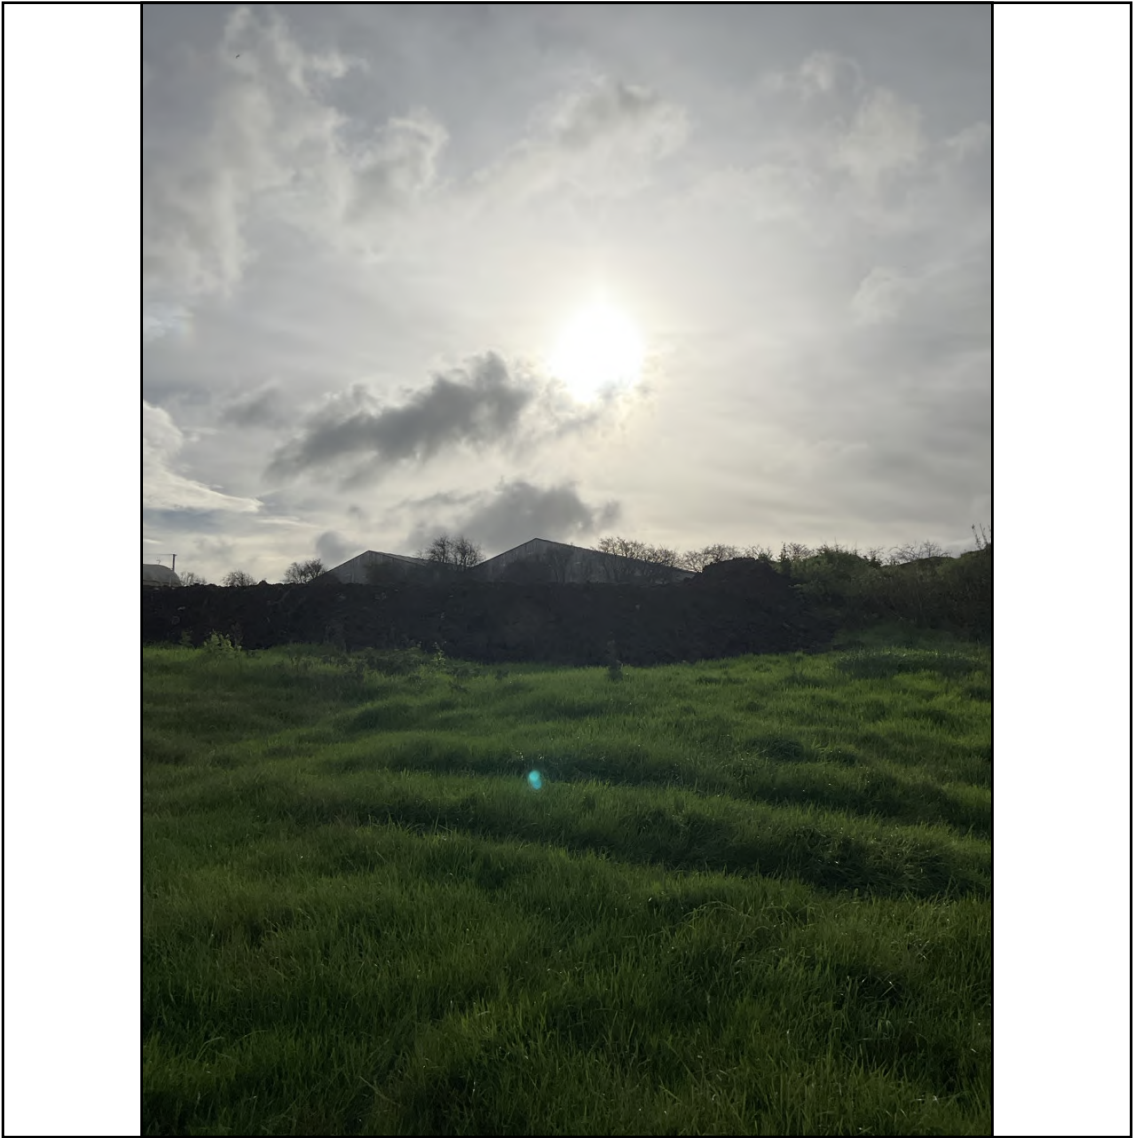
| Feature Description : | Stockpile |

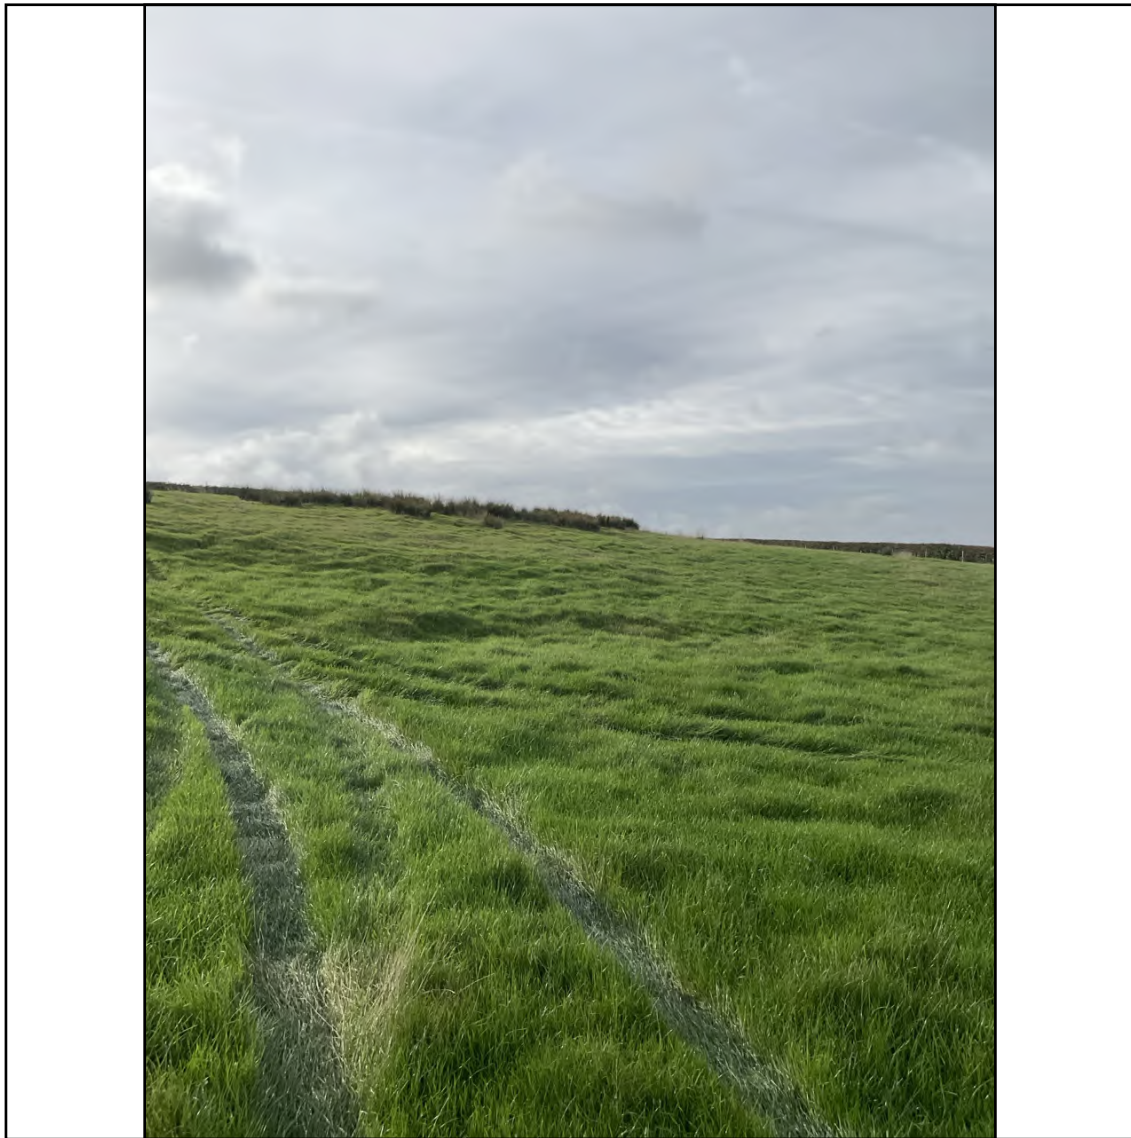
| Feature Description : | Possible Landslip |

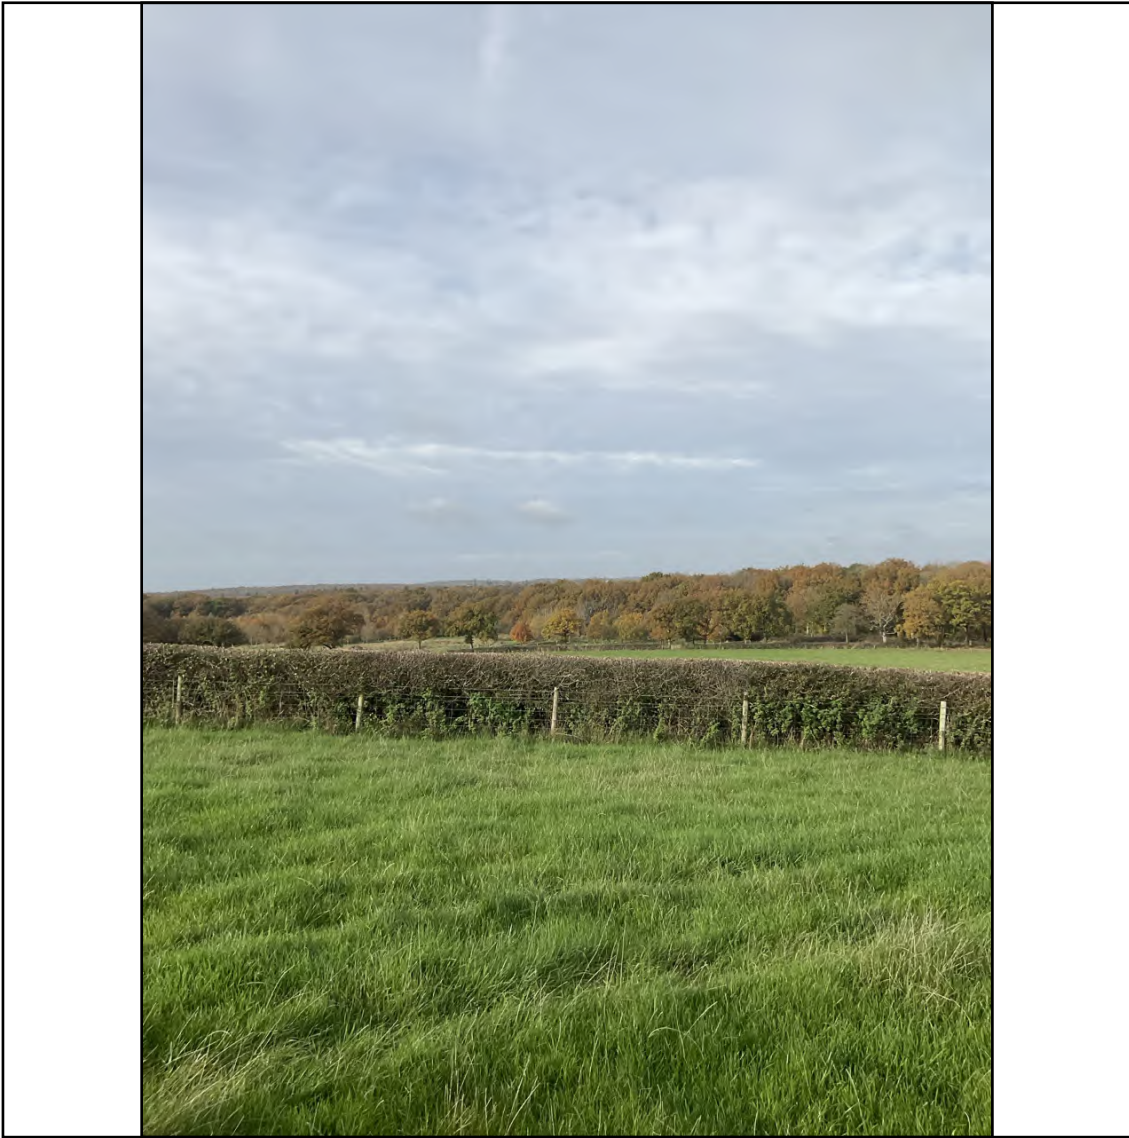
| Feature Description : | Marsh grass at top of hill groundwater perched? |

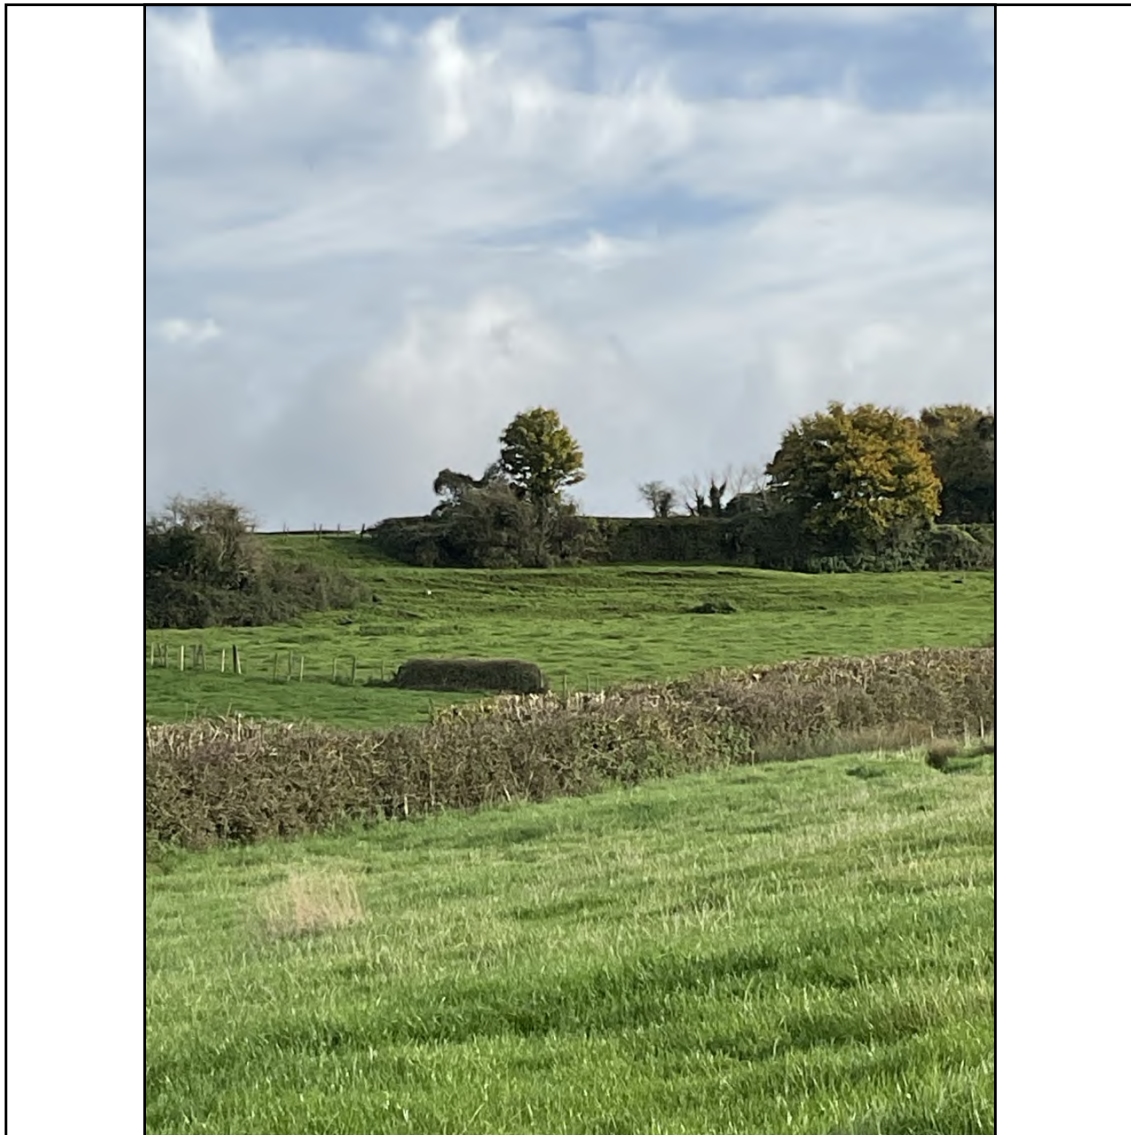
| Feature Description : | Slope Landslip |

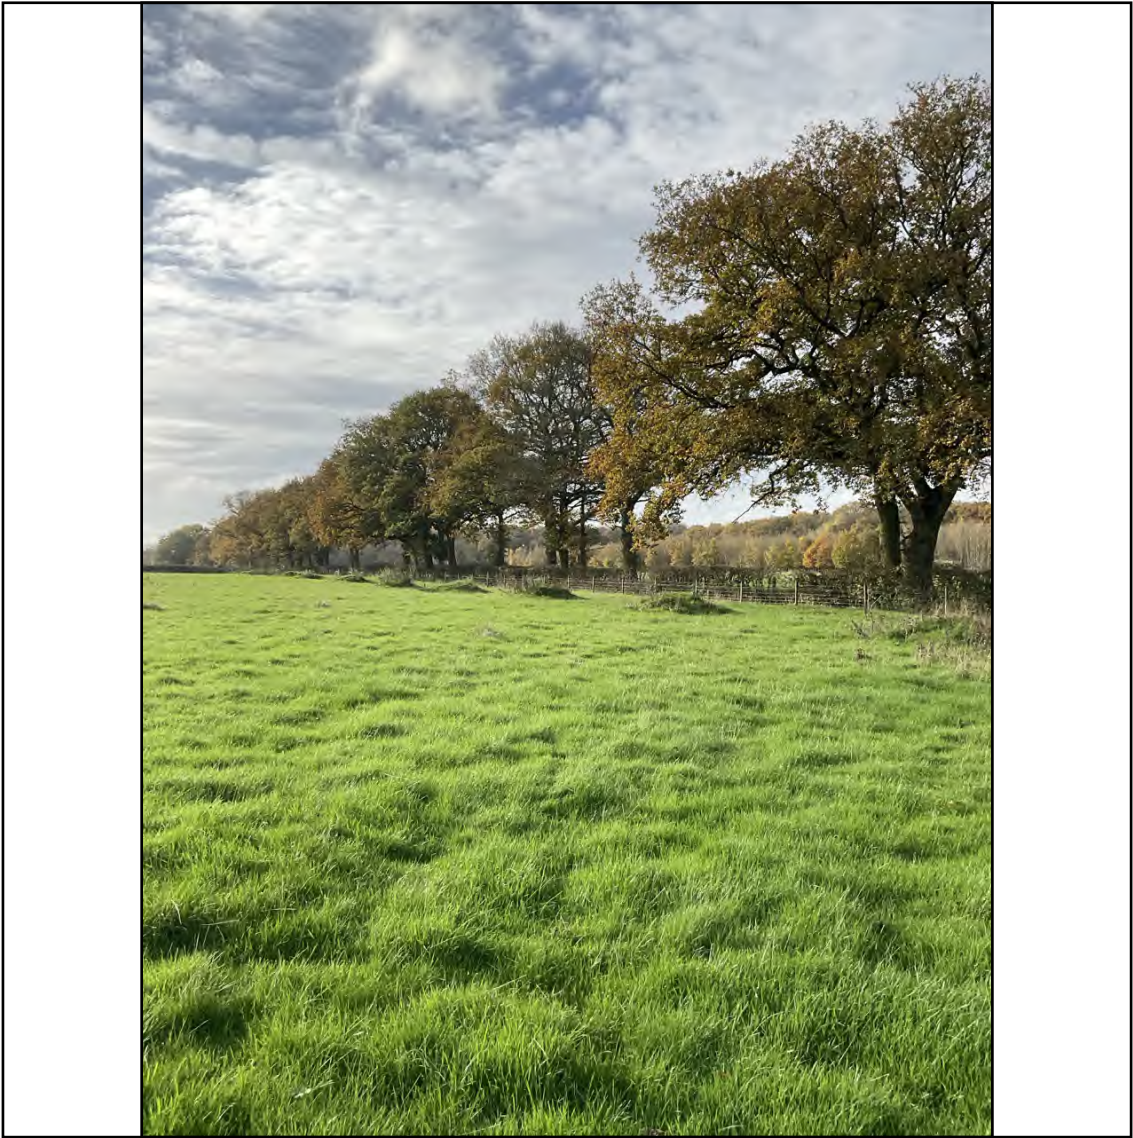
| Feature Description : | Series of mounds 13 paces apart 2mx2m x1m |
