# FORUM Heritage Services

## **BUNDLE 6A: Full heritage justification (12/08/25)**

# **THE OLD VICARAGE, COOMBE BISSETT, WILTSHIRE**

## **Statement of Significance and Impact Statement**

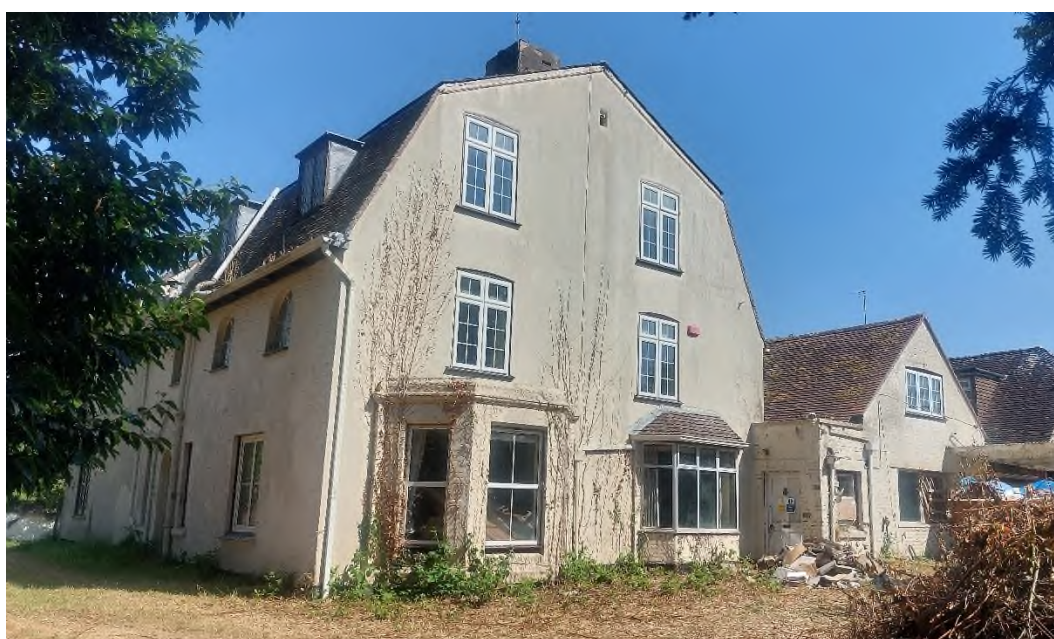
Figure 2 The rendered west elevation with modern fenestration to the first and attic levels.

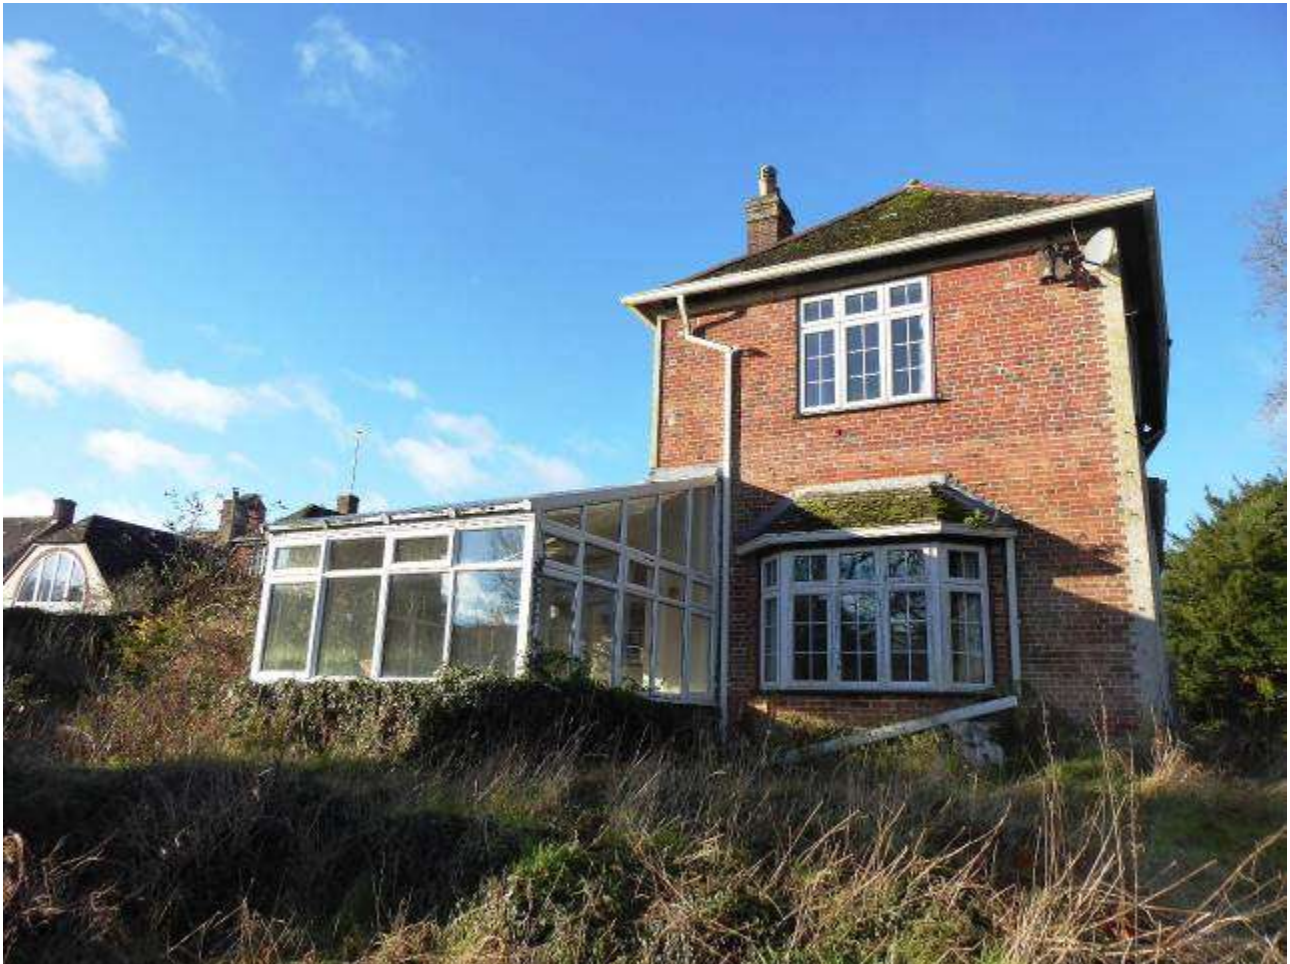
Fig: Old Vicarage from the northeast

The main part of the building is suffering from severe wet related decay entry right the way through, from roof to ground floor with related loss of ceilings, damages to walls and in certain areas roof structure is also greatly affected and will require localised rebuilding. There is long term movement within the three storey west section of the main house in the section of the north wall showing as cracking and bowing. This is probably due to the additional loading applied by the application of the mansard roof. This is likely to require significant structural repair, and possible remaking, to stabilise this whole part.

The roof over the two storey east section of the main part of the house has partial failure of the central roof truss and that in turn is resulting in roof thrust and spread. That has caused severe external bowing to the roof at the eaves and is likely to be part of the cause of the partial collapse of the west end wall head to this where it overlaps the western roof. This movement is also noted by the opening up of the construction joint between the two main parts of the building on the north side. Internally there is severe cracking to the walls and ceilings within the east section where this abuts the west part. Rebuilding is likely to be required too much of this.

Around the building the roof coverings are in a very poor condition with much internal water entry that is resulting in much damage to the internal structure as well as decorations and finishes. Similarly most of the joinery in the form of doors and windows, together with eaves and ancillary aspects are largely failed and need of replacement.

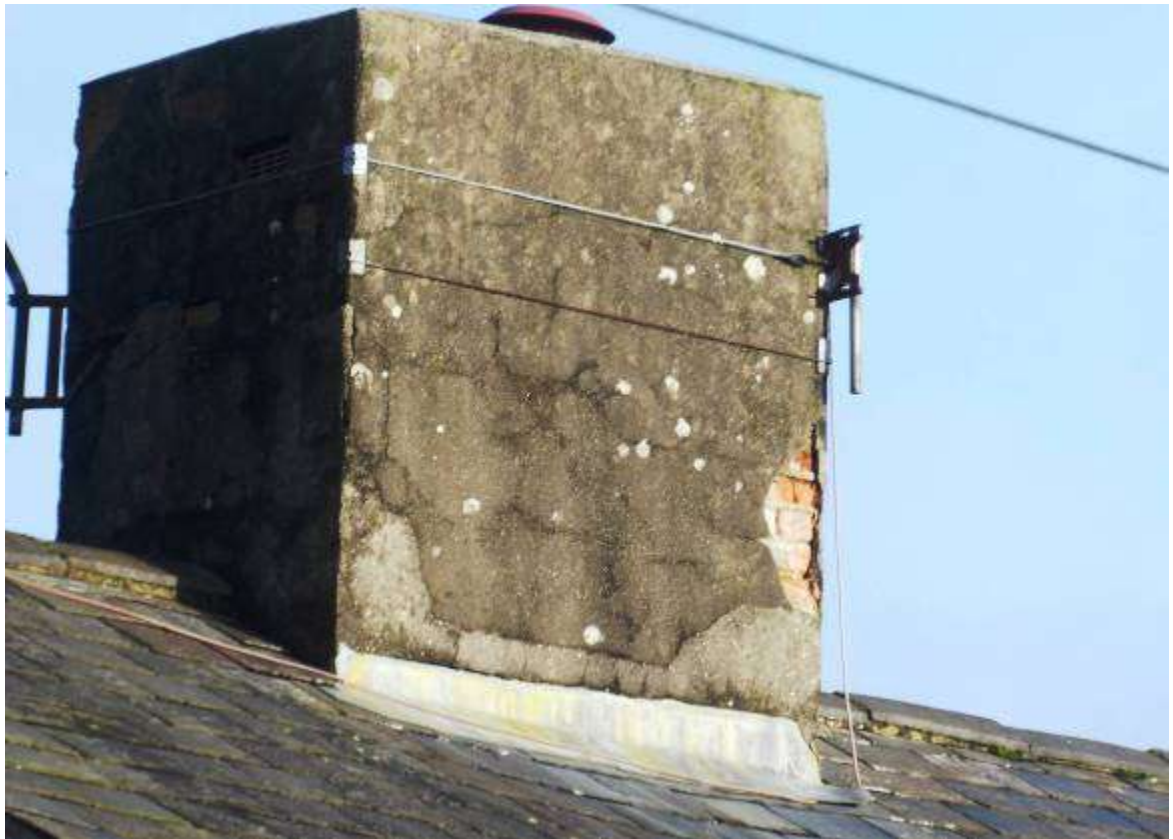
- 3.3.1 Projecting up through the west end of the ridge of the west three storey section, there is a large, somewhat monolithic looking, chimneystack of brickwork that has been fully rendered and has lead flashings to the surrounding roof.

Fig 3.3.1: Main chimney

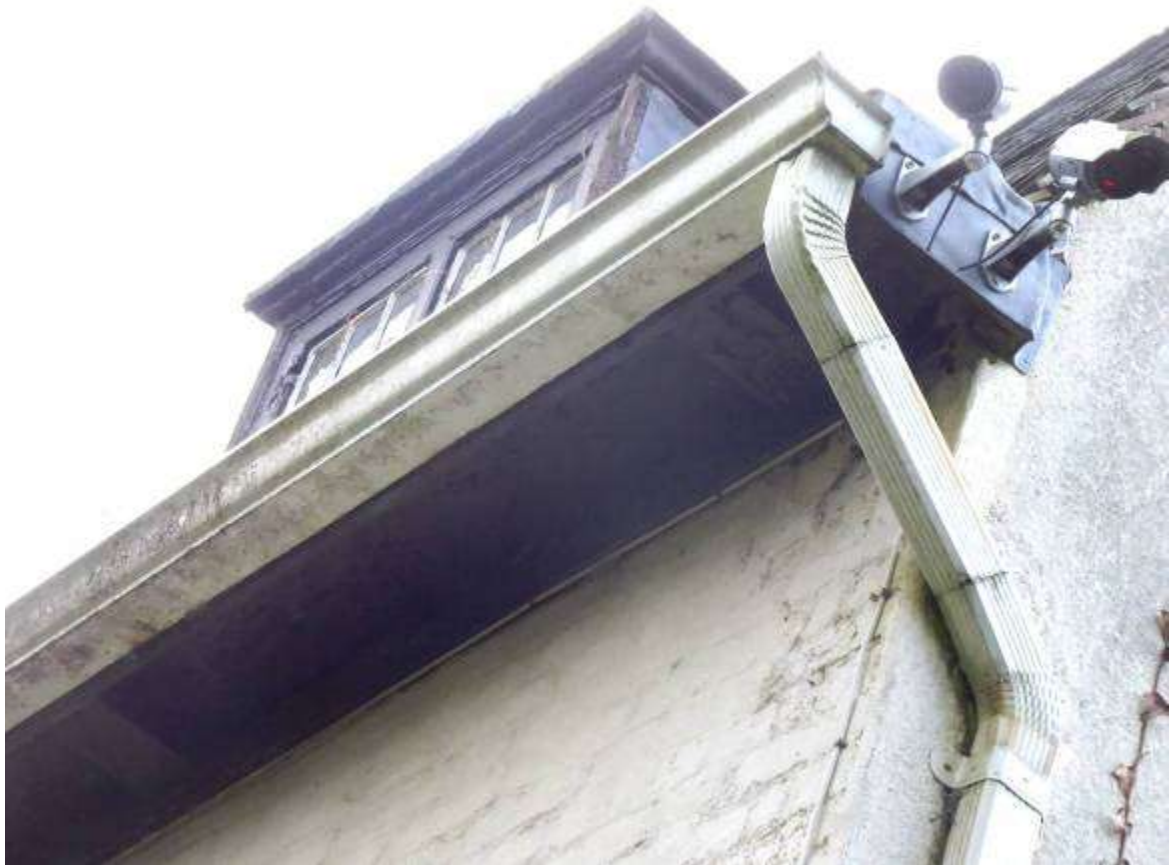
- 3.4.1 All the way around the main house and the service block the guttering is extruded aluminium with somewhat crude box section and where the box section downpipes are attached to the walling with very lightweight aluminium strap.

Fig 3.4.1: Main eaves structure

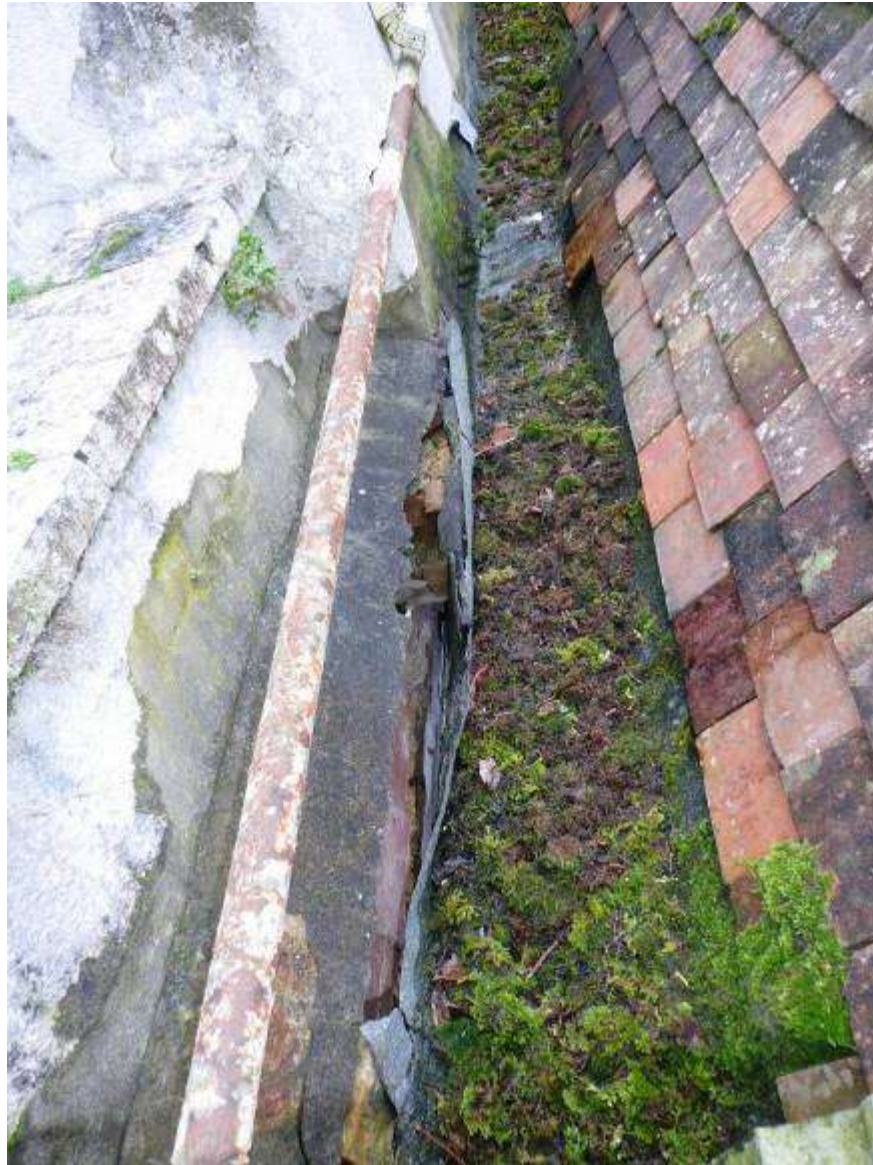
Fig 3.4.6: Failed valley gutter to north side of service block

- 3.4.6 On the north side of the service block, from the side of the link corridor to the west end over the main entrance door, there is a valley gutter, which is lined with bituminous felt that probably had lead flashings, but are all missing.

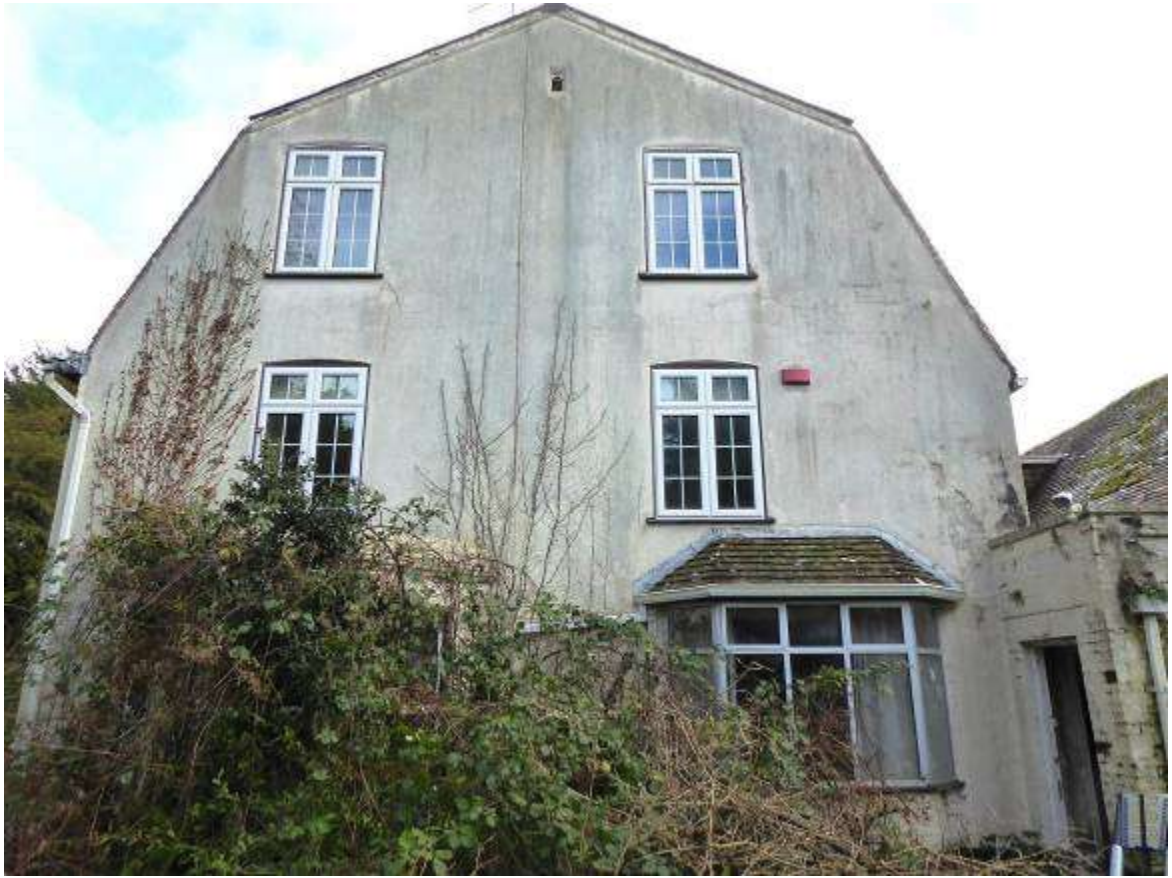
Fig 3.5.1: West elevation of main house

- 3.5.1 The west wall to the main house in the three storey part is covered with a hard cement type render from ground level to top and which is finished with what would appear to be a cement slurry type paint. However, the bottom of the south bay windows is of brickwork painted with modern plastic or polymer paint, whilst the north bay is fully rendered and painted and there is much disruption of the render to the parapet and backing wall that is in need of repair.

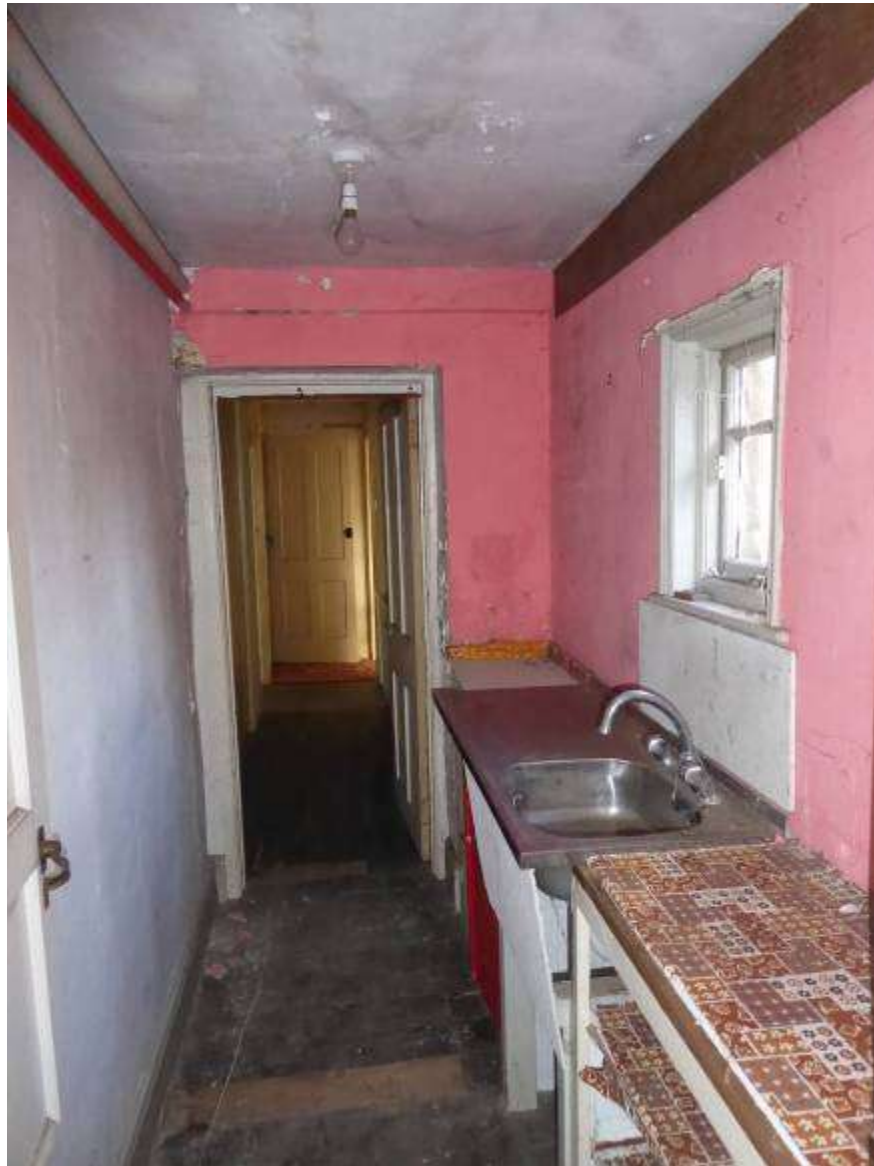
- 4.21.1 This has a suspended floor where it passes through this area and is in poor condition. It shows much signs of previous repairs to the surface and has a certain amount of flexion within it.
- 4.21.2 The walls are all of hollow construction, showing much signs of damp ingress and related problems of deterioration and decay.

Fig 4.21: First floor link to Service block
