STATEMENT IN SUPPORT OF  
APPLICATION FOR LISTED BUILDING CONSENT  
1 SCHOOL LANE, DILTON MARSH, WESTBURY, BA13 4FE

REFERENCE: PL/2025/07802

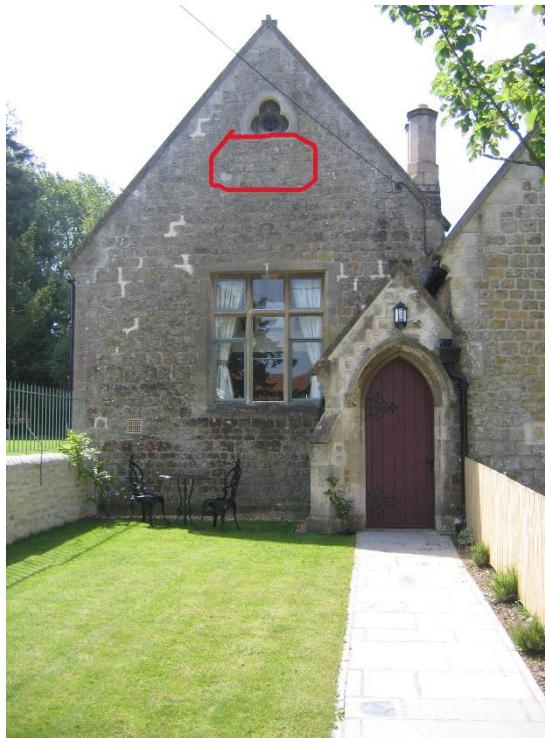
1. Main area of repointing between window and trefoil – this is the area affecting approximately 1m<sup>2</sup> as shown within the red line on the photo below.

The above repairs are individually described and identified in the photos below. All repointing will be carried out using a natural hydraulic lime (nhl3.5) to match the original in colour, texture, and strength to ensure mortar is compatible with the existing masonry and prevent further spalling or water ingress. Repointing will only be done to those areas where necessary, leaving the sound mortar intact.

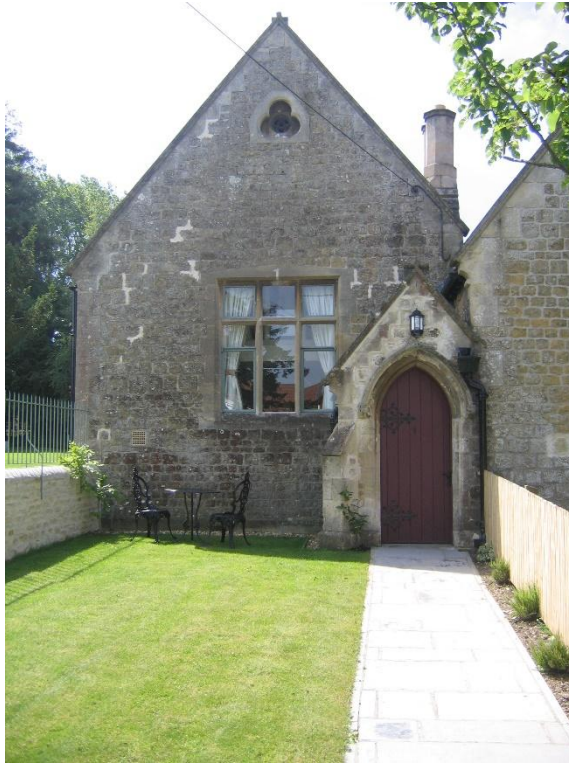
2. localised repointing where inappropriate mortar mix was used at the time of the conversion from school to dwelling. The individual areas have not been highlighted on the photograph below because these are visually obvious to identify.

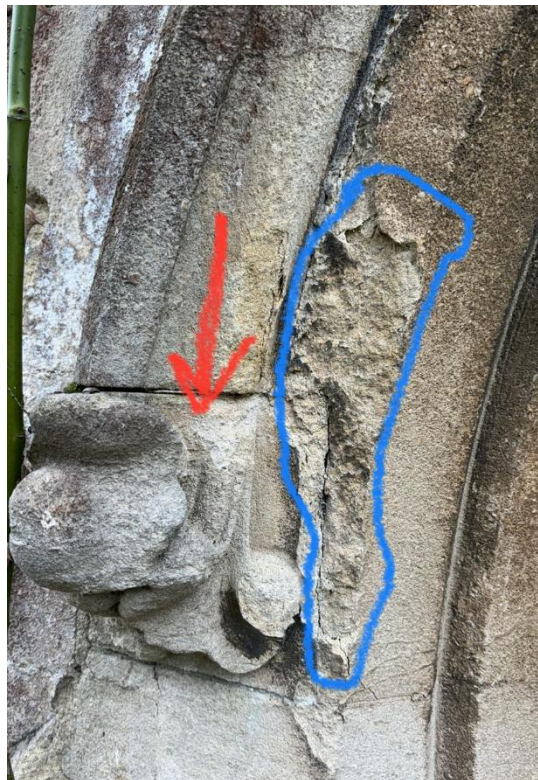
LHS of porch entrance

3. Sympathetic restoration of dressed stone to window and other detailed areas, as necessary, where defective due to spalling and deterioration over time. This will be done by raking

out the soft areas and repair, using an appropriate lime-based bath stone dust restoration mortar, approved by the LPA before work commences. Open joints to be treated with a lime putty. All repair techniques are to follow conservation methods to maintain the building's character and integrity.

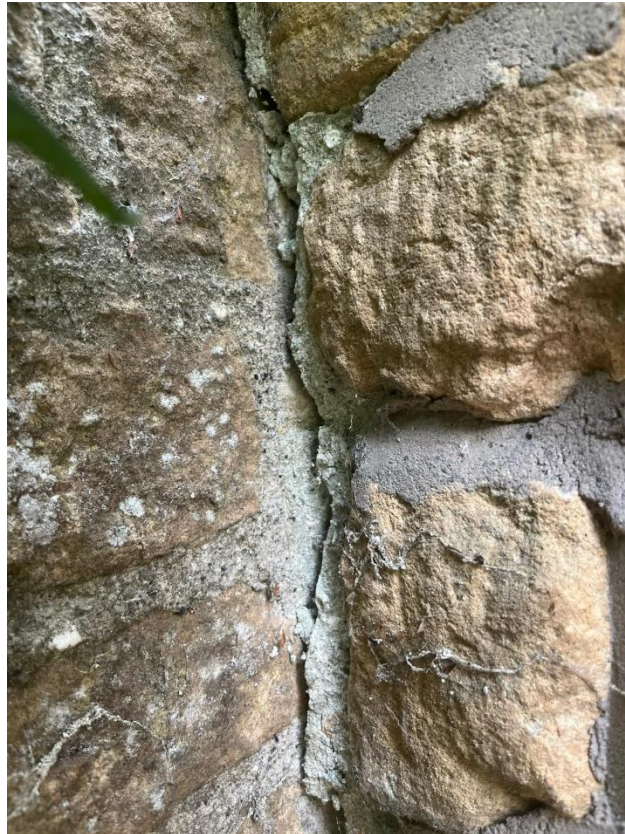
4. Pointing up vertical joint between LHS front porch wall and gable wall of house. During this year's long hot dry spell, differential movement has occurred between the left unbonded stone wall of entrance porch, which bears onto high level footings with 225mm projections from face of wall at ground level and being some 150 deep, with the deeper footings of the main dwelling. At its widest, this crack is some 10mm and is not considered significant to affect the stability of the structure. the joint will be raked out and repointed.
