Heritage Impact Assessment and Design and Access Statement  
for works involving a  
replacement chimney capping at  
Lacock Abbey

For and on behalf of the National Trust

November 2025

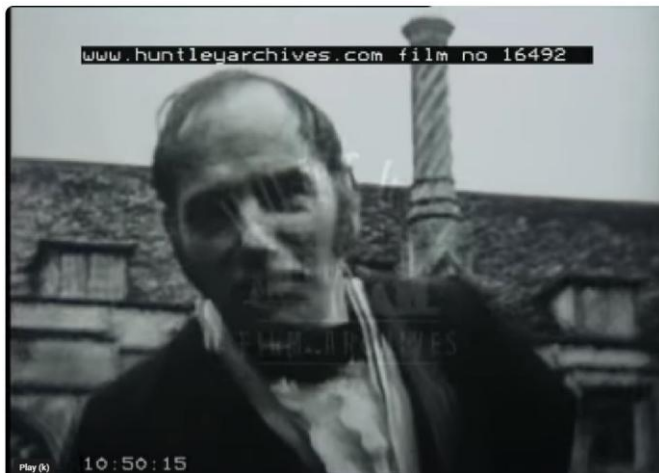
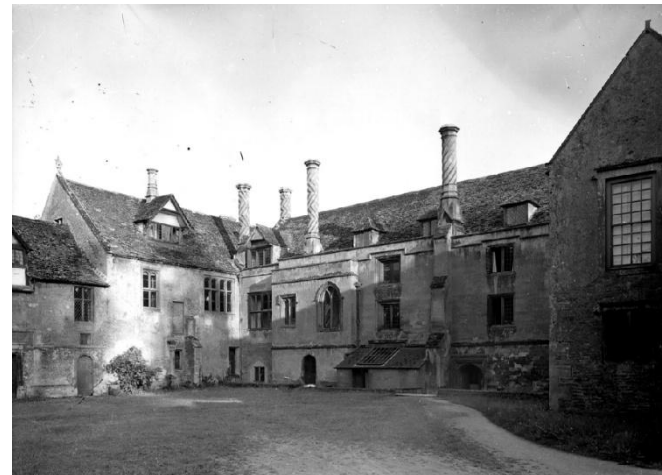
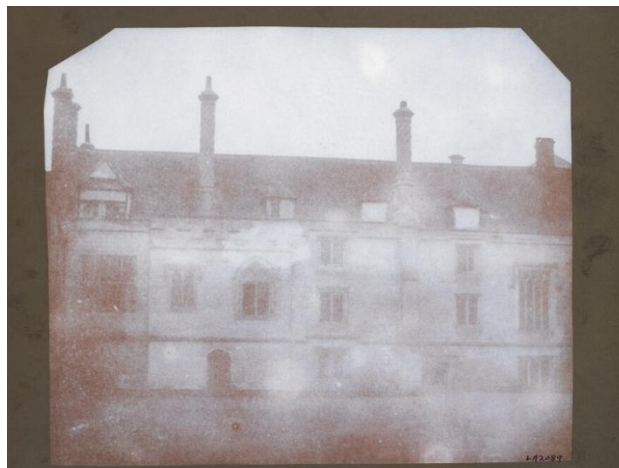
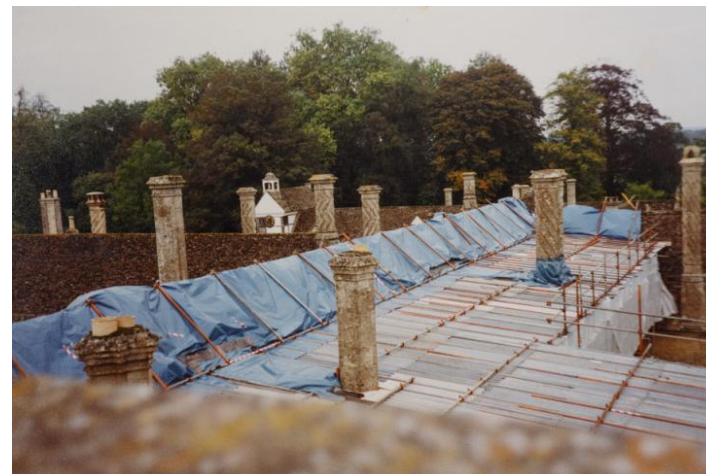
| | Criteria | Response | Risk Level |
|---|---|---|---|
| Impact | Could the proposal put the significance of the heritage assets at risk? | The proposal could only put the significance at risk if the extant capping were deemed to be of overwhelming significance to the heritage asset. Our research has informed us that the chimney capping was most likely installed in the 1950s, so could be considered to have been an intrusive addition. | Low risk |
| Knowledge and Understanding | Is there enough information to avoid any risks? | The NT have located photographic and film evidence to support this, so we can conclude that the removal would not present a risk to the significance of the heritage asset. | Low risk<br><i>Photos 1-4</i> |

**Photos 1-4** showing 1) still from 1950 film; 2) unpublished Country Life photo from 1923; 3) early Fox Talbot photo showing chimney pot and no stone cap; 4) cap visible in 1990s photo during general roof repair works.

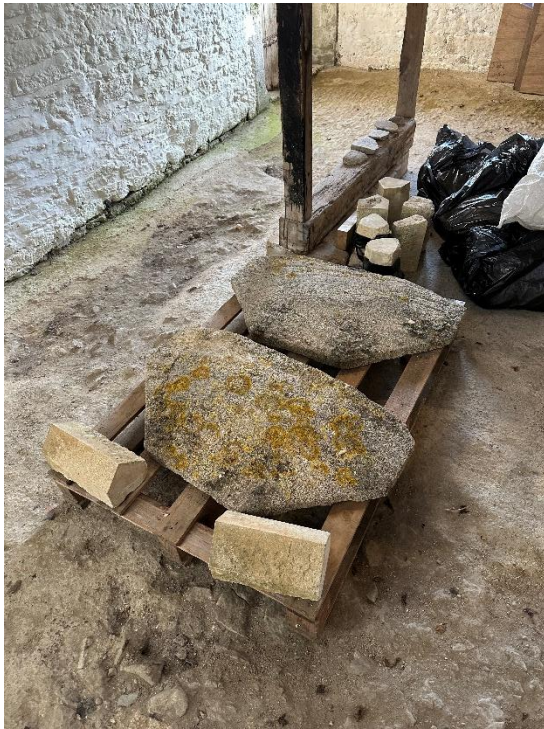
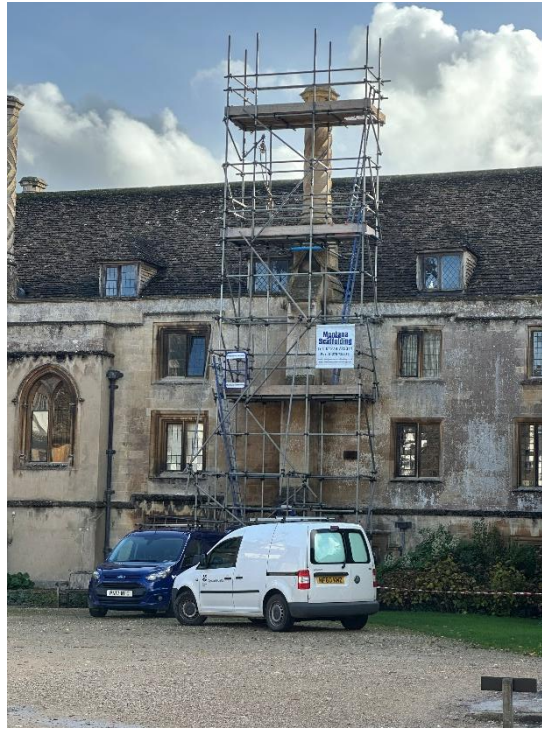
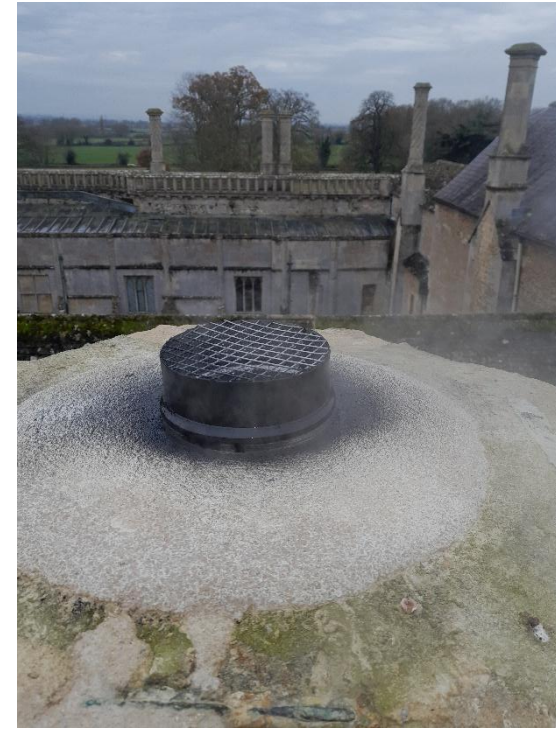
3.4 *Current condition of management unit / location:* The building is generally in good condition but there are ongoing works to improve this associated with general maintenance and compliance. The particular issue that resulted in the need to remove the chimney capping came about because of a sudden area of damp that was discovered around the chimney that serves the boiler for the heating system for the main outbuildings at Lacock Abbey. The gas heating system was turned off in April 2023 following the discovery that the flue was blocked with a bird's nest causing condensed gases to permeate through the building resulting in water damage to the fabric. The project that arose from this required replacement of the boiler and also the flue liner, as the extant asbestos cement flue liner was

not compliant. A new stainless-steel liner was installed and these works necessitated removal of the stone cowl. The pre-application advice from Wiltshire Council was that “Listed Building Consent will need to be submitted for the removal with justification and options for either leaving the stack without a cowl or alternative protection for bird and other debris from entering the chimney stack shaft /flue.”

The chimney cap was formed from short stone columns with a capstone which was placed on top. The construction was quite fragile and not compliant with the requirements of the new boiler and flue system. Furthermore it did not provide an adequate level of bird protection. On researching the provenance of the extant chimney capping, the collections and house manager at Lacock has identified a 40-year period within which the cap was installed. There is footage in the archives from a 150th anniversary event for Fox-Talbot’s birthday in 1950 which shows no cap (photo 1). Documents have been found from the early-mid 1950s when they were replacing the boiler and doing works to the chimney flue and they don’t mention installing a cap. There is a photograph from Country Life from 1923 (photo 2) showing no cap, and one of the very early photographs from Fox-Talbot’s time showing a chimney pot is sitting inside the chimney, but no cap (photo 3). A photograph of the roof repairs being undertaken in the 1990s shows the cap in place (photo 4). It seems likely therefore that the cap was installed in the mid 1950s when associated works were being undertaken, so we’d consider its removal to be of low impact to the significance of the heritage asset.

**Photos 5-7** showing the dismantled chimney capping, the works underway and the completed terminal with finished flaunching.

3.5.1 Remove the stone chimney capping, to facilitate installation of new flue liner. Stainless steel flue terminal to be finished with bird mesh and masonry chimney shaft brought to finish with mortar flaunching.

| | Criteria | Response | Risk Level |
|---|---|---|---|
| Impact | Will the proposal improve the condition and/or the significance of the heritage assets? | The proposal will improve the condition of the heritage asset going forward by removing what could be considered to be an intrusive addition to the heritage asset and replacing it with one of lower impact. | Very low risk<br><i>Photos 5-7</i> |
