# Mompesson House

## North-East Bedroom

### Heritage Statement

Connolly Wellingham Architects

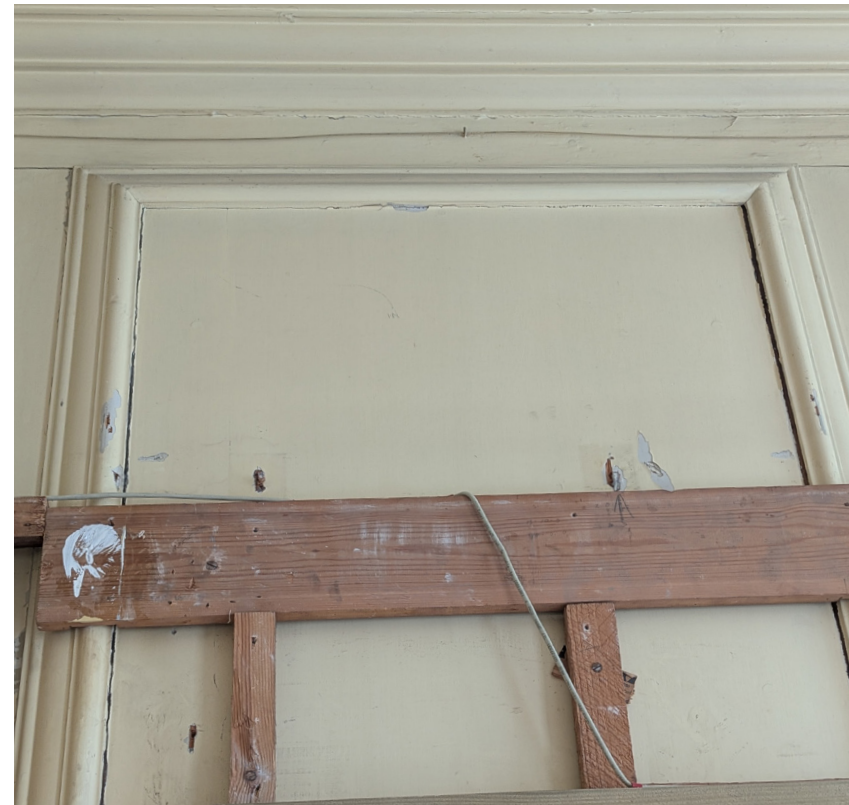
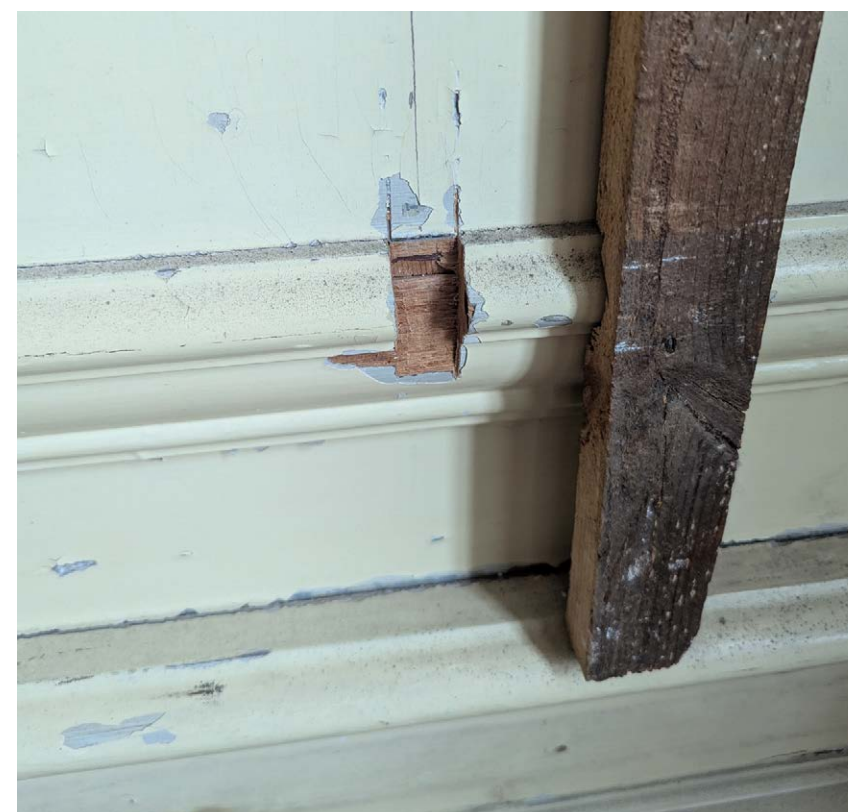
Aside from this loss, panelling and associated features exhibit a level of damage and degradation consistent with their age, principally resulting from structural movement in the house since its construction. This movement, in combination with the shrinkage of wide wall panels across the grain of the wood, has opened up joints between the panels and the bolection moulding. This has caused the loss of support to some panel edges, and is especially marked in the 'mirror' panel between the windows where the modern timber battens have been left in place to support it until repair works are carried out.

Top: cross-grain shrinkage and loss of connection at panel edge  
Bottom: localised notching of moulding and loss of fabric

Small areas of damage, of around 7-8mm in diameter or less, will be made good by filling and sanding flush prior to redecorating. These will include the many nail holes resultant from the attachment of the timber battens that supported the modern wall linings.

There are a number of larger holes through the panelling, in the stiles / rails and in the panels themselves, most of which result from the formation of holes for pipework and other services. These are to be repaired by piecing cross-grain wooden plugs to match adjoining material.

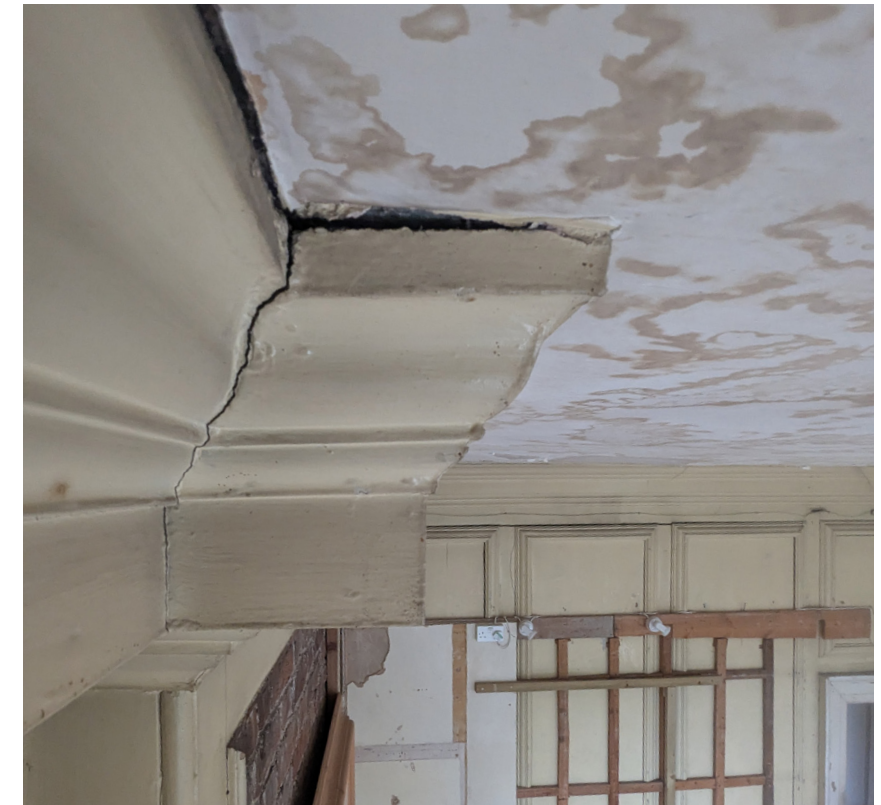
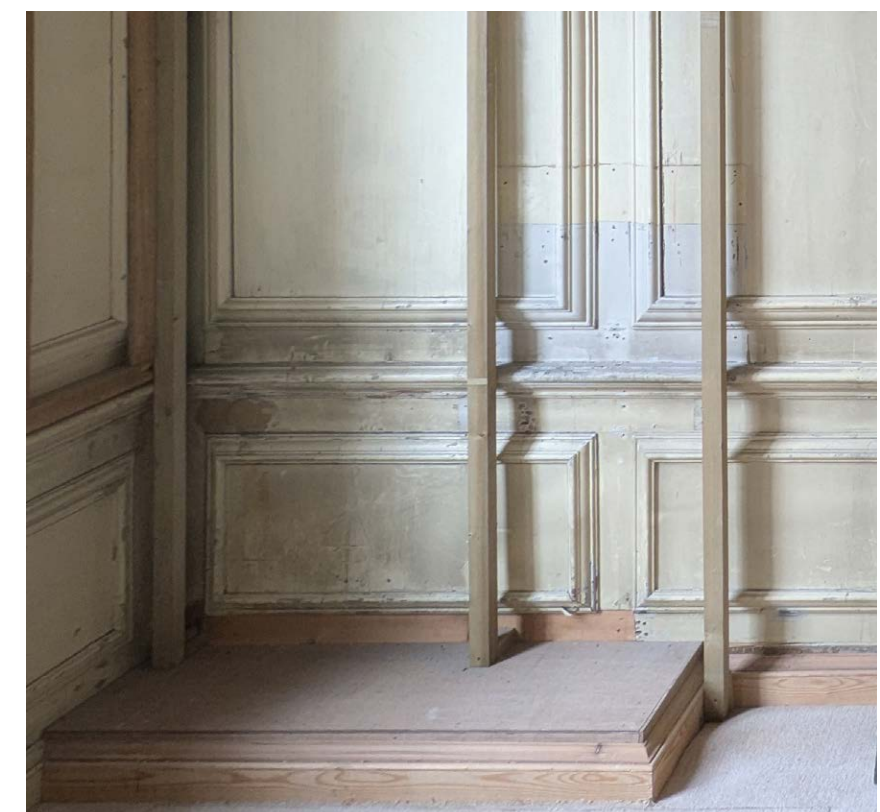
The eighteenth century skirting survives to the full width of the north wall while, on other sides, it has been replaced in whole or in part with modern, unpainted pine, in facsimile of the original. This was done after the removal of wall linings in the early 2000s.

Top: timber cornice  
Bottom: skirting reinstated in facsimile with 'plinth' to conceal pipes

- Dado rail: Missing section beneath window W2 to be reinstated to match existing adjacent.
- Skirtings: The historic skirting is intact on the north side of the room but, on other sides, has been replaced in whole or part in facsimile. At the north-east corner of the room, the skirting projects as a small 'plinth', formed in the reinstated skirting material with a flat, timber top. Investigation reveals that this encloses water and gas pipes, which terminate inside

the plinth, or penetrate the wall and floor within it. Further survey and testing is required in order to determine whether these pipes can be removed or re-routed, but it is hoped that they can be removed from the space and the skirting reinstated on its historic alignment with the panelling, as elsewhere. If this is found to be possible, the 'plinth' section will be dismantled and the skirting material from it re-used in the re-set skirtings.

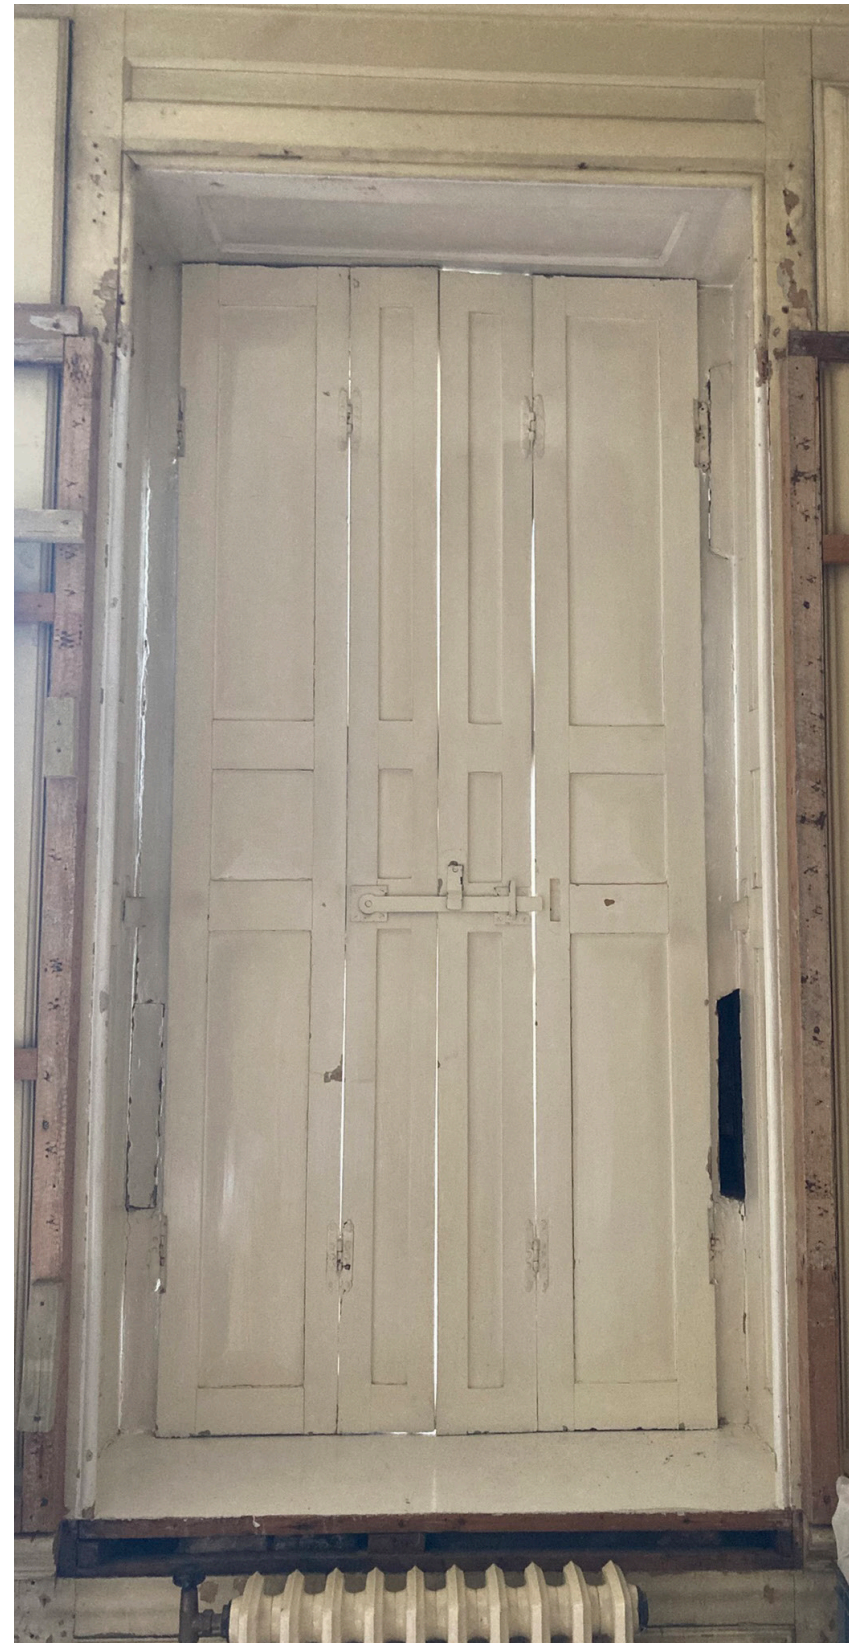
The window and shutter joinery is in reasonable condition. There are two cracked panes, which are to be replaced, and redecoration is needed. There is a missing cover panel to a sash weight on the eastern window, which is visible within the shutter recess.

Window with shutters closed, showing locking bar and missing cover to sash box on right hand side

No significant repair is required: two cracked glass panes will be replaced, sash pulleys will be overhauled and the missing cover panel to the box frame at the right hand side of W2 will be replaced in matching timber.

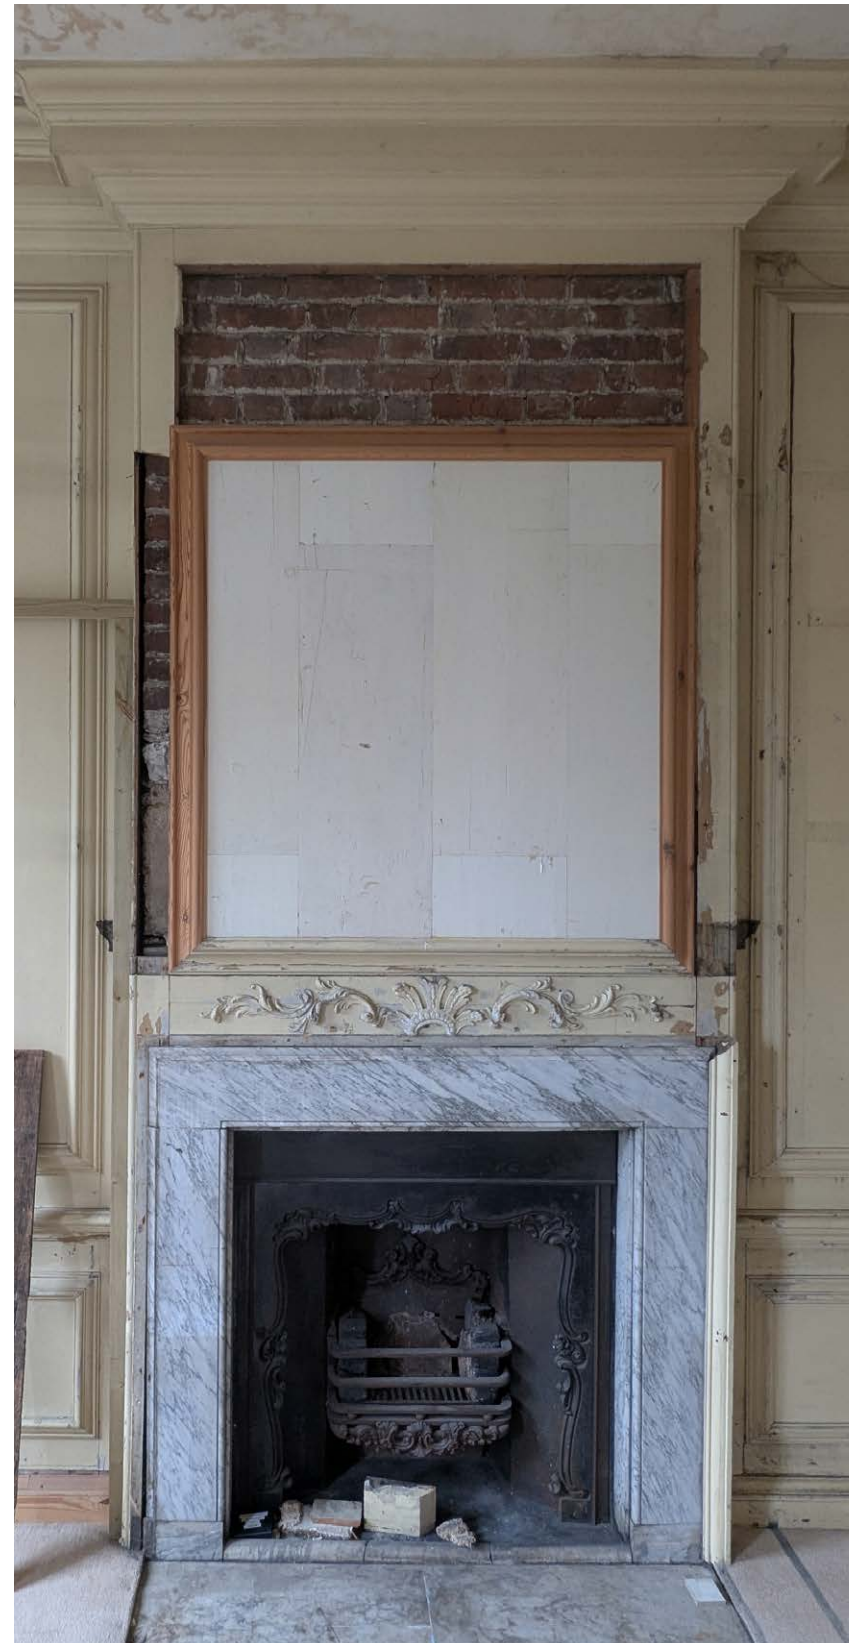
The hole in the brickwork has since been made good. A modern re-creation of the wall panel, re-using an original bolection moulding on one side, has been fixed in the wrong place, leaving missing and damaged fabric around it where the underlying masonry remains visible.

The mantle shelf is missing, presumed to have been removed at the time of the insertion of a bathroom in the mid-twentieth century. Its presence is revealed by the 'ghost profile' of its outline in the painted finish of the adjoining stiles of the wall panelling.

Fireplace, with displaced modern panel above and missing mantle shelf

Between the mantle shelf (see below) and this reinstated rail, a plain, flush panel will be fitted. Its historic size is known (since the position of the removed rail above it, and missing mantle shelf below, are both precisely located). Its treatment as a flush panel is informed by that of the overmantle in the Small Drawing Room on the ground floor of the house, which we believe to have a similar treatment to that of the north-east bedroom. In this case, a shallow, flush panel above the mantle shelf provides a 'clean' backdrop that does not detract from objects displayed on the shelf. For the reinstated panel, we propose a small 'check' recess to the top and side joints, pre-empting differential movement that will open these joints a little wider and crack the painted finish (as indeed is evident in the Small Drawing Room overmantle).

The stile on the left hand side of the fireplace has been cut out between the level of the mantle shelf and a point around half a metre below the cornice. The surviving portions will be removed and joined to a new middle section, then reinstated. This middle section will include the mortice of the pegged tenon joint for the new rail above the mantle shelf (referred to above).

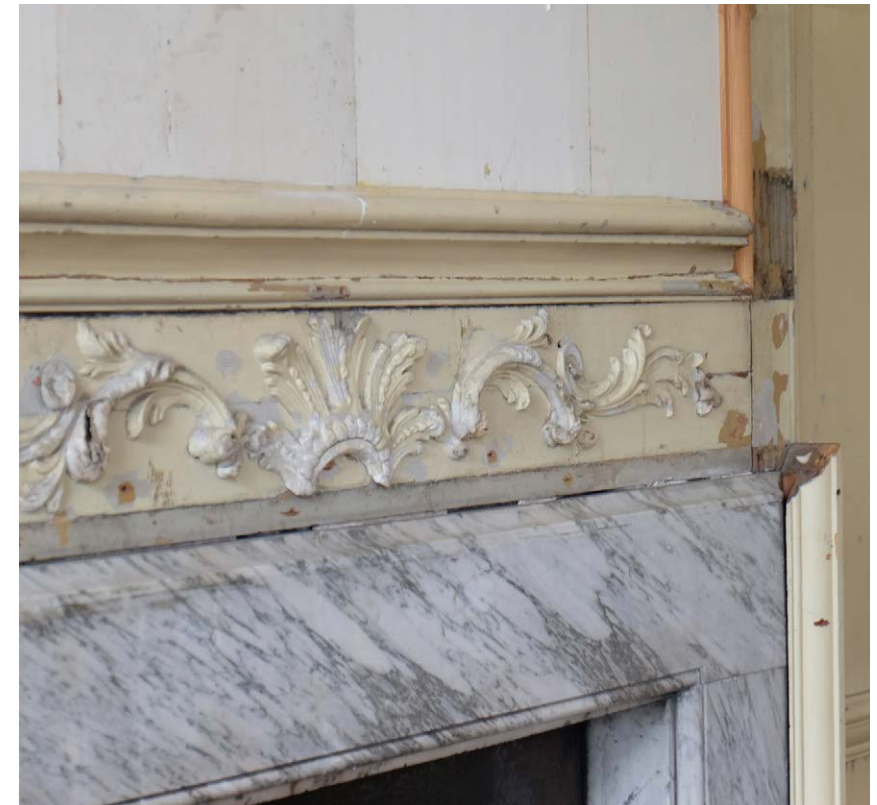
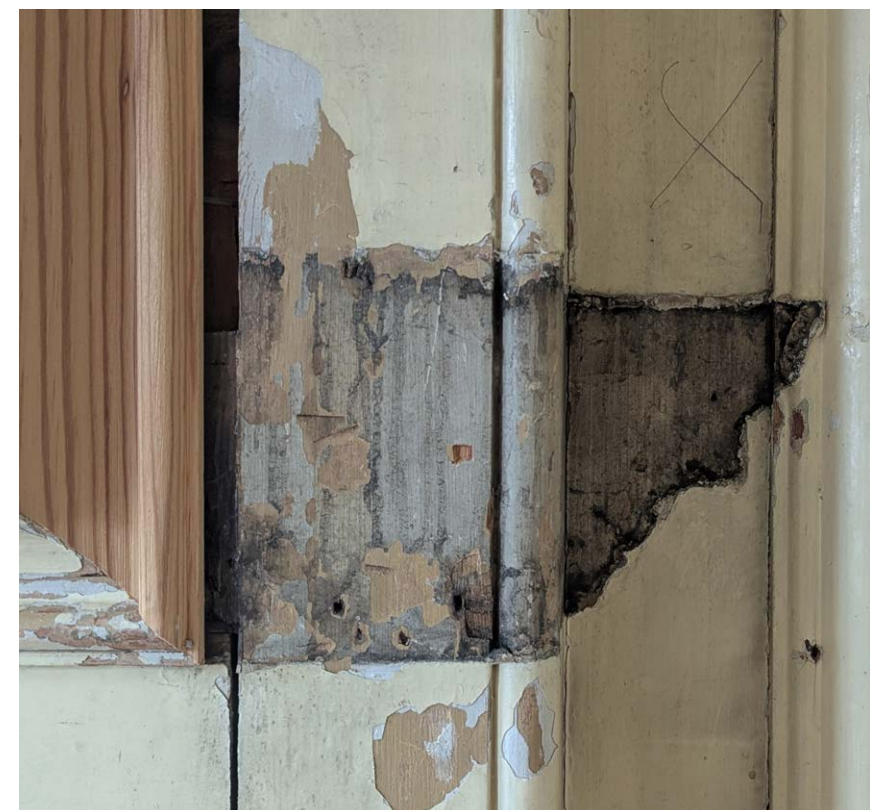
Although in damaged and very fragile condition, the papier mâché detail is very rare as a survival of eighteenth century decoration in this material - partly because it is so inherently vulnerable to damage.

Top: papier mâché ornamental frieze  
Bottom: 'ghost profile' of missing mantle shelf at right hand side

As described in the previous section, the papier mâché detail of the ornamental frieze immediately beneath the mantle shelf is damaged and in need of urgent stabilisation and repair. Permission for this work is sought as part of this submission, with a more detailed methodology to be prepared by a specialist. Initial advice has suggested that this might preferably be done in controlled workshop conditions, with the timber backing laid horizontally.

With this in mind, the detailing of the edges of the timber backing could be designed to allow it to be removed and / or reinstated in a later phase of work. As can be seen from the photograph on this page, the timber backing will lap behind both the reinstated architrave to the fire surround at its bottom edge, and the reinstated mantle shelf above. Dependent on the programme and sequence of work, it may be beneficial for both of these reinstated elements to be fixed temporarily so that they can be removed easily to allow the paper mâché panel to be removed for off-site conservation.

The National Trust will determine the timescale for this but, for the duration of the works described in this submission, the fragile papier mâché ornamentation will either be protected with a hard cover, or removed for safe storage until conservation work of the ornamentation is complete.

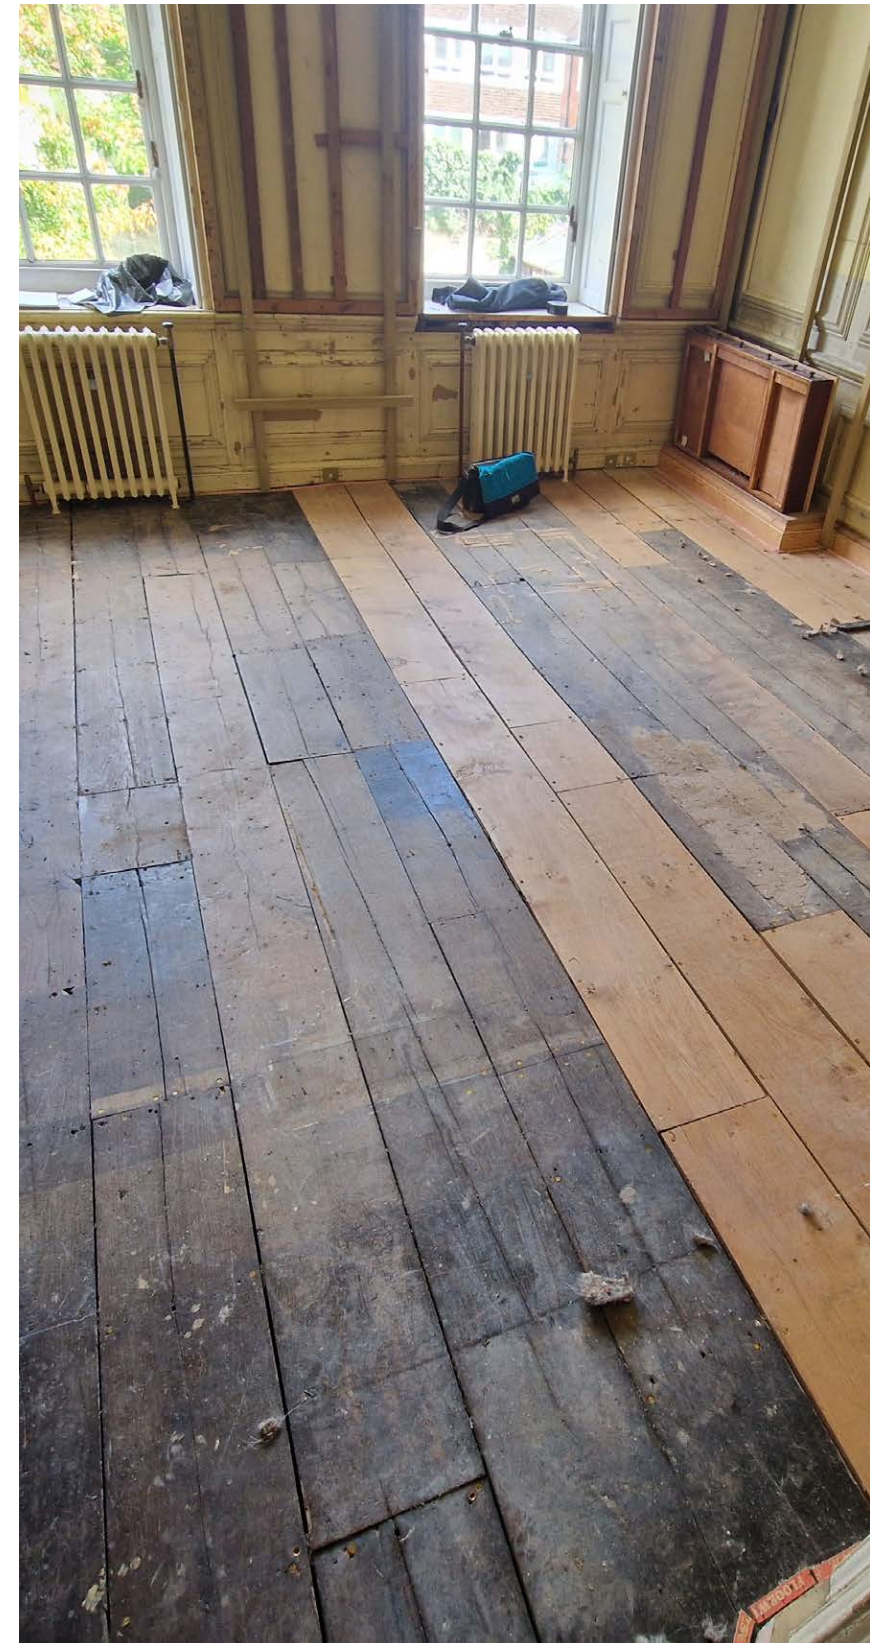
The boards have a mixed appearance, being partly treated with a dark stain. This would have been applied to boards around the margins of the room, with boards left untreated where a rug would have been laid in the middle of the room. However, it is apparent that most / all of the boards have since been lifted and relaid without regard to their original position.

Floor with carpet and underlay removed

To balance this necessity with the desirability of revealing the presence of the floorboards, it is proposed to install new carpet on a padded underlayer, but to draw this back from the margins of the room. This will give the carpet something of the character of a rug, while making visible the boarded floor beneath. As CWa drawings show, the carpet will be set within a timber edging, to hold it in place and mitigate the risk of a trip hazard at its edge.

The revealed portion of board will be rubbed down and refinished as necessary, to reinstate the darker stained margin evident in earlier treatments of the interior. This will involve the application of a stain to the modern floor boards so that they closely match the colour of the original ones.

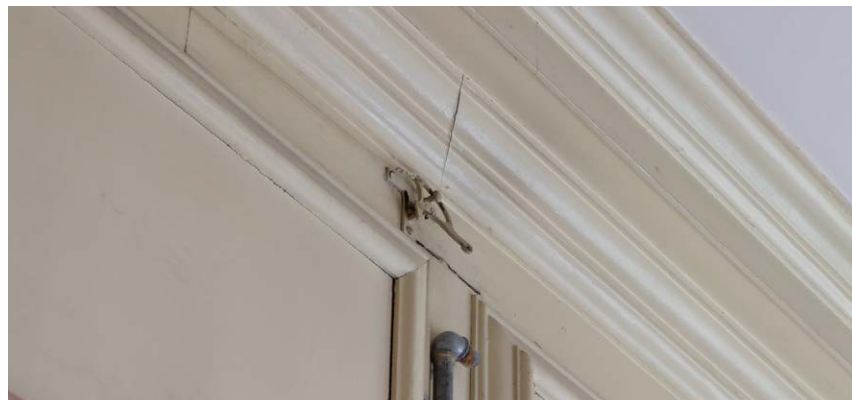
The room retains a substantial part of the fittings of a mechanical bell pull system, with levers and cranks attached to the top rail of the wall panelling, immediately beneath the cornice. It can be seen that these would have served two rope pull positions: one to the south of the fireplace and a second on the opposite (west) wall which would have corresponded to the position of the bed.

Remnant of mechanical bell pull system

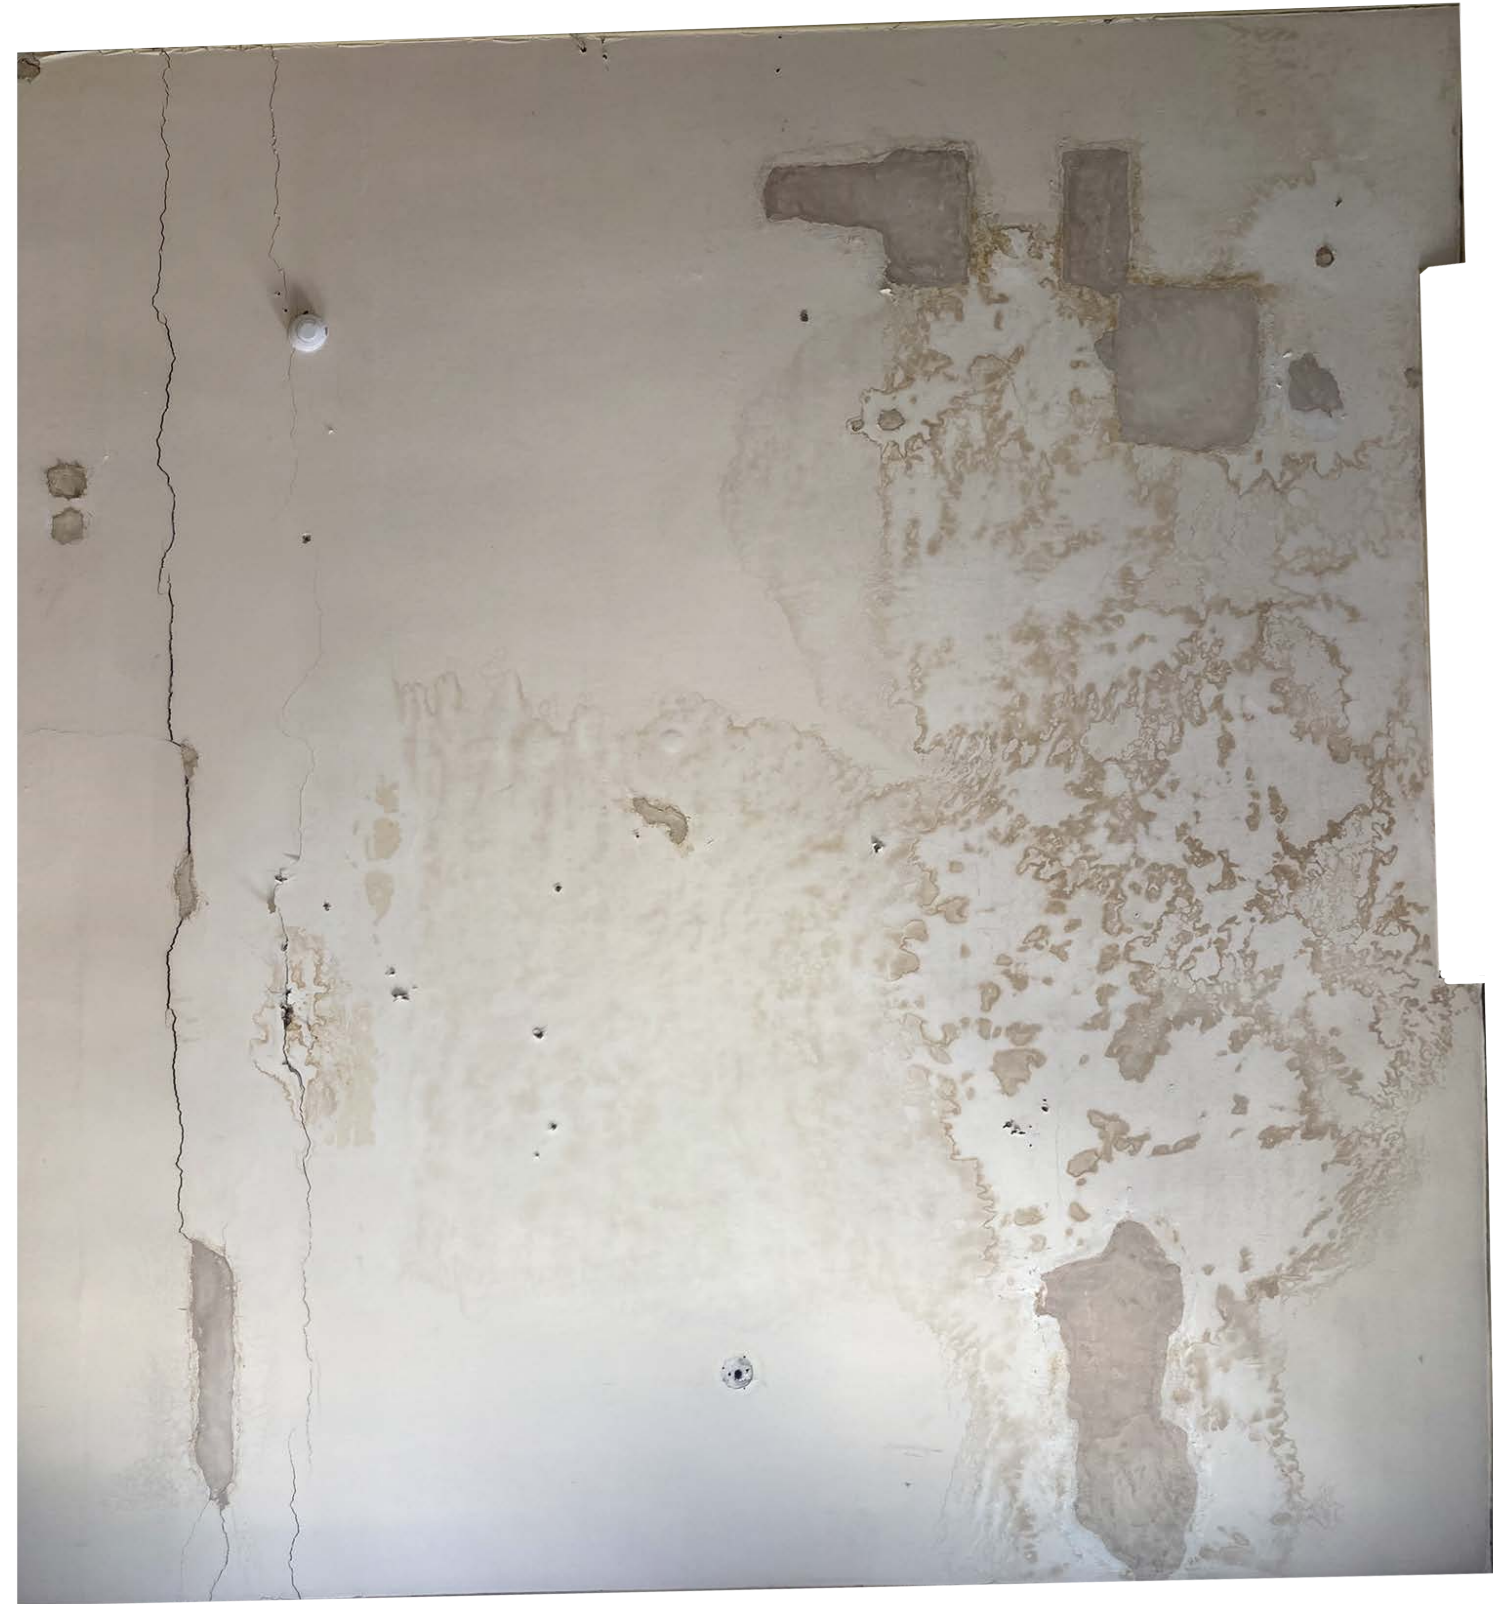
There has been a degree of damage to the fabric of the ceiling through historic water leakage and structural movement. Small patch repairs have previously been carried out and, being unpainted, these are clearly legible. Notwithstanding, the ceiling is of moderate architectural significance as an integral part of a highly significant interior.

Existing condition of ceiling

- Removal of lining paper across the entire ceiling, and application of a stainblock treatment.
- Addressing damage caused by historical movement in the vicinity of a supporting beam above the ceiling. Longitudinal cracks parallel to the beam will be opened up and filled. This area of ceiling will be stabilised and supported using washer supports, recessed into the plaster and filled.
- Addressing damage caused by historical water ingress. Cracks will be opened up and filled. This area of ceiling will be stabilised and supported using washer supports, recessed into the plaster and filled.

This work will stabilise the lath and plaster ceiling, and address its patchy and discoloured appearance - the result of historic damage and localised repair.

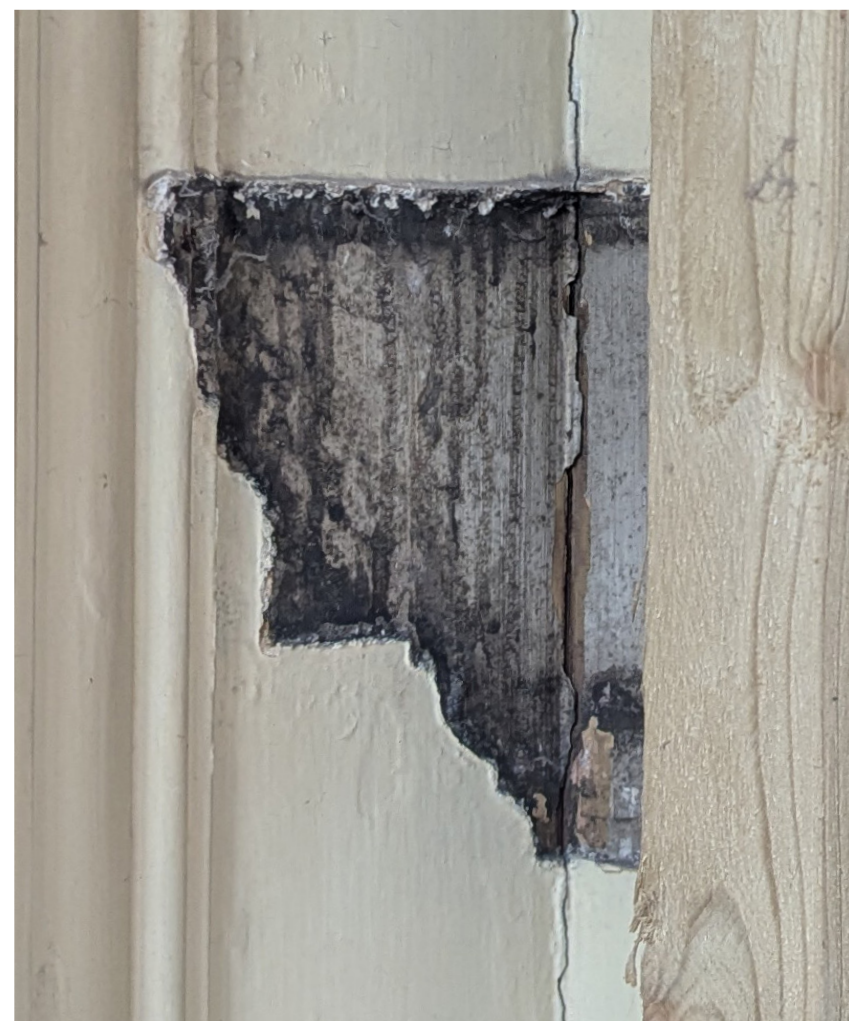
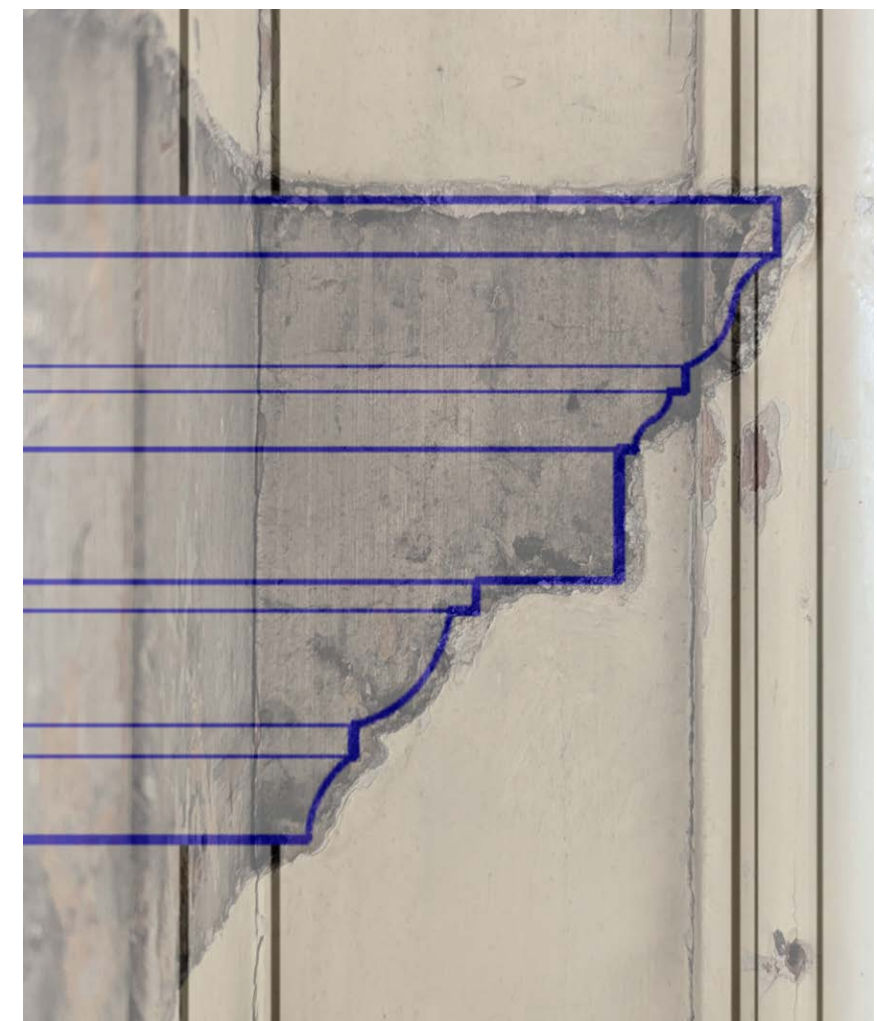
'Ghost profile' of mantle shelf at left hand side of fireplace

Proposed profile of reinsrated mantle shelf superimposed on 'Ghost profile' at right hand side of fireplace

While the missing architrave can be matched to the surviving portion, the mantle shelf is entirely missing. Its reinstatement will therefore be based on contemporary examples at Mompesson, and, critically, the 'ghost profile' left on the stiles to the adjacent panelling by the painted finish prior to the removal of this element.

From the top, the new profile will consist of (from top down): cymatium (cyma recta), corona and bed moulding with ovolo and cavetto profiling.

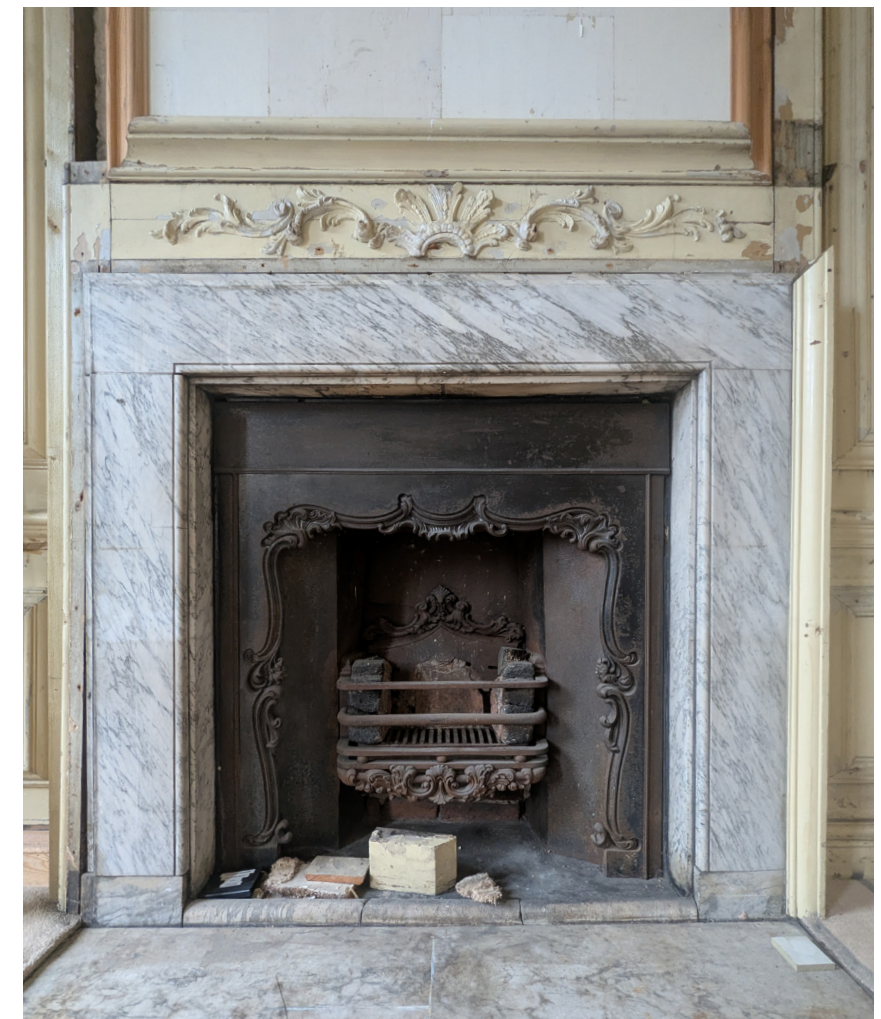
It is formed of a light grey marble surround and hearth bounded by ovolo-moulded architrave (missing at the top and left hand side of the fireplace). Within the surround is set a cast iron insert of flowing acanthus foliage, of probable nineteenth century date.

Extant condition, showing missing architrave at top and left hand side, to be reinstated to match that on right

These proposals seek to return the fireplace to its historic arrangement, pre-dating its mutilation and concealment in the twentieth century. Principally, this will involve the reinstatement of missing elements: the top and left hand side of the architrave to the fire surround and the mantle shelf.

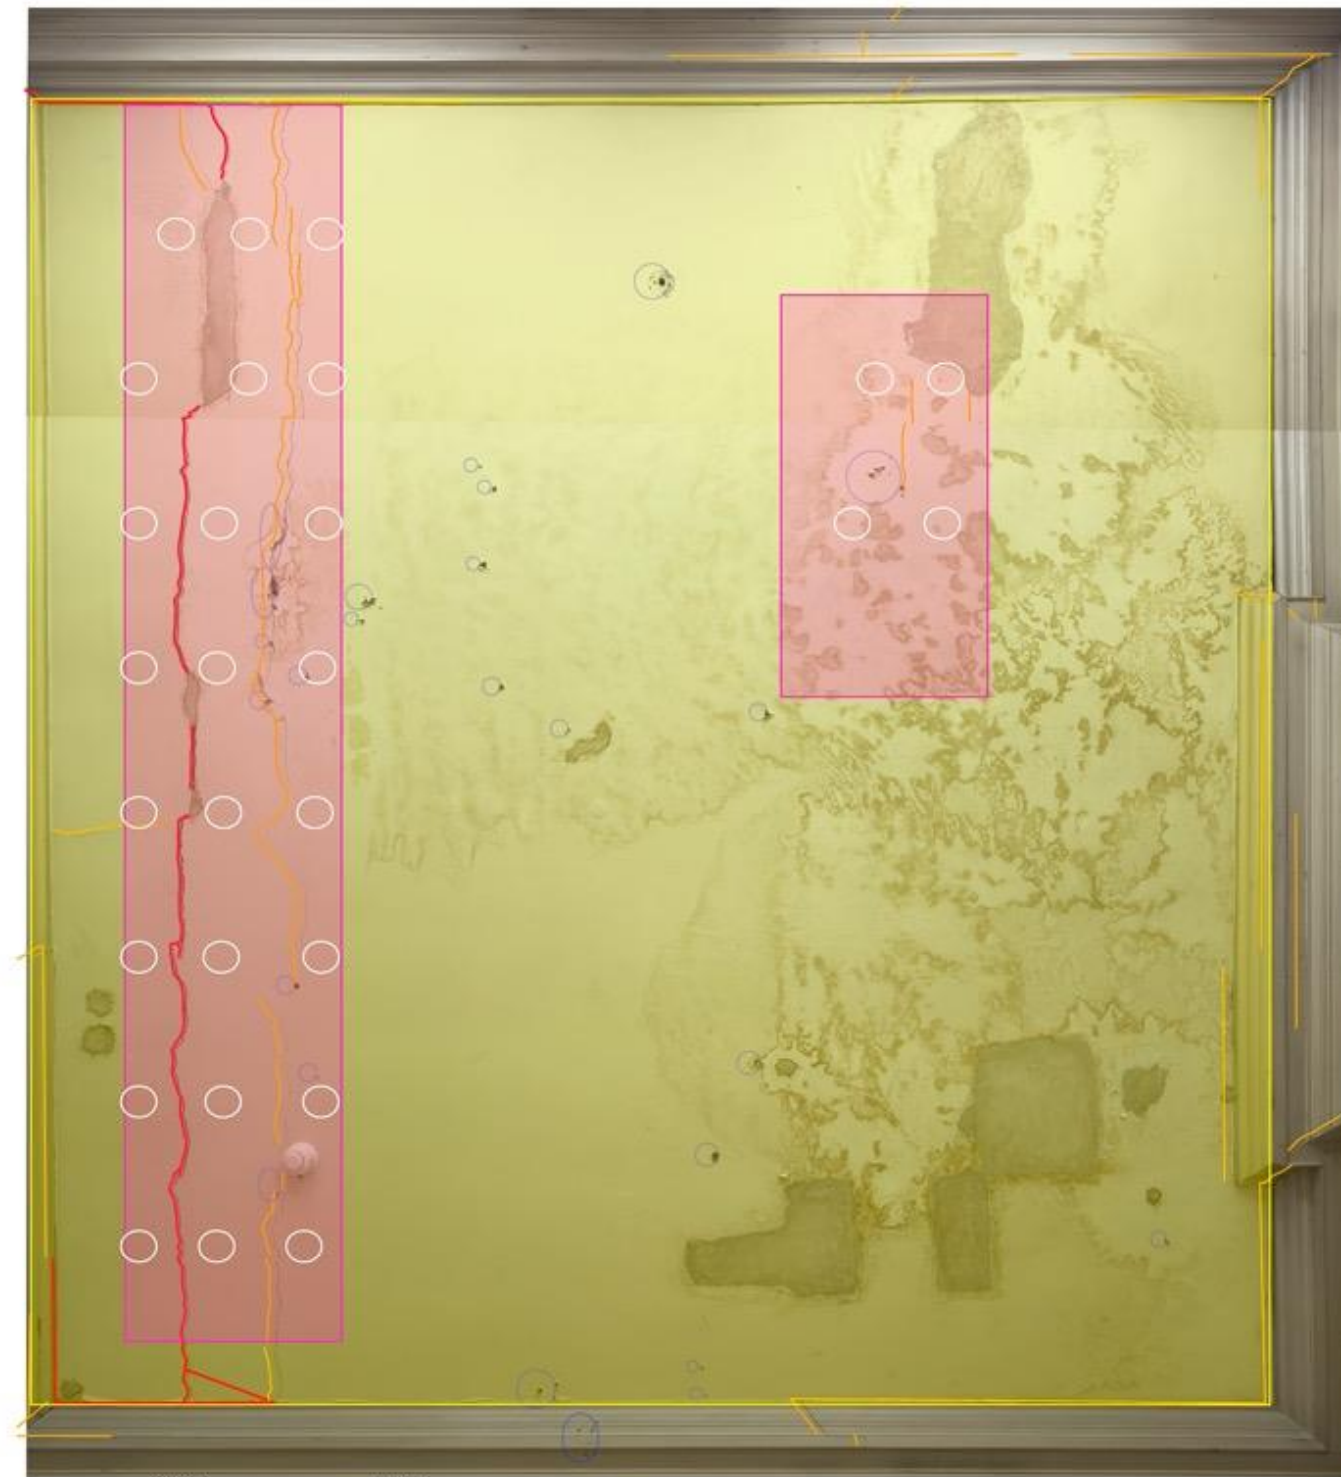
An inspection of the ceiling has been undertaken by Cliveden Conservation, and a summary report prepared on the findings and proposed remedial work (October 2025). This has found damaged areas that are slightly detached and in need of re-support. The works recommended in their report form part of the scope to which this application relates.

Reflected ceiling plan from Cliveden Conservation report.  
Areas in red to receive recessed washer support
