# Planning, Design & Access Statement

**Proposal:** Repairs to Grade II Listed Barn (retrospective)  
**Site:** Shrub Farm Barn, Shrub Farm, Castle Combe, SN14 7JA  
**Our Reference:** 2517\_Planning Statement

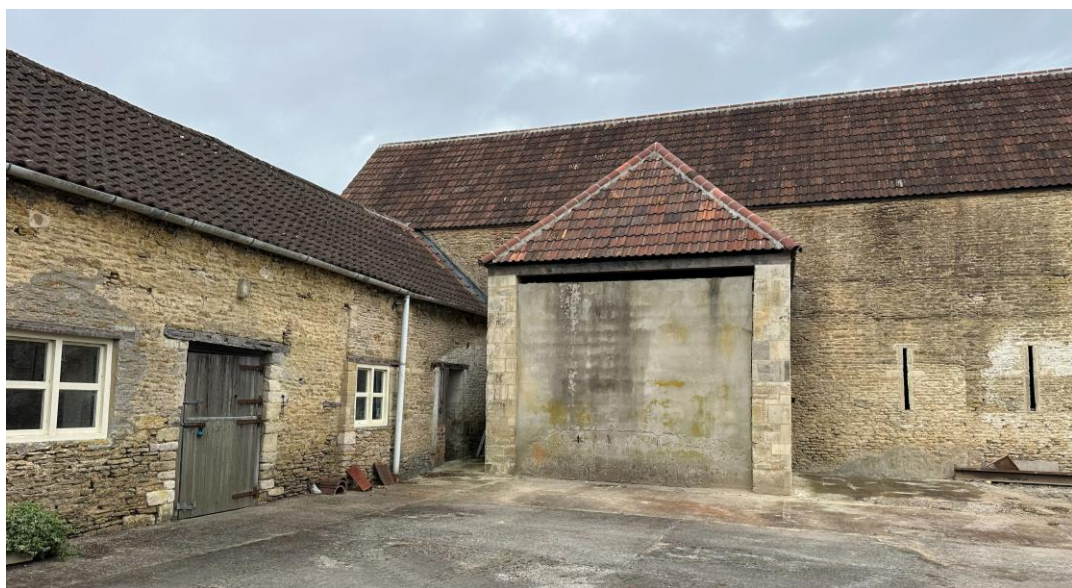
3.22

3.21 Double Roman tiles are also found on Pinetum Cottage to the west of the barn and Shrub Cottage to the northeast, and as mentioned, formed the majority of the pre-existing roof covering to barn. The reclaimed Double Romans are a traditional tile that does not detract from the essential form of the barn. A significant material benefit is derived by the interlocking nature of the tile, which will provide long term security from the elements over the large roof area. The use of reclaimed tiles has ensured that the new roof finish has successfully assimilated with the surrounding buildings, as shown below where the pantiles of the stable range abut the Double Romans of the subject building.
