# RIBA STAGE 3 - STATEMENT OF SIGNIFICANCE FOR LISTED BUILDING CONSENT APPLICATION

Window renovations  
'Allington House', Allington, Chippenham, Wiltshire, SN14 6LN

November 2025

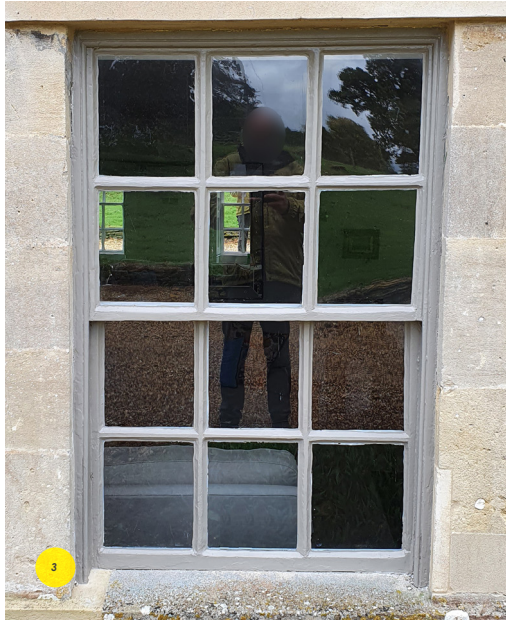
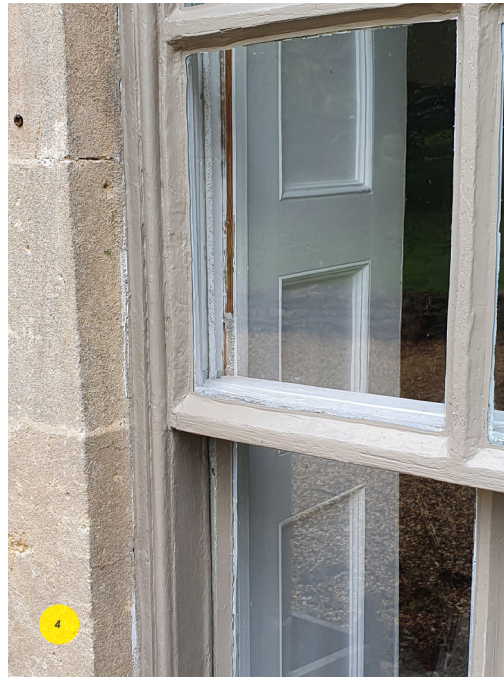
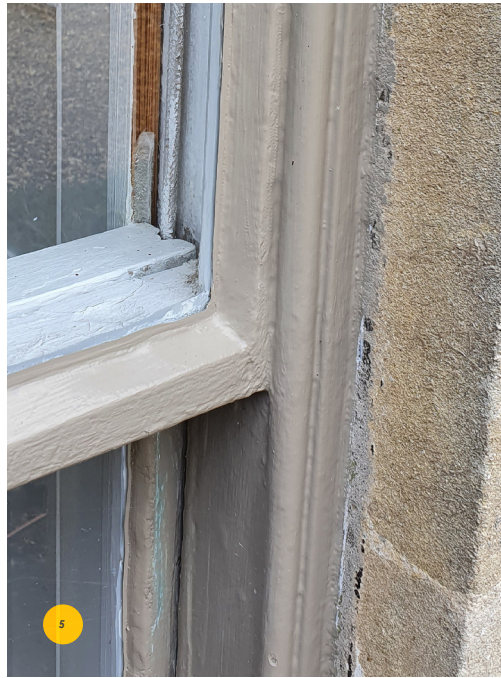
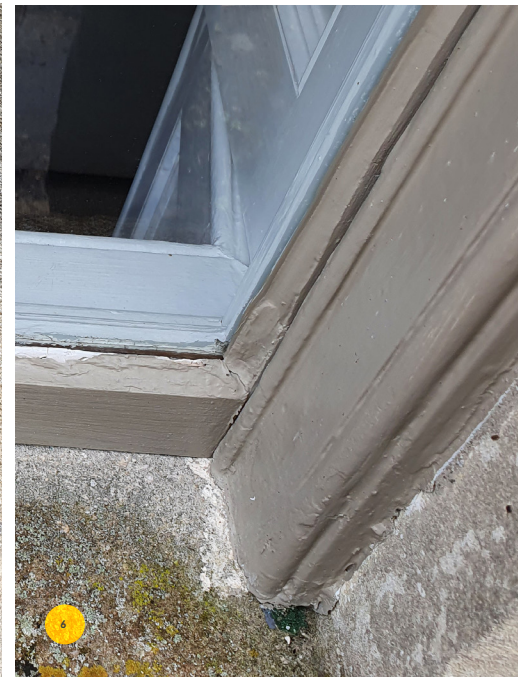
| Window Ident | Location | Action needed to the frames | Action needed to the Sashes |
|---|---|---|---|
| WG07 | West elevation | Small amount of repair need that can be done in-situ | Sashes very poor and beyond repair, will need to be remade |

- WG07 appears to be the earliest (wide glazing bars or at least they look as if they have and are based upon etc typical Bath design with no timber bottom cill; the bottom sash simply rests upon the stone cill);
- WG01 looks to be a slightly younger c, 1780 possibly with crown glass and interestingly has an exposed sash box - not too common in these part;. Interestingly if this window was in London it would predate the London Building Act of 1709 after which all windows were set back 4inches from the face of the external wall and the 1774 Act then required the box to be set within the wall/reveal; and
- WF04 and WF05 c.1800-20, in a Regency style.

FIG 3. WG07

FIG 4. WG07

FIG 5. WG07

FIG 6. WG07

Frames and sashes to be repaired in accordance with the noted actions in Table 1. Where appropriate, historic fabric shall be retained wherever possible, with localised, rotted sections of frames to be carefully removed with new paint-quality hardwood frames scarfed / spliced in.

Timber chocks removed from sash boxes and boxes to be renewed as required with new spiral balances.

New sashes to be formed to run in existing rebates / grooves. New glazing bars to be paint-quality hardwood with 18mm ovolo profiles. New FINEO 'Heritage 8' panes to be set into a 6 over 6 pane arrangement.

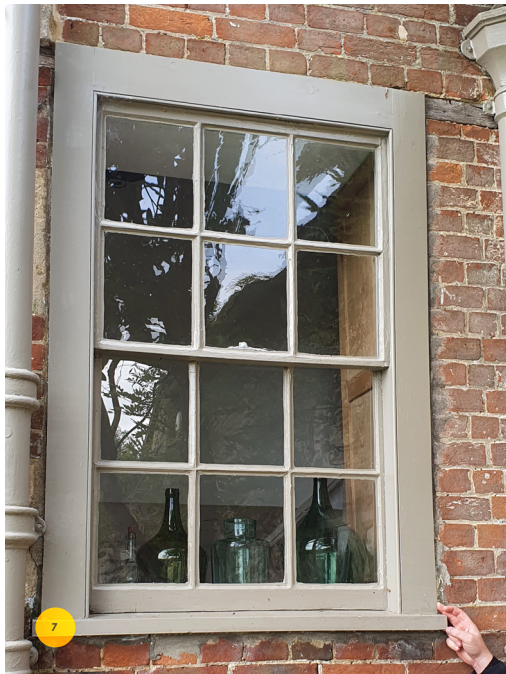
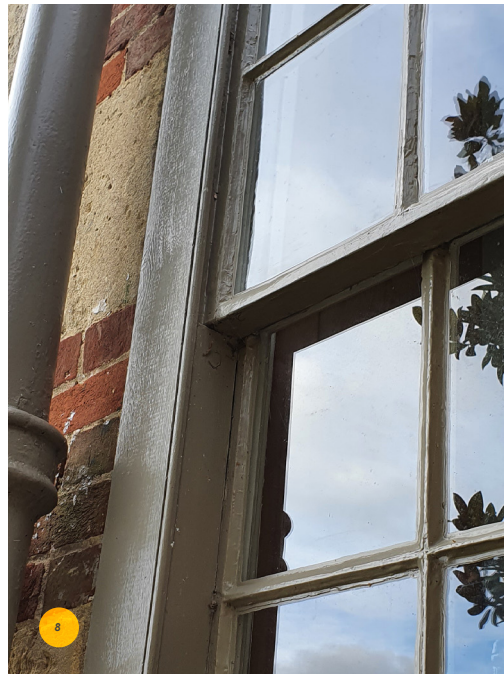
| Window Ident | Location | Action needed to the frames | Action needed to the Sashes |
|---|---|---|---|
| WG01 | North elevation | Frame very poor and beyond repair, will need to be remade | Sashes very poor and beyond repair, will need to be remade |

FIG 7. WG01

FIG 8. WG01

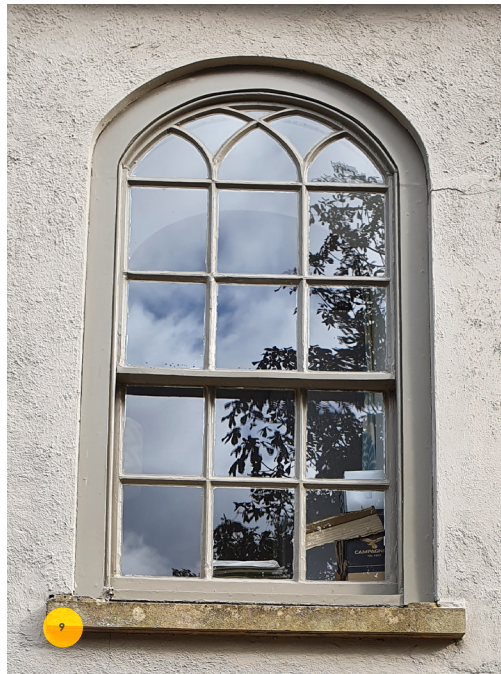
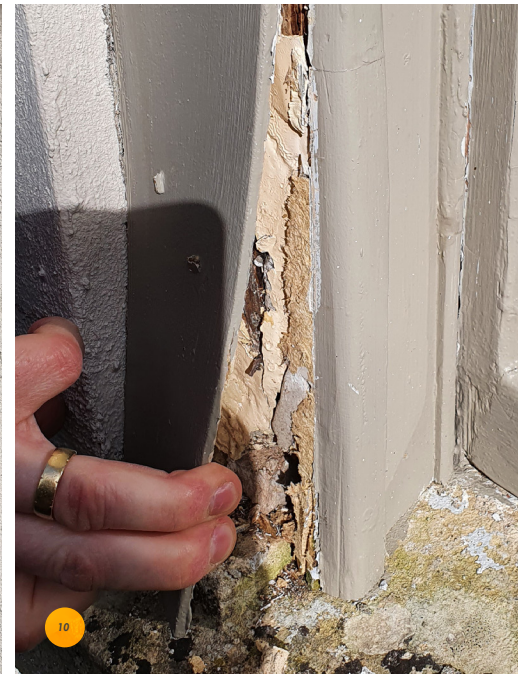
| Window Ident | Location | Action needed to the frames | Action needed to the Sashes |
|---|---|---|---|
| WF05 | South elevation | Small amount of repair need that can be done in-situ | Bottom sash beyond repair and to be remade. Top sash repaired in workshop |

Works to frames and sashes to be undertaken per Table 1. This elevation has evidently born the brunt of prevalent wind and rain which has seen more damage and degradation of the timber.

Poor quality patching and cover strips have been installed to disguise badly rotten frames and these will need to be removed fully in order to carry out a more detailed assessment of the repairs and replacement works that are required.

FIG 9. WF05

FIG 10. WF05

The arched fan-lights over the first floor windows would be renewed in-situ and would leave the existing glazed panes unaffected.
