# Silverwood School Rowdeford House Refurbishment

Calm Room & WC Repair & Refurbishment  
**Design & Access Statement**

November 2025  
Planning Application Ref: PP-14515956  
SWS-AHR-ZZ-ZZ-DR-A-005091

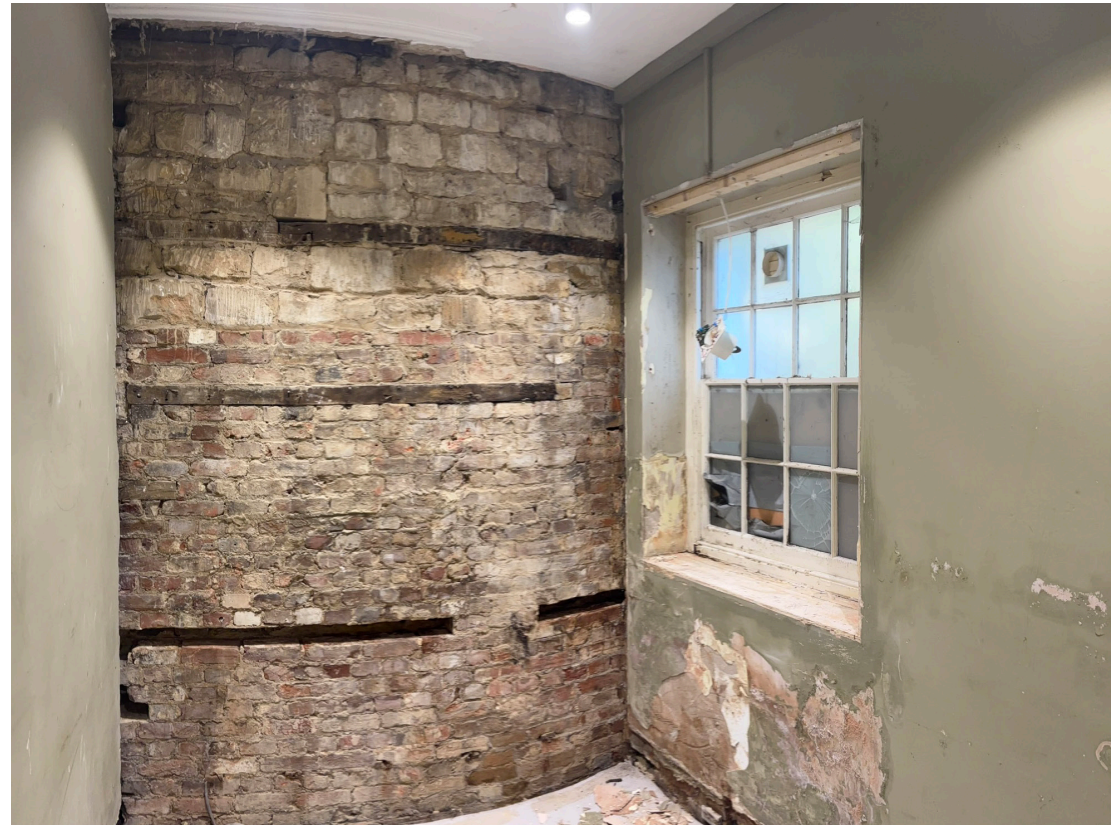
The main damage to the Calm Room is to the north & west elevation shown opposite, both being external walls.

The west elevation is now cleared of the damaged remaining of a lath & plaster wall lining. It can be seen that the lower level timber wall inserts are completely missing. Upon investigation these timbers were completely rotten, effectively being dust and providing no support to the vertical timbers the laths were attached to. The lower portion of the vertical timbers were similarly damaged and the wall lining removed on safety grounds.

The northern elevation shows a previous refurbishment has used bonding plaster at low levels and this has now developed damp damage where it is not moving and breathing with the building. The existing window is damaged with water ingress clearly damaging the low level plaster where the previous window cover was shielding damp & condensation issues from view along side a broken pane allowing water to enter the void behind the covering. A vent to a window pane attempted to alleviate the water issues in this void but this appears to have been unsuccessful.

The west elevation with the original lath & plaster wall lining removed & north elevation with damaged plaster & window

1. Rebuilding the lath & plaster wall lining to the west elevation. New treated timber grounds to be installed to existing voids in bricks to same detail as existing grounds. New vertical battens/studs to be fixed to new timber grounds from floor joist to ceiling. New laths to match existing fixed horizontally to vertical studs. New lime plaster to be applied to laths to finish in the same place against the existing ceiling as the original lining.  
New plastered finish painted with colour of the school's choosing & new soft wood timber skirting to match surrounding spaces added.

2. Remove existing bonding plaster to lower elevation leaving original lime plaster to north elevation. Re-plaster with lime plaster. New plastered finish painted with colour of the school's choosing & new soft wood timber skirting to match surrounding spaces added.

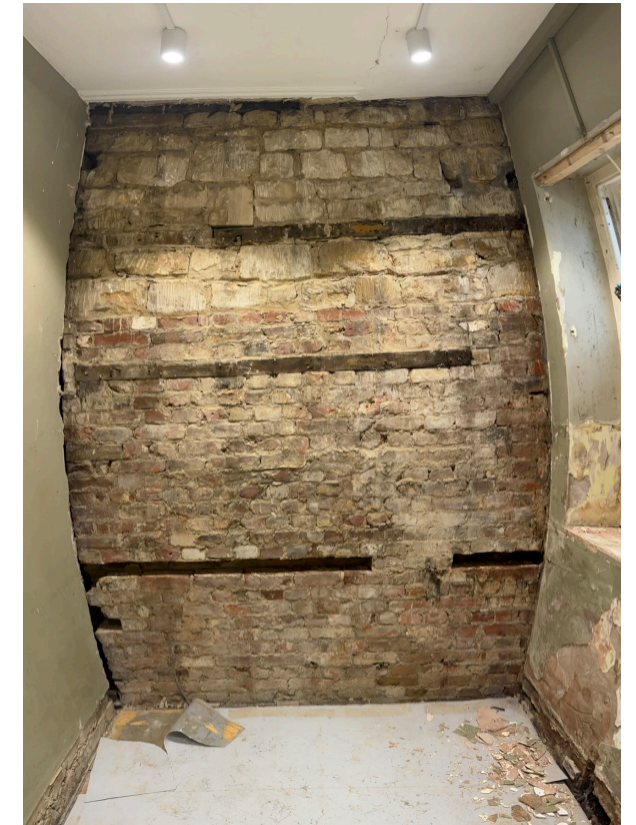
The floor to the north west corner is supported on timber joists that sit on a wall plate attached to the northern wall. This wall plate and other associated timber inserts into this external wall have rotted away and are not much more than powdered timber.

West elevation showing the lower inset timber rotted away

5. The floorboards shall be lifted to identify the structural repair strategy. New timbers shall be installed to replace any defective items found. New items shall match existing items. The existing floorboards will then finish the floor prior to a finish covering of the schools choice (vinyl or carpet).

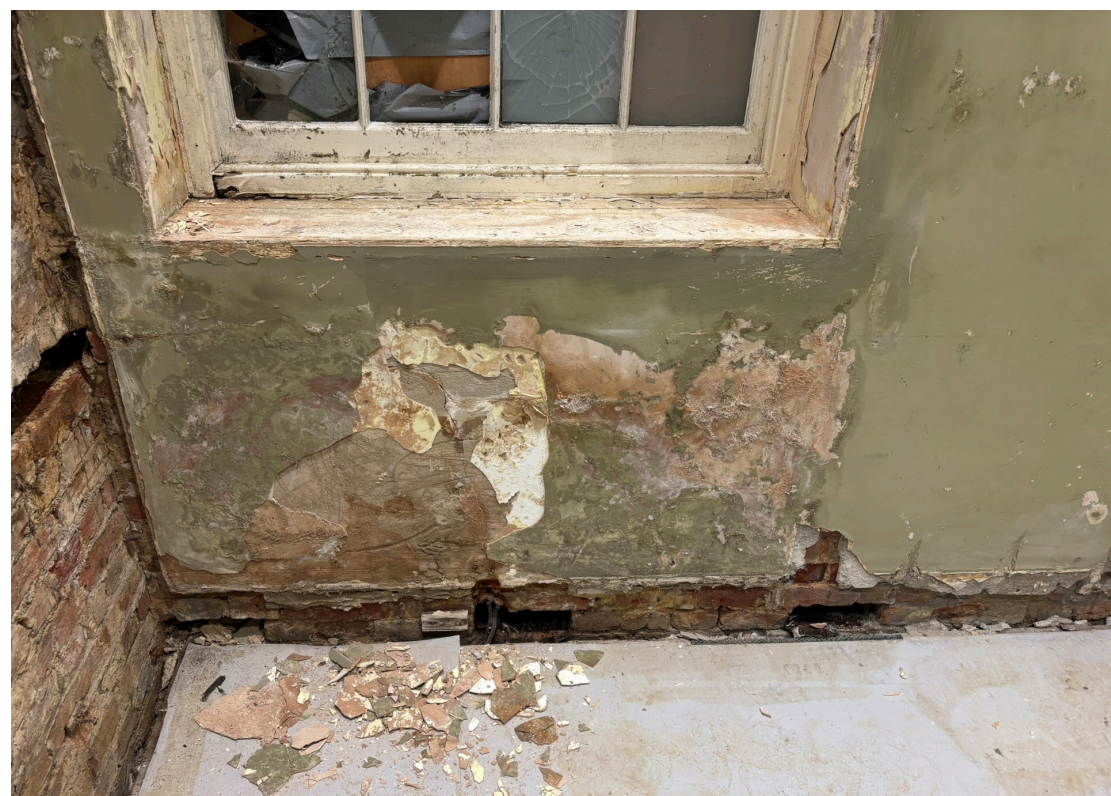
Low level existing bonding plaster damage beneath the north elevation window.

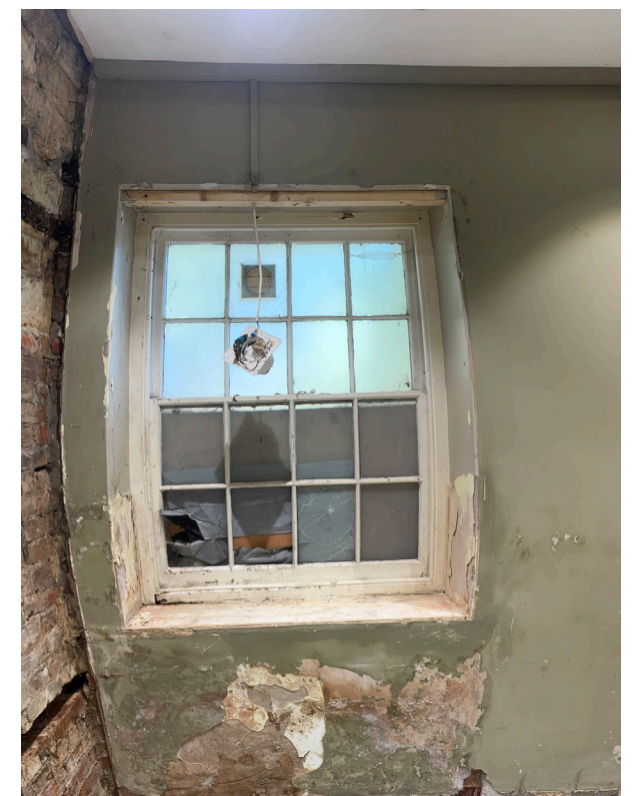
The condition of north elevation window.

4. Window to be refurbished by specialist contractor. This will involve splicing a new lower section to the existing top section. Specialist to determine extent & final detail. Broken panes replaced & all panes to receive security film for protection against breaking.

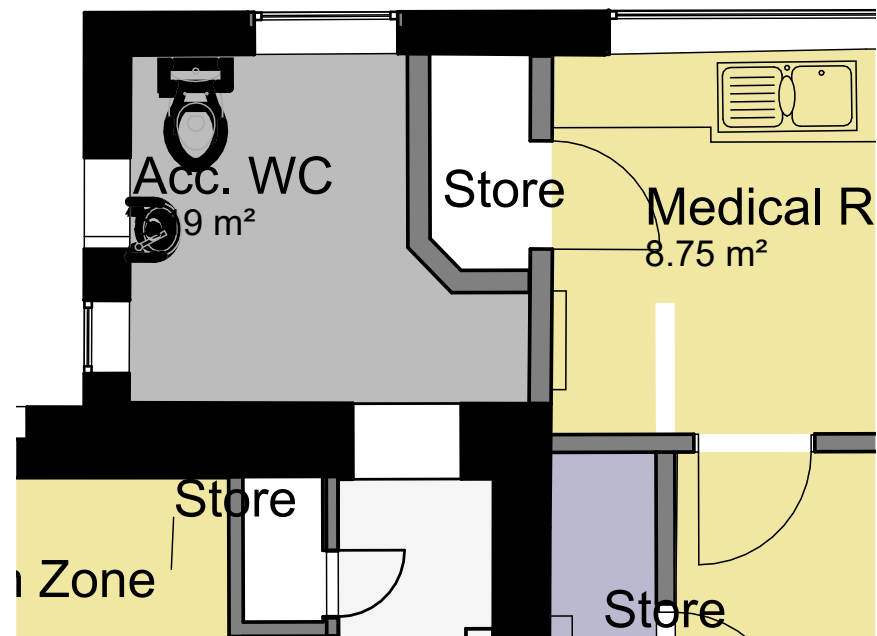
However, it is not a useful space as the door to the space is not a formal door and a boxing exists to the one side. This boxing used to be a cupboard to what is now the new Hygiene Room and is not used. This is a void that could offer better utilisation to this space.

Existing layout of the WC space

1. Remove existing cupboard space to the Hygiene Room. This space becomes part of the WC. The east elevation wall of this space to be made good with new lime plaster & skim. The floor to be made good. This wall is already closed as part of the new Hygiene Room works. This will allow this space to function as a formal Accessible WC as the space around the WC is compliant for WC access from a chair.
2. The cubicle door will be removed and a new formal door will be added to the wall opening. For accessible widths to be maintained this is to be constructed internally to the WC space with the door.

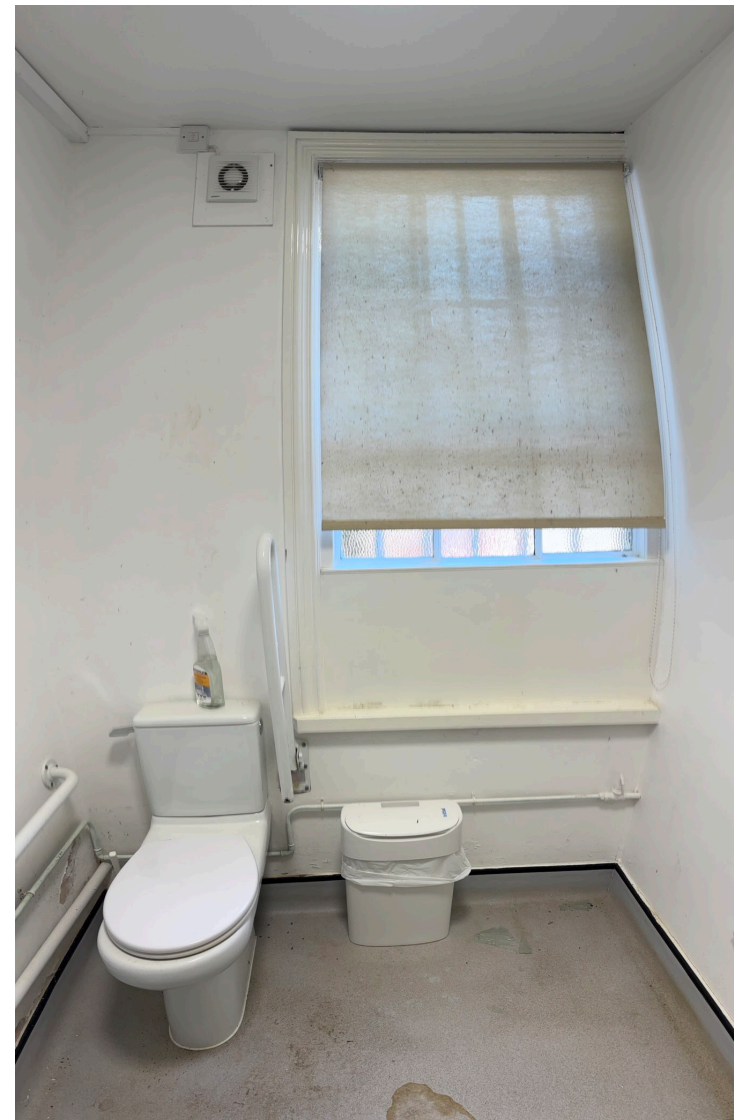
Existing north elevation of the WC

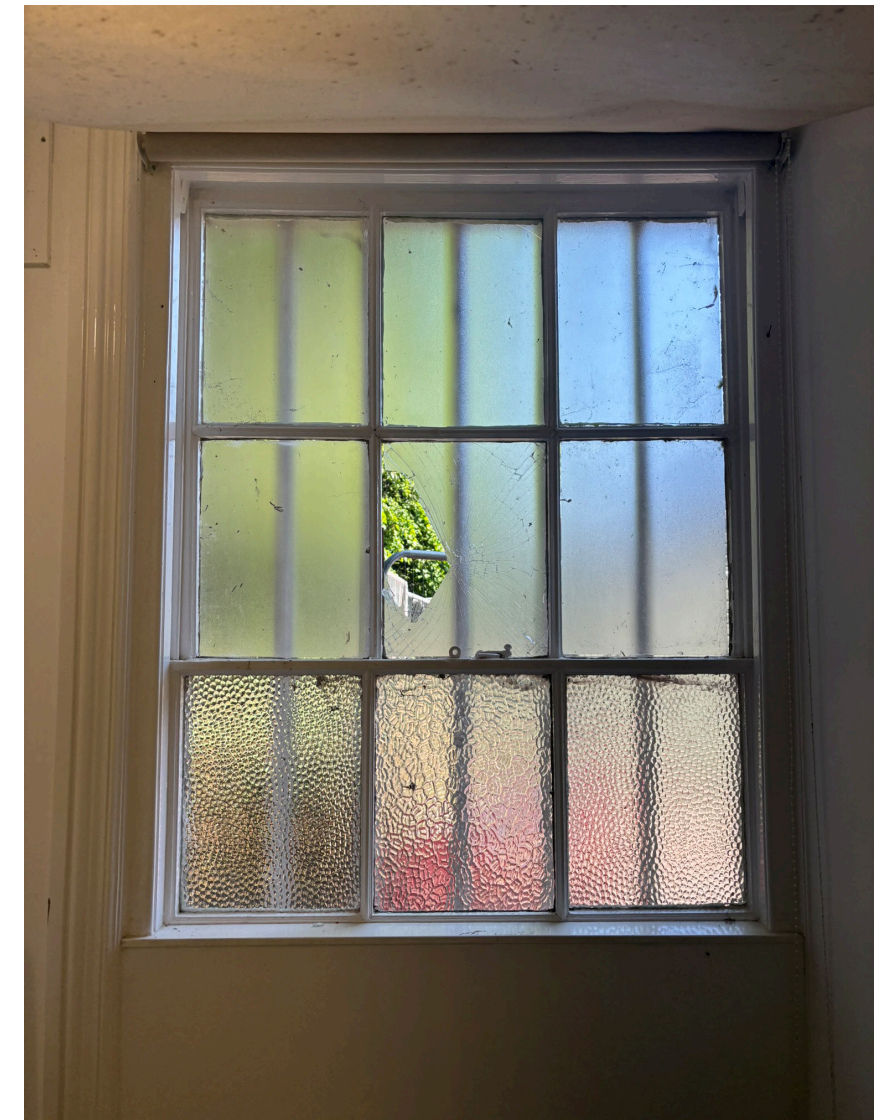
The window to the WC is damaged though is less affected by damp.

Existing window within north elevation of the WC
