# Arboricultural Constraints and Implications Report

Melksham Community Hospital

# Tree Constraints Report

RSKHL\_8795.25 – Kendall Kingscott Ltd – Melksham Hospital (BS:5837 2012) – Arb. Constraints.

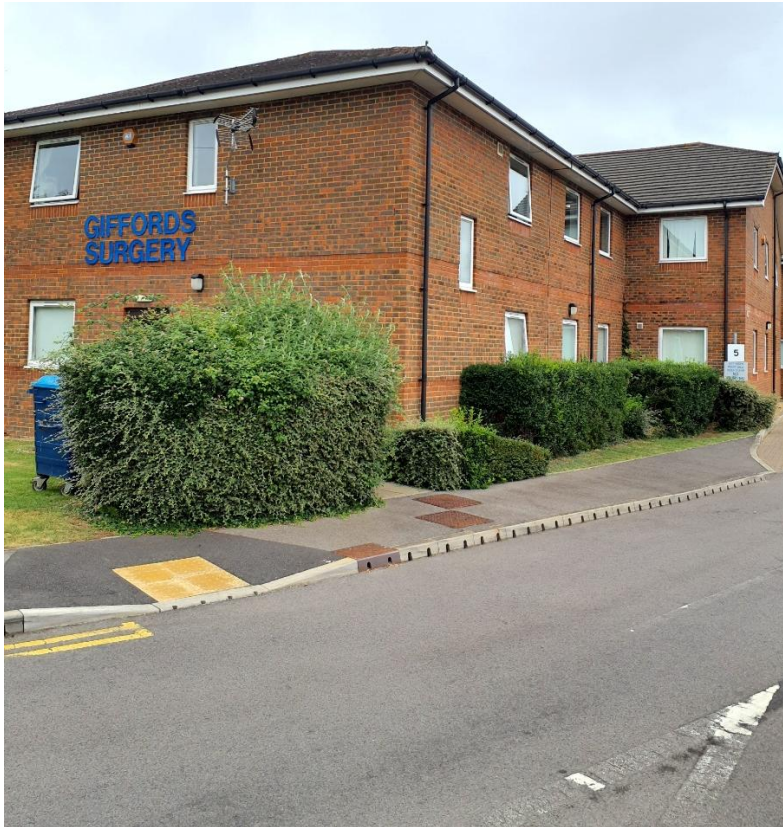
Image 01: G001, shrub group (typical, small, well-managed shrubs within the site).

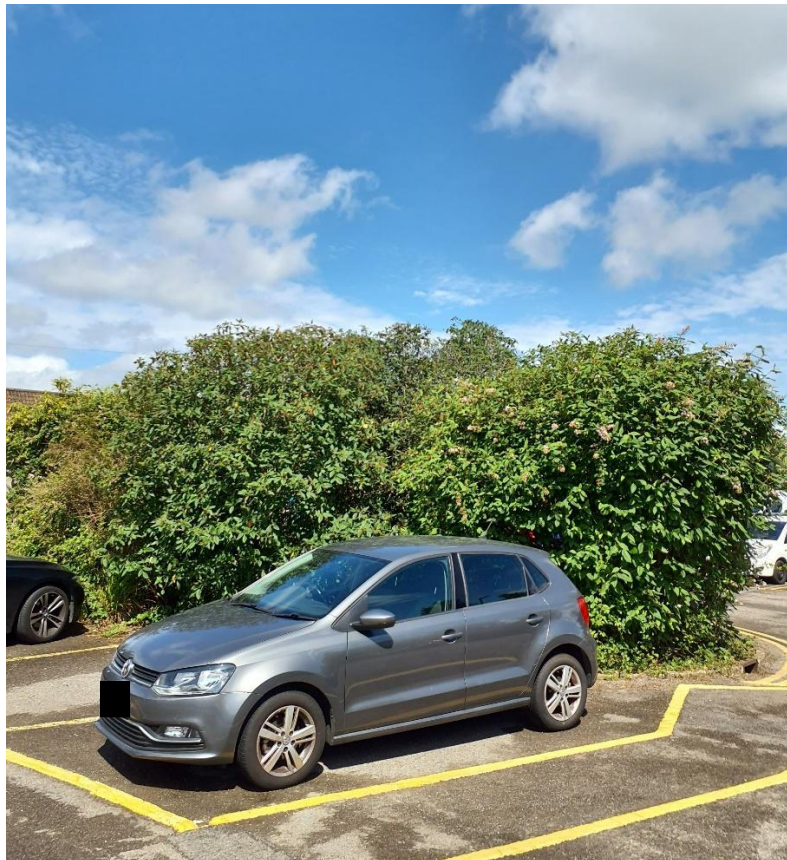
Image 02: G005, shrub group adjacent to existing car parking.

| Tree ID | BS 5837 Quality | No Impact | Some Impact | Impact Description | Severity of Impact | Suggested Mitigation | Revised Impact Long - Term |
|---|---|---|---|---|---|---|---|
| T010<br>-<br>T011<br>G004<br>G005 | C x 4 | | ✓ | Trees within footprint of proposals; removal required | H | Replacement of low stature trees and shrubs within comprehensive landscape scheme in close proximity to proposal area | L |

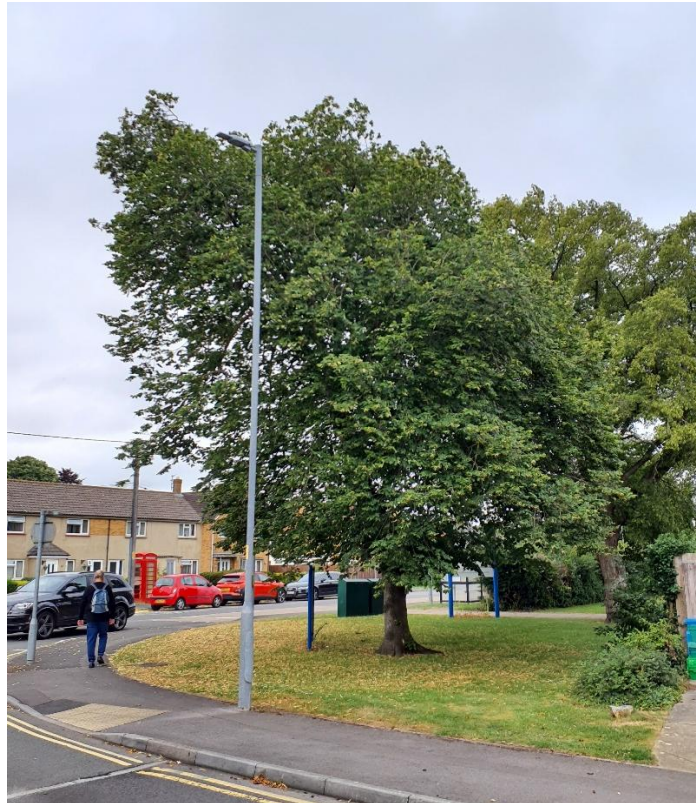
Image 03: T001, lime adjacent to the access road entrance.

| Ref. | Common Name | Botanical Name | Height | Ult. Height (M) | Num. Stems | Stem dia (cm) | RPA radius | RPA (m²) | North | East | South | West | Crown Clearance (m) | Lowest Branch (m) | Lowest Branch Direction | Age Class | General Observations | Rem. Contrib. | Retention Category |
|---|---|---|---|---|---|---|---|---|---|---|---|---|---|---|---|---|---|---|---|
| T001 | Lime | <i>Tilia sp.</i> | 12 | 25 | 1 | 44 | 5.28m | 87.58 | 5 | 4.9 | 4 | 4.6 | 1.5 | 2.1 | SW | Mature | Good vitality and form, minimal defects | 50+ | B2 |

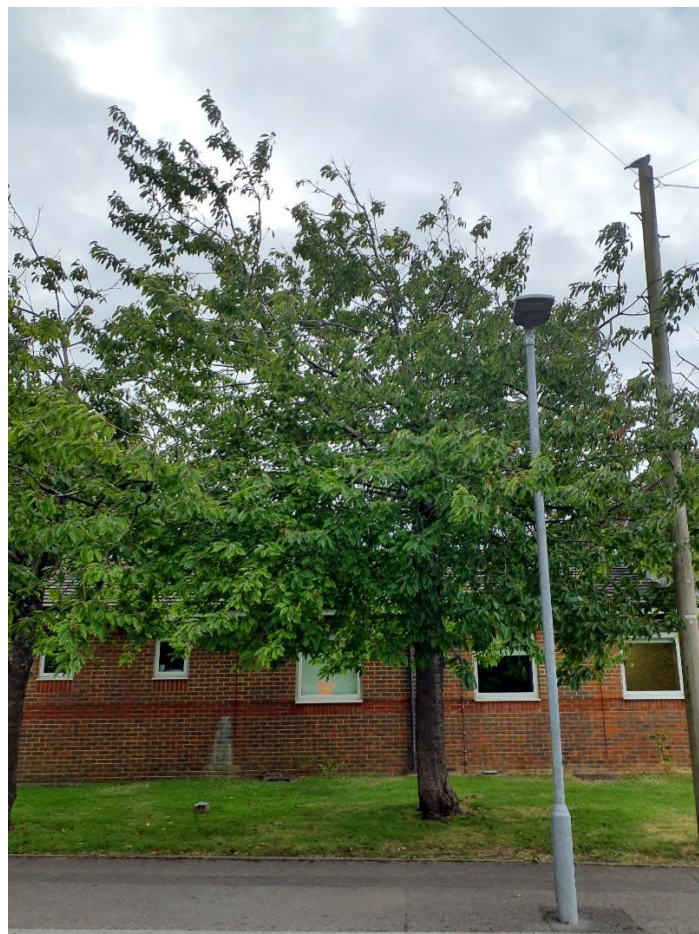
Image 04: T003, cherry adjacent to access road.

| Ref. | Common Name | Botanical Name | Height | Ult. Height (M) | Num. Stems | Stem dia (cm) | RPA radius | RPA (m²) | North | East | South | West | Crown Clearance (m) | Lowest Branch (m) | Lowest Branch Direction | Age Class | General Observations | Rem. Contrib. | Retention Category |
|---|---|---|---|---|---|---|---|---|---|---|---|---|---|---|---|---|---|---|---|
| T003 | Wild cherry | <i>Prunus avium</i> | 8 | 12 | 1 | 31 | 3.72m | 43.47 | 3.7 | 3.6 | 3.3 | 3.5 | 1.6 | 4 | SW | Mature | Fair vitality and form, minor crown dieback. Surface roots damage by mower | 20 | B2 |

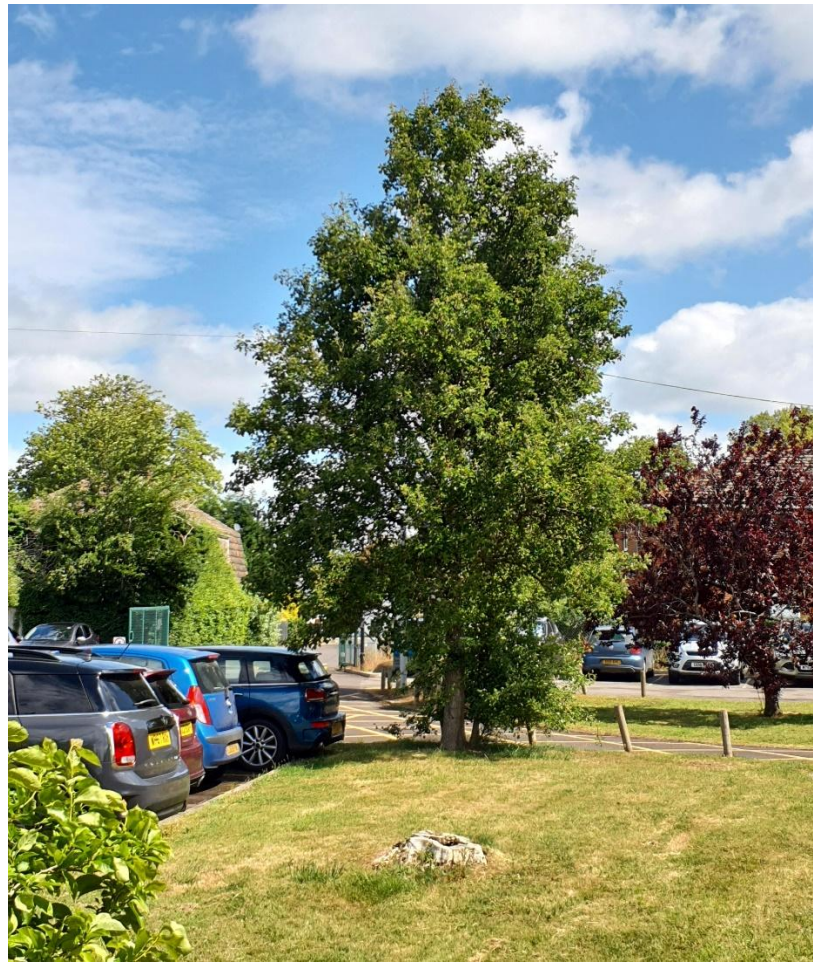
Image 05: T007, cherry plum and T008, pear in grass areas adjacent to existing parking.
