## Land at Biddestone Lane, Yatton Keynell

### Arboricultural Report containing:

*Prepared by:*  
**Chris Wright. M.Arbor.A.**  
**Arboricultural Consultant**  
**November 2025**

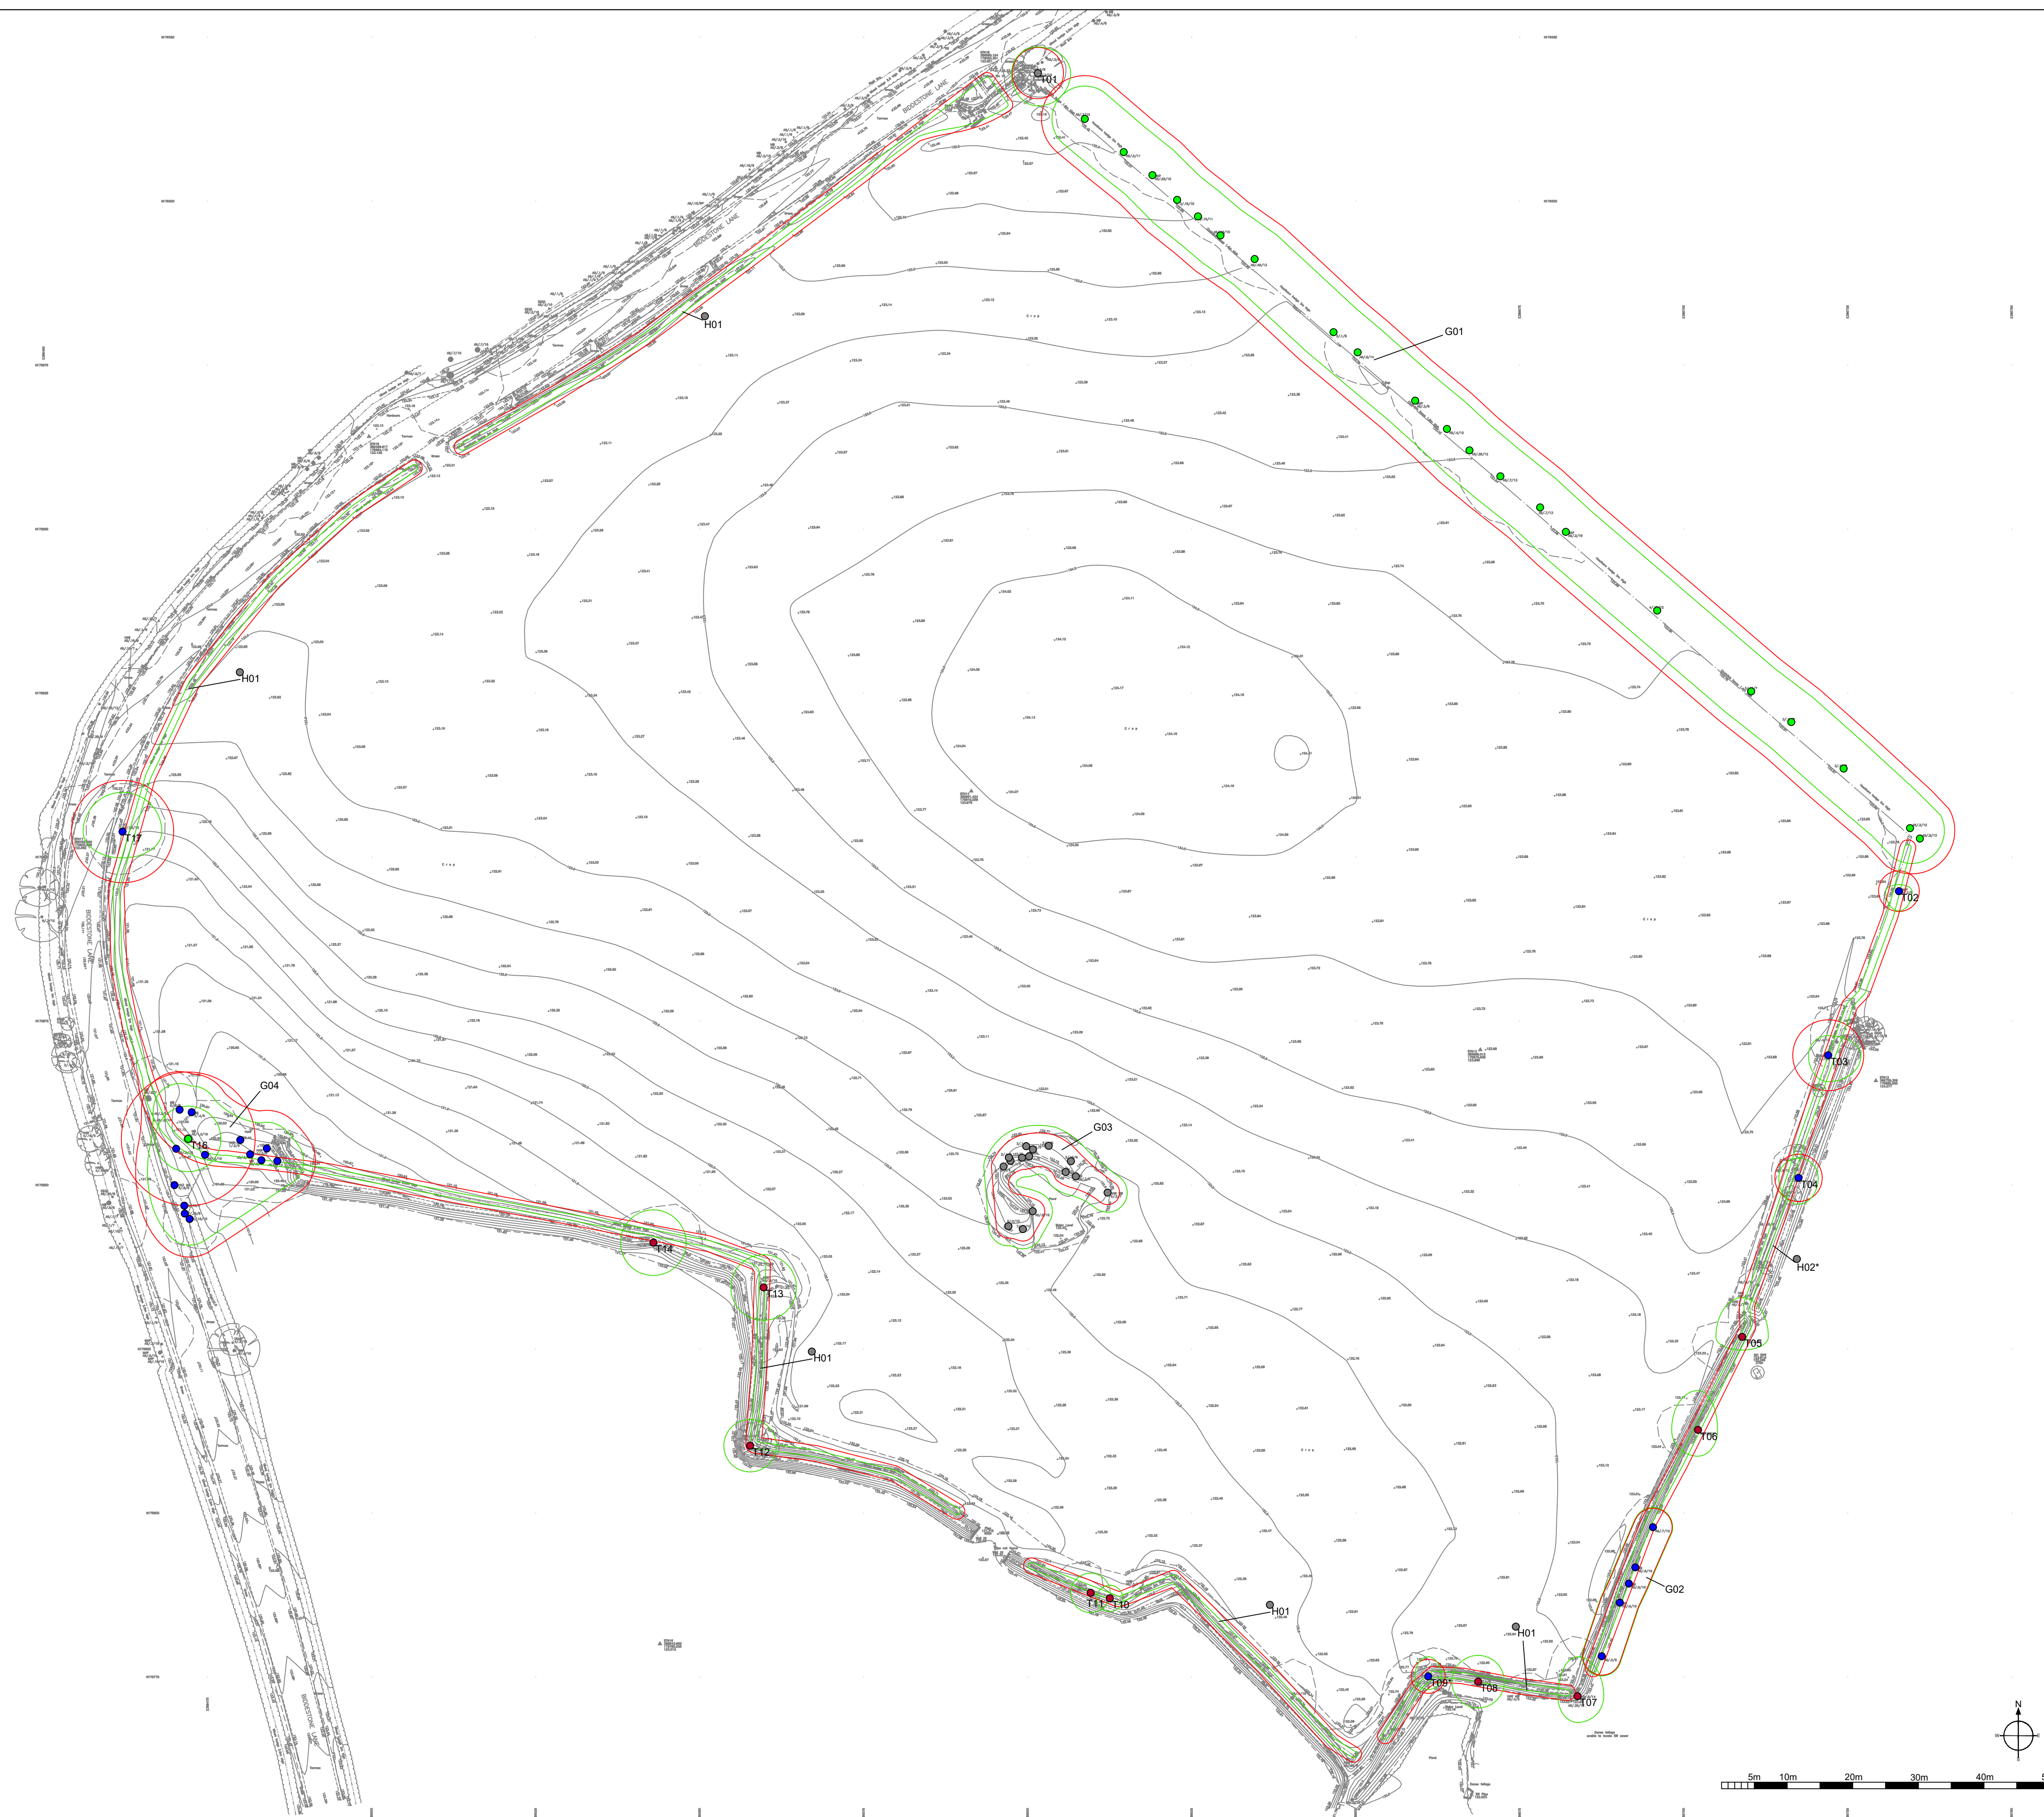
- 5.6 Seventeen trees, four groups of trees, and two hedgerows were surveyed. Of the trees surveyed, one tree and one group of trees was categorised **A**, five trees and two groups of trees were categorised **B**, nine trees were categorised **U**, the remaining trees, groups and hedgerows were categorised **C**. The trees were assessed and graded in accordance with the Cascading Chart of Tree Quality Assessment contained within BS5837:2012.

- 6.2 The Tree Constraints Plan (TCP), (appendix 2), shows the Root Protection Areas (RPAs) for the individual trees identified in the tree schedule tables. This represents the minimum area in m<sup>2</sup> which ideally, should be left undisturbed around each tree were it to be retained. Underground structures, services and other topographical feature, such as different ground levels, can influence root spread and potentially restrict extension growth.

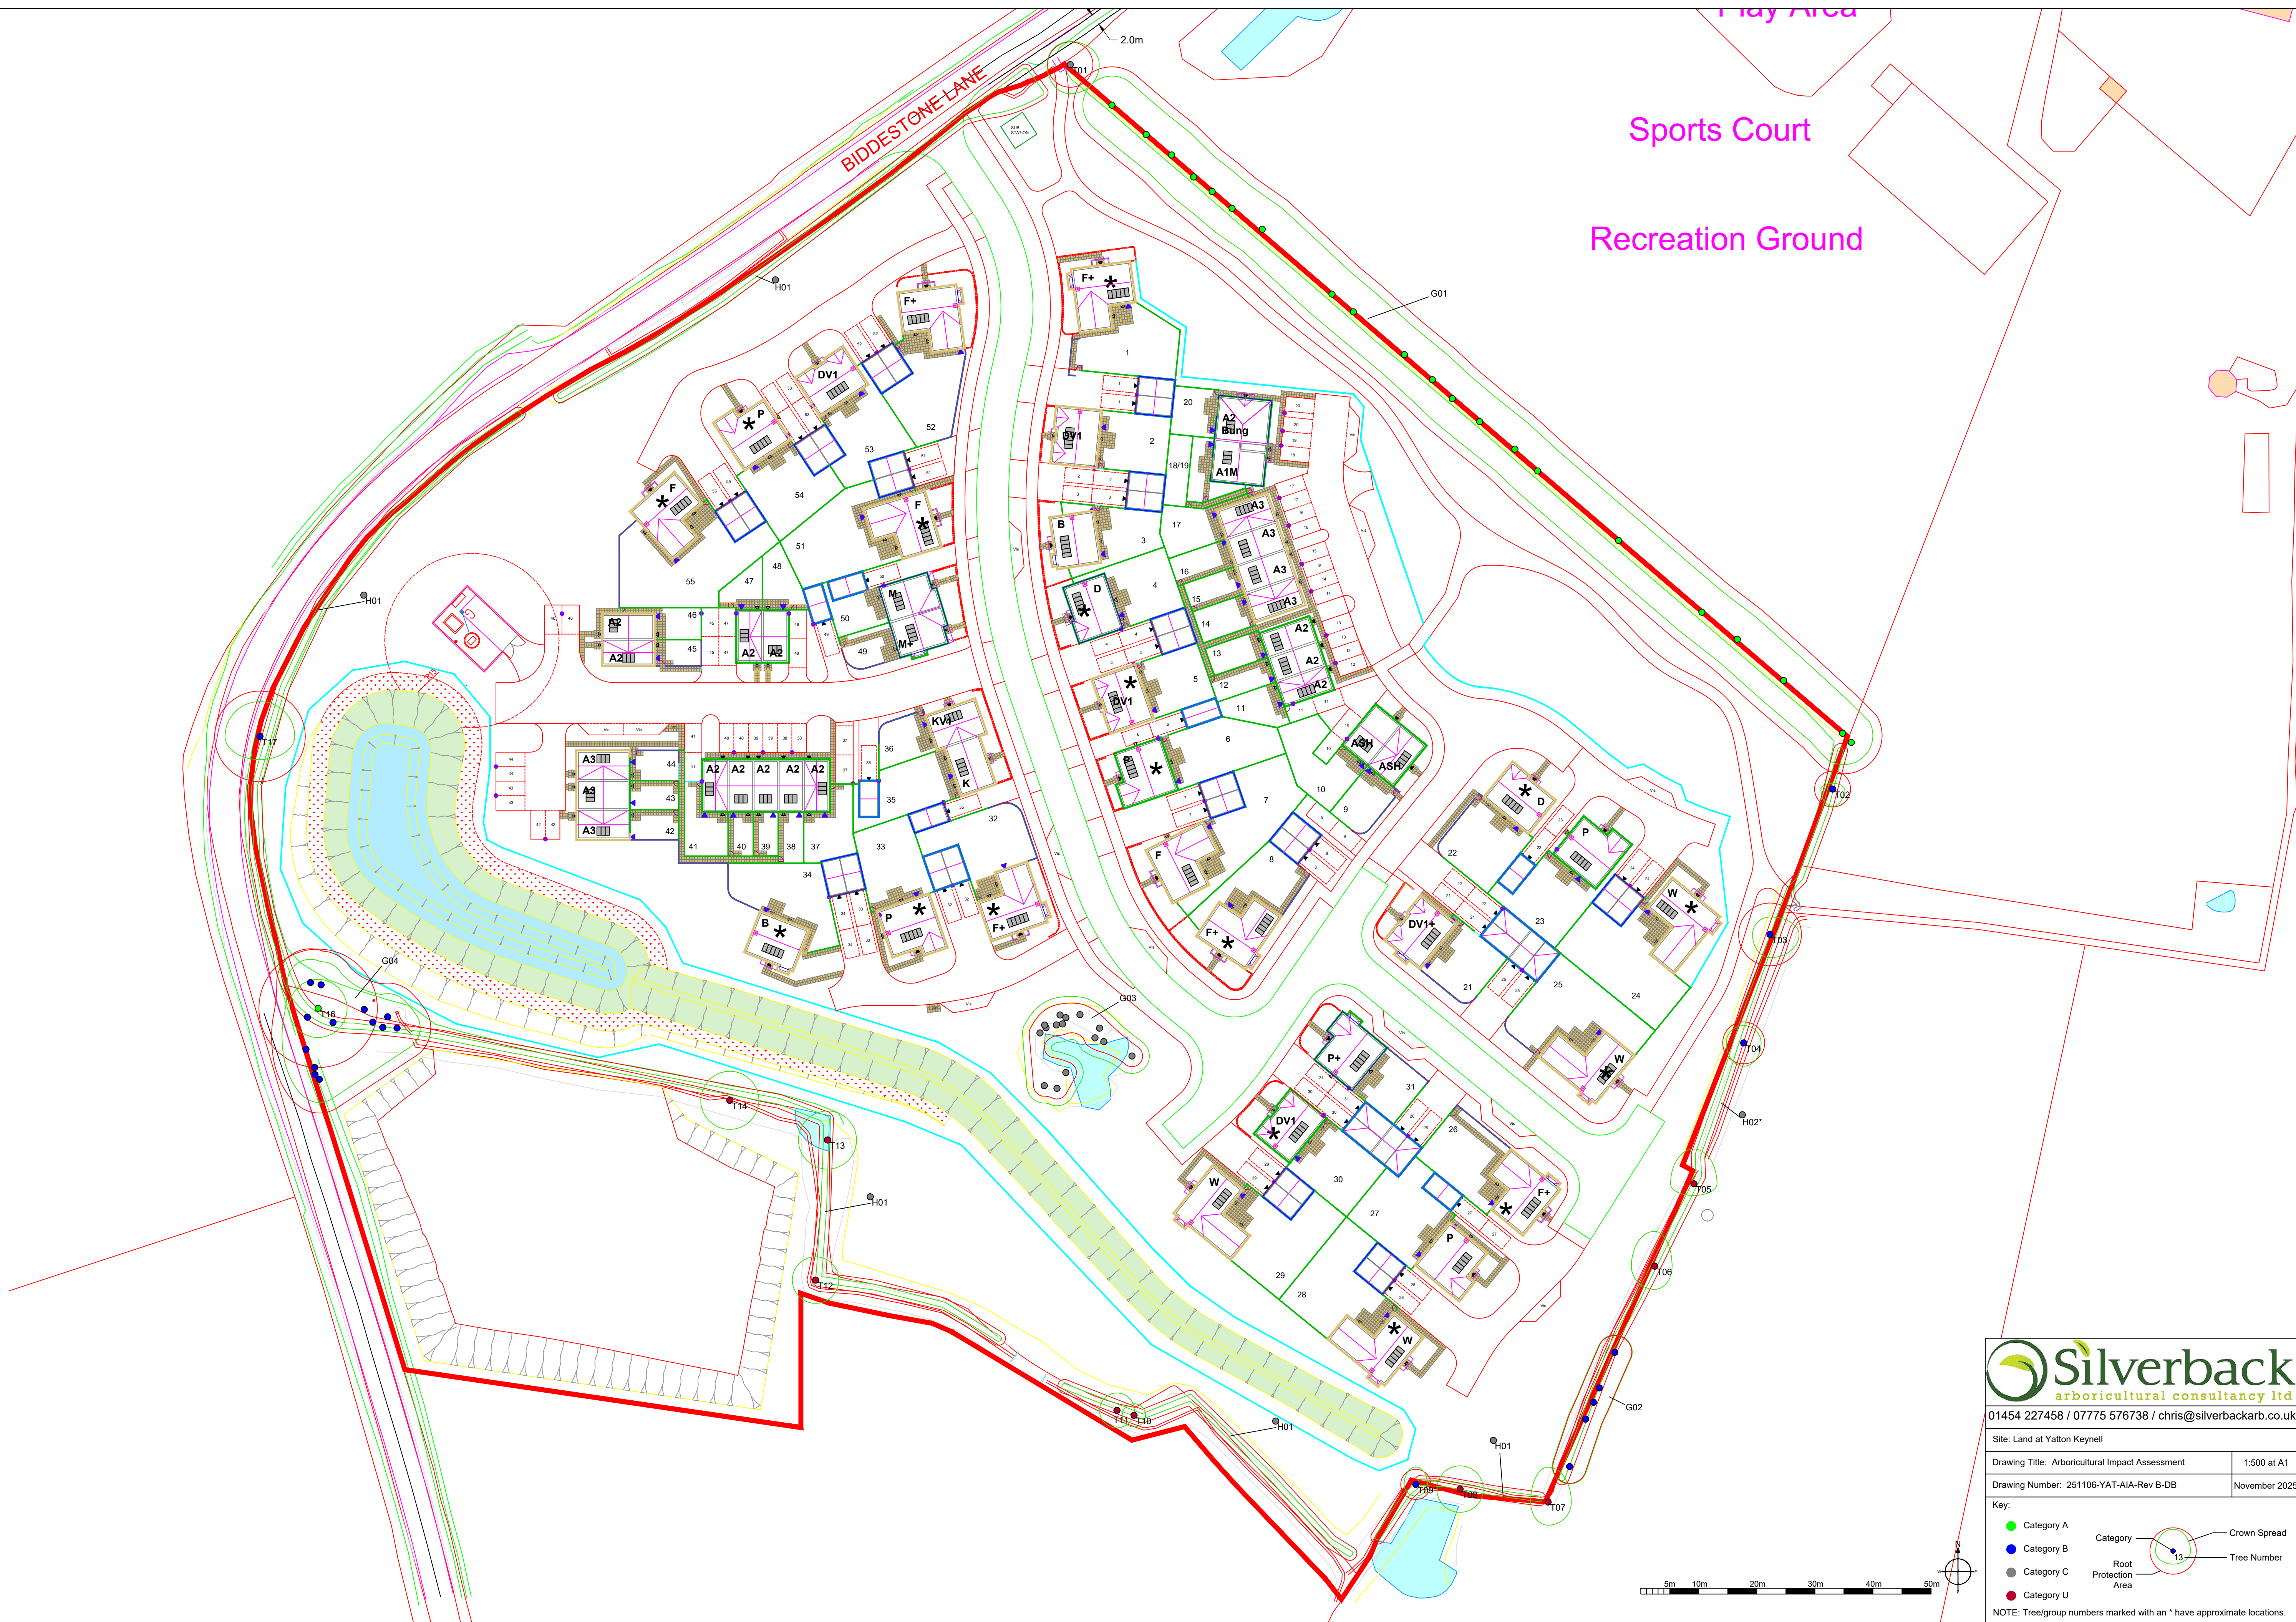
- 7.1 The position of the main development is outside the calculated Root Protection Area (RPA) of existing trees. Any excavation or soil compaction in this area could potentially lead to root severance or damage. This could subsequently lead to a reduction in the trees ability to take up water and nutrients, which may lead to a deterioration in the tree's health.

- 7.2 A small section of proposed footpath extends through the calculated Root Protection Area of T01. Any excavation or soil compaction in this area could potentially lead to root severance or damage.

**Protective fencing will be erected to prevent any un-authorised access into the Root Protection Area (RPA) during the development works.**
