**Wincombe Lodge  
Wincombe  
Shaftesbury  
Dorset  
SP7 9AB**

**Arboricultural Statement**

Project Ref: 643

11<sup>th</sup> December 2025

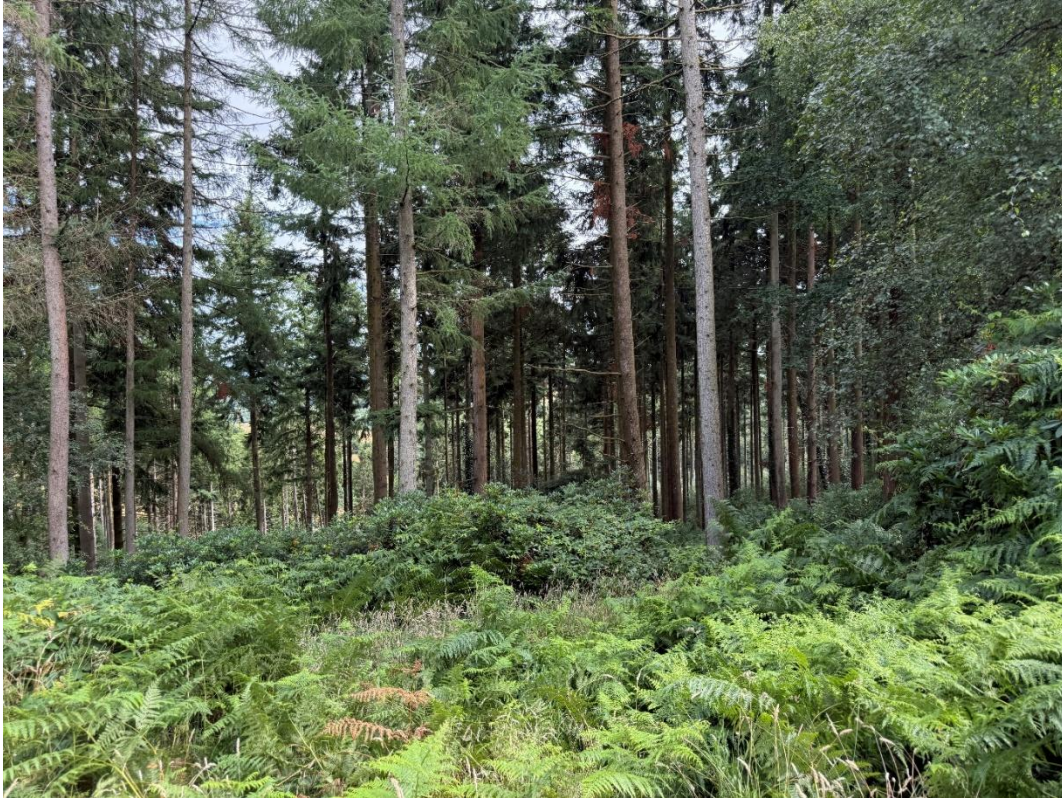
*View looking South East from the bridle path into the Douglas Fir woodland.*

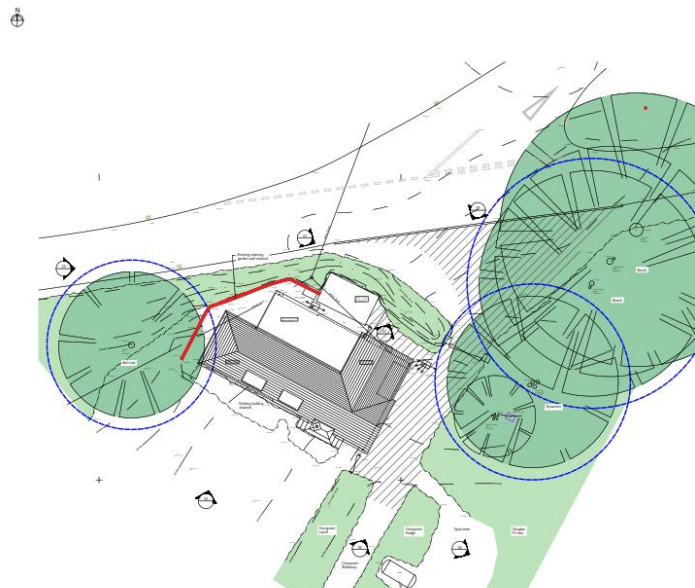
### *Tree survey report*

Wincombe Lodge has the feel of a property within a clearing in the woodland, though it is on the edge of the wood. The site plan below shows the Douglas Fir trees to the South with a sycamore and beech trees adjacent to the highway. There is a laurel / mixed hedge between the property and highway which is overgrown and has some self-seeded ash within. The Northern side of the site between the property and adjacent field has Douglas Fir trees and mature ash.

As with the actual building, the trees and hedges need to be maintained and managed. Douglas Fir trees will be harvested at some point in the future, the hedges need to be cut back and the ash tree is being monitored due to the issue of 'Ash die back'. This ash tree might require removal in due course.

The sycamore and beech trees to the South of the bridleway are not affected. The hedge adjacent to the highway will be managed and cut to a height of 2m but retained in full. The existing single garage building, tucked between the building and hedge, will be removed and the area given over to grass and a gravel path which will be beneficial for the hedge. The self-seeded ash tree, within the hedge, will be removed.

The ash tree to the North of the building is sufficient distance so as to not affect the building, though it is considered that this will be removed due to the potential presence of 'Ash die back'.

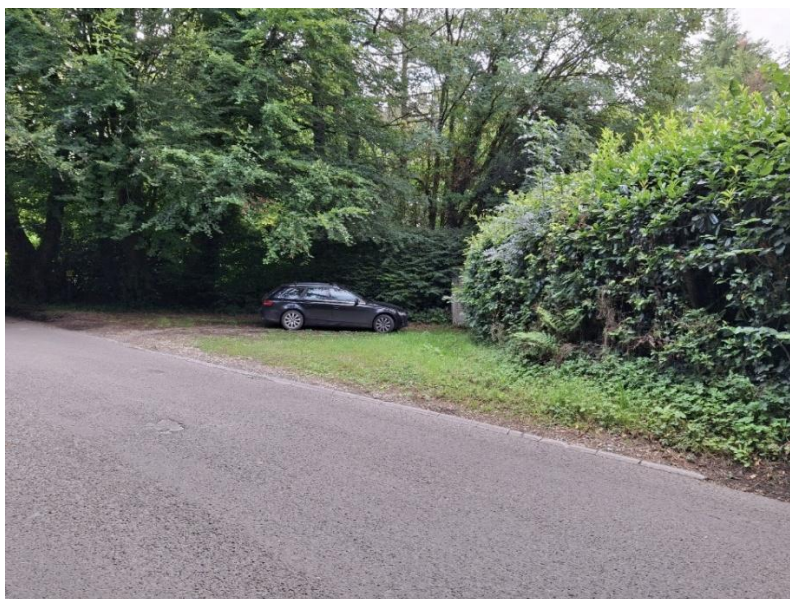
***View of the site entrance with the overgrown hedge on the right. The beech and sycamore trees can be seen beyond the access drive with Douglas Fir in the distance.***

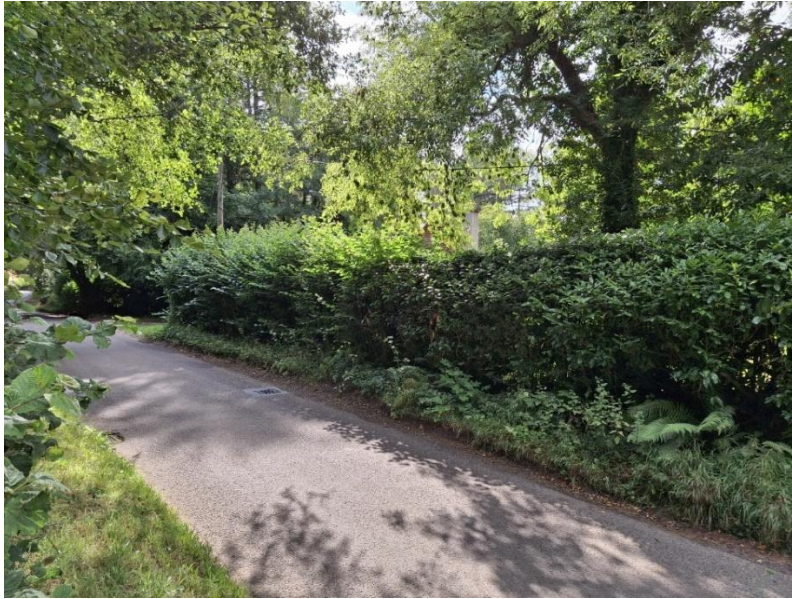
*View down the road with the boundary hedge on the right and the existing ash tree behind it.*

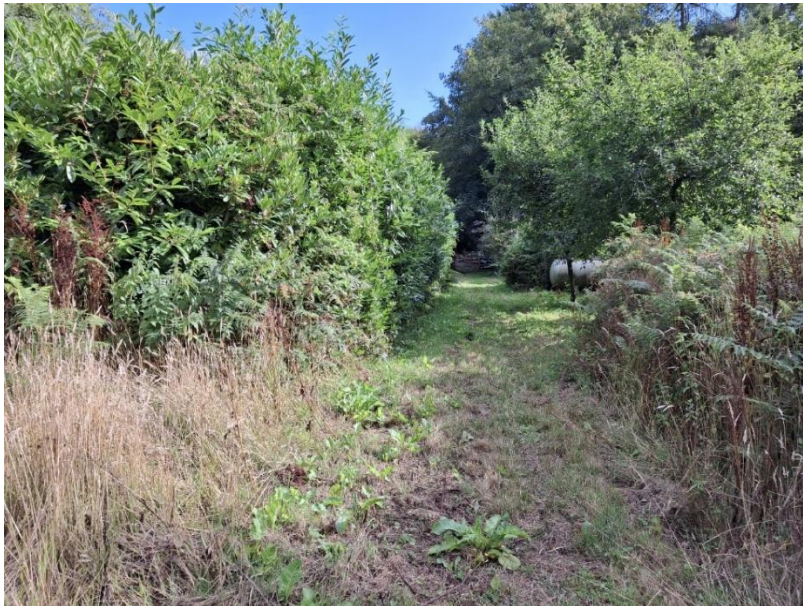
*View up the bridle path with the overgrown garden and hedge to the left. The existing above ground gas tank can be seen on the right.*

The garden is a simple grass lawn which requires regular cutting. The hedge between the garden and bridleway simply requires general maintenance and management.

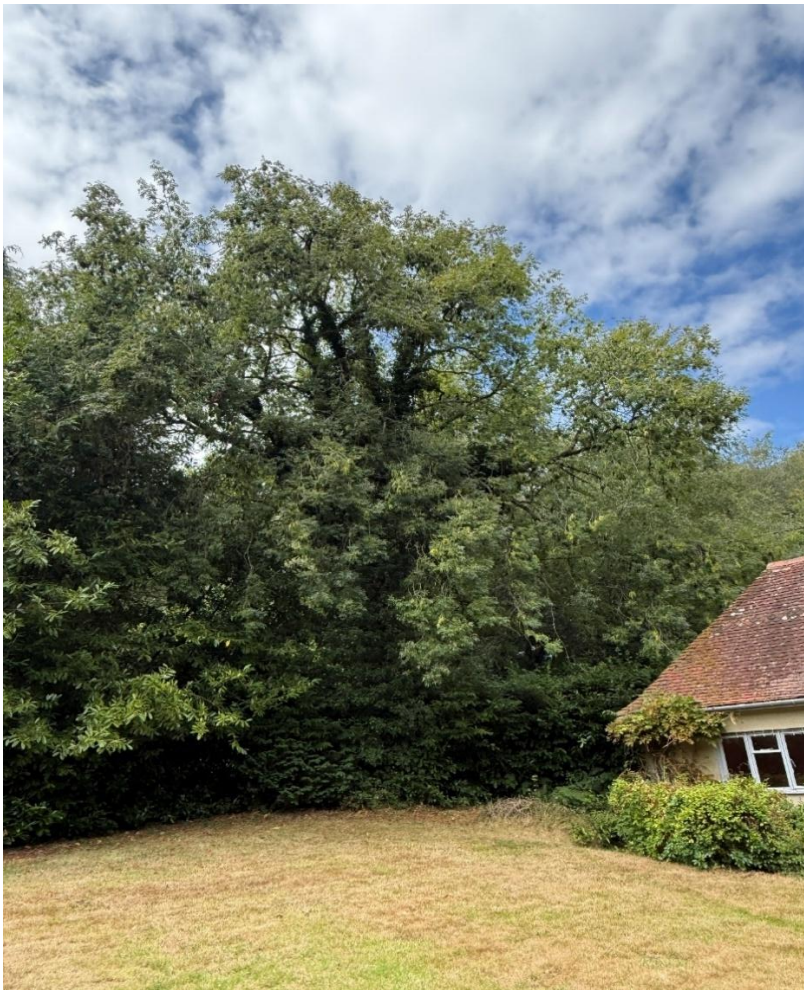
*View from rear garden showing the end of the existing property and the ash tree to the left.*

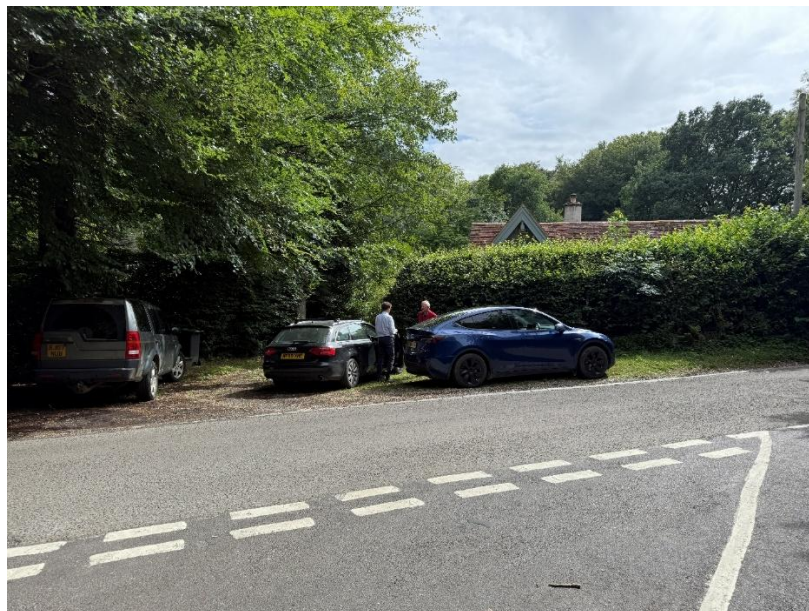
*View of the side from the road showing the boundary edge and mature beech and sycamore trees to the left.*

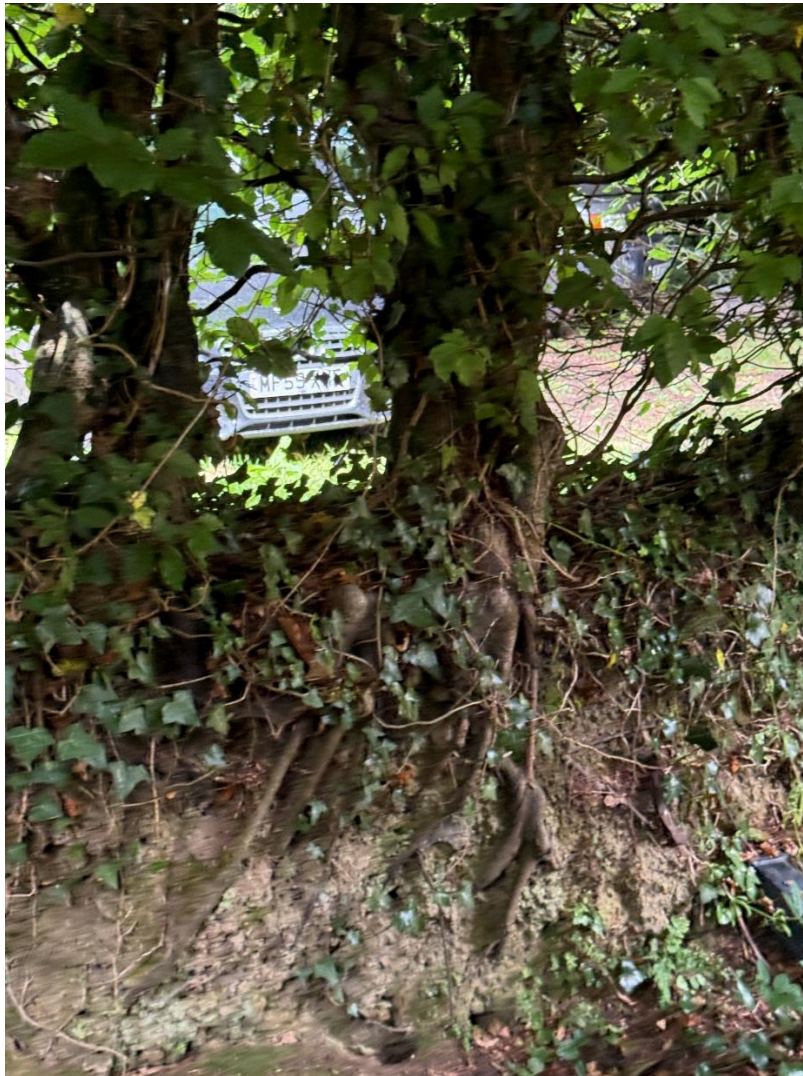
*View from the front of the house looking through the edge toward the current parking space.*
