## Arboricultural Impact Assessment for: Fives Court, Mere

27<sup>th</sup> November 2025

Fives Court  
Angel Lane  
Mere  
Warminster  
BA12 6DH

FivesCourt\_AIA\_112025\_RevA

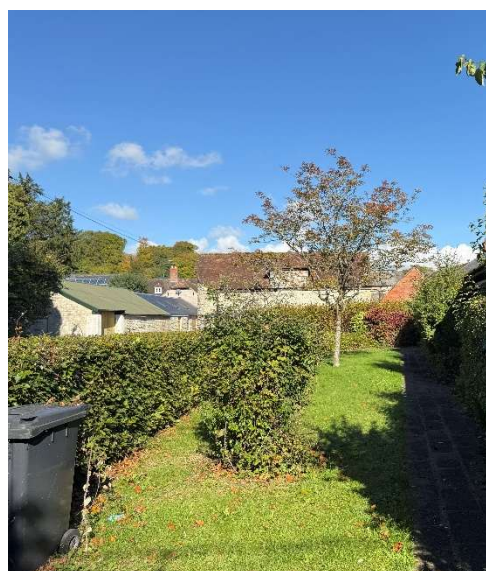
- 9.2 T01 is a small cherry that is visible from the public realm (image 1), the loss of the cherry will have a minor impact on public visual amenity. The remainder of the trees and hedges proposed for removal are internal to the site with limited visibility, their loss will have a negligible impact on public visual amenity.

**Image 1:** T01 in centre with H02 on the left and H03 in the background.

- 9.3 **Mitigation:** Tree removals will be mitigated by the planting of fifteen new trees on the site as part of a high-quality landscape scheme produced by Greenhalgh Landscape architecture. Planting plan including tree species, location and planting stock size to be submitted separately to this report for approval.

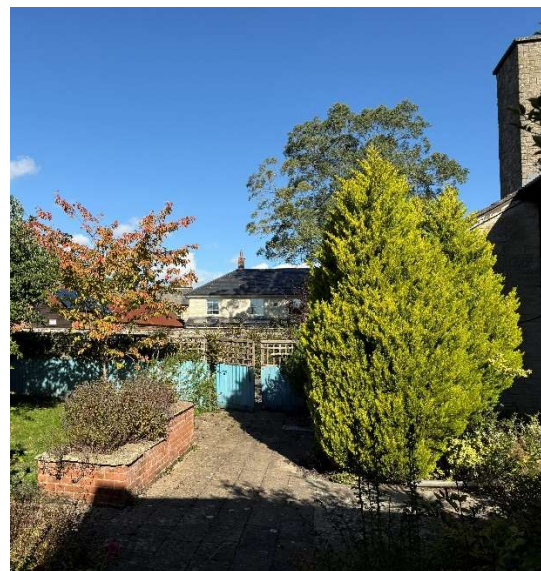
**Image 2:** Trees G06-08 proposed for removal with T10 visible in the background.

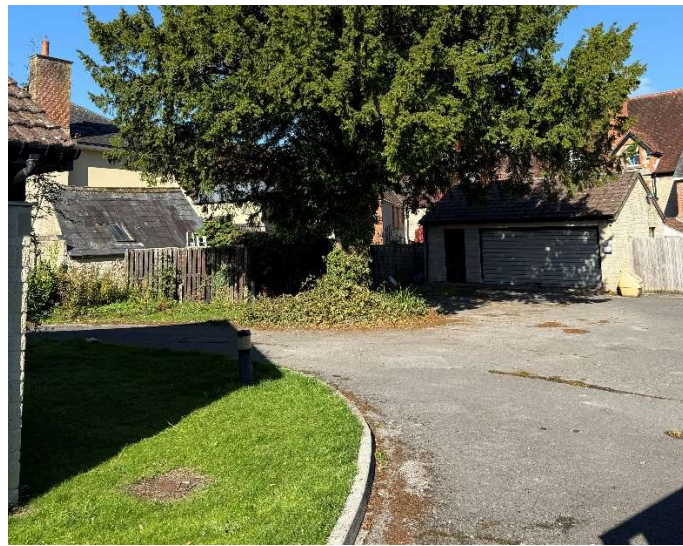
- 11.2 **Demolition:** The garage to the north of the RPA of T11 will be demolished and the area turned to additional parking (image 3). As the foundations of the garage will have prevented root growth below, the demolition will not impact roots however there are likely to be roots growing along the south side of the south building foundation that could be damaged if the foundation is removed. To prevent root damage the south foundation of the garage must only be demolished to the minimum depth necessary to lay the new carpark surface.

- 11.4 A small section of the existing carpark surface at the base of T11 will be removed and reinstated to soft landscape (image 3), as there will be roots below the existing surface it is essential that works take place using hand tools taking great care to avoid damaging the underlying roots, that any roots exposed during the works are covered to prevent drying out and that the area is backfilled with good quality topsoil as soon as practicable.

- 11.5 A small section of footpath is proposed in an area of existing soft landscape within the RPA to the south of T11 (image 3). If the footpath is constructed using conventional methods, excavating into ground level to establish a compacted subbase, then underlying roots could be severed or suffer compaction damage. To prevent root damage the footpath must be a NO DIG installation using a load bearing product as a subbase that prevents ground compaction such as Cellweb<sup>6</sup>.

***Image 3:** T11 with parking area within RPA, garage due for demolition on the right and the soft verge proposed for a NO DIG footpath on the left.*

- 4.1 **Demolition:** The existing garage to the north of the site will be demolished but due to the likelihood of roots from T11 growing along the south side of the south building foundation, the south wall of the garage will only be demolished to 100mm below the level of the car park to the south to allow for surfacing. There will be no disturbance of existing ground level to the south of the garage.

- 4.3 A minor section of the tarmac at the base of T11 will be removed to provide an area of soft landscape for planting adjacent to the parking bay. The works will take place as part of the landscape phase of operations when all plant and machinery associated with the construction phase has been removed from site so that there is no risk of compaction damage following the works. The tarmac surface and subbase will be removed using hand tools taking care to retain all roots encountered, the underlying soil will be broken up using a fork and the excavation will be backfilled with good quality topsoil compliant with *BS3882:2015 - Specification for topsoil*.

- 4.4 **Footpath:** A section of footpath through the RPA of T11 will be a NO DIG construction laid directly onto existing ground level, using a 75mm deep cellular confinement ground protection system, similar to Cellweb<sup>1</sup>, as a subbase, surfaced with a porous wearing course (figure 2).
