**BASSET DOWN GOLF COMPLEX, HAY LANE,  
SWINDON, WILTSHIRE, SN4 9QW**

**TREE SURVEY, ARBORICULTURAL IMPACT  
ASSESSMENT & TREE CONSTRAINTS PLAN**

**PROPOSED PADEL-TENNIS COURT EXTENSION**

**Project Reference: 25.1991**

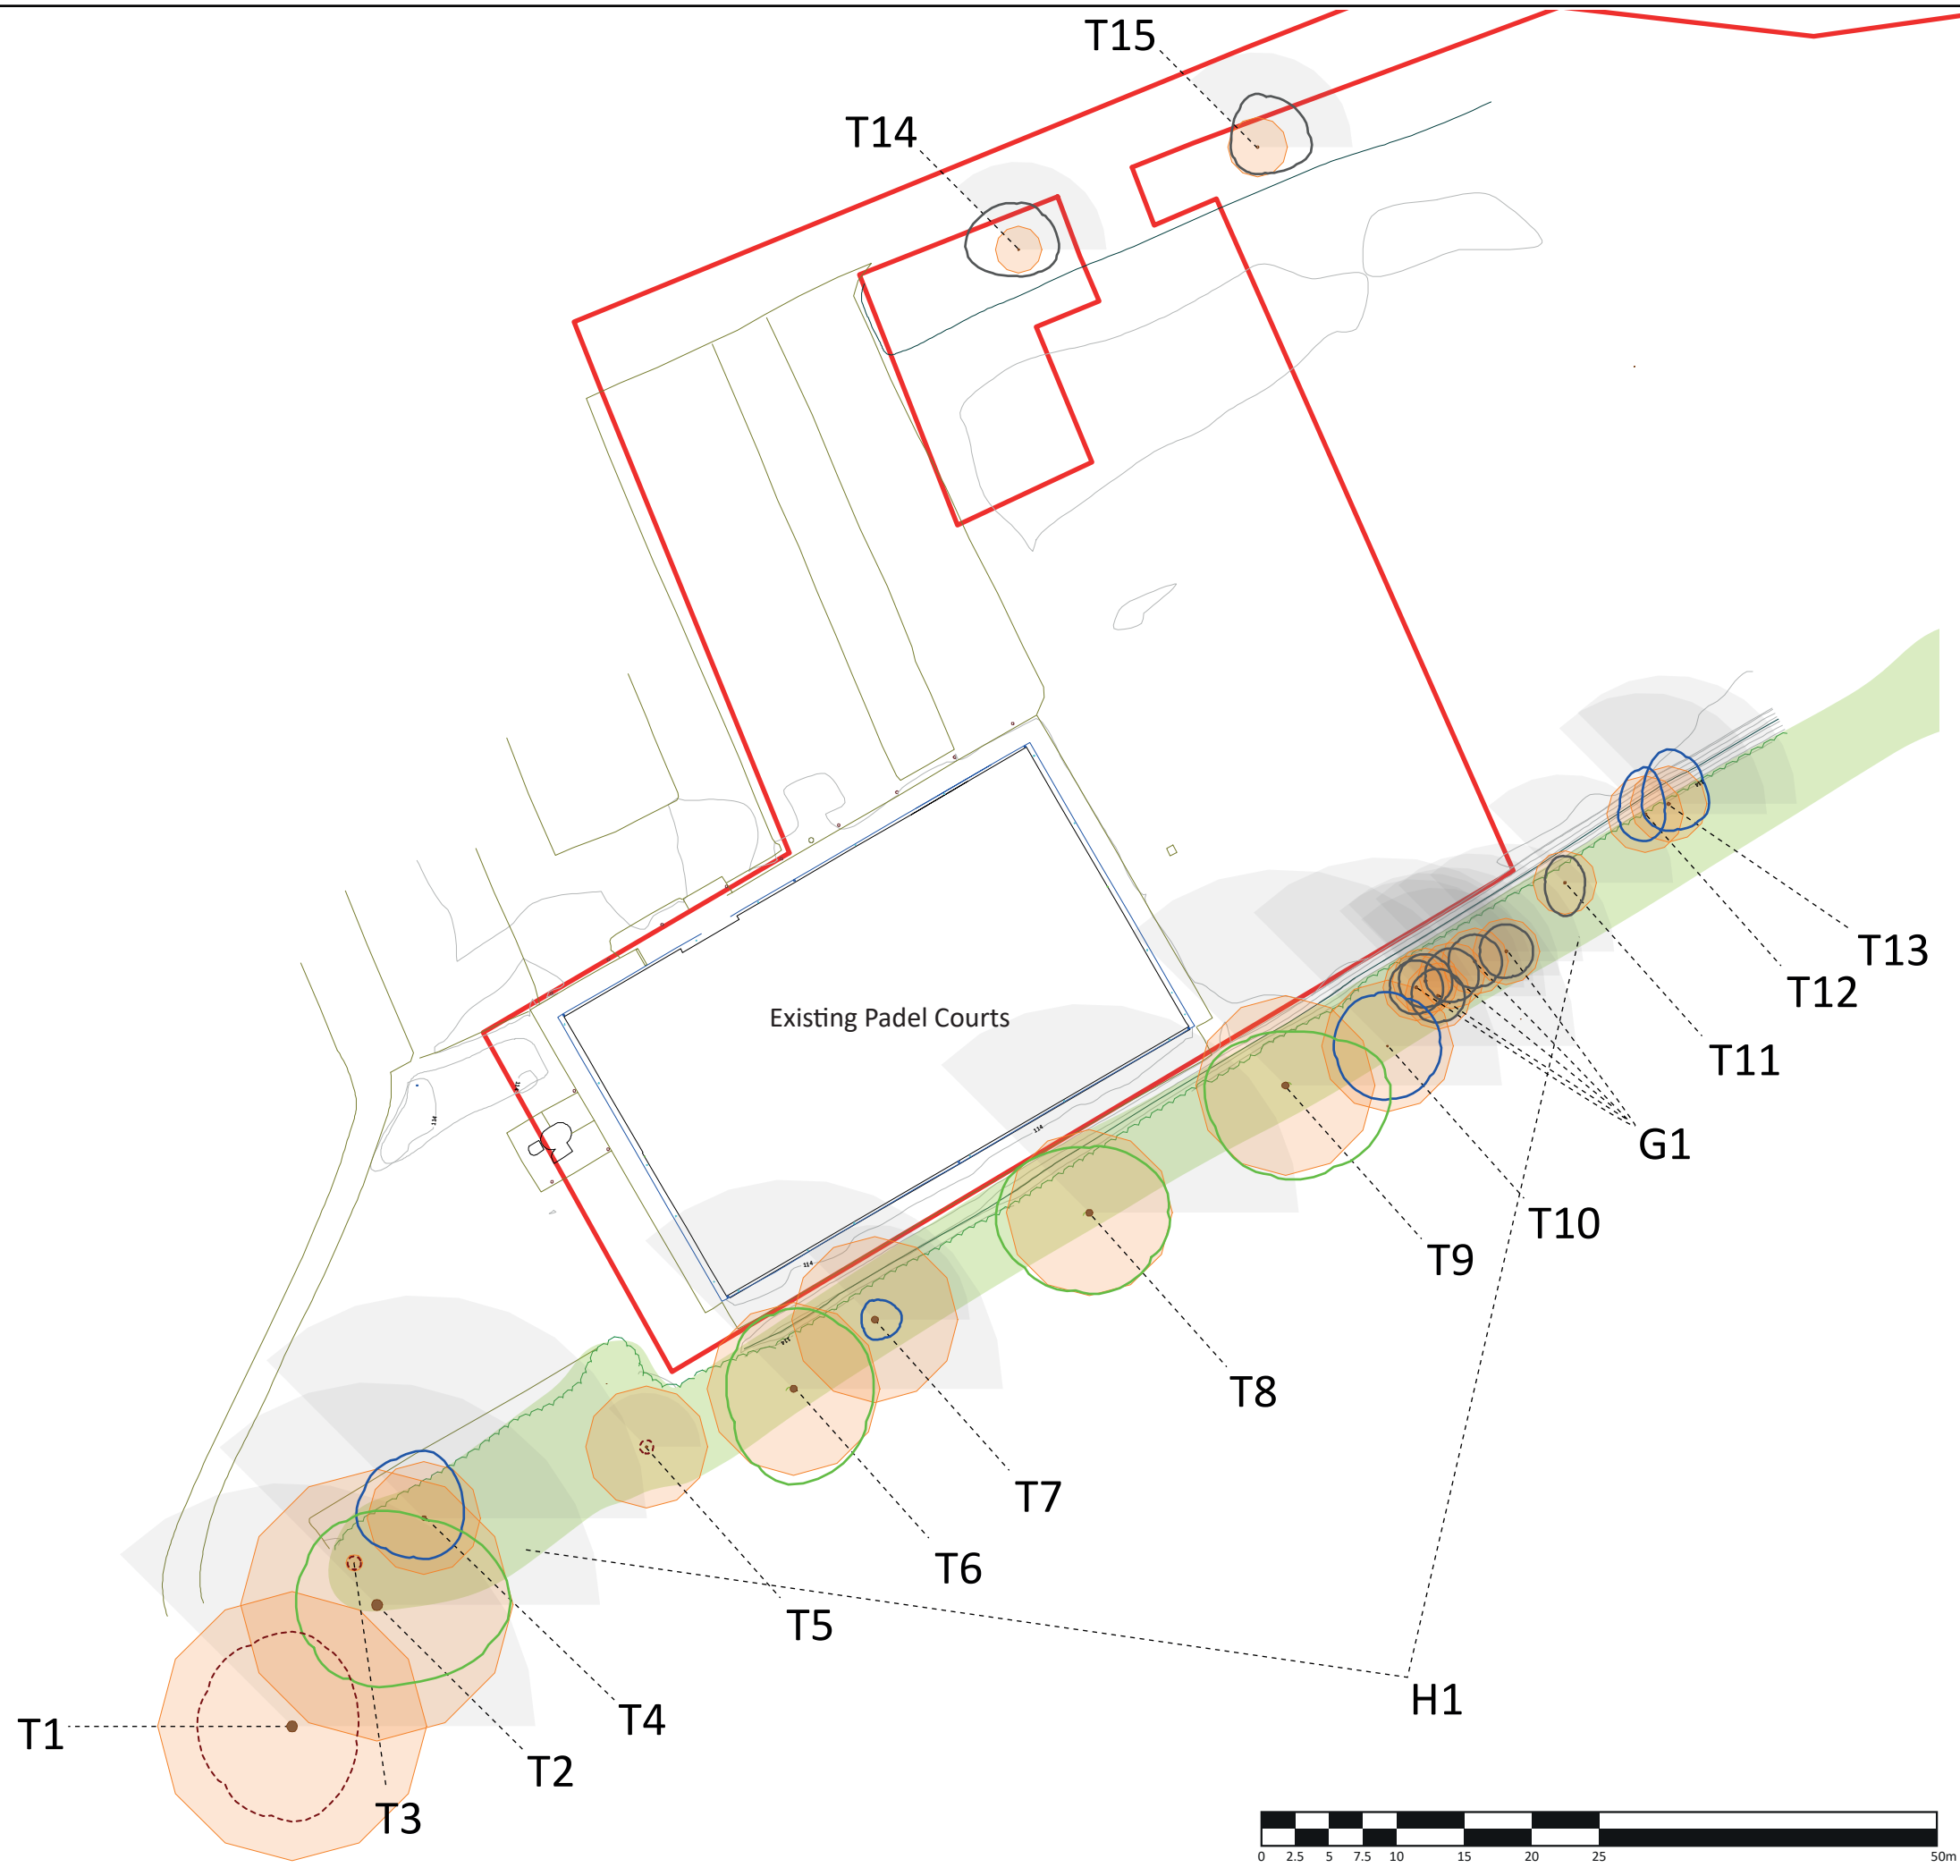
**5.7** In order to protect the sensitive features of the trees to be retained that are potentially threatened by the construction process, CEZs would need to be established protected by CEZ fencing as exemplified in Appendix 1 & 2. This will ensure that those trees to be retained, particularly their RPAs and critical root systems are not inadvertently damaged during the development process, particularly through ground compaction by the passage of vehicles or plant, inadvertent excavation or ground contamination through the mixing of materials. The proposed position of CEZ fencing is marked as a blue dashed line in the TCP at plan ARB-1991-01.
