## DESIGN AND ACCESS STATEMENT

REPAIRS TO GABLE WALL AND REPLACEMENT OF RENDER

68 CURZON STREET

**Report: 4583-D and A**

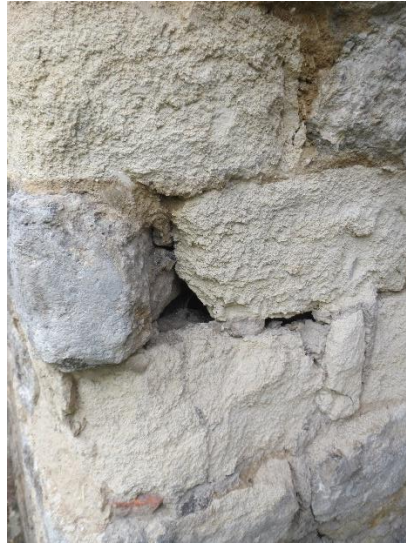
001

During removal of the existing cementitious render from the gable wall, which has been in situ since at least 2005 based on the oldest readily available images, it was found that the stone beneath had become damaged by the unsympathetic material and is currently in poor condition (001-003).

Where the stone is not badly damaged, it will be cleaned of old mortar and then reinstated in a colour matched lime mortar. Areas where the stone is significantly damaged and cannot be reused will be replaced with a like for like rubble limestone to match existing. The wall will be consolidated and strengthened locally with stainless steel studding.

The gable will then be consolidated and regularised with a NHL 3.5 lime mortar. The wall will then be rendered using a three-coat NHL 3.5 lime render. This will then be painted with a limewash with four coats minimum (colour to be agreed, to match existing unless noted otherwise).

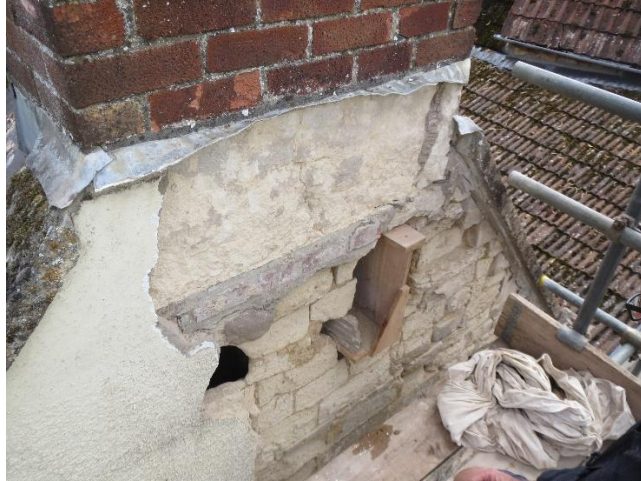
004

There is particular concern for an area of the stone near the top of the gable wall which is very degraded and friable (**004-006**). This is to such an extent where two local holes have formed in the stonework which exposed the chimney flues. There is concern for the stability of the wall in this condition.

This section of the gable is likely to be more significantly damaged due to the lower wall thickness next to the chimney flue and additional degradation of the stone from heat impact from the chimney flue – a common and unavoidable weakness with this type of stone used to form chimney flues.

Following the discovery of the holes in this section of the wall, the Contractor executing repairs, halted work and instructed MLDE to conduct a structural survey. MLDE have specified that the wall in its current form is unstable and requires structural improvements. MLDE have produced a temporary work scheme that will allow the proposed permanent works outlined below (detailed in document 4583-SCHEME-01) to take place.

The proposed works will only impact the gable wall of the property. Temporary works will be installed to allow for a local area of the gable wall to be taken down and rebuilt in sections. The rebuilt section is roughly 800mm in height and 1600mm of width across, near the very top of the western gable.
