# Application for Tree Removal & Hedge works at 23, The Mead, Ashton Keynes, SN6 6PL

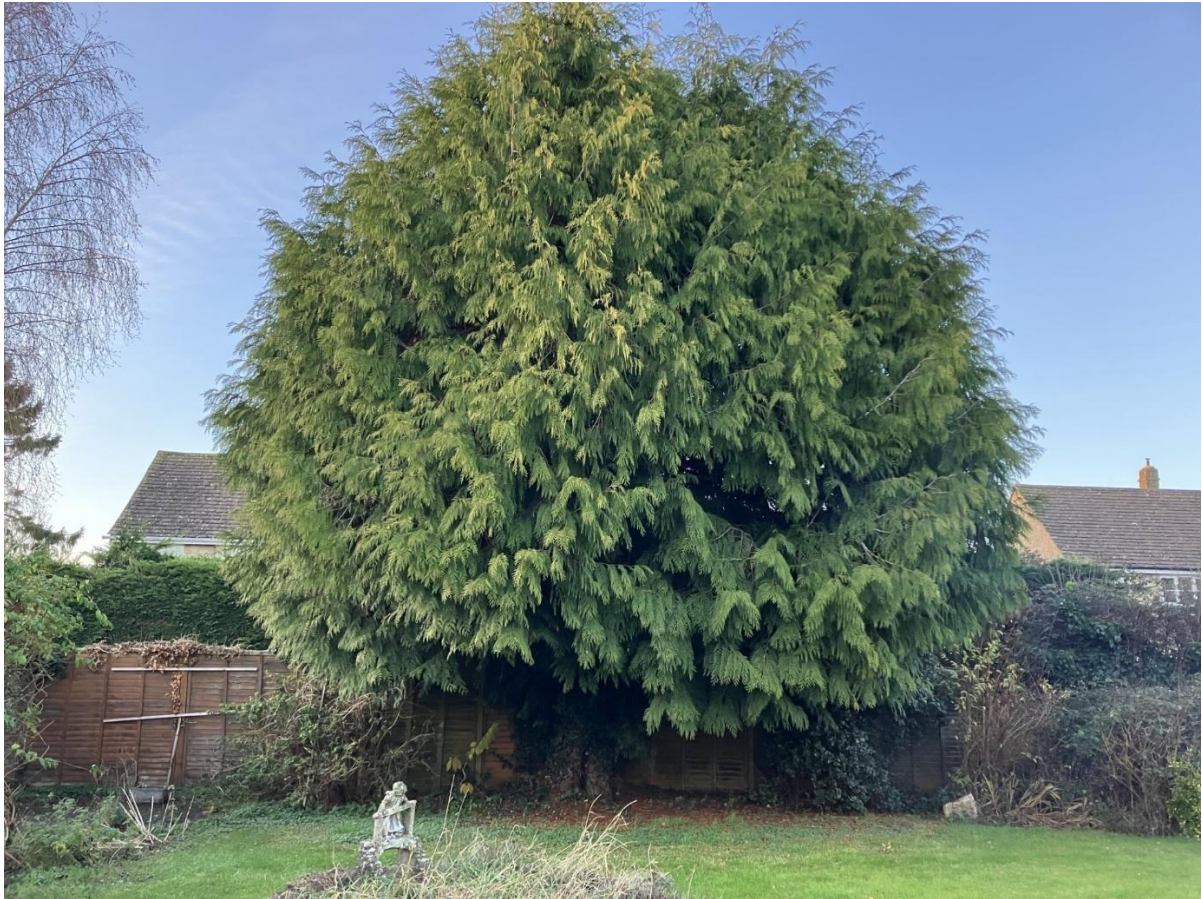
*Photo 1: Western Red Cedar View from rear Garden*

The primary reason for this application is the large and overbearing Western Red Cedar (please see photo 1) situated on the North Western Boundary of the property. The area immediately under the tree is brown. This is caused by fallen leaves prohibiting grass growth combined with the effect of the root system. These trees can reach 65m in height. The root system on a Western Red Cedar is fibrous and extends beyond its canopy soaking up water and nutrients to the detriment of other plants. Certainly, no

lawn survives under it. Approximately 30% of the lawned area to the rear of 23 the Mead is devoid of grass. This is the area underneath the tree and within its root system. On the footpath at the rear of the property no grass is growing underneath the tree canopy causing the footpath to be a muddy mess.

We are more concerned with the size of the tree and its potential to cause damage should it fall.

We wish to remove this Western Red Cedar tree and stump grind its roots.

Once removed the back fence, which is currently a panel fence of some age will be replaced with either a stile and rail fence or composite panels held in place by concrete posts.

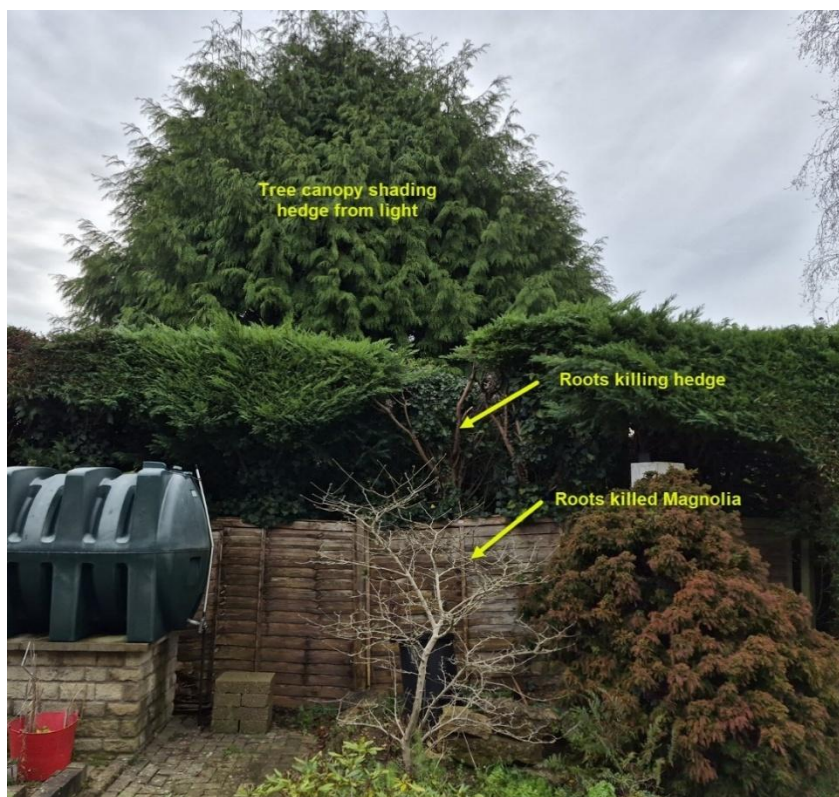
Our rear neighbour has been kind enough to share and annotate some photographs detailing how the tree is currently impacting his family and the local community. Photo 2 below details how the tree has killed the magnolia in his garden and is affecting his boundary hedge. Photo 3 below details how grass is prevented from growing under the tree and how its roots now protrude above the soil presenting a trip hazard on a path used by the public. The lack of grass growth will exacerbate soil erosion in this area. I am unaware as to who is responsible for the upkeep of this footpath but believe it to be owned by Green Square Accord.

*Photo 2 View from property at rear (photograph provided by neighbour)*

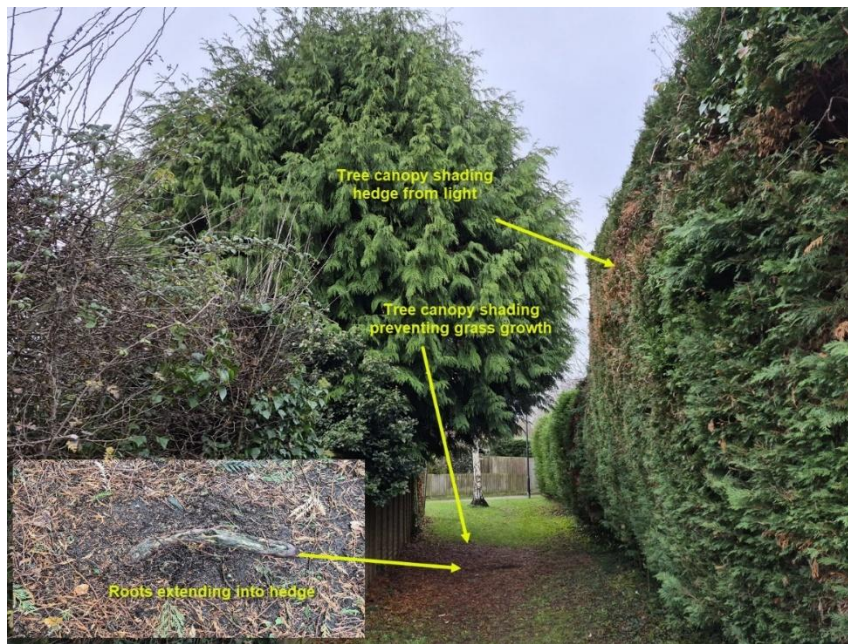
*Photo 3 view along pathway at rear of property (photograph provided by neighbour)*

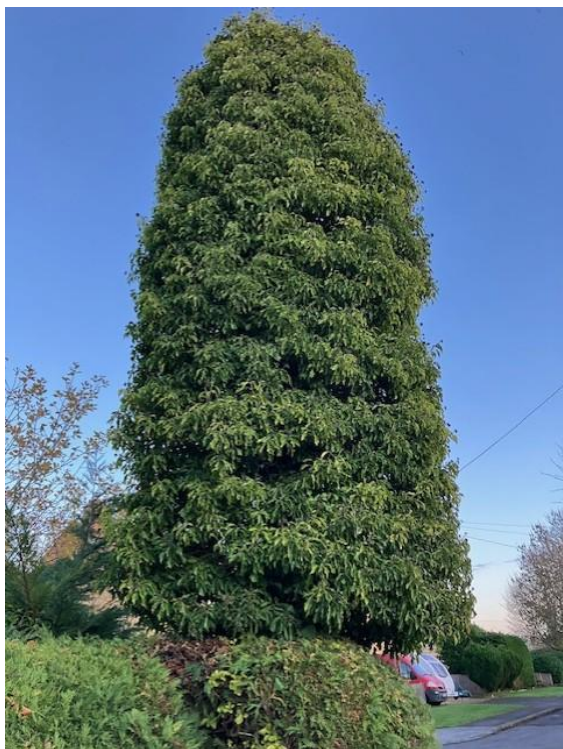
Photograph 4 is in fact not a tree, but an Ivy clad Scottish and Southern Electricity Network (SSEN) pole and is included here for completeness of record. This is located at the front of the property. Photograph 4 (viewed from front of property towards The Mead) shows the ivy covered SSEN pole that should have been removed back in 2014 as part of the works involved in planning application 13/05914/ful covering the new builds in The Mead. Unfortunately, the removal of this derelict pole was overlooked and SSEN are attending the property shortly to rectify this error. In the meantime, ivy has used the pole as a runway and overtaken it completely. This has also had the effect of removing the effectiveness of the streetlight that stands in front of the pole which is now surrounded by ivy significantly limiting its effectiveness. Photograph 10 shows the effect on the light at night.

*Photo 4 View of redundant electric pole at front*

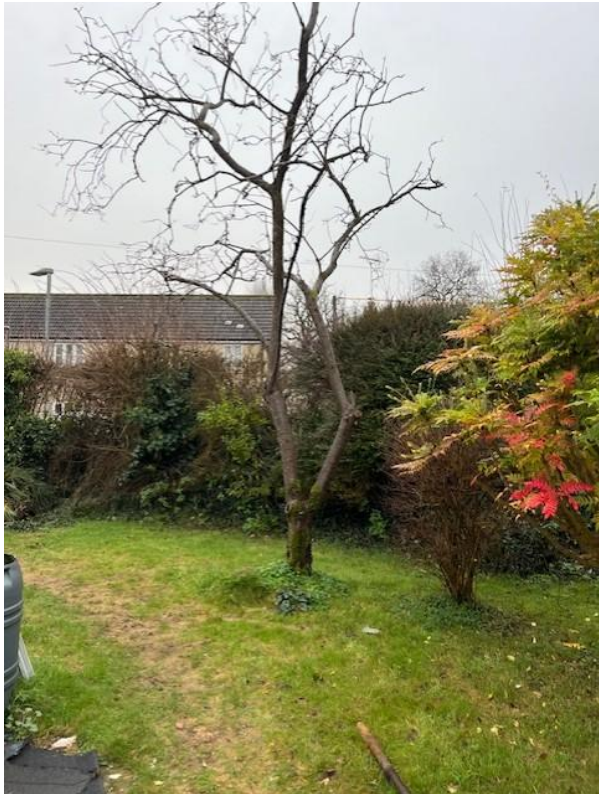
Photograph 5 details a dead tree within the garden which we wish to fell and stump grind.

*Photo 5 Dead tree within property grounds*

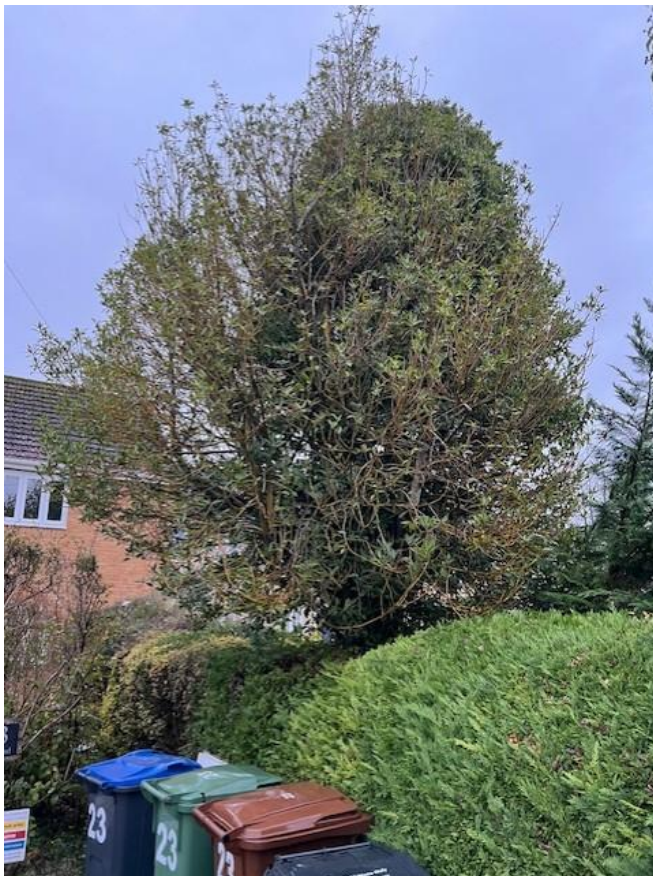
Photograph 6 details two small, intertwined trees that have grown within the front hedge on the Eastern Boundary. We wish to remove these to restore the uniformity of the hedge.

*Photo 6 Small trees within hedge on Eastern Boundary*

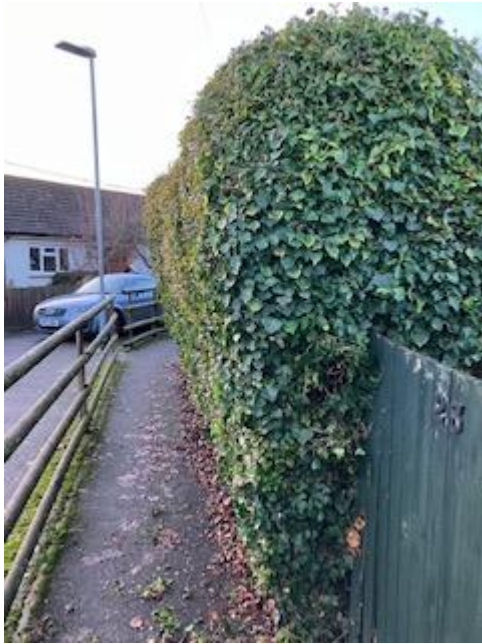
Photographs 7 through 9 details how far the boundary hedge has overreached and grown beyond the curtilage boundary, encroaching onto the footpath on the West boundary of the property. The gate in photograph 7 is situated on the boundary line,

evidencing the depth of overreach. I have observed pedestrians walking along the road on this western edge as they cannot easily walk down the footpath. Large sections of the hedge are dead and have been overtaken by ivy utilising the dead bushes for support.

*Photo 7 Hedge encroaching footpath from gate*

We seek permission to cut the hedge back so that it does not encroach upon the public footpath or extend beyond the property's curtilage. To remove all ivy and dead bushes from the hedge. Once the hedge has been cut back to within the property's boundary to shape and balance the hedge, replacing hedging as appropriate.

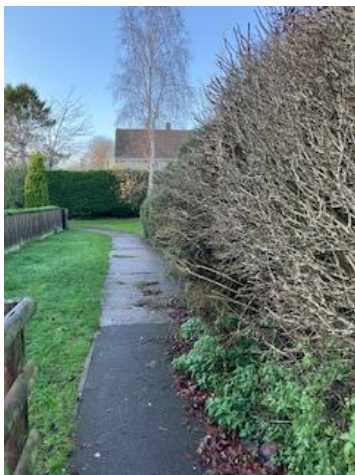
*Photo 8 Hedge encroaching footpath at barrier end*

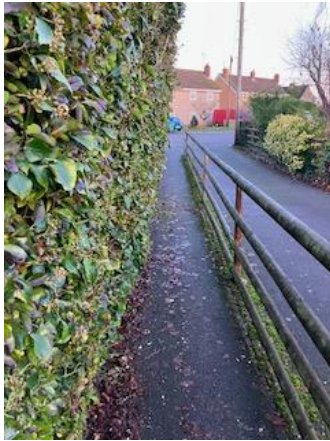
*Photo 9 view from barrier end toward The Mead*

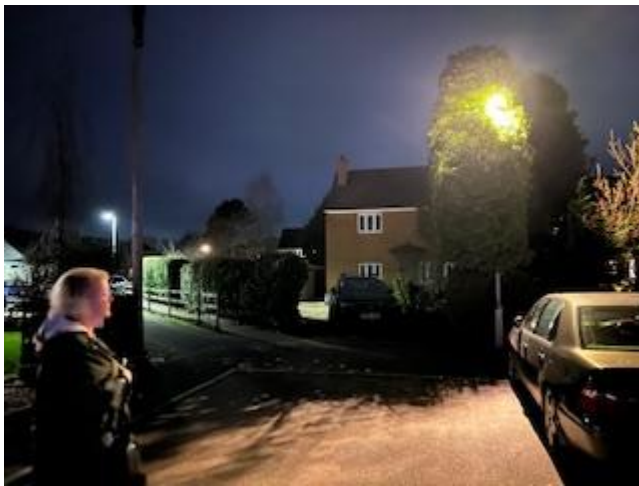
*Photo 10: Electric pole at night, ivy obscuring the light*
