## DESIGN, ACCESS & HERITAGE STATEMENT

Change of use & Alterations of ancillary buildings (Stable 1 & Tractor shed) at:

## Manor Farm, Erlestoke, SN10 5UE

Date: Friday 30 August 2024

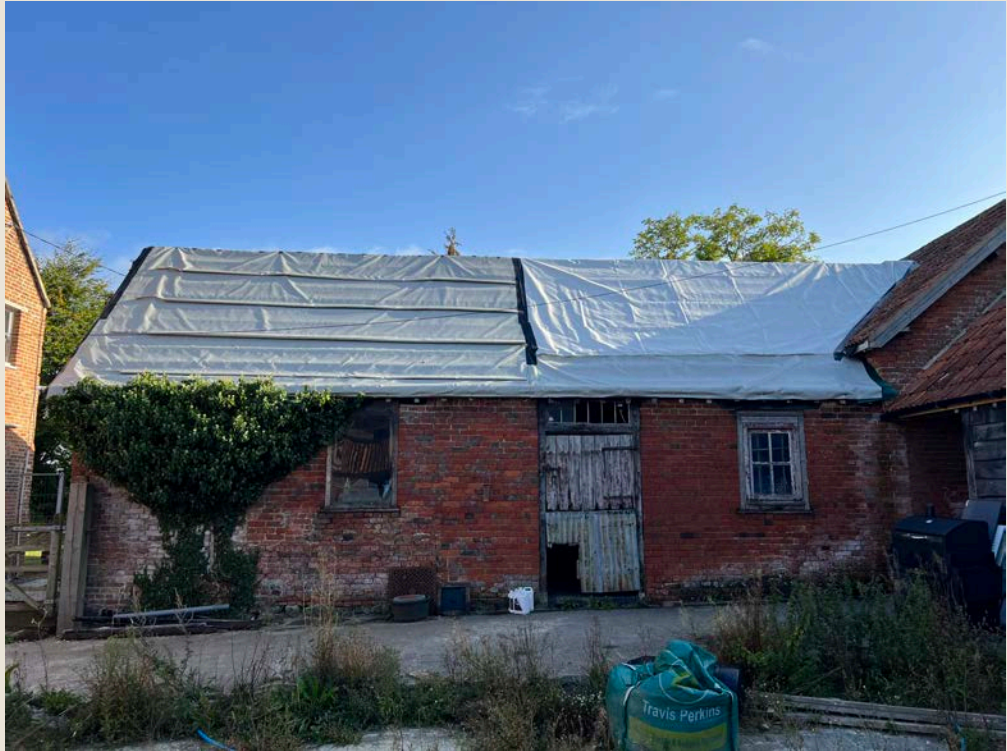
Figure 1: South Elevation of Stable 1 from courtyard showing temporary tarpaulin roof

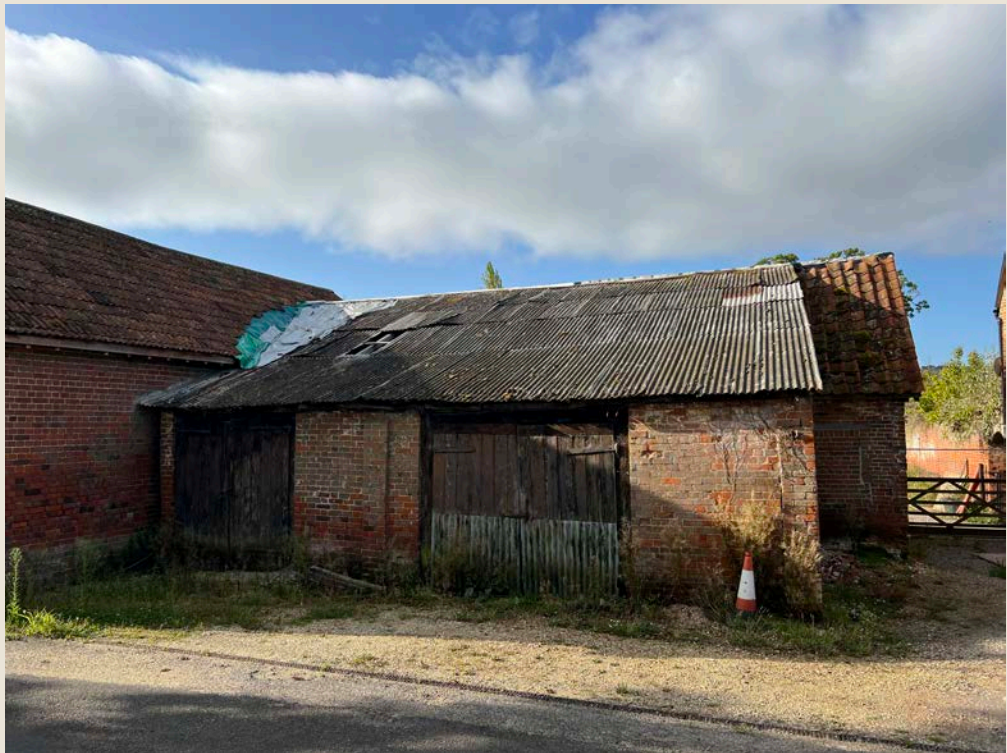
- 6.5. The current Tractor Shed (building 3) roof is lightweight corrugated metal (see Figure 2), and not of the quality or permanence of Stable 1. The Tractor Shed rafters are propped on the front wall of the Tractor Shed and the side wall of the Stable, with timbers lapped to extend up to the ridge of Stable 1.

Figure 2: North elevation of Tractor shed from road

3. Reducing the structural load on the Stable.
- 9.3. We propose to rebuild the roof and front wall of the Tractor Shed, using the same palette of materials. The materials will ensure the new fabric sits comfortably in the setting, whilst the detailing will allow historical clarity.

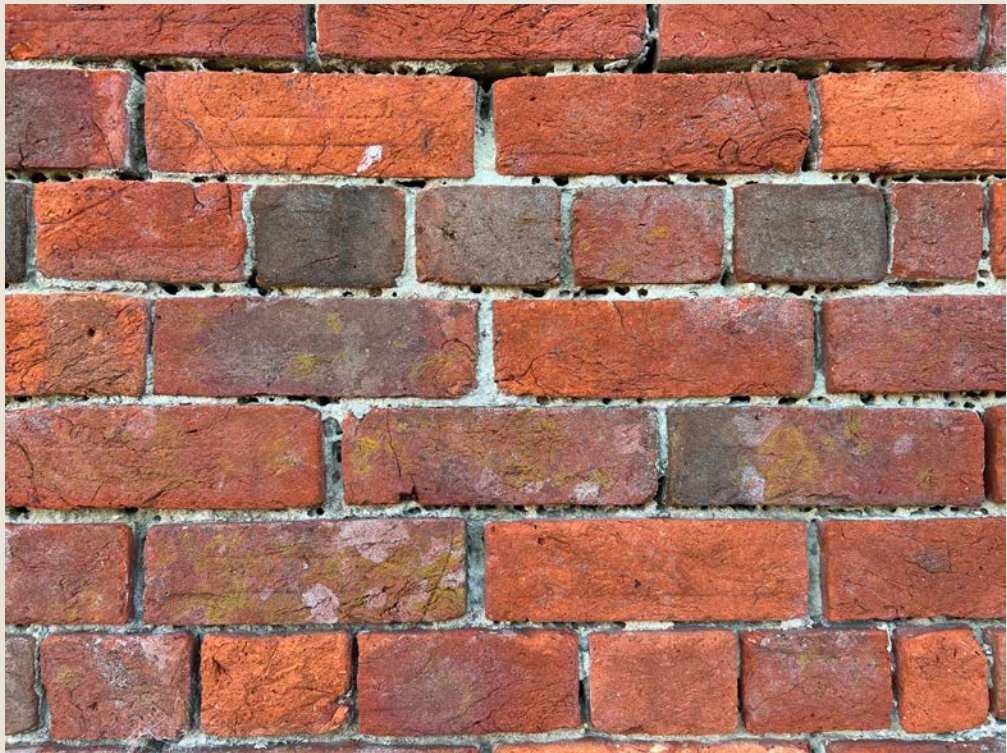
Figure 8: Brickwork condition

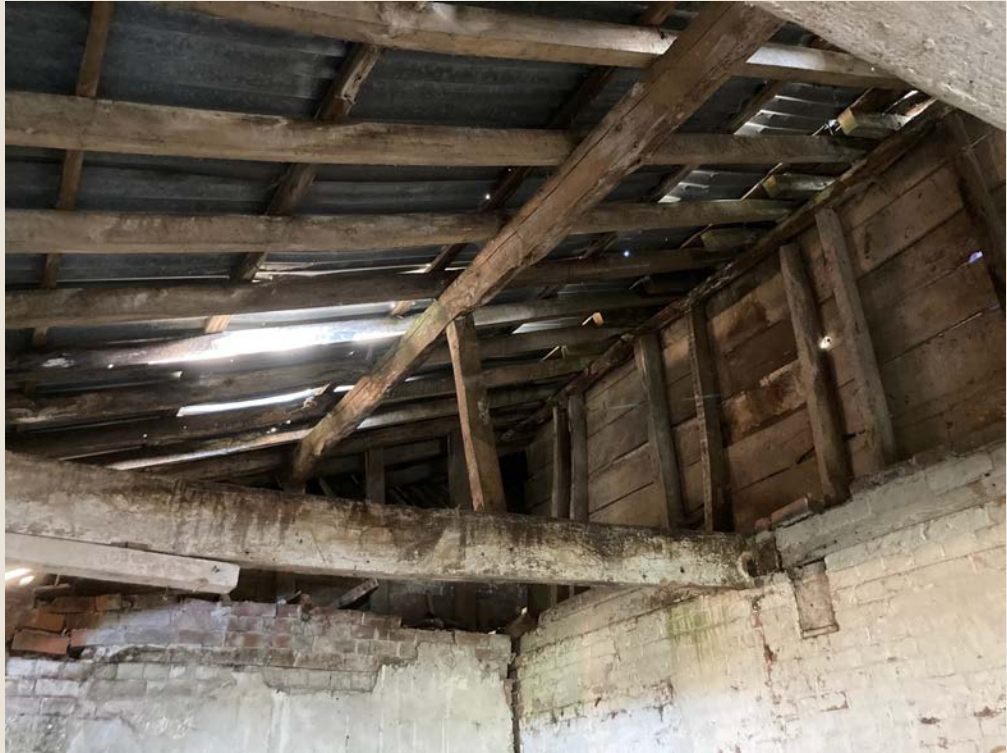
- 7.7. Brickwork to the front is bowing significantly
- 7.8. Wall plate to the east has rotten and the brickwork above is collapsing.
- 7.9. The principal trusses are also bowed most likely evidence of them being undersized to take the load and span of the roof.

Figure 9: Roof structure of Tractor shed

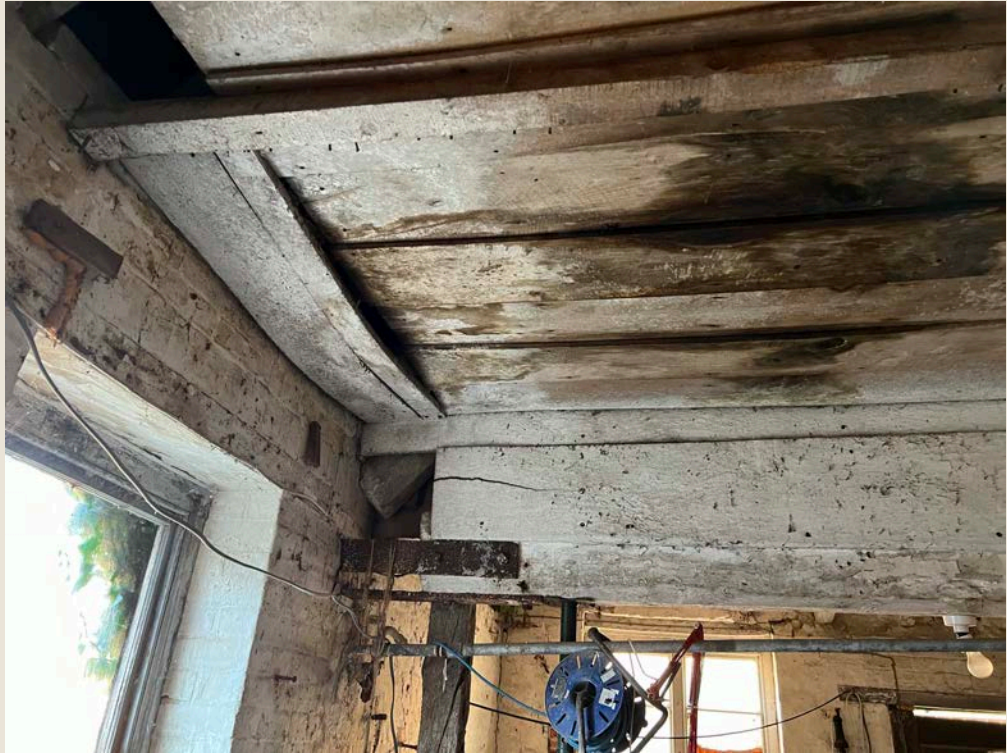
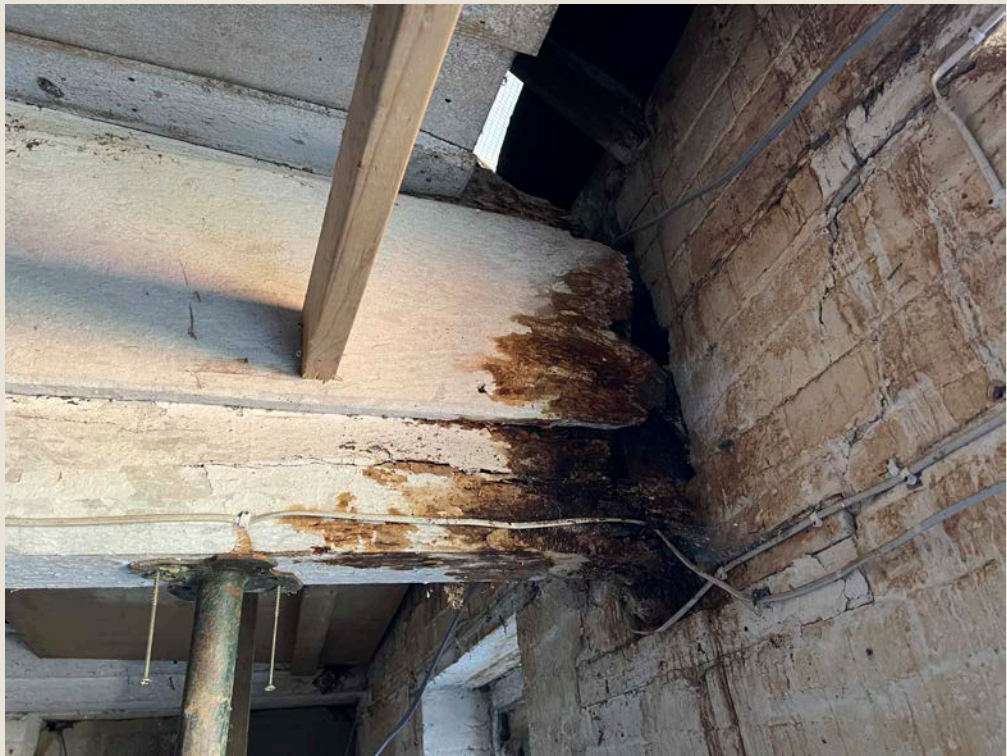
- 7.6. Repairs have been undertaken to several beams where they bear onto the south wall. Metal strapping added. Further repair work will be needed in order to stabilise these and allow the removal of the temporary props (See Figures 11 & 12)

Figure 11: Stable 1 interior, showing propped beam

Figure 12: Stable 1 interior, concrete floor

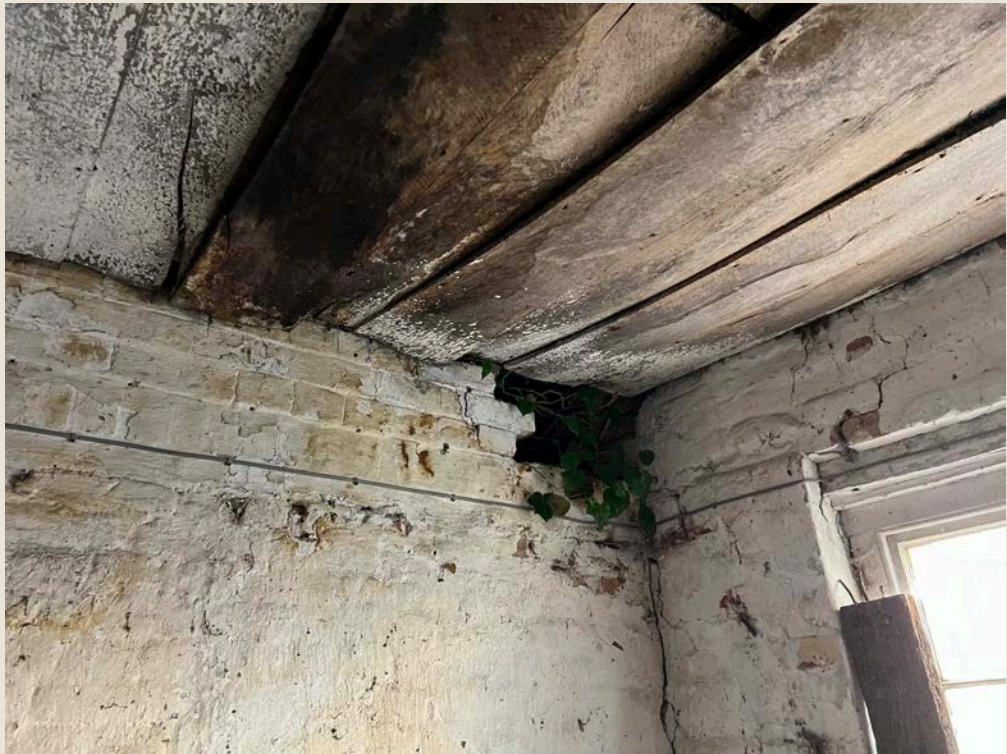
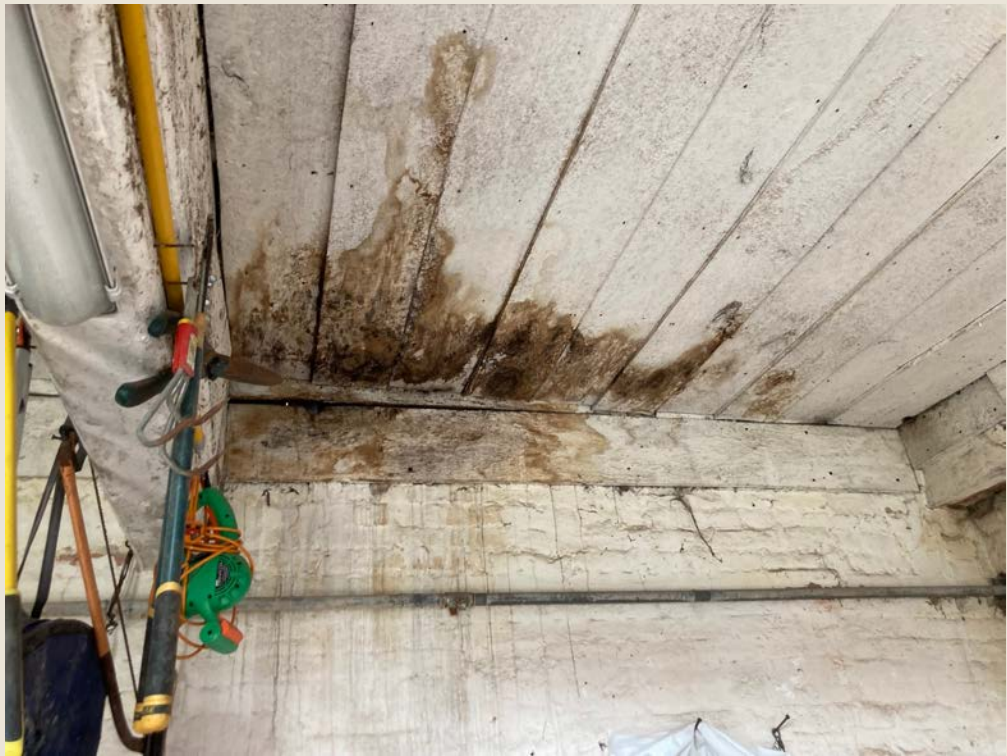
- 7.5. Roof leaks have caused damage to some of the boarding on the intermediate floor (see Figures 13 & 14), the structural timbers (other than the main beams) appear in relatively good condition from what is accessible and visible.

Figure 13: Stable 1 interior, water damage

Figure 14: Stable 1 interior, water damage

- 9.4. The existing fabric will be insulated internally, and the boarding to the Stable floor removed (this is modern sheet material in poor condition).

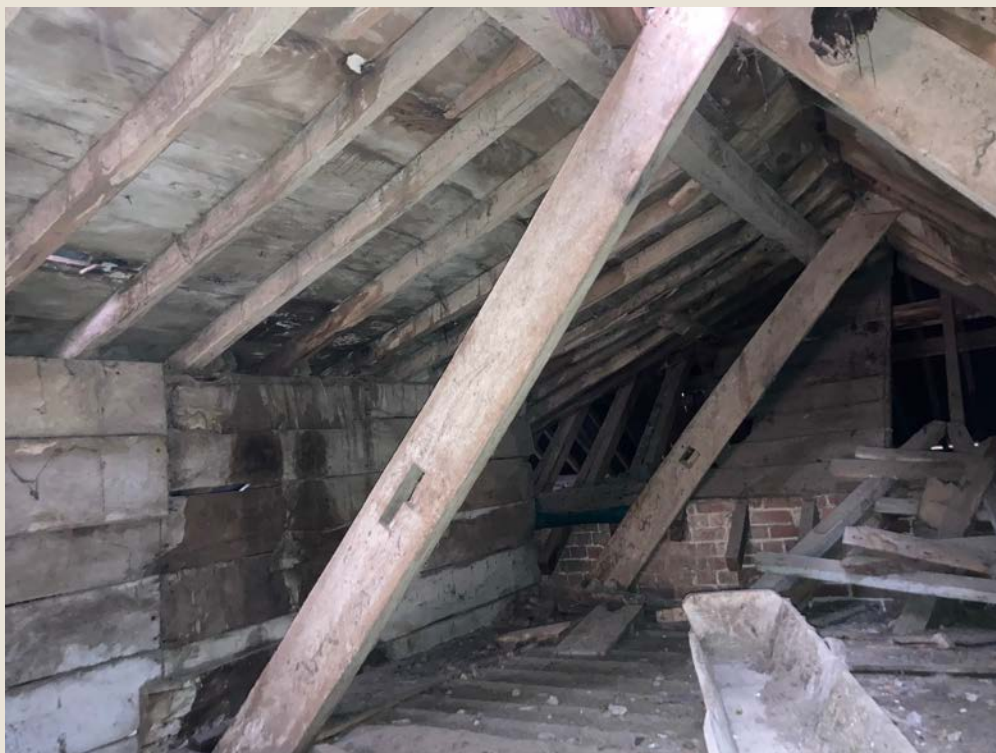
- 6.6. Unfortunately, the rafters have been removed from Stable 1 below the Tractor Shed roof (see Figure 15), as to have the purlins, weakening the trusses. Further, the additional size of the Tractor Shed roof has created additional weight bearing on the Stable roof trusses and walls below.

Figure 15: Stable 1 roof structure

- 7.4. The roof structure needs significant repair and stabilisation through the replacement of removed members and augmentation of existing failed members.

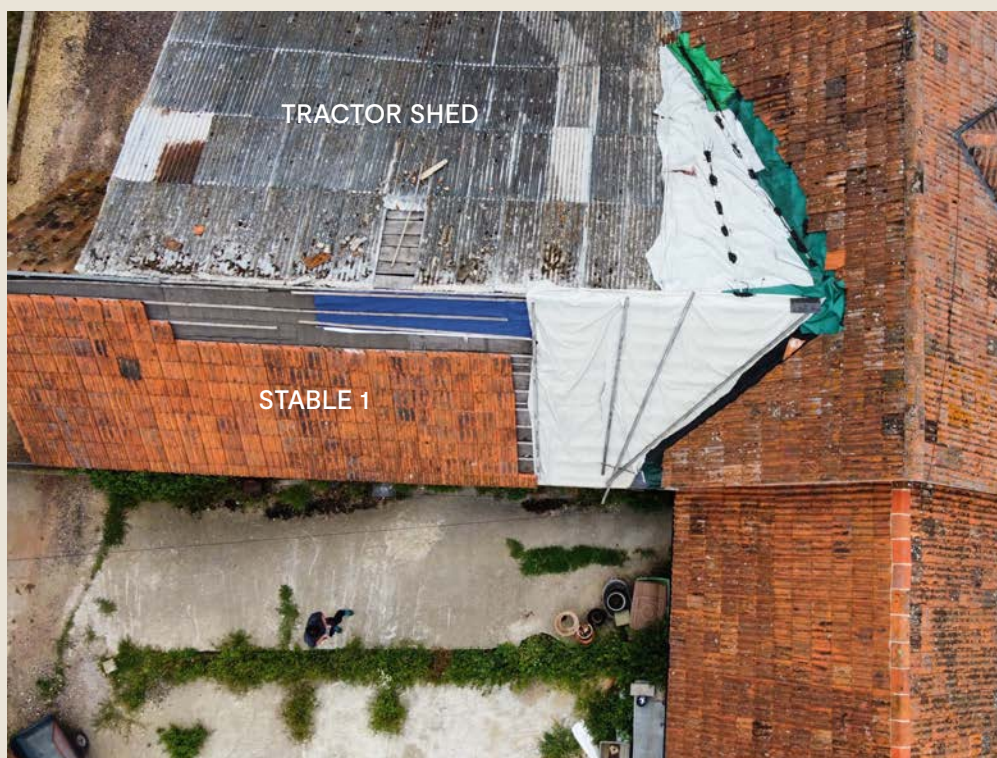
- 7.2. There are some cracks to the masonry in the north west corner that need repairing, and possibly require underpinning of the foundations.
- 7.3. The roof covering is incomplete and is currently covered with tarpaulin to prevent any further water ingress (see Figure 16).

Figure 16: Roof
