# DESIGN & ACCESS STATEMENT

## AVON HOUSE, LANGLEY PARK

JANUARY 2026

T1425 - Rev 0

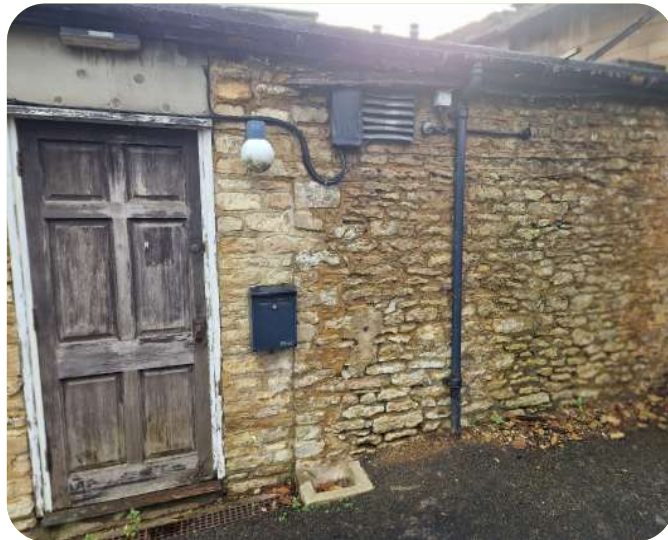
PHOTO 1

Externally, the stonework has been extensively repointed in hard cement, leading to spalling and decay. Some elevations, primarily the eastern elevation have been rendered.

NORTH ELEVATION SHOWING SATURATION AND SPALLING

Raking out of defective cement-based pointing to a depth sufficient to achieve a sound key (typically 25–30mm);

Repointing in a compatible lime mortar (likely NHL 3.5 or hot-mixed lime, to be determined following mortar analysis), matched in texture and colour to surviving historic pointing;

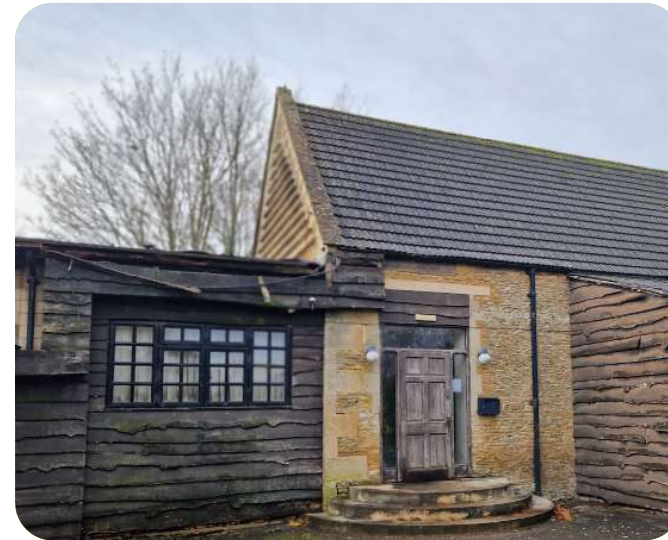
PHOTO 2

NORTH WEST ELEVATION SHOWING SINGLE STOREY LINK EXTENSION

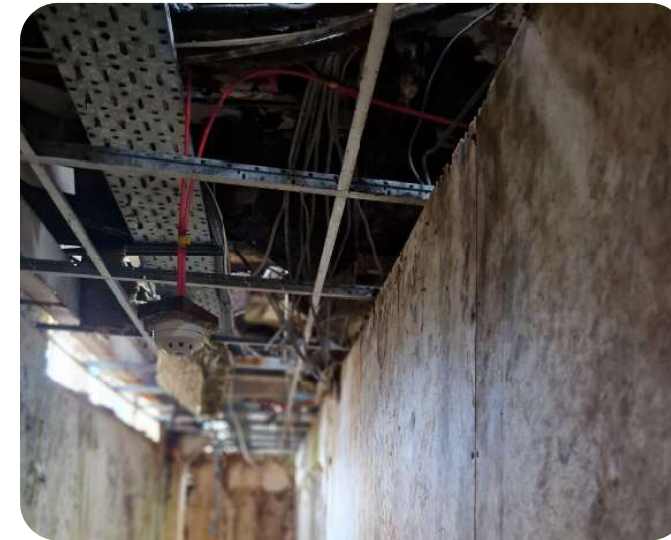
PHOTO 3

The central link extension is uninhabitable and unsafe to access as it has been subject to roof collapse and has been exposed to the elements for an extensive period of time. The floor and roof structures have visible failures and are saturated with moisture and are not accessible. The external walls have been repointed in hard cement, leading to very visible spalling and decay.

INTERNAL VIEW OF LINK EXTENSION SHOWING EXPOSURE TO ELEMENTS AND EXTENSIVE DAMP

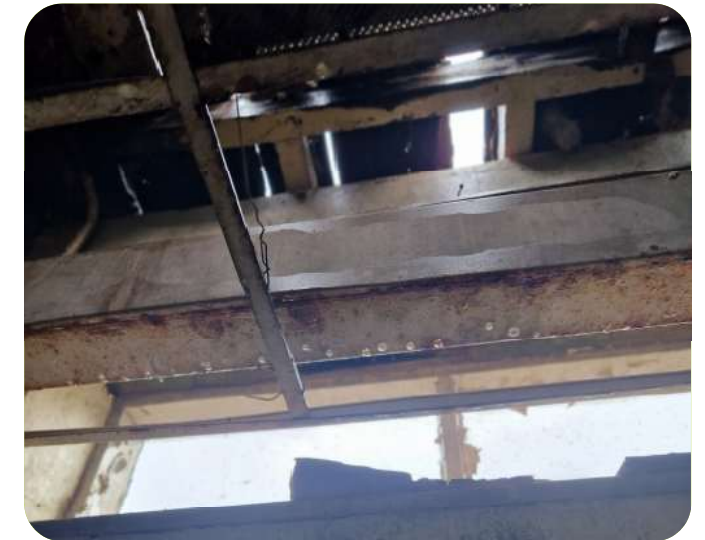
PHOTO 4

VIEW OF SINGLE STOREY LINK SHOWING ROOF COLLAPSE AND EXPOSURE TO ELEMENTS

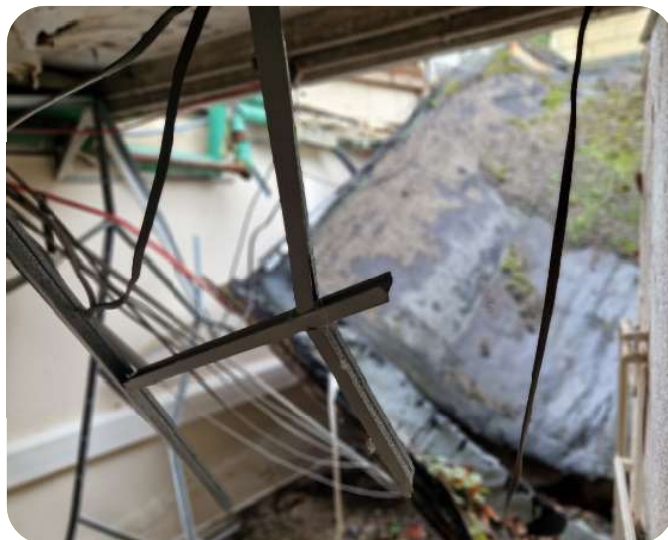
PHOTO 5

ROOF COLLAPSE TO SINGLE STOREY LINK EXTENSION

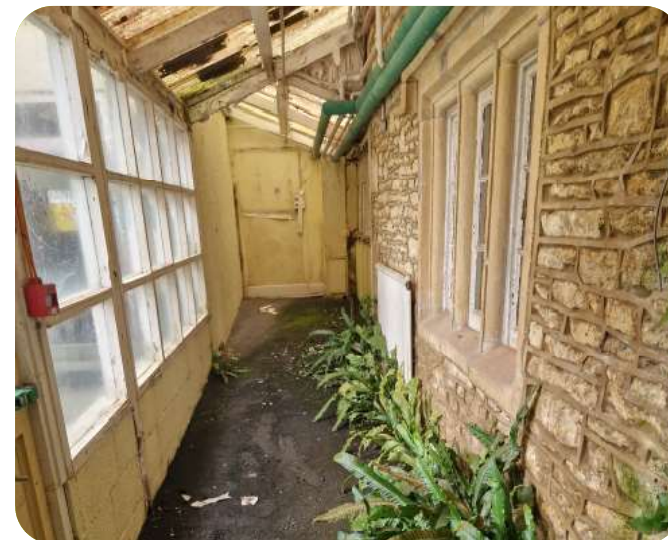
PHOTO 6

SOUTHERN LINK EXTENSION SHOWING POOR CONDITION, CONSTRUCTION AND VEGETATION GROWTH

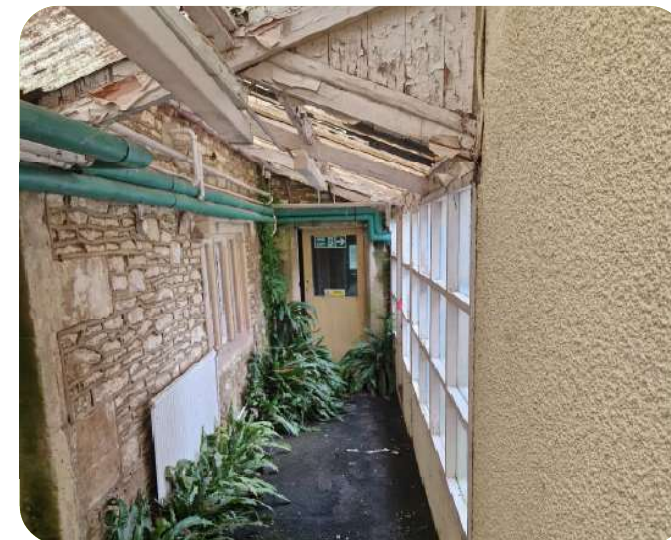
PHOTO 7

SOUTHERN LINK EXTENSION SHOWING POOR CONDITION, CONSTRUCTION AND VEGETATION GROWTH

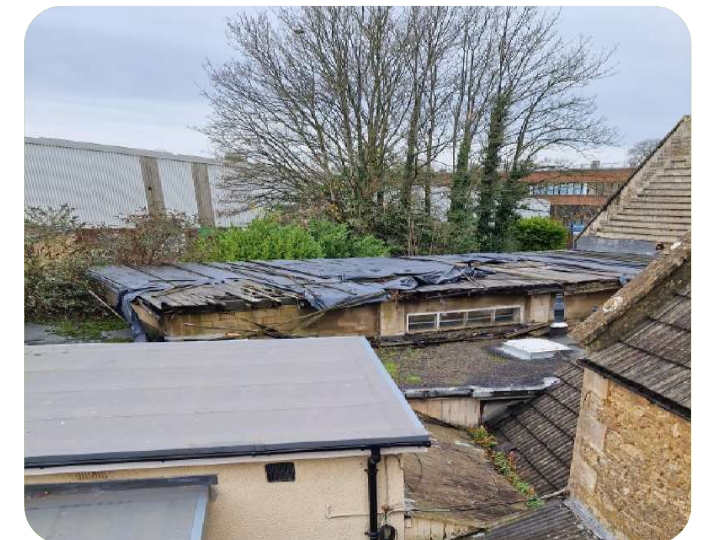
PHOTO 8

VIEW SHOWING POOR CONDITION OF ROOF TO LINK EXTENSION AND ROOF COLLAPSE

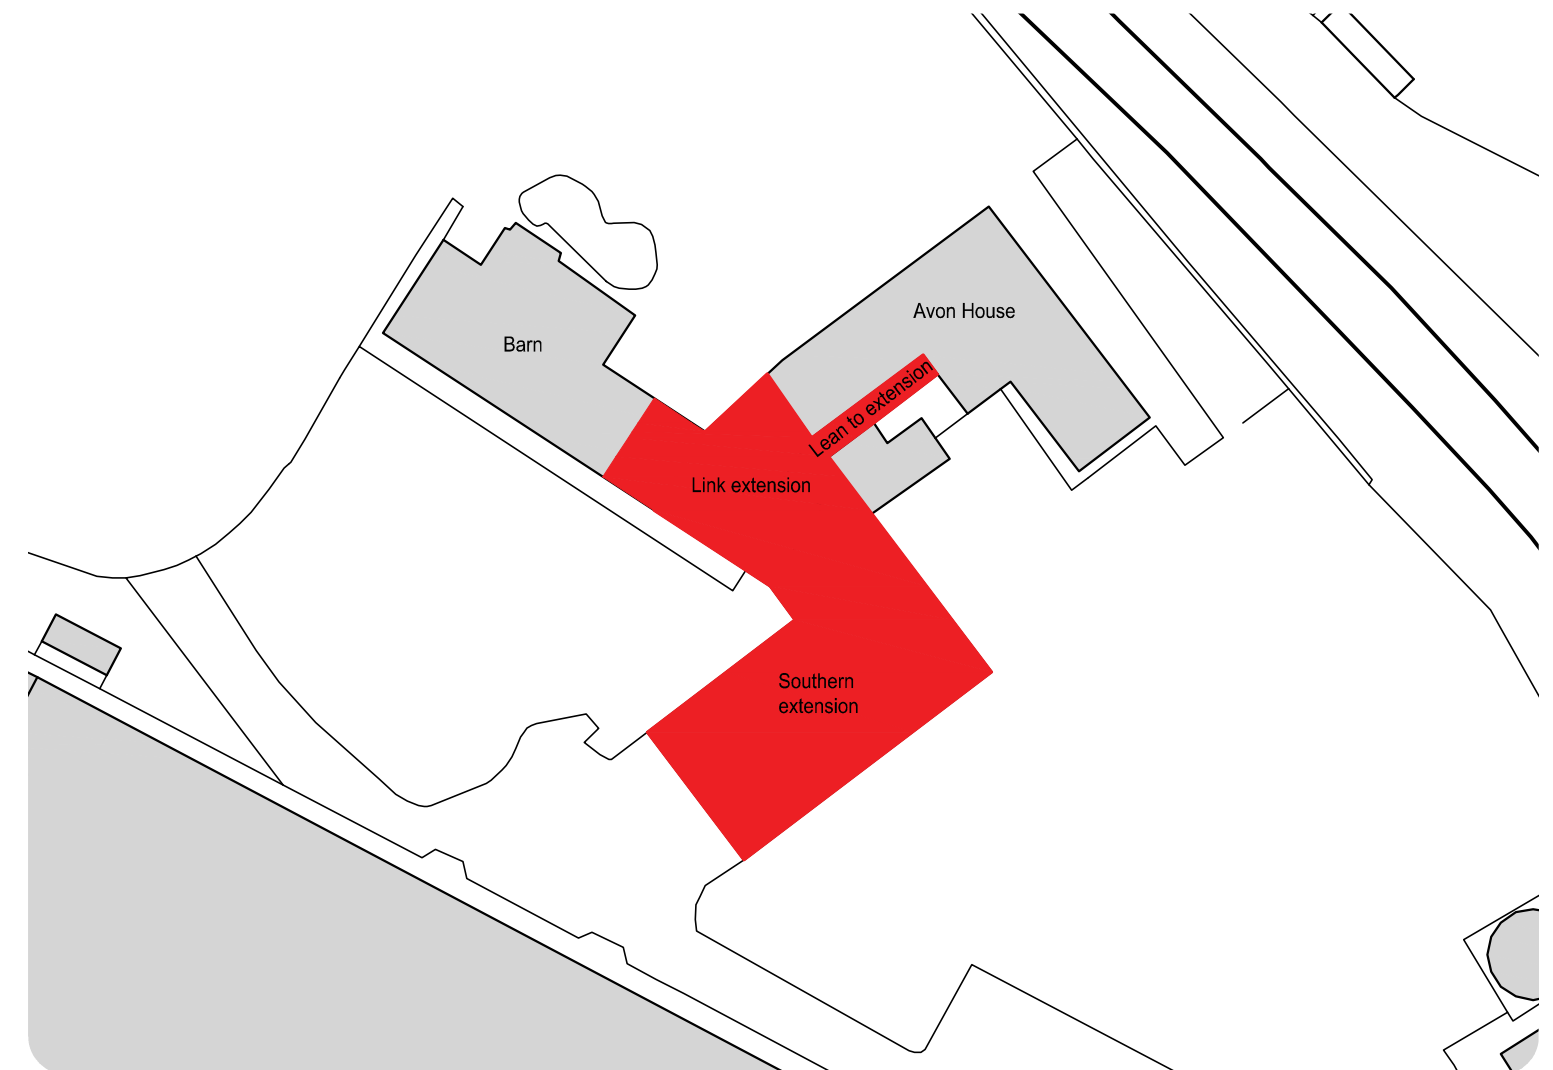
DEMOLITION PLAN

The proposed areas of demolition are unsafe and not accessible, sections of roof have collapsed and external walls are saturated with moisture and have visible mould growths internally, elements of the timber floor construction have also collapse and are unsafe to traverse.

The proposed extent of demolition is for the full extent of the later extensions, including roofs, walls, ground floor construction and foundations.

Elements of structure that abut Avon House and the Barn will be inspected prior to demolition and carefully removed to ensure there is no damage or long term impact to the structural integrity of the remaining buildings.
