**BASSET DOWN GOLF COMPLEX, HAY LANE,  
SWINDON, WILTSHIRE, SN4 9QW**

**TREE SURVEY, ARBORICULTURAL IMPACT  
ASSESSMENT & TREE CONSTRAINTS PLAN**

**PROPOSED PADEL-TENNIS COURT EXTENSION**

**Project Reference: 25.1991**

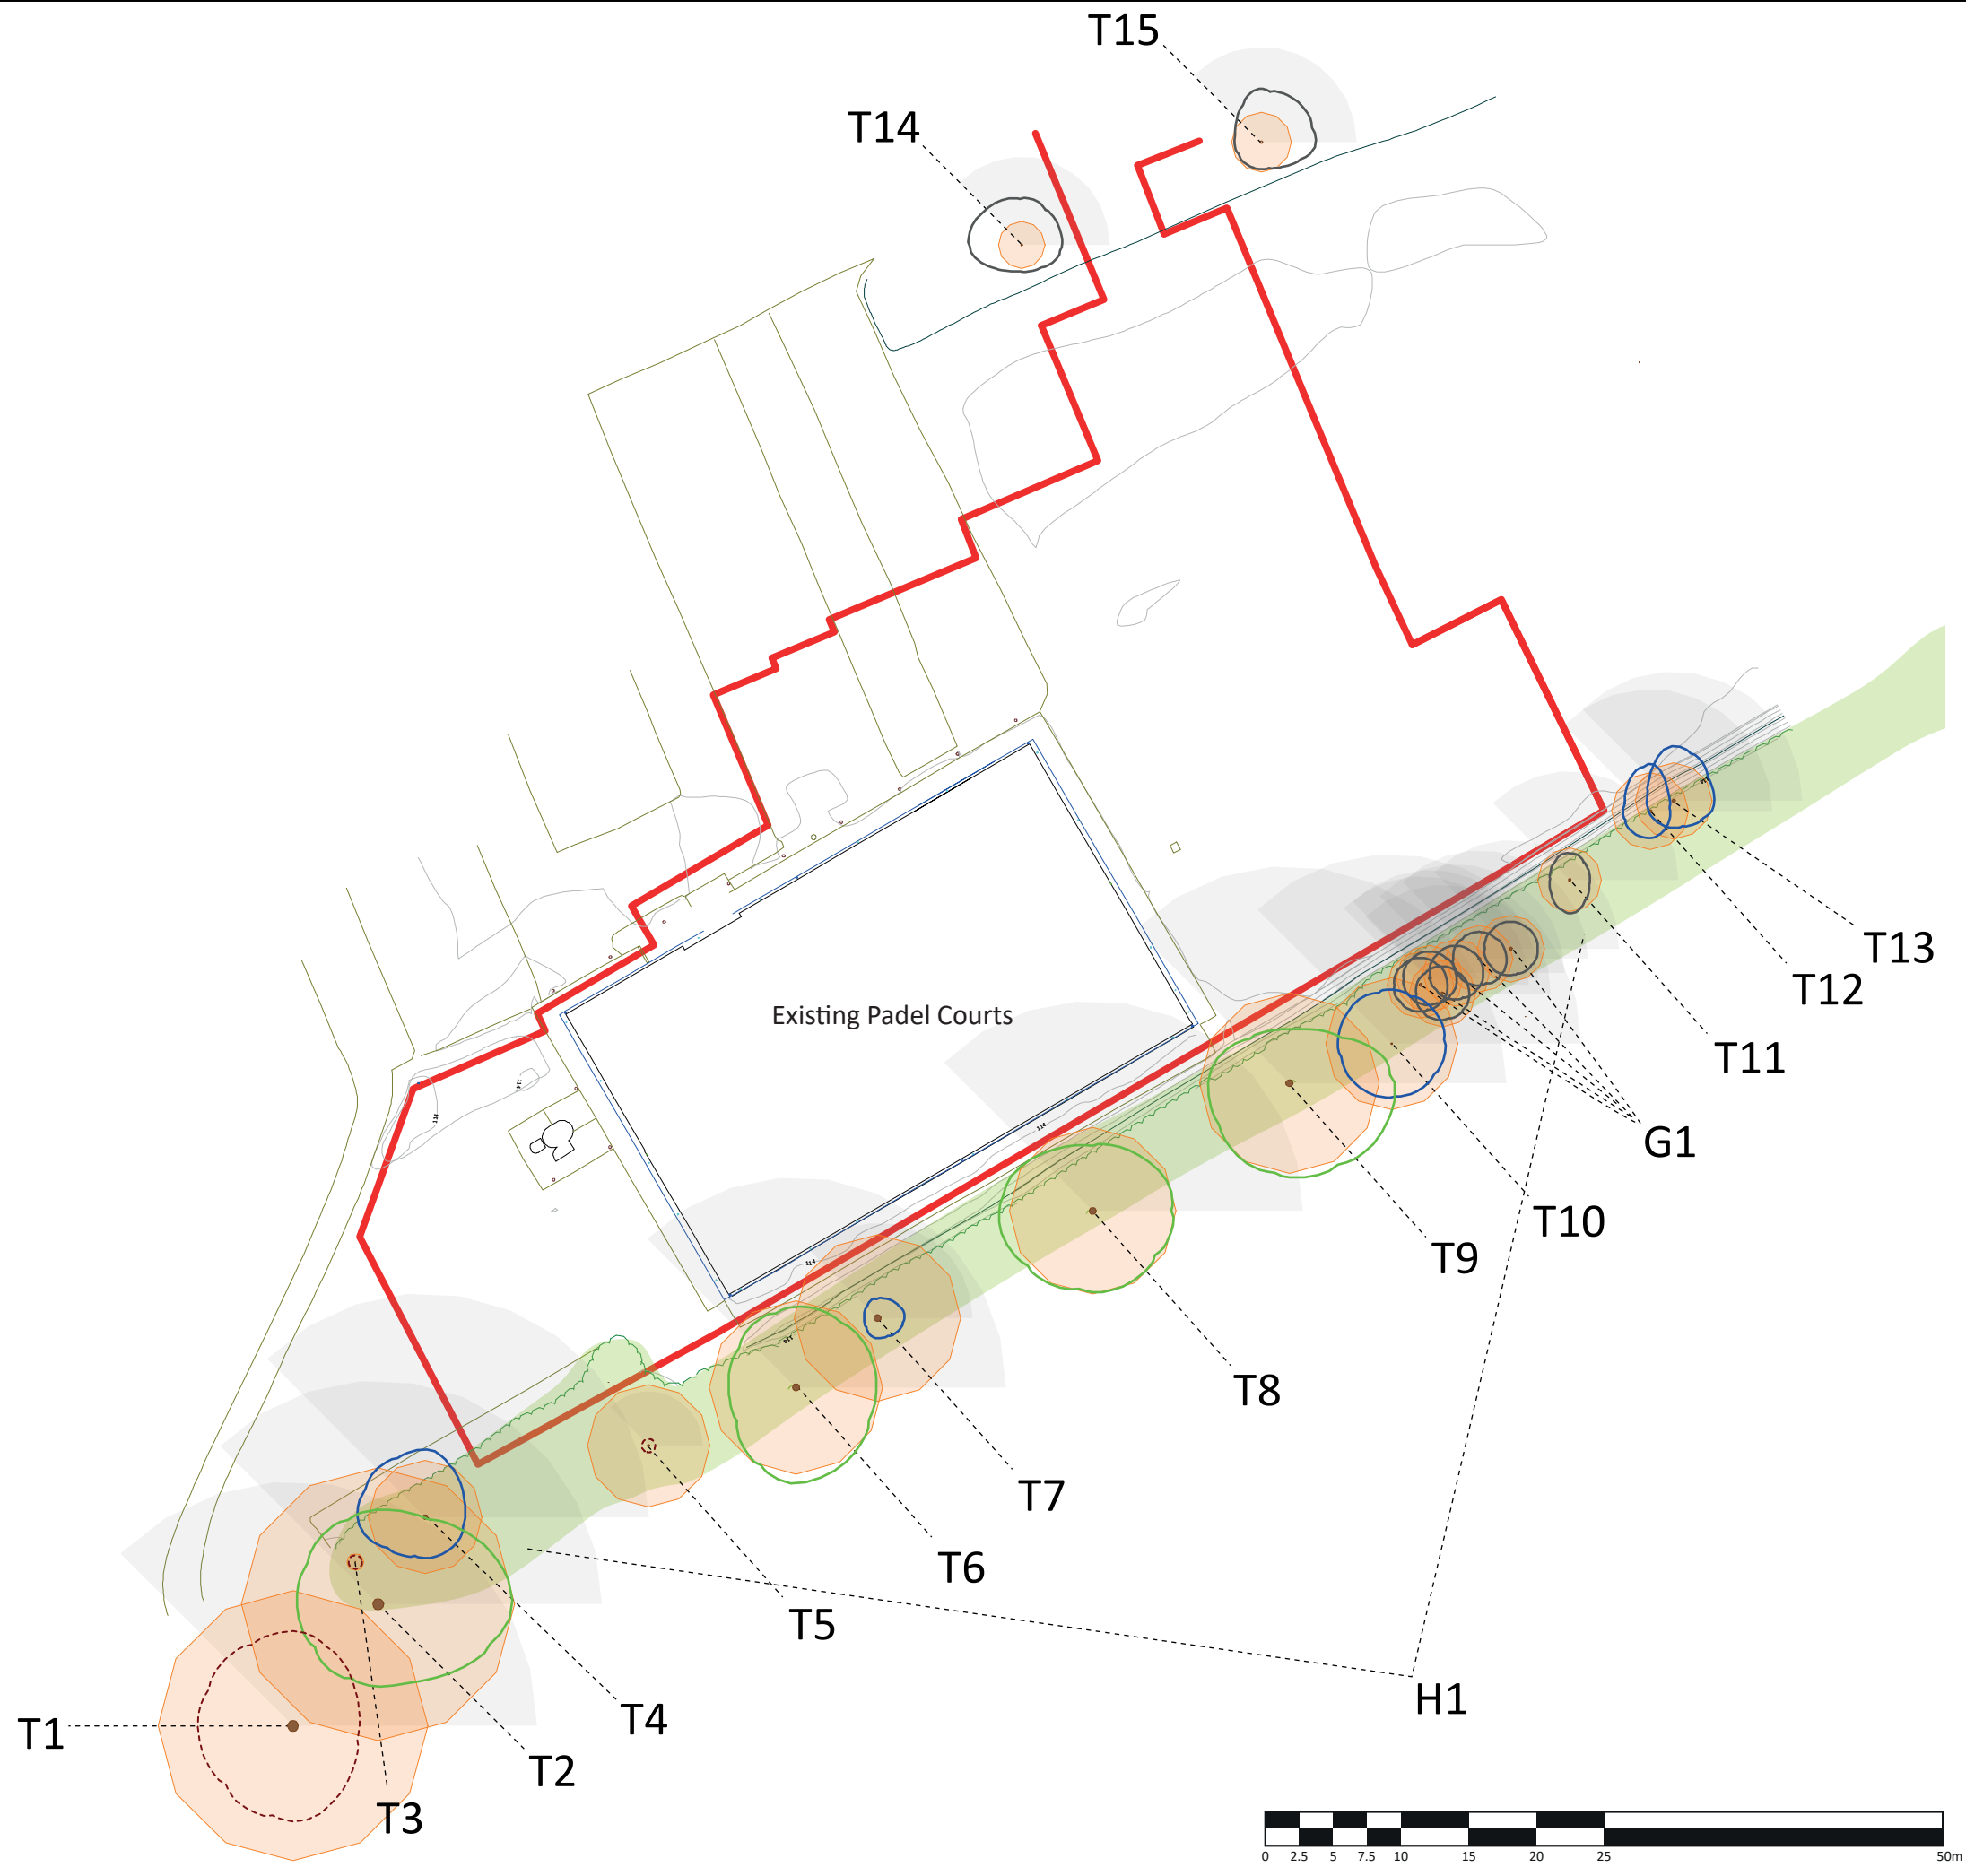
| Drawing number:<br>ARB-1991-01 | Rev:<br> | Date:<br>Jan 26 |

**5.5** There are no direct conflicts between the footprint of the proposed extension to the existing courts and any of the stem, crown spreads or RPAs of the trees and hedgerow to the south. The northern extent of the RPA of tree T9 extends close to the footprint of the extension and this, along with aspects of the other arboricultural features to the south of the existing and proposed courts remain vulnerable to inadvertent damage during the development process.

**5.7** In order to protect the sensitive features of the trees to be retained that are potentially threatened by the construction process, CEZs would need to be established protected by CEZ fencing as exemplified in Appendix 1 & 2. This will ensure that those trees to be retained, particularly their RPAs and critical root systems are not inadvertently damaged during the development process, particularly through ground compaction by the passage of vehicles or plant, inadvertent excavation or ground contamination through the mixing of materials. The proposed position of CEZ fencing is marked as a blue dashed line in the TCP at plan ARB-1991-01.
