## HERITAGE, DESIGN AND ACCESS STATEMENT

Yew Tree Farm, 20 The Street, Wilsford, Pewsey SN9 6HB

Issued for Listed Building Consent May 2025

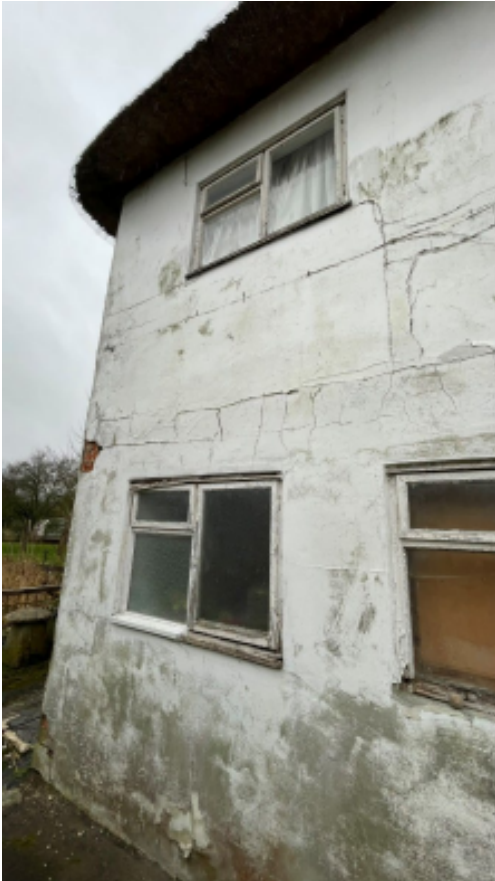
East elevation, Windows 8-10

Windows 8-10, on the east elevation are modern timber casements dating from the 1970s/80s. The proposal is to replace windows 8 and 9 with new traditional flush timber casements, and to brick up and render over 10.

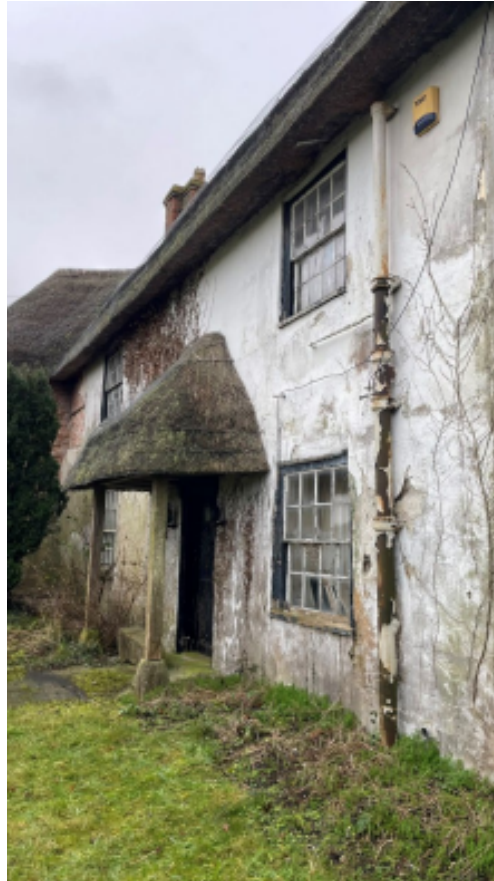
North Elevation windows 13-16

Windows 13-16, on the North Elevation of the property, are sliding sashes likely to date from the early C19. These windows are proposed for traditional repairs only.

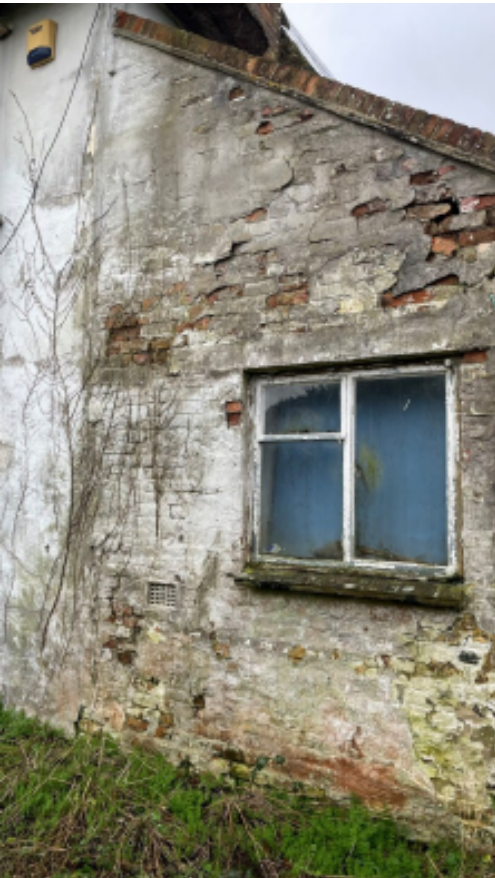
North Elevation window 17

Window 17, is a Crittall window on the north elevation single storey lean-to. It is proposed to replace this window with a traditional flush timber casement window.

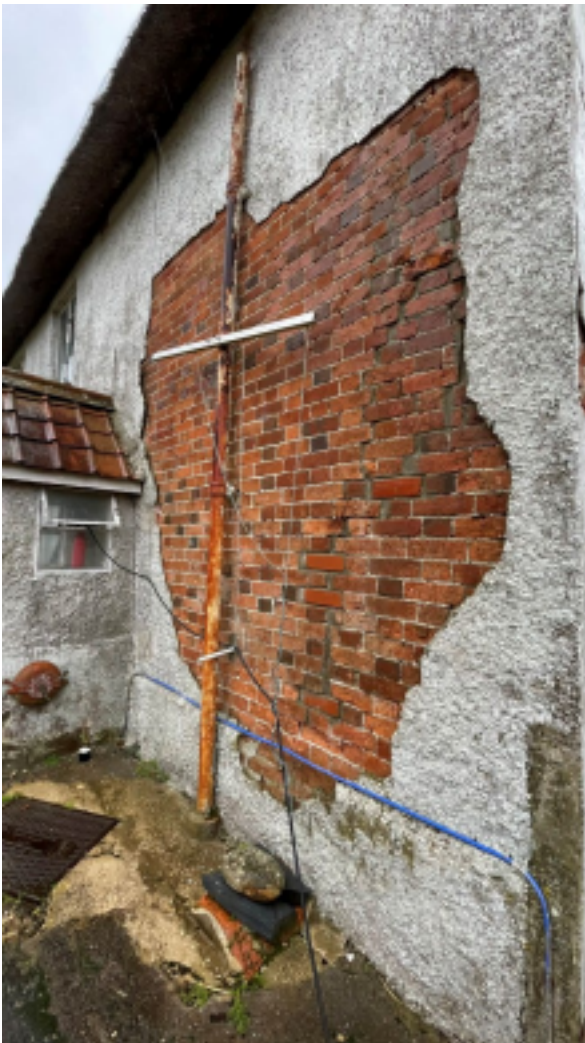
Render South Elevation

The render on the south elevation is understood to be a 20<sup>th</sup> century cement based roughcast render and is in poor condition and is detaching in large areas. It is proposed to replace this with a smooth-finished traditional lime render system which is more appropriate for the age of the building and will improve the breathability of the wall. The proposed replacement lime system consists of a haired harling coat of Seciltek Reabilita Cal CS and a top coat of un-haired Reabilita Cal RB natural hydraulic lime.

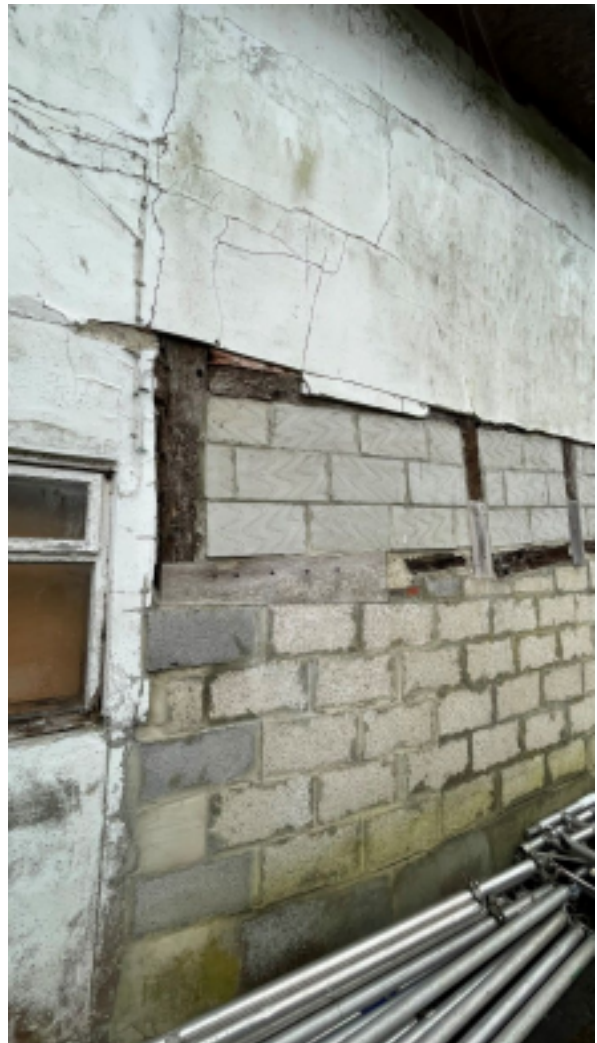
Render east elevation

The render on the east elevation requires significant repair and reinstatement over the exposed block work portion. This will be reinstated as a smooth lime render to match the retained existing lime render. The area of smooth render above the blockwork is likely to be historic lime render and possibly bonded to laths so where possible this will be repaired rather than replaced in order to avoid damage to the substrate.

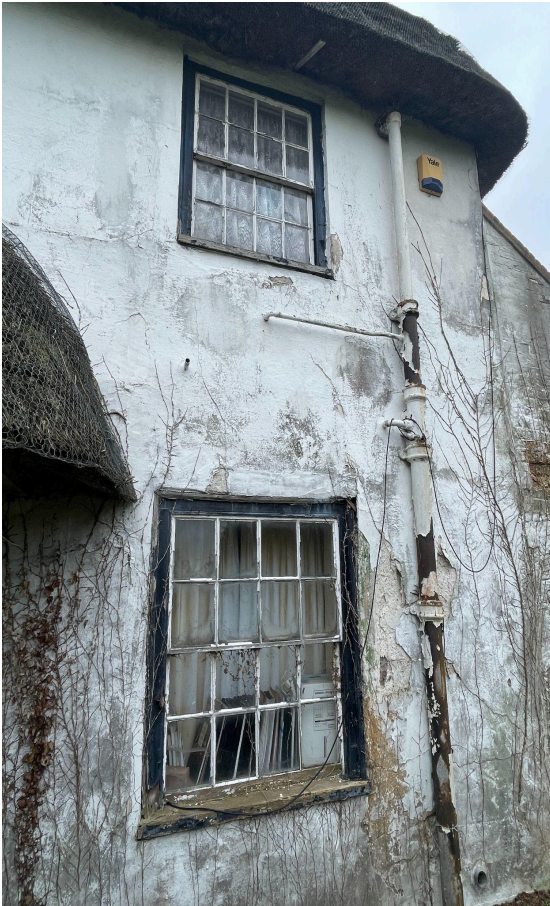
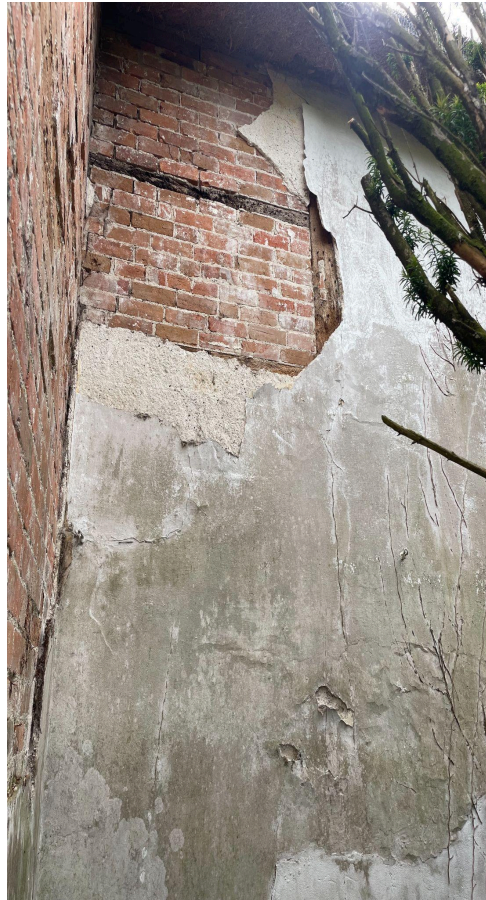
The north elevation appears to have an early C19 smooth lime render with a hard top coat which has been lined to mimic stonework. This render will be retained and repaired to match, using matching materials where possible.
