**76a Main Street, Keevil, Wiltshire, BA14 6ND**

**Tree Survey, Arboricultural Impact Assessment & Tree  
Constraints Plan**

**January 2026**

**Ref: 26.300**

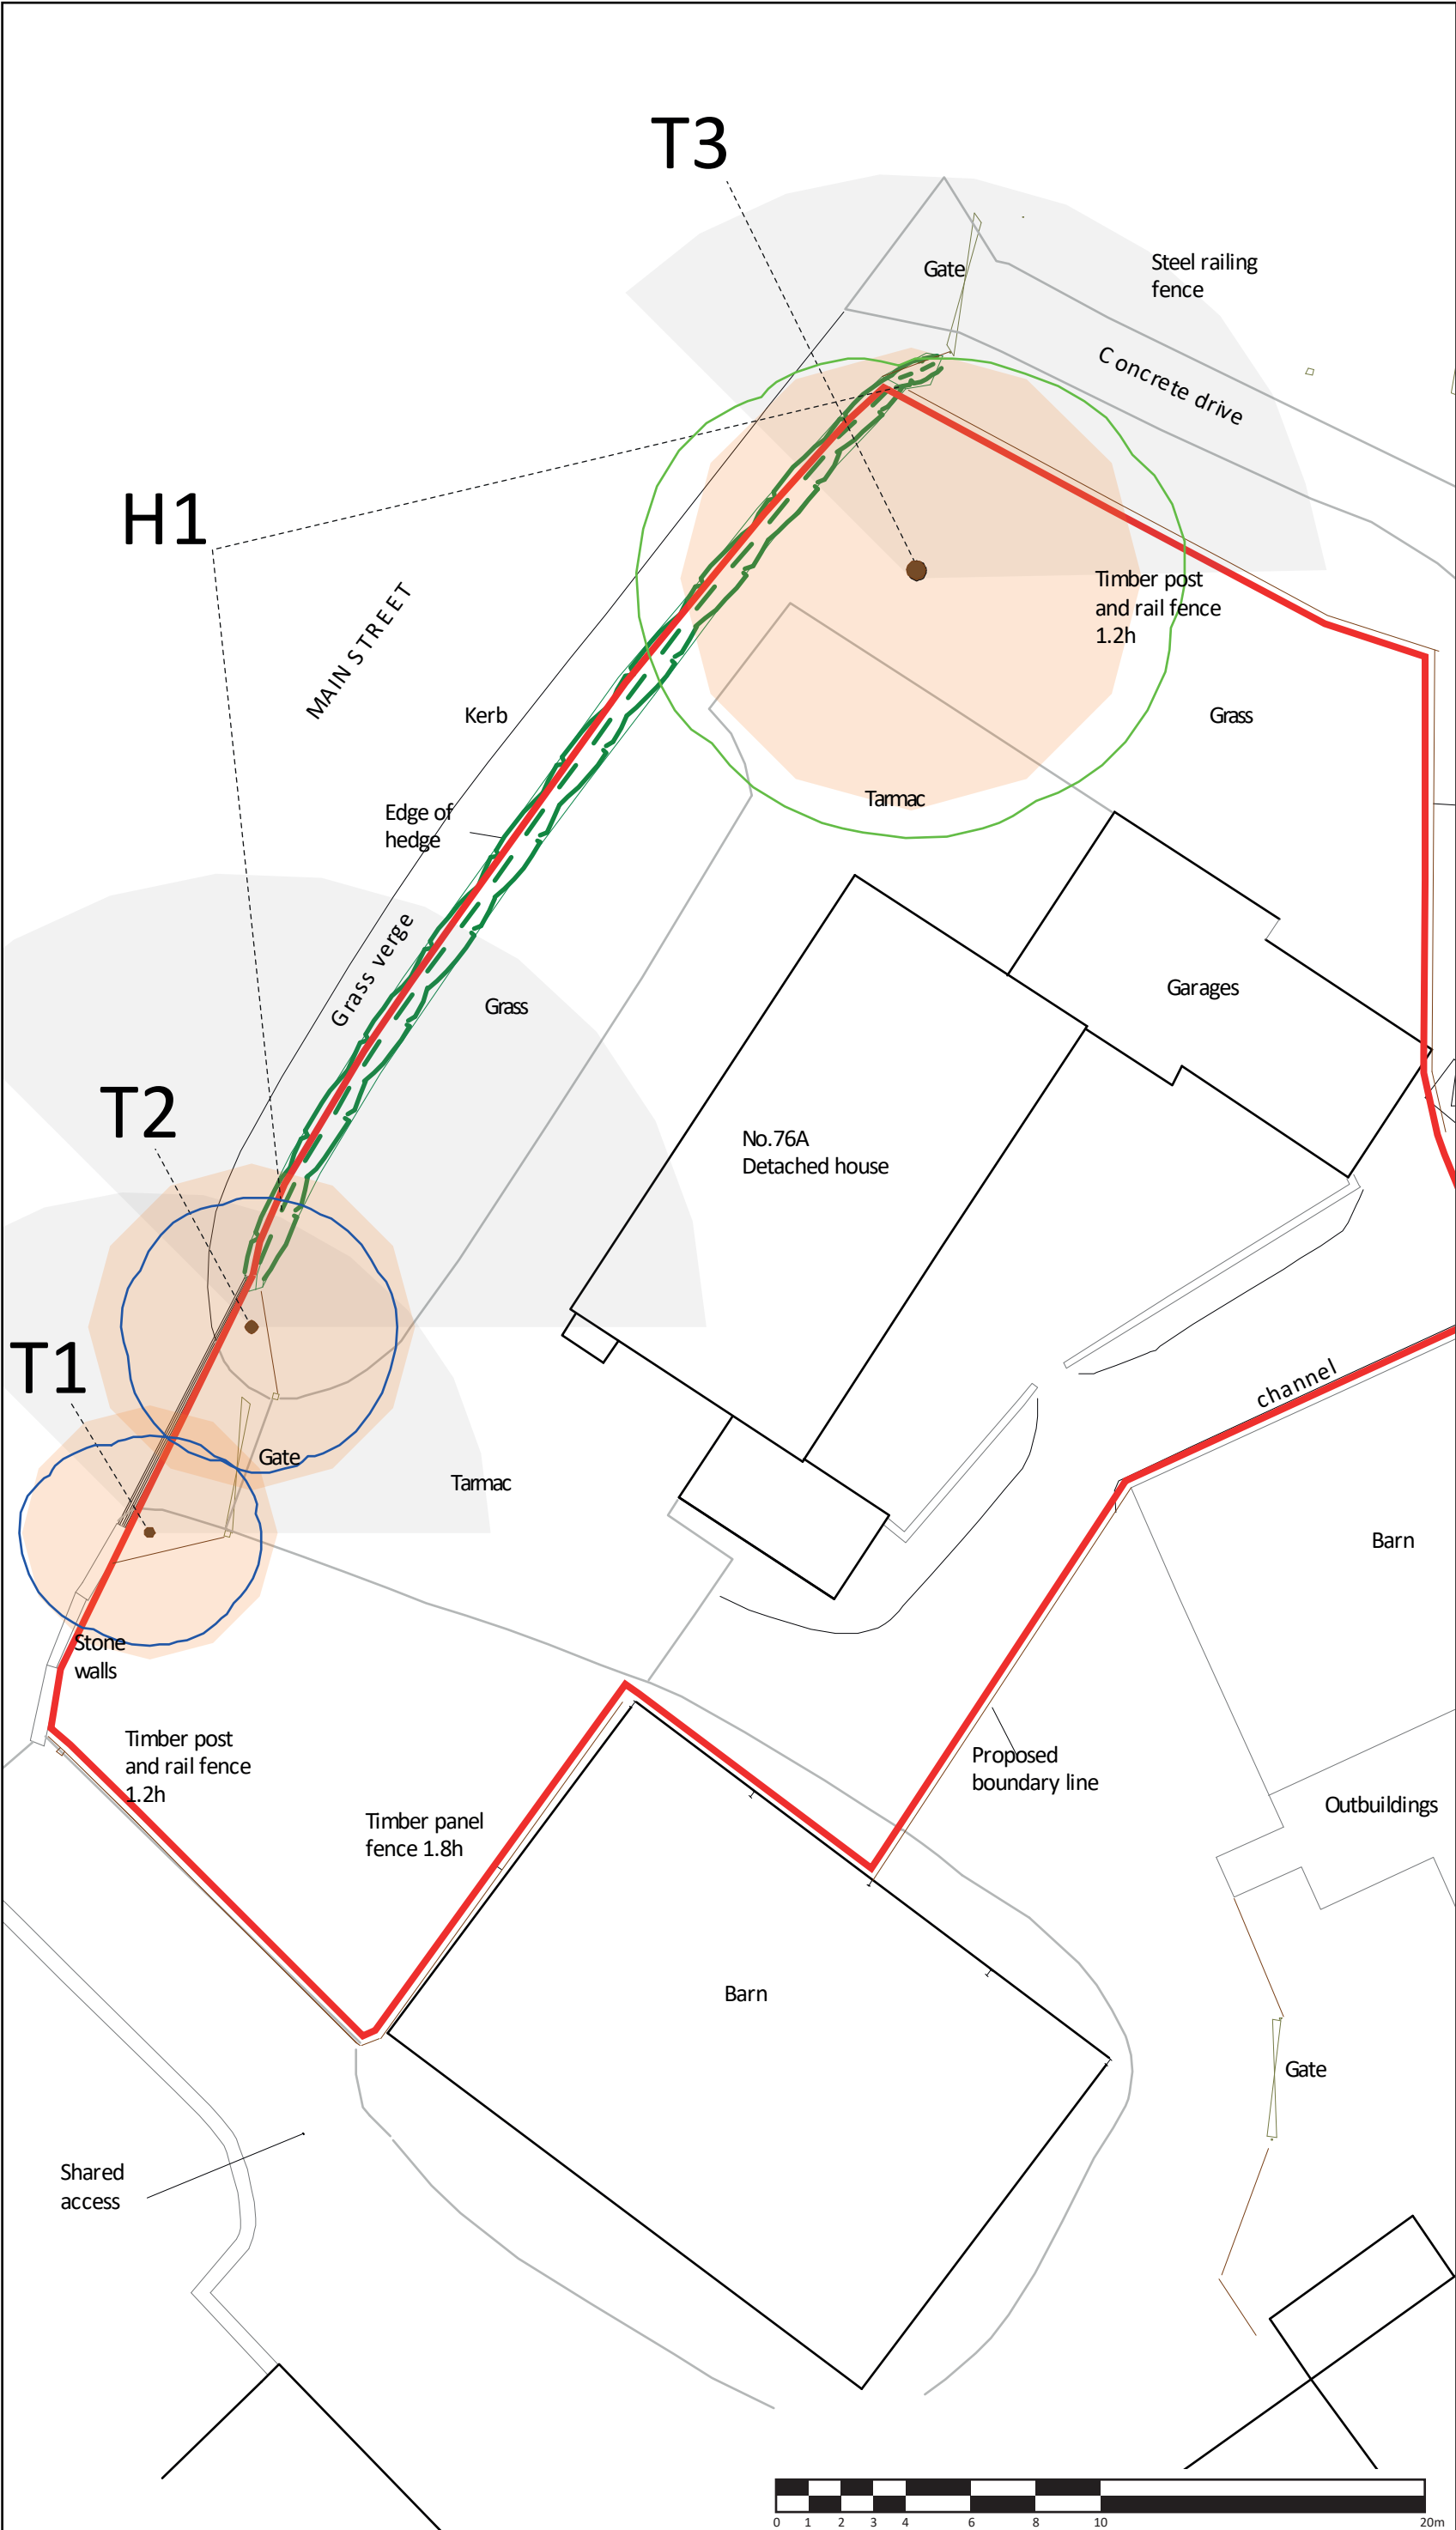
STS-300-01: TREE CONSTRAINTS PLAN (EXISTING)

**4.2** Two mature birch (T1 & T2) straddle the existing gated vehicle access from Main Street and are relatively homogenous in size and form with T2 to the north of the drive being the slightly larger specimen. Both birch show evidence of previous historic crown reduction work having been undertaken and are in good structural and physiological condition. Both are assessed as good quality B grade retention category features.

**4.3** The prominent arboricultural feature assessed is the early-mature (a tree in the second third of its life cycle) oak (T3) standing in the northern corner of the garden area to the front of the dwelling. The oak is a very good specimen of its species in good structural and physiological condition and is assessed as A grade retention category.

**4.4** The hedge (H1) running along much of the highway boundary is a relatively newly planted feature that appears to have established well and is assessed as B grade retention category.

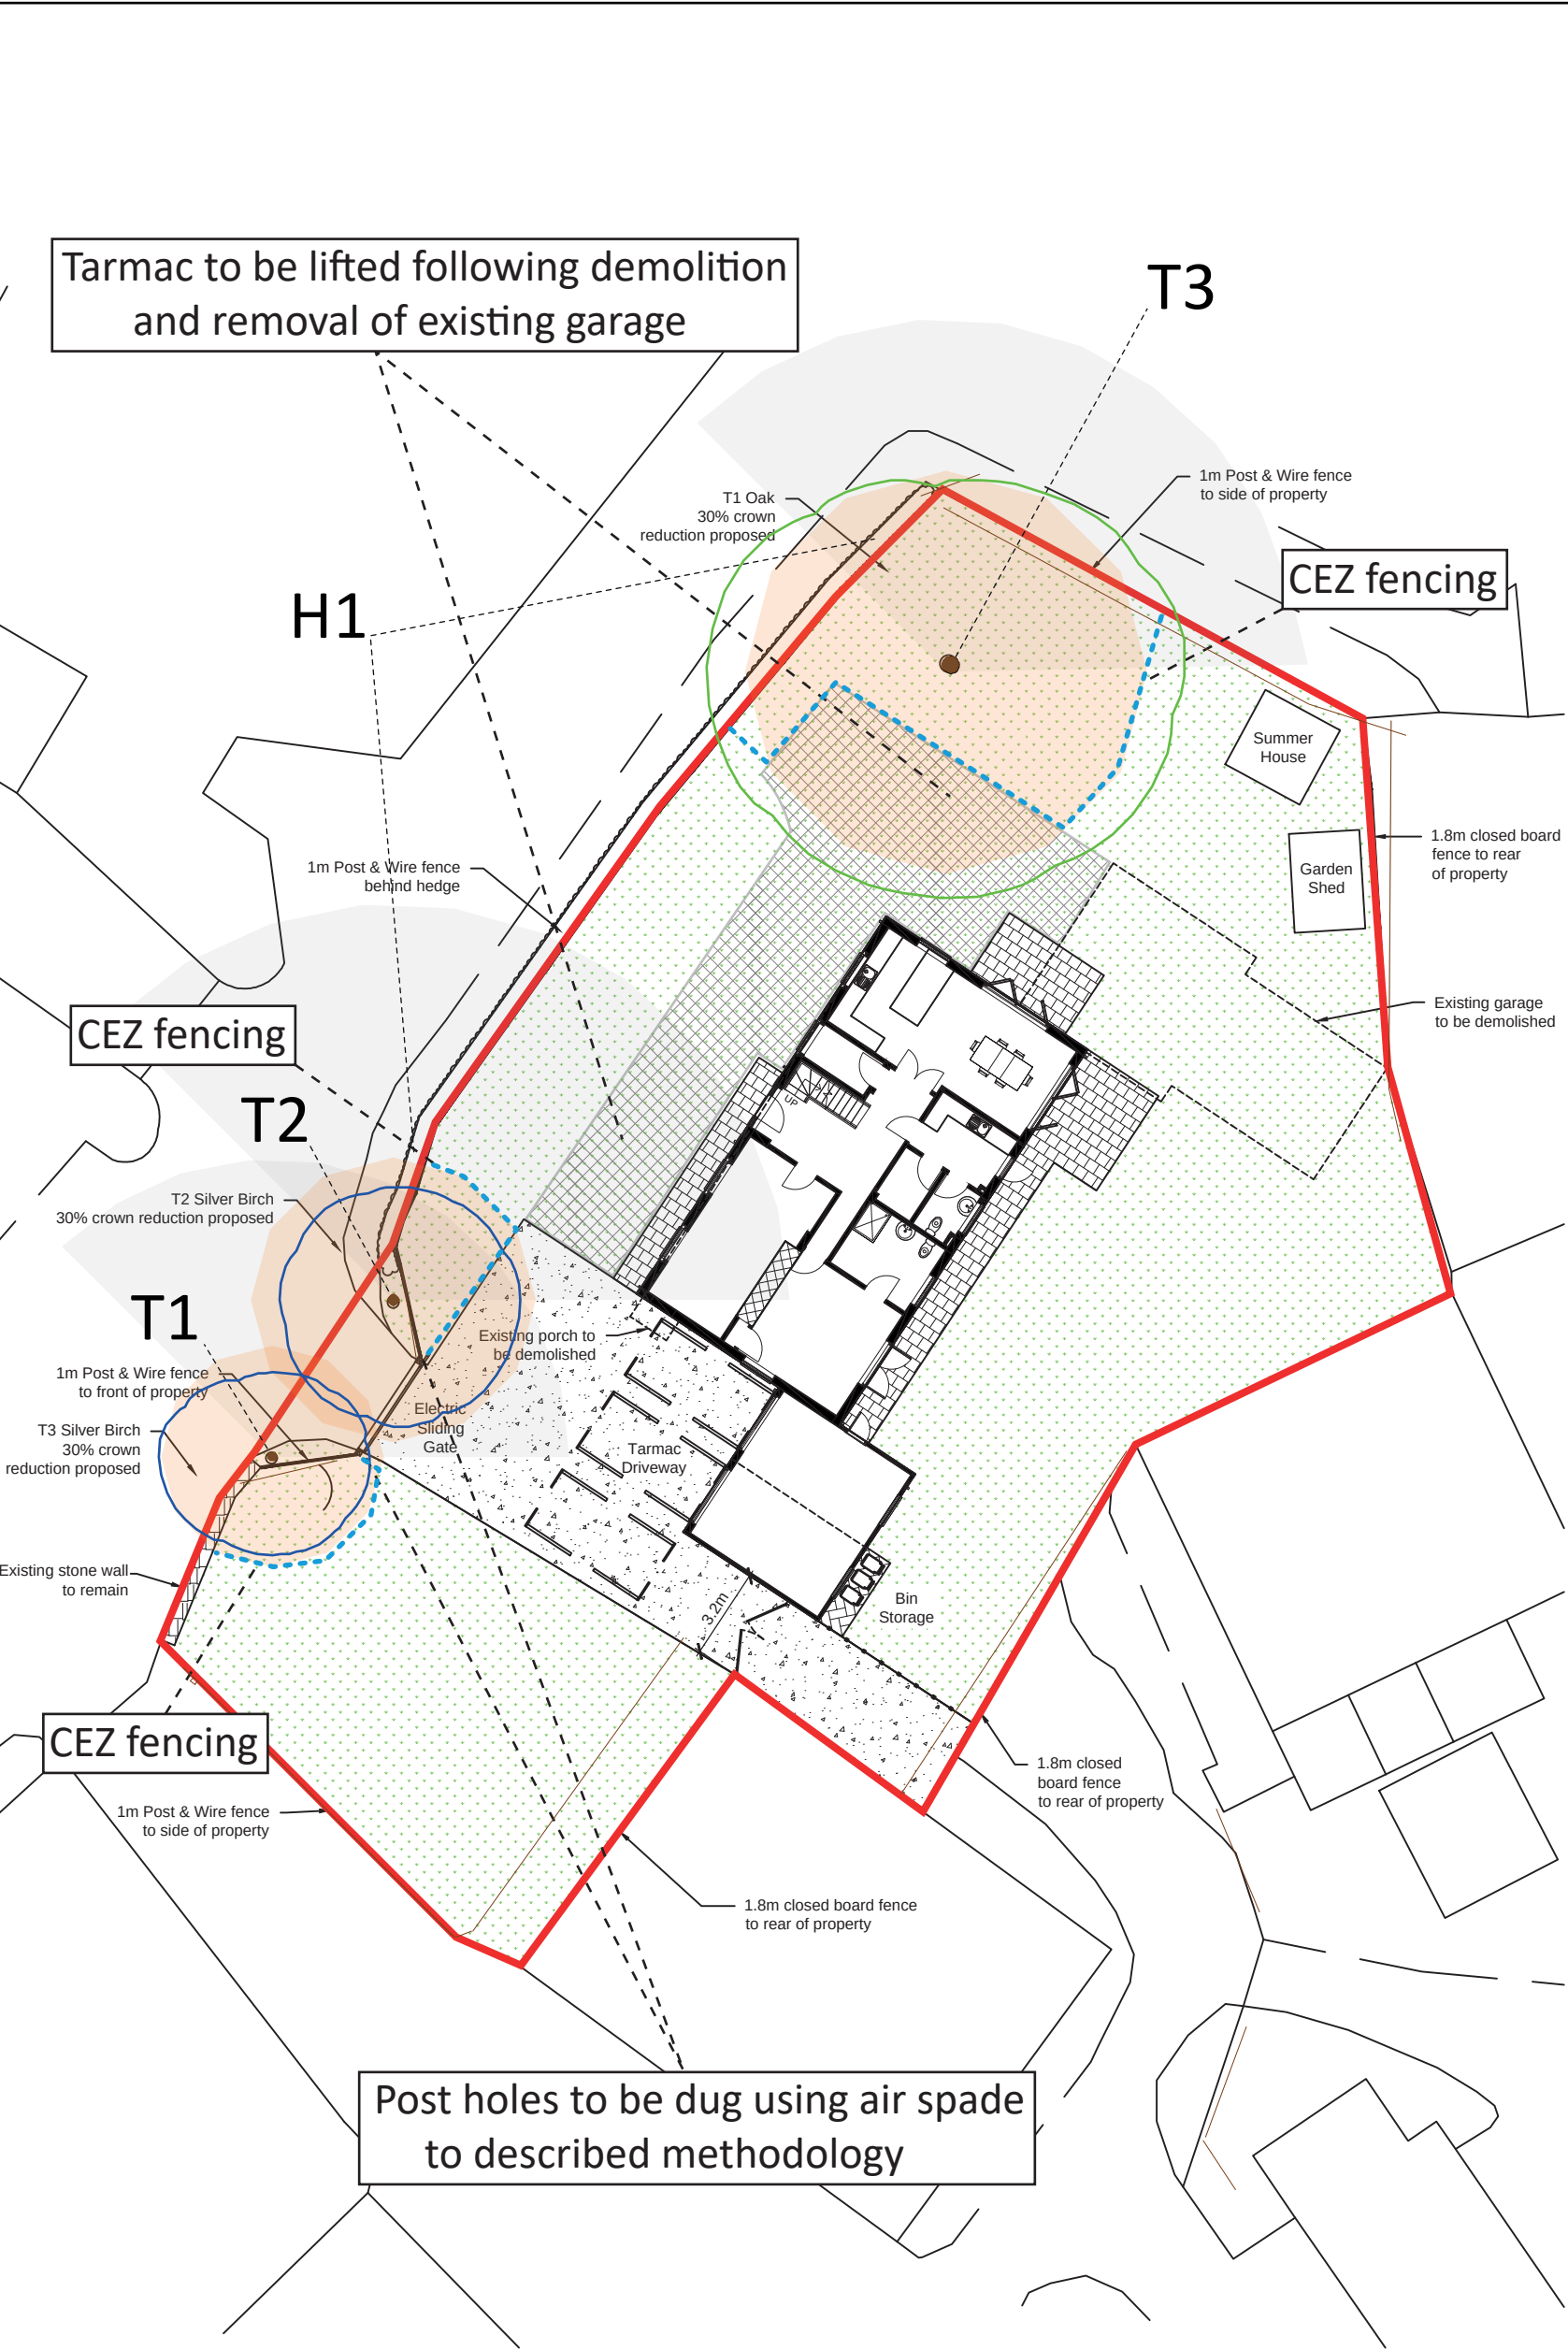
STS-300-01: TREE CONSTRAINTS PLAN (PROPOSED)

- The post holes for the upright supporting pillars of the proposed replacement gate are to be inset from the locations of the upright posts for the existing gateway and will be positioned within the RPAs of the birch trees T1 and T2. Therefore, there is the potential for root damage to occur during the excavation of pits for the uprights and their establishment.

- Part of the existing driveway is to be lifted, removed and replaced with grass stands within the RPA of the oak T3. There is the potential for root damage to be inflicted on the critical roots of the tree during this process or after the tarmac has been lifted. Damage could occur if the area below removed tarmac is subject to the movement of vehicles or plant during the remaining development process
- The proximity of the oak (T3) to the garage to be demolished presents a threat that the areas of its RPA within vegetated ground could be subject to inadvertent damage via ground compaction resulting from the passage of vehicles or plant during the demolition process.

**6.4** The principal threat posed by the scheme to the trees assessed will be for root damage to be inflicted to the root systems of the two birch (T1 & T2) during the excavation of the post holes for the upright supporting sections of the automatic sliding gate. Some minor root damage is likely to be inflicted during the excavation process, but if the methodology described in Para. 5.3 is correctly followed, the damage inflicted should be minimum, localised and will not result in any significant or noticeable decline in either tree. Therefore, the negative arboricultural impacts of this aspect of the scheme are assessed as low.

**5.3** The primary conflict between the scheme lies between the proposed excavation of 2x post holes to set the upright sections of the new automatic sliding gate within the RPAs of the two birch trees (T1 & T2). In order to reduce the potential for direct damage during the insertion of upright posts to support the gate, a methodology to hand dig the locations of the upright posts prior to their insertion must be followed. This is in order to avoid damage to roots found that are over 25mm in diameter which could have negative structural or physiological implications for either tree affected. This process is advised be undertaken using a compressed air spade to limit the potential inadvertent damage to significant roots within the pit locations. Any roots under 25mm in diameter could be cut back to the face of the test pit with secateurs. The design and precise location of the supporting posts and therefore the location of the gate as a whole would require the capacity to be marginally relocated if roots over 25mm in diameter are found during the excavation process and those post holes are relocated to avoid such roots. Pits would need to be excavated to a depth of 60cm below the existing ground level using the air spade, beyond which significant roots are very unlikely to be found. If posts are to be set in concrete an impermeable plastic membrane would need to line the edges of the holes to prevent concrete leaching into the surrounding ground and burning the adjacent tree root systems. This process would ideally be undertaken under arboricultural supervision.

**5.5** Tarmac to be removed within the RPA of the oak (T3) must be lifted and removed from site to a methodology that minimises potential damage to the root system of the oak below. Ideally tarmac will be lifted by hand or if machinery is employed it must work backwards away from the stem of the oak as it lifts the tarmac, remaining on tarmacked areas. Vehicles or plant must not travel over the ground within the RPA of the oak once it is lifted and new soil must be reinstated within the newly exposed ground within the RPA of T3 immediately after tarmac is lifted to avoid desiccation of any exposed roots.

**5.6** In order to protect the trees to be retained adjacent to the areas to be developed, Construction Exclusion Zones (CEZ) will need to be established, protected by CEZ fencing as exemplified in Appendices 1 & 2. This is intended to exclude all construction activity from the sensitive areas of those trees during the development process, particularly vegetated ground within their RPAs that are vulnerable to inadvertent damage during development. The proposed position of CEZ fencing is shown as a blue dashed line in the TCP provided at plan STS-300-02 and would have to be installed prior to any other construction activity commencing on site and remain in situ throughout the remainder of the development process.
