PROJECT: Bulford Manor Wall  
SHEET: Flint and Brickwork Front Elevation

DRAWING NO: V1013 - PRA - ZZ - XX - DR - A - 30011  
SCALE: NTS @A3

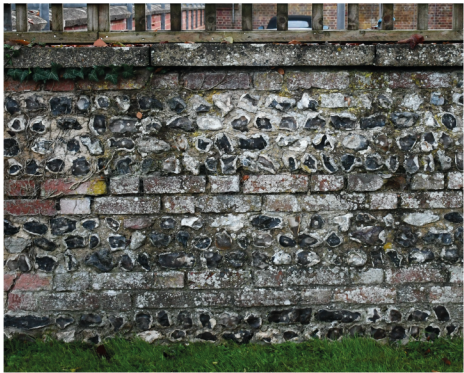
①  
Flint knapped and coursed, with one course of brick below the coping. Two bands of brick, each of two courses with alternating headers and stretchers, roughly dividing the wall into thirds.

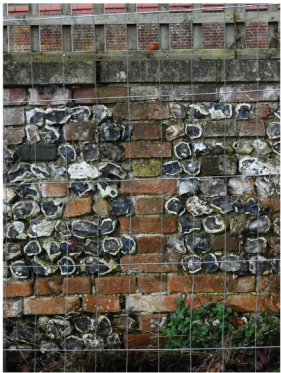
④  
The middle band of brick ends before an area of brick repair, vertically alternating between stretchers and headers, and interrupting the flintwork.

**Note:**  
Flintwork to be carried out by a suitably experienced flint worker.

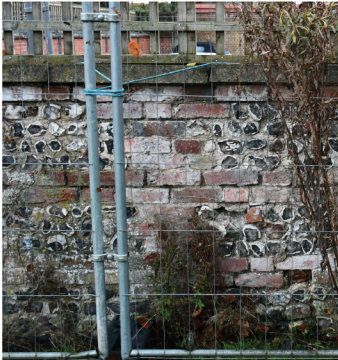
②  
An area of brick repair interrupting the flintwork, slightly slanted.

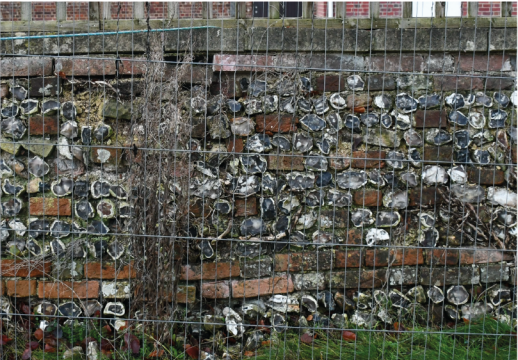
⑤  
The lower band of brick continues here. Above, a pattern of brick and coursed flint, in a bungaroosh style. One course of brick below stone coping.

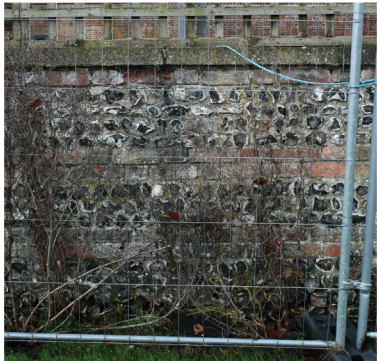
③  
See area 1.

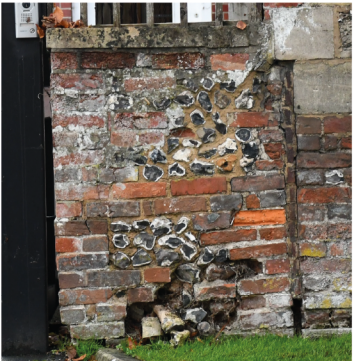
⑥  
Either side of the gateposts, brick quoins and coursed knapped flint. Next to the house, a band of brick in two courses centrally.
