## DESIGN, ACCESS AND HERITAGE STATEMENT

### Retrospective Listed Building & Planning Application

Penleigh Farmhouse, Penleigh

Atelier 17 Ltd

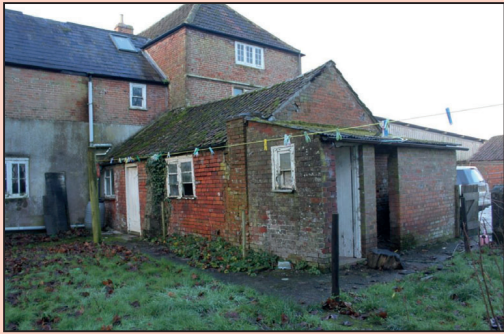
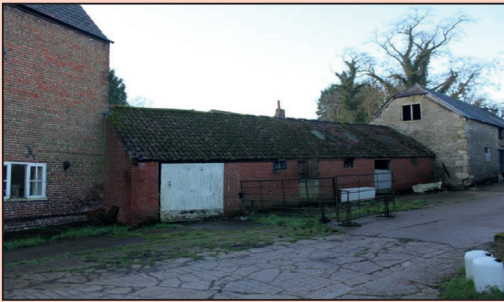
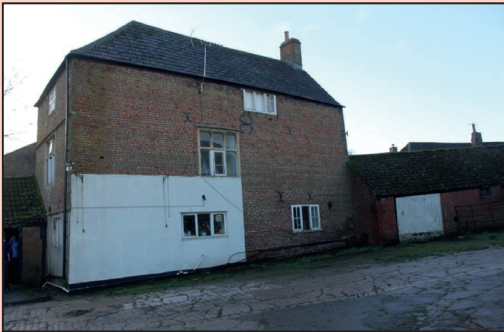
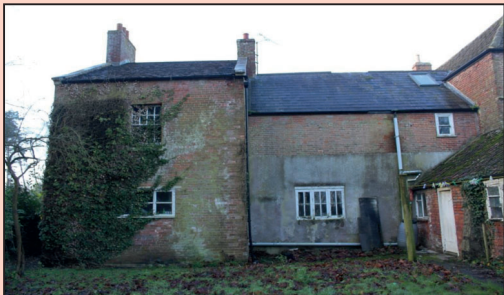
At the time, the Agent in their supporting documentation described the building as ‘although generally structurally sound the house has not been maintained as ideally would have been the case for many years and is now in a tired state of repair and in need of works to safeguard its longevity and bring it to a condition where it can be lived in in comfort’.

Images to the right taken from the Design & Access Statement and Architectural Justification Statement prepared by the Agent show the general condition of the building at this time.

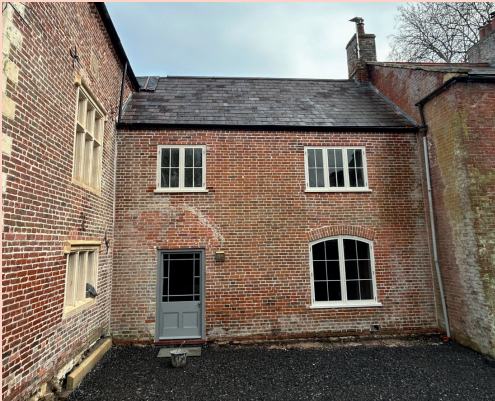
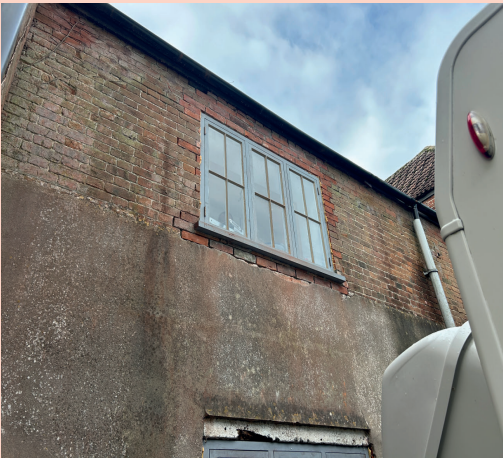
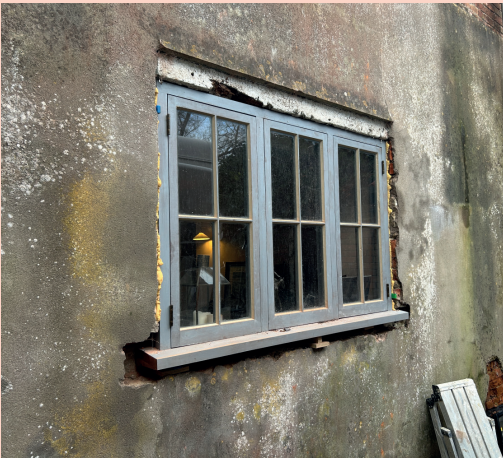
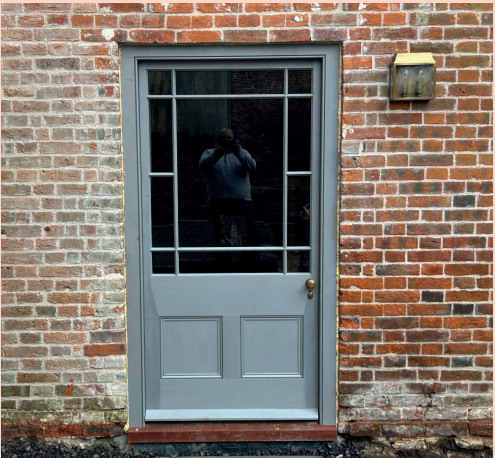
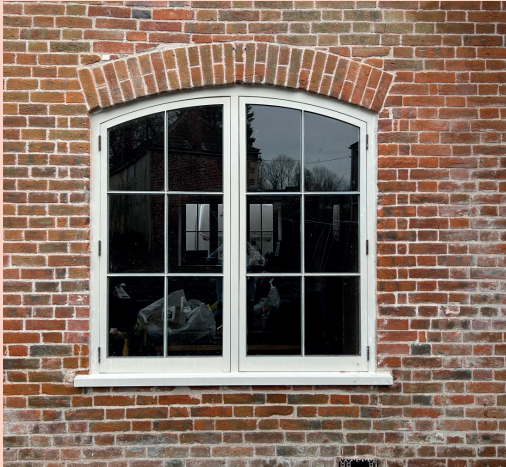
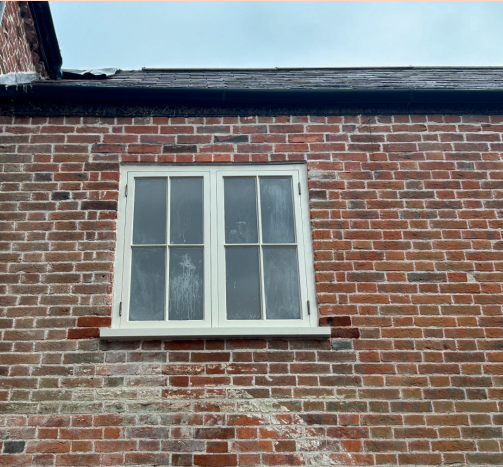
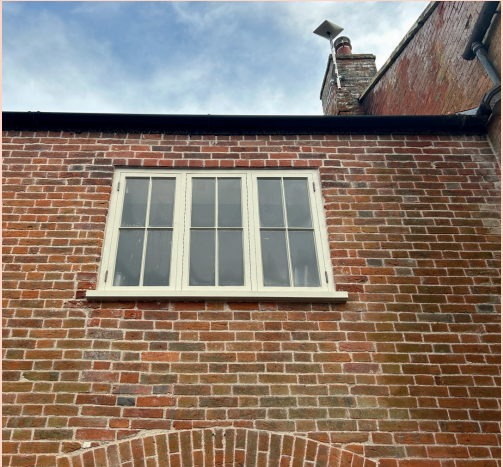
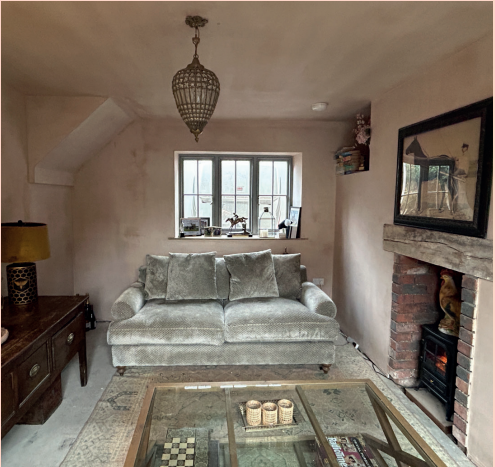
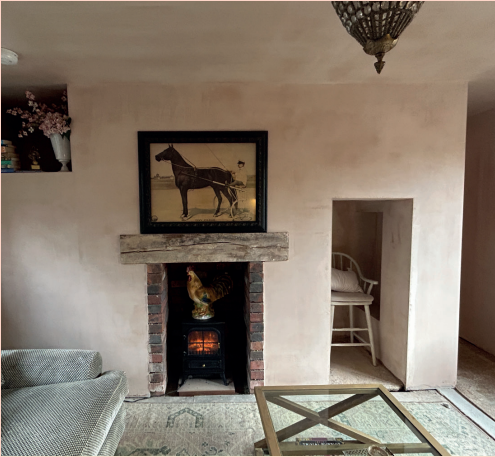
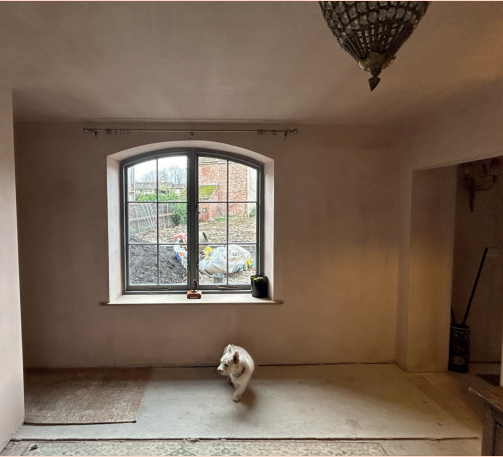
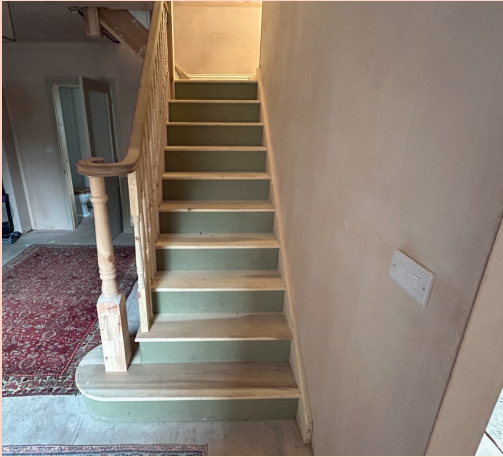
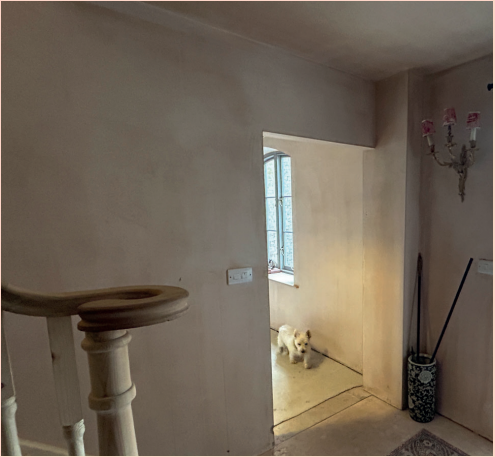
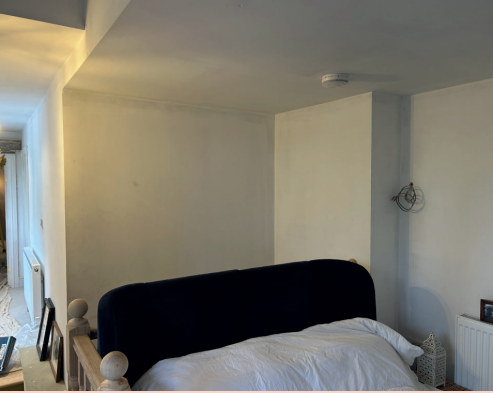
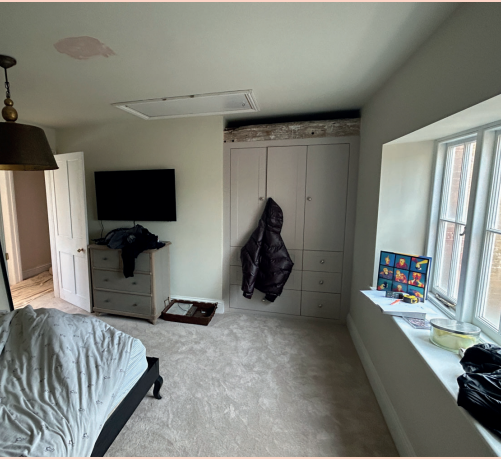
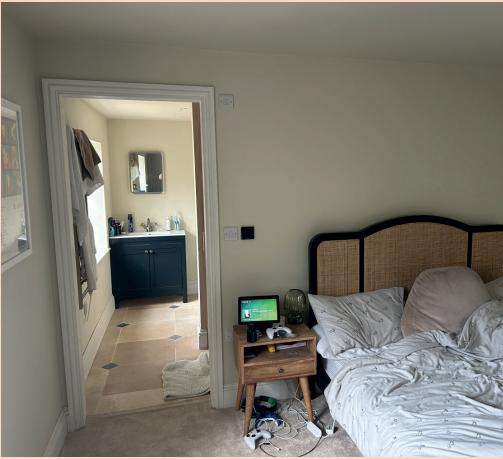
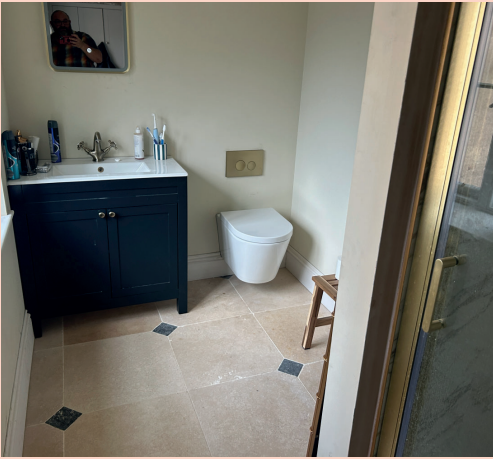
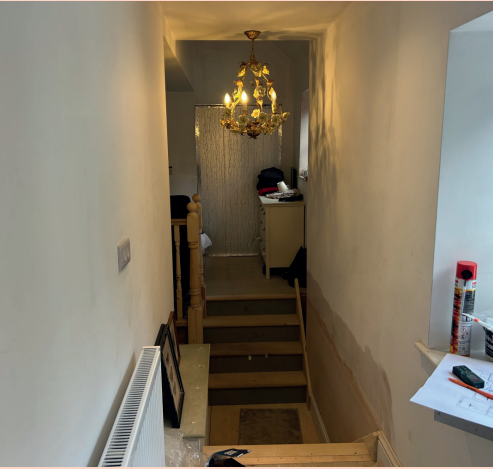
Photographs B02

The timber floor structure and floorboards in this area had failed due to wet rot and fire damage. The floor structure has been replaced with modern timbers and a new T&G chipboard deck has been installed. As part of this work the floor ventilation has been re-established and the floor has been insulated between the joists.

The modern stairs and adjoining partition had also been substantially destroyed by fire. The removal of the stair and its replacement with a newly configured stair was Approved as part of the 2014 Applications.

The modern porch overhang has been removed and damage caused by the mechanical fixings have been repaired. The walls have had all ivy and other vegetation removed and have been subsequently cleaned and locally re-pointed in matching lime based mortar.

The roof has been stripped with battens and failed felt removed, relined with breathable membrane, re-battened and covered in a mix of reclaimed and matching natural slates. All flashings have been locally repaired / replaced in lead work.

All the existing windows were removed and other than the existing store window from the attached single storey range, the intention was to have them repaired, re-glazed and reinstated. It became clear either at the point of removal or in the workshop that all the windows were too far gone and were not sensibly repairable. However, with what was available, faithful replicas were made including all frame profiles, window bars and single glazing were made and installed.

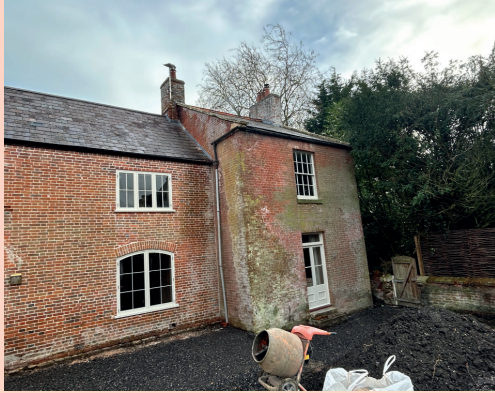
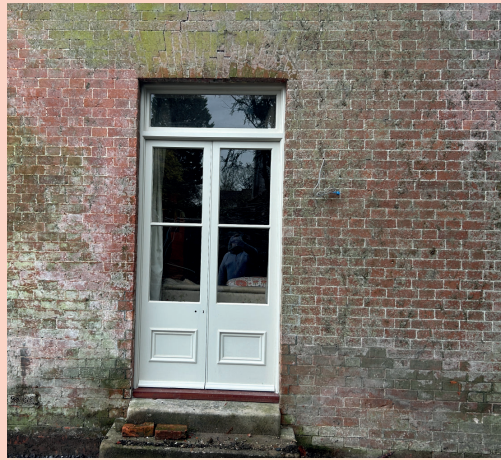
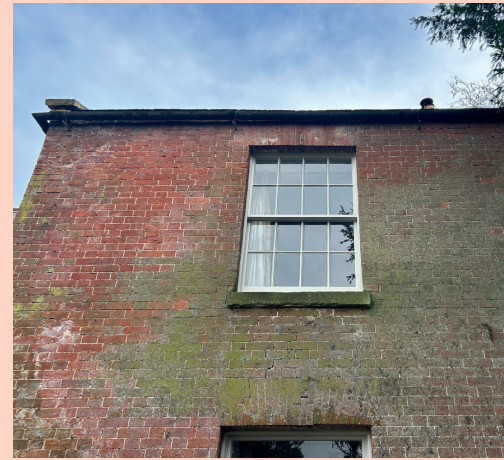
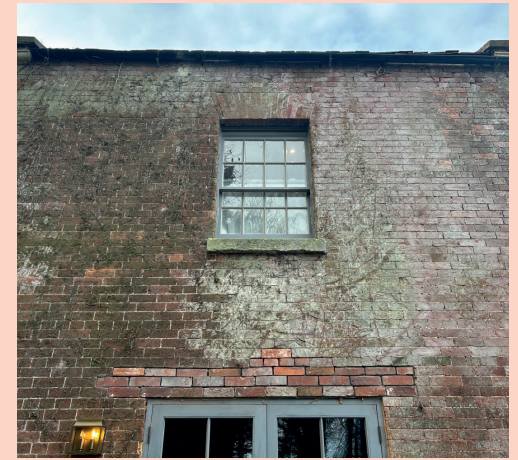
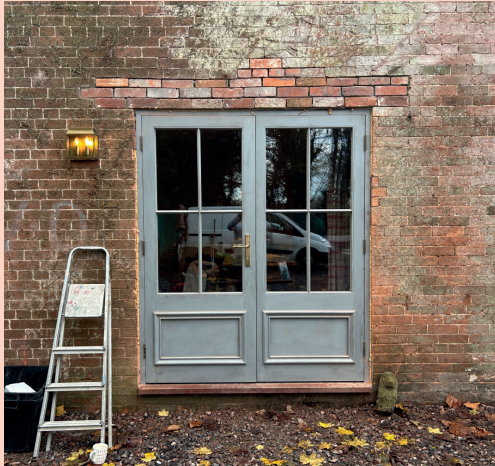
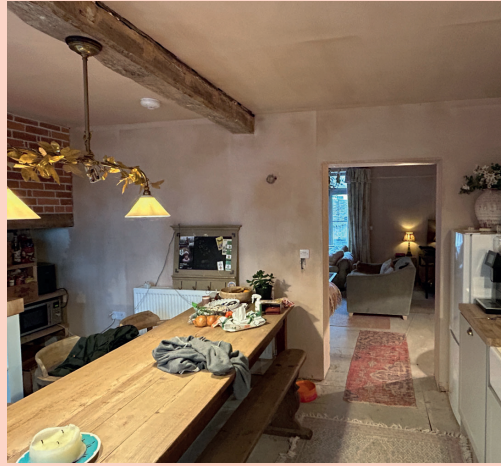
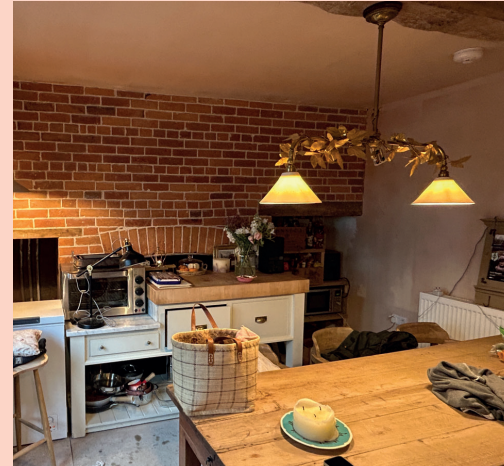
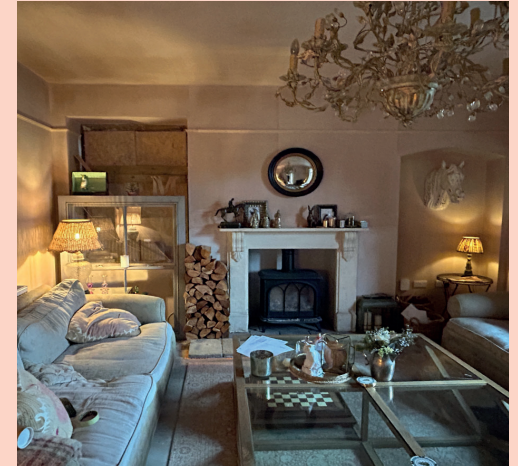
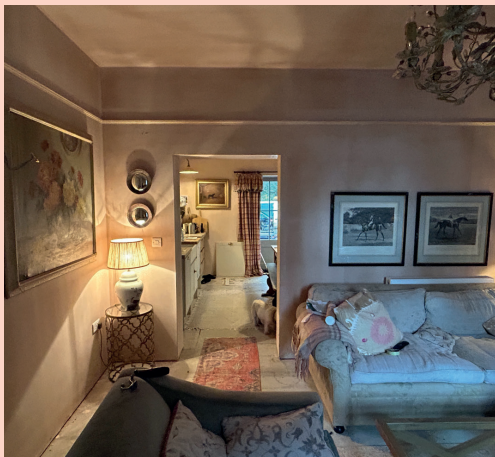
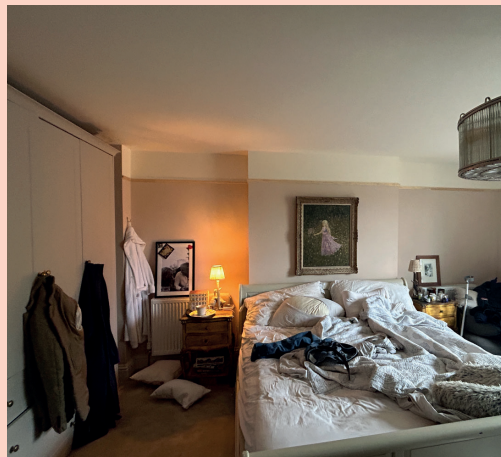
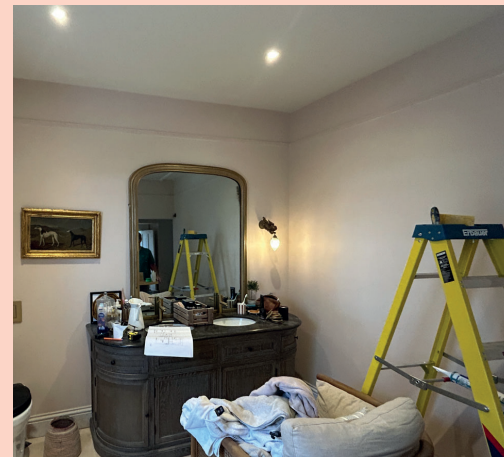
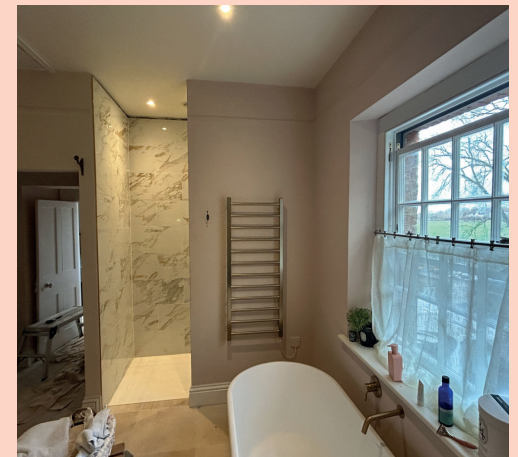
## Photographs B03

At the ground floor the original French doors on the west elevation have been replaced due to not just decay but also

fire damage sustained during the period when the building was empty.

The walls have had all ivy and other vegetation removed and have been subsequently cleaned and locally re-pointed in matching lime based mortar

The roof has been stripped with battens and failed felt removed, relined with breathable membrane, re-battened and covered in a mix of reclaimed and matching natural

As above, the first floor windows have all been faithfully recreated in material, style and profile.
