Date: 22<sup>nd</sup> December 2025

Pond Cottage  
60 The Green  
Poulshot  
Devizes  
Wiltshire, SN10 1RY

## Re: Replacing Sheds with an Ancillary Building at Pond Cottage – Protected Species Survey

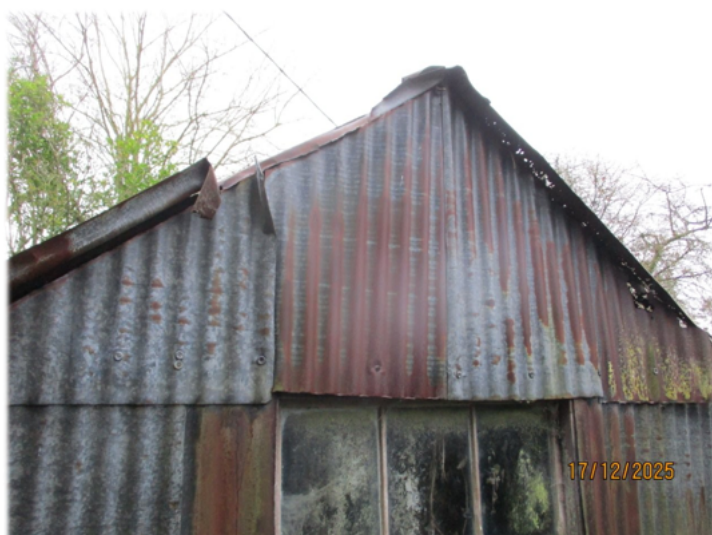
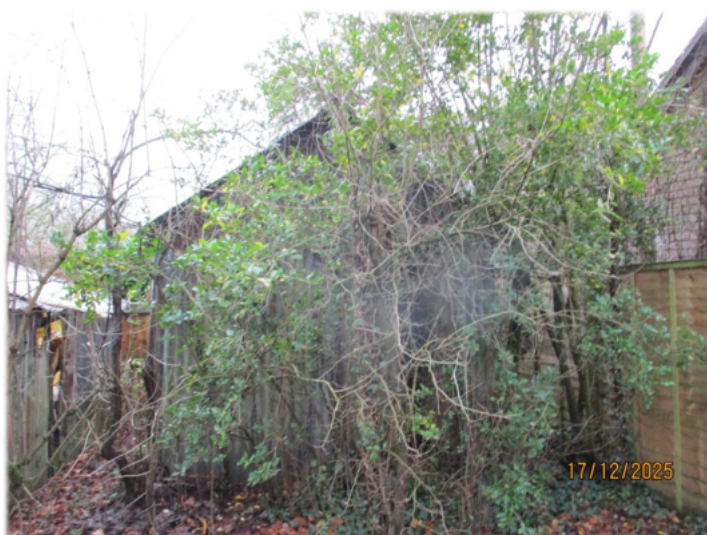
Shed 1 has no external or internal gaps, crevices or hidden voids that could potentially be exploited by roosting bats. The interior of the shed has exposed roof timbers that hanging/clinging bats could potentially use, but the building interior provides unsuitable environmental conditions for bats being open, light, draughty (thermally unstable) and damp while there are no large flyways into the shed interior. Furthermore, there is established spider webbing along / spanning / filling the roof ridge / under eaves / across walls and purlins etc.

*Shed 1 showing west-facing elevation (left) and east-facing elevation with privet vegetation scheduled for removal (right)*

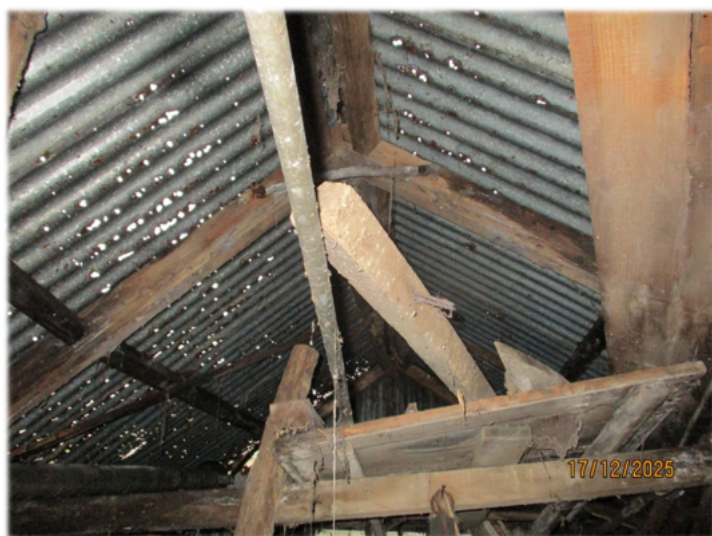
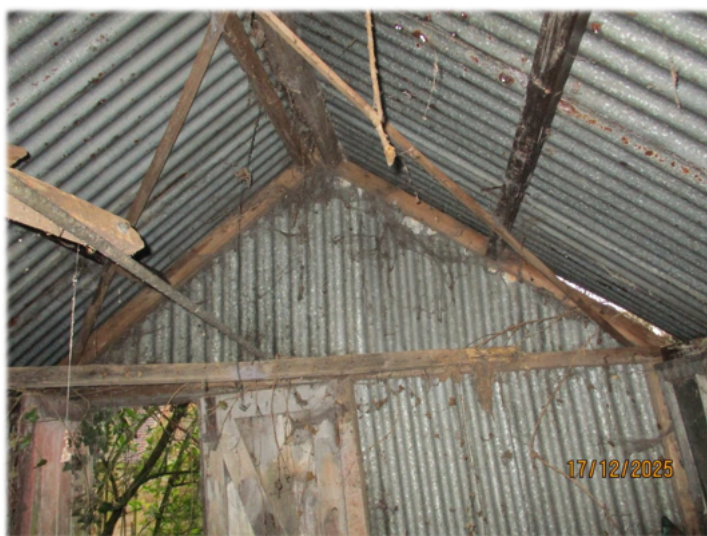
*Shed 1 interior with degraded roof (left) and established webbing (right)*

The environmental conditions within the shed interiors are sub-optimal for roosting bats, and there is evidence indicating the absence of bats including established spider webbing spanning, covering or filling the roof ridge, eaves etc., which demonstrates that bats have not accessed the internal spaces or used the roof features of the sheds.

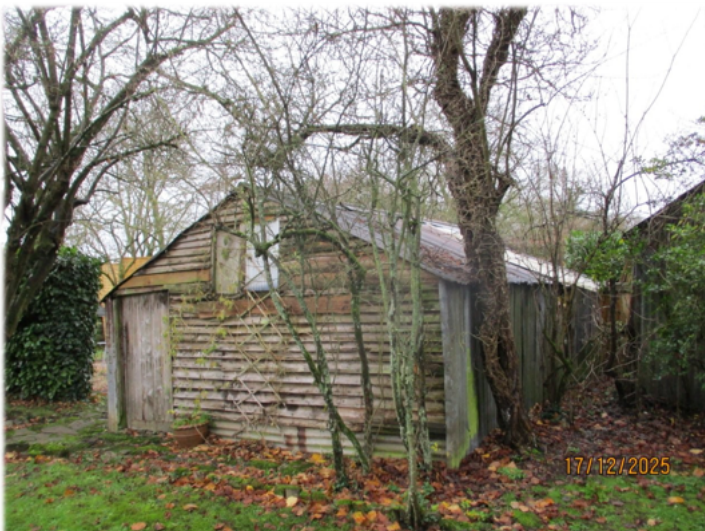
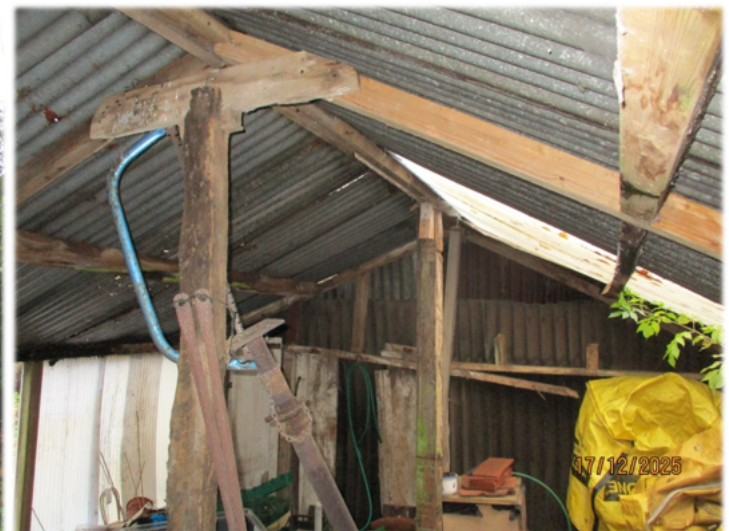
*Shed 2 showing east and north-facing elevations with vegetation scheduled for removal (left) and the shed interior which is open and light (right)*

Shed 2 has no external or internal gaps, crevices or hidden voids that could potentially be exploited by roosting bats. The interior of the shed has exposed roof timbers that hanging/clinging bats could potentially use, but the building interior provides unsuitable environmental conditions for bats being very open, light and draughty (thermally unstable). Furthermore, there is established spider webbing along / spanning the roof ridge / under eaves etc.

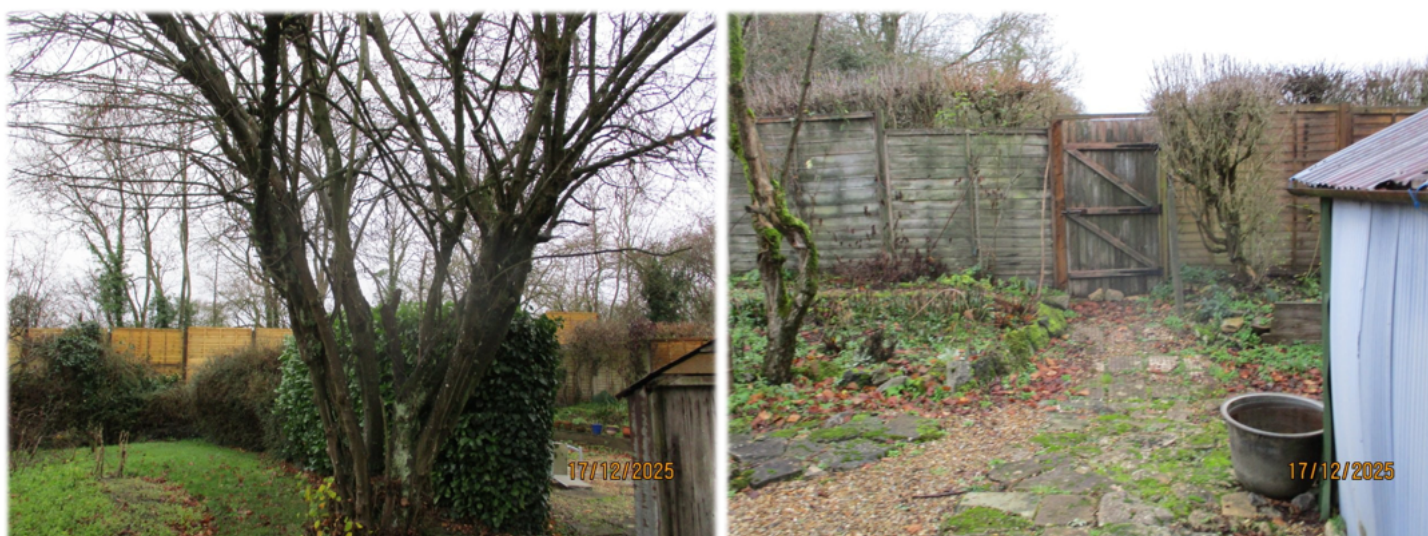
*Multi-stemmed hazel and cherry laurel hedge scheduled for removal (left) and small tree scheduled for removal with close-boarded fencing at end of garden (right)*

The trees, shrubs and hedge located around the sheds, which are scheduled to be removed, do not support potential bat roosting features given their size, age and condition. All trees, shrubs and hedge are classed as Category 1 (not a roost / negligible potential).

To ensure compliance with the Wildlife and Countryside Act, 1981 (as amended) the removal of the garden sheds and vegetation should proceed carefully giving due consideration to the potential to find a nesting bird. If a bird nest is found (including birds constructing a nest, nest with eggs or hatchlings) work in that location / affecting the nesting site should stop, an ecologist consulted and work should not re-start until birds have vacated the nest.

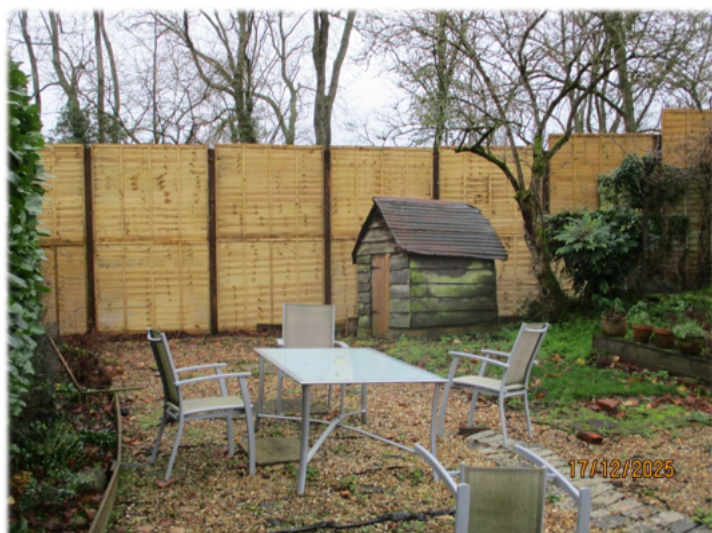
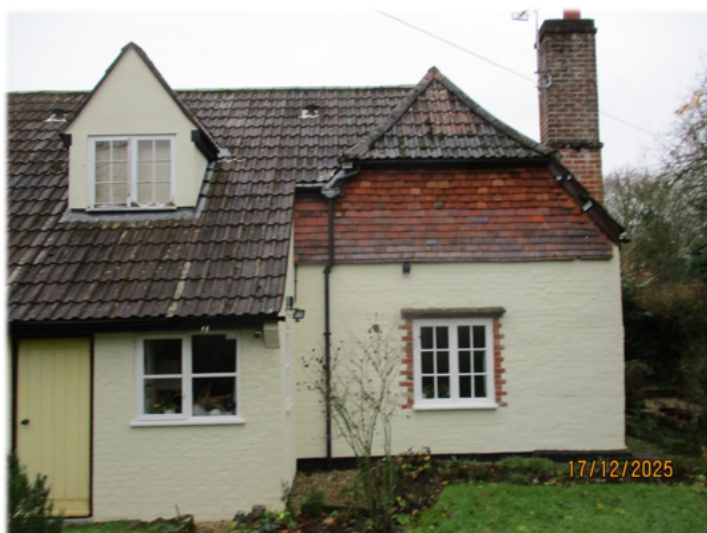
*Rear garden with 3m+ high close-boarded fencing along southern boundary (left) and floodlights on rear of main house (right)*

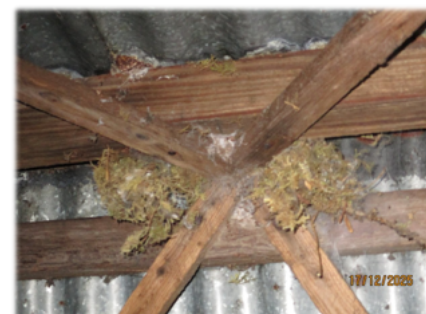
There was very old nesting material for a small passerine bird, possibly wren (*Troglodytes troglodytes*), within the open ridge of Shed 2 – shown here - while bird droppings were observed in Shed 1.
