## Hilmarton Manor - Sample Panel Photographs

LBC ref. PL/2024/10022

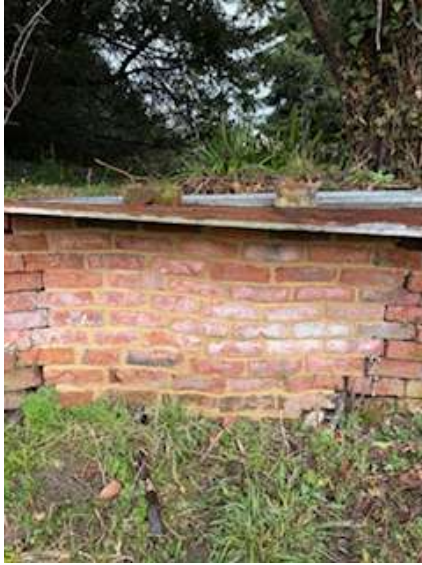
Photograph showing sample panel on-site with mortar.

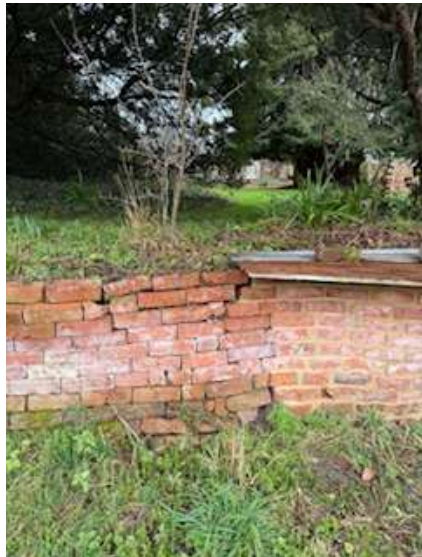
Photograph showing sample panel with existing ha-ha wall.

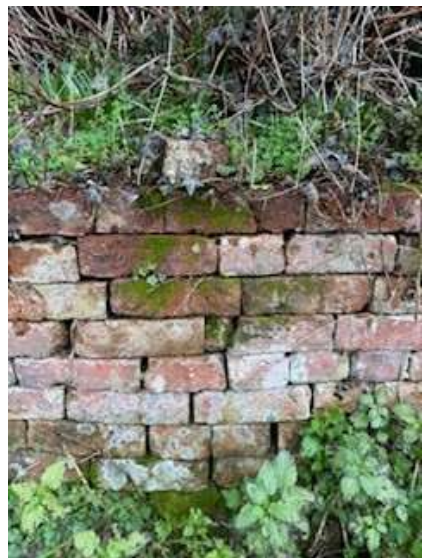
Photograph showing close-up of the wall indicating that it appears to be a dry wall with gaps that are too small to mortar.
