## Arboricultural Impact Assessment & Tree Protection Plan For trees at Langfords Car Spares in Shaftesbury

On behalf of Karl Langford  
Langfords Car Spares  
Semley  
Shaftesbury  
Wiltshire  
SP7 9AQ

Inspected and Prepared by Nick Baxter BSc(Hons) MArbora

4<sup>th</sup> February 2026

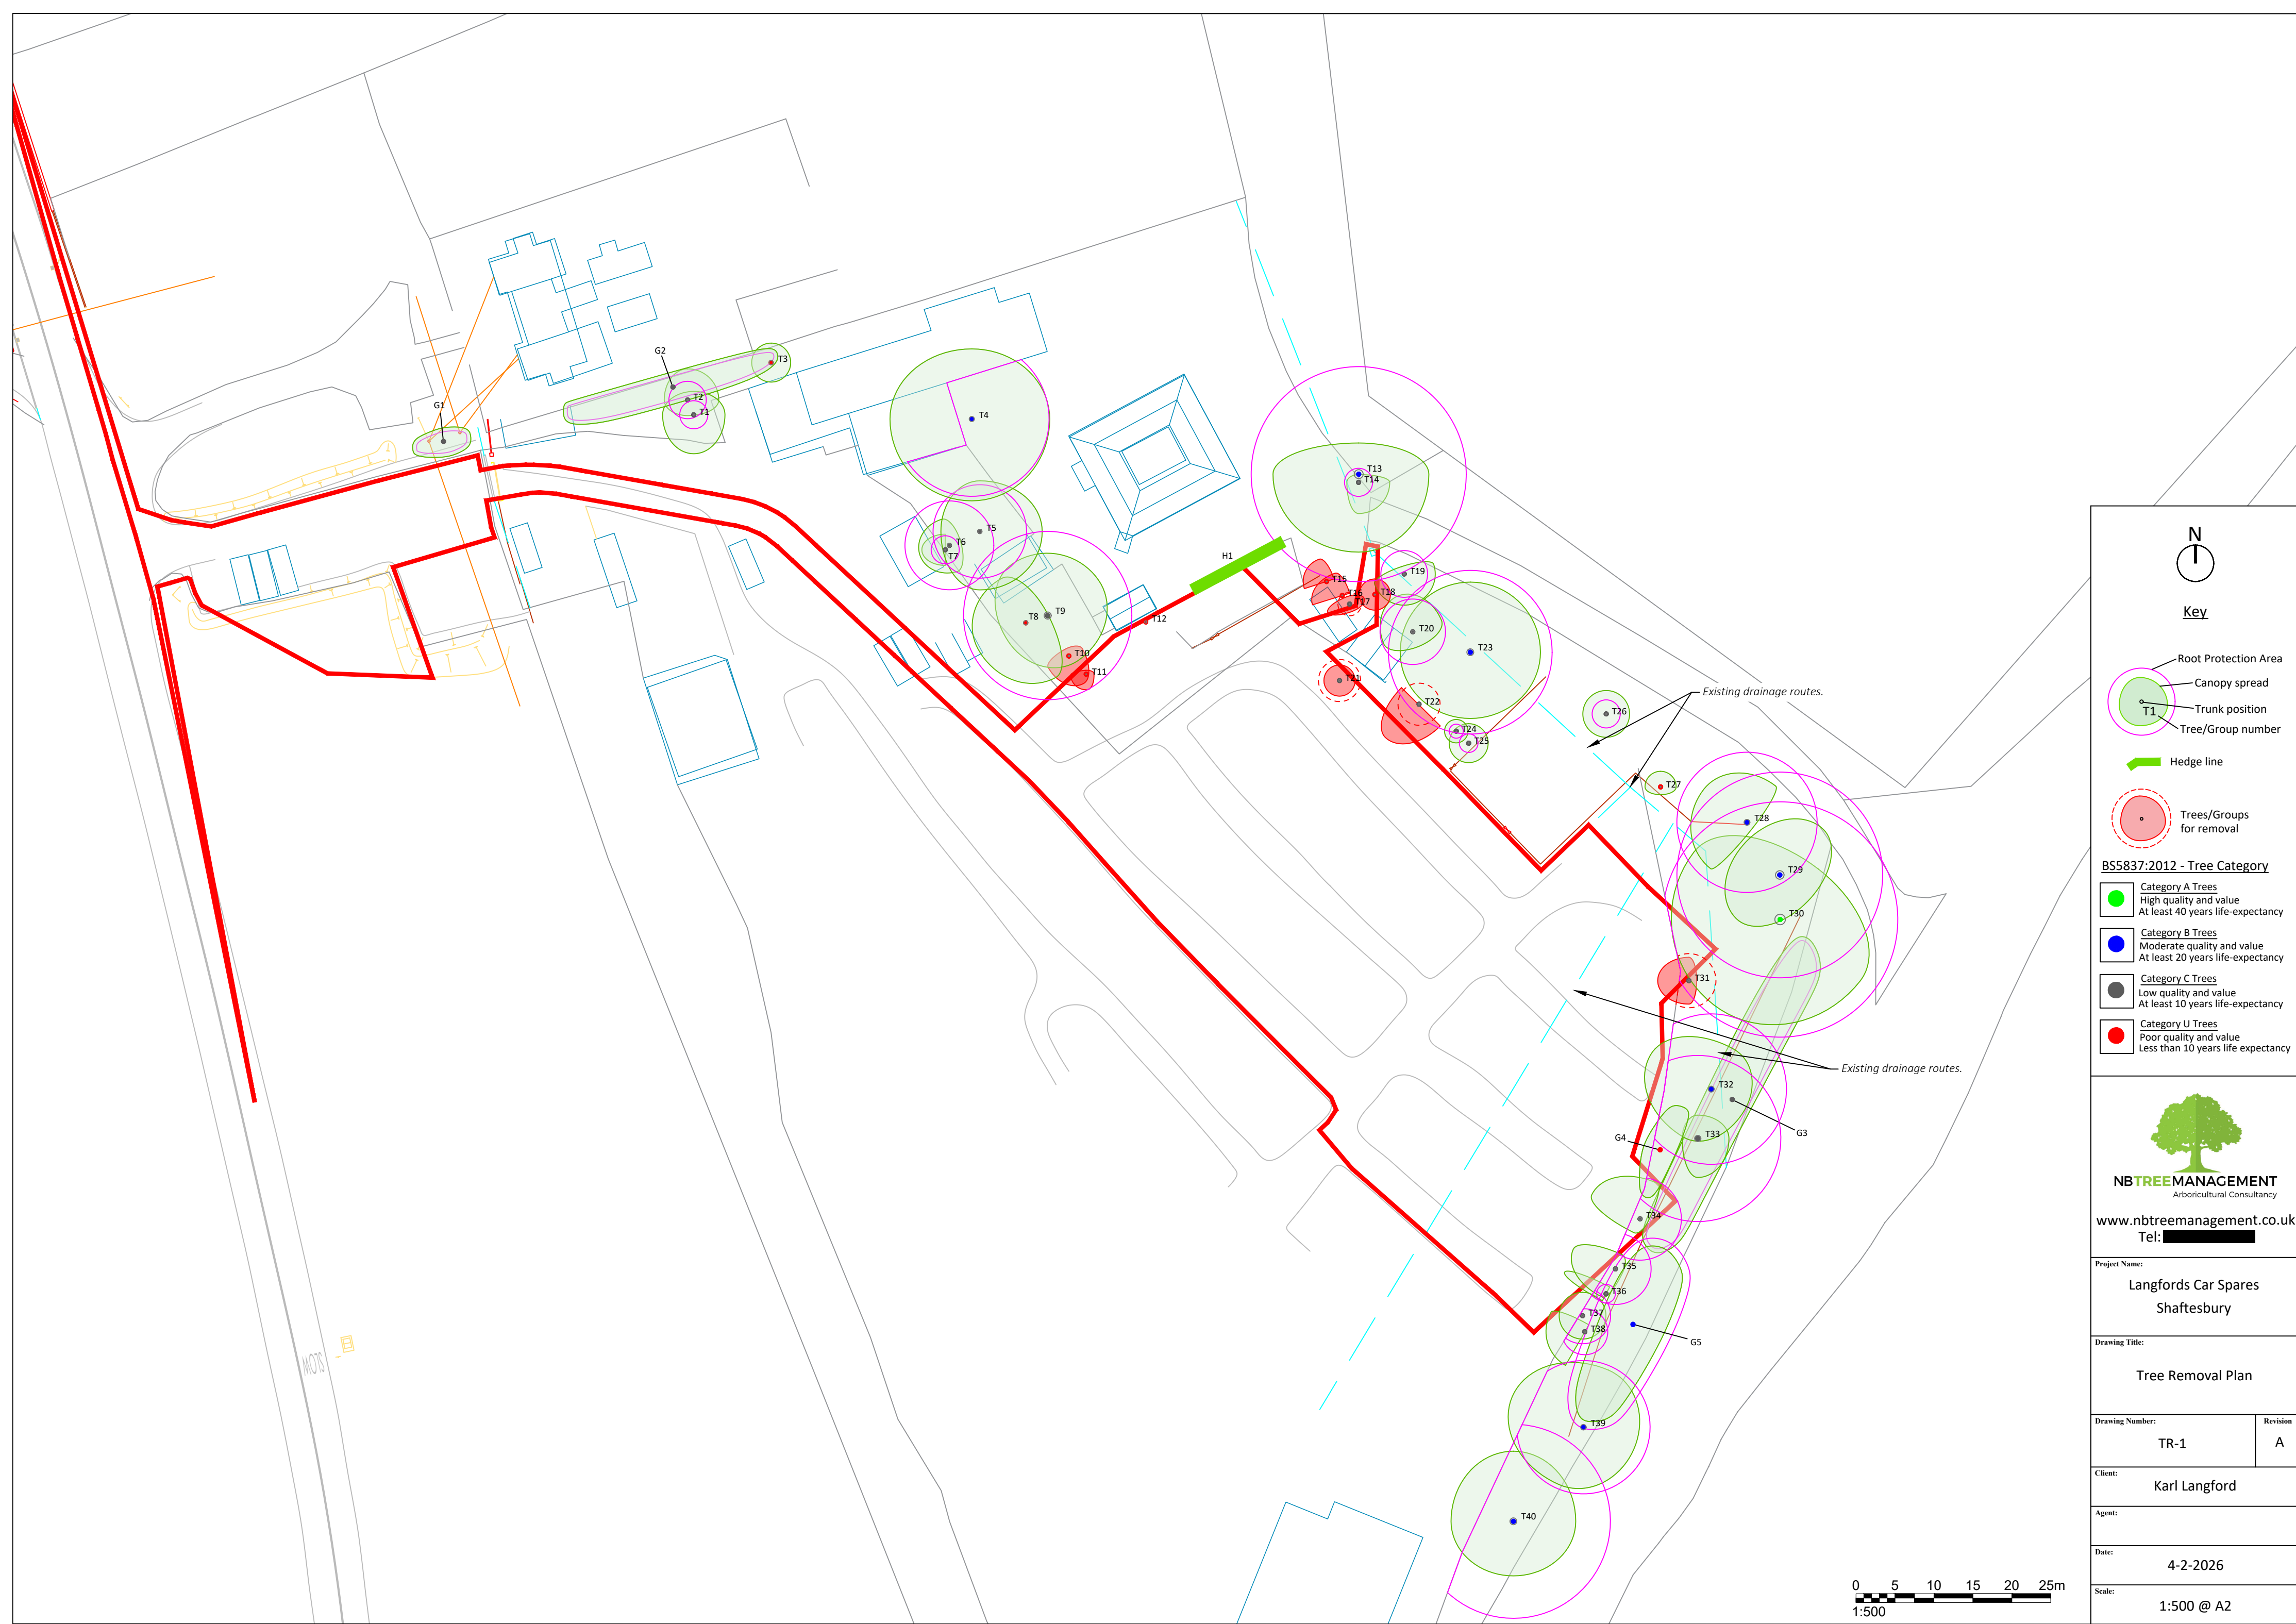
Appendix 2 Tree Removal Plan (TR-1A)

**Tree Removal Plan (TR-1A)** A plan which shows which trees require removal on the existing site layout.

Ten trees will need to be removed to construct the proposed development; these include four category C trees (T17, T21, T22 & T31) and six category U trees (T10, T11, T12, T15, T16 & T18). All the tree removals are listed in Appendix 1, but a summary of tree removals is shown in Table 3.

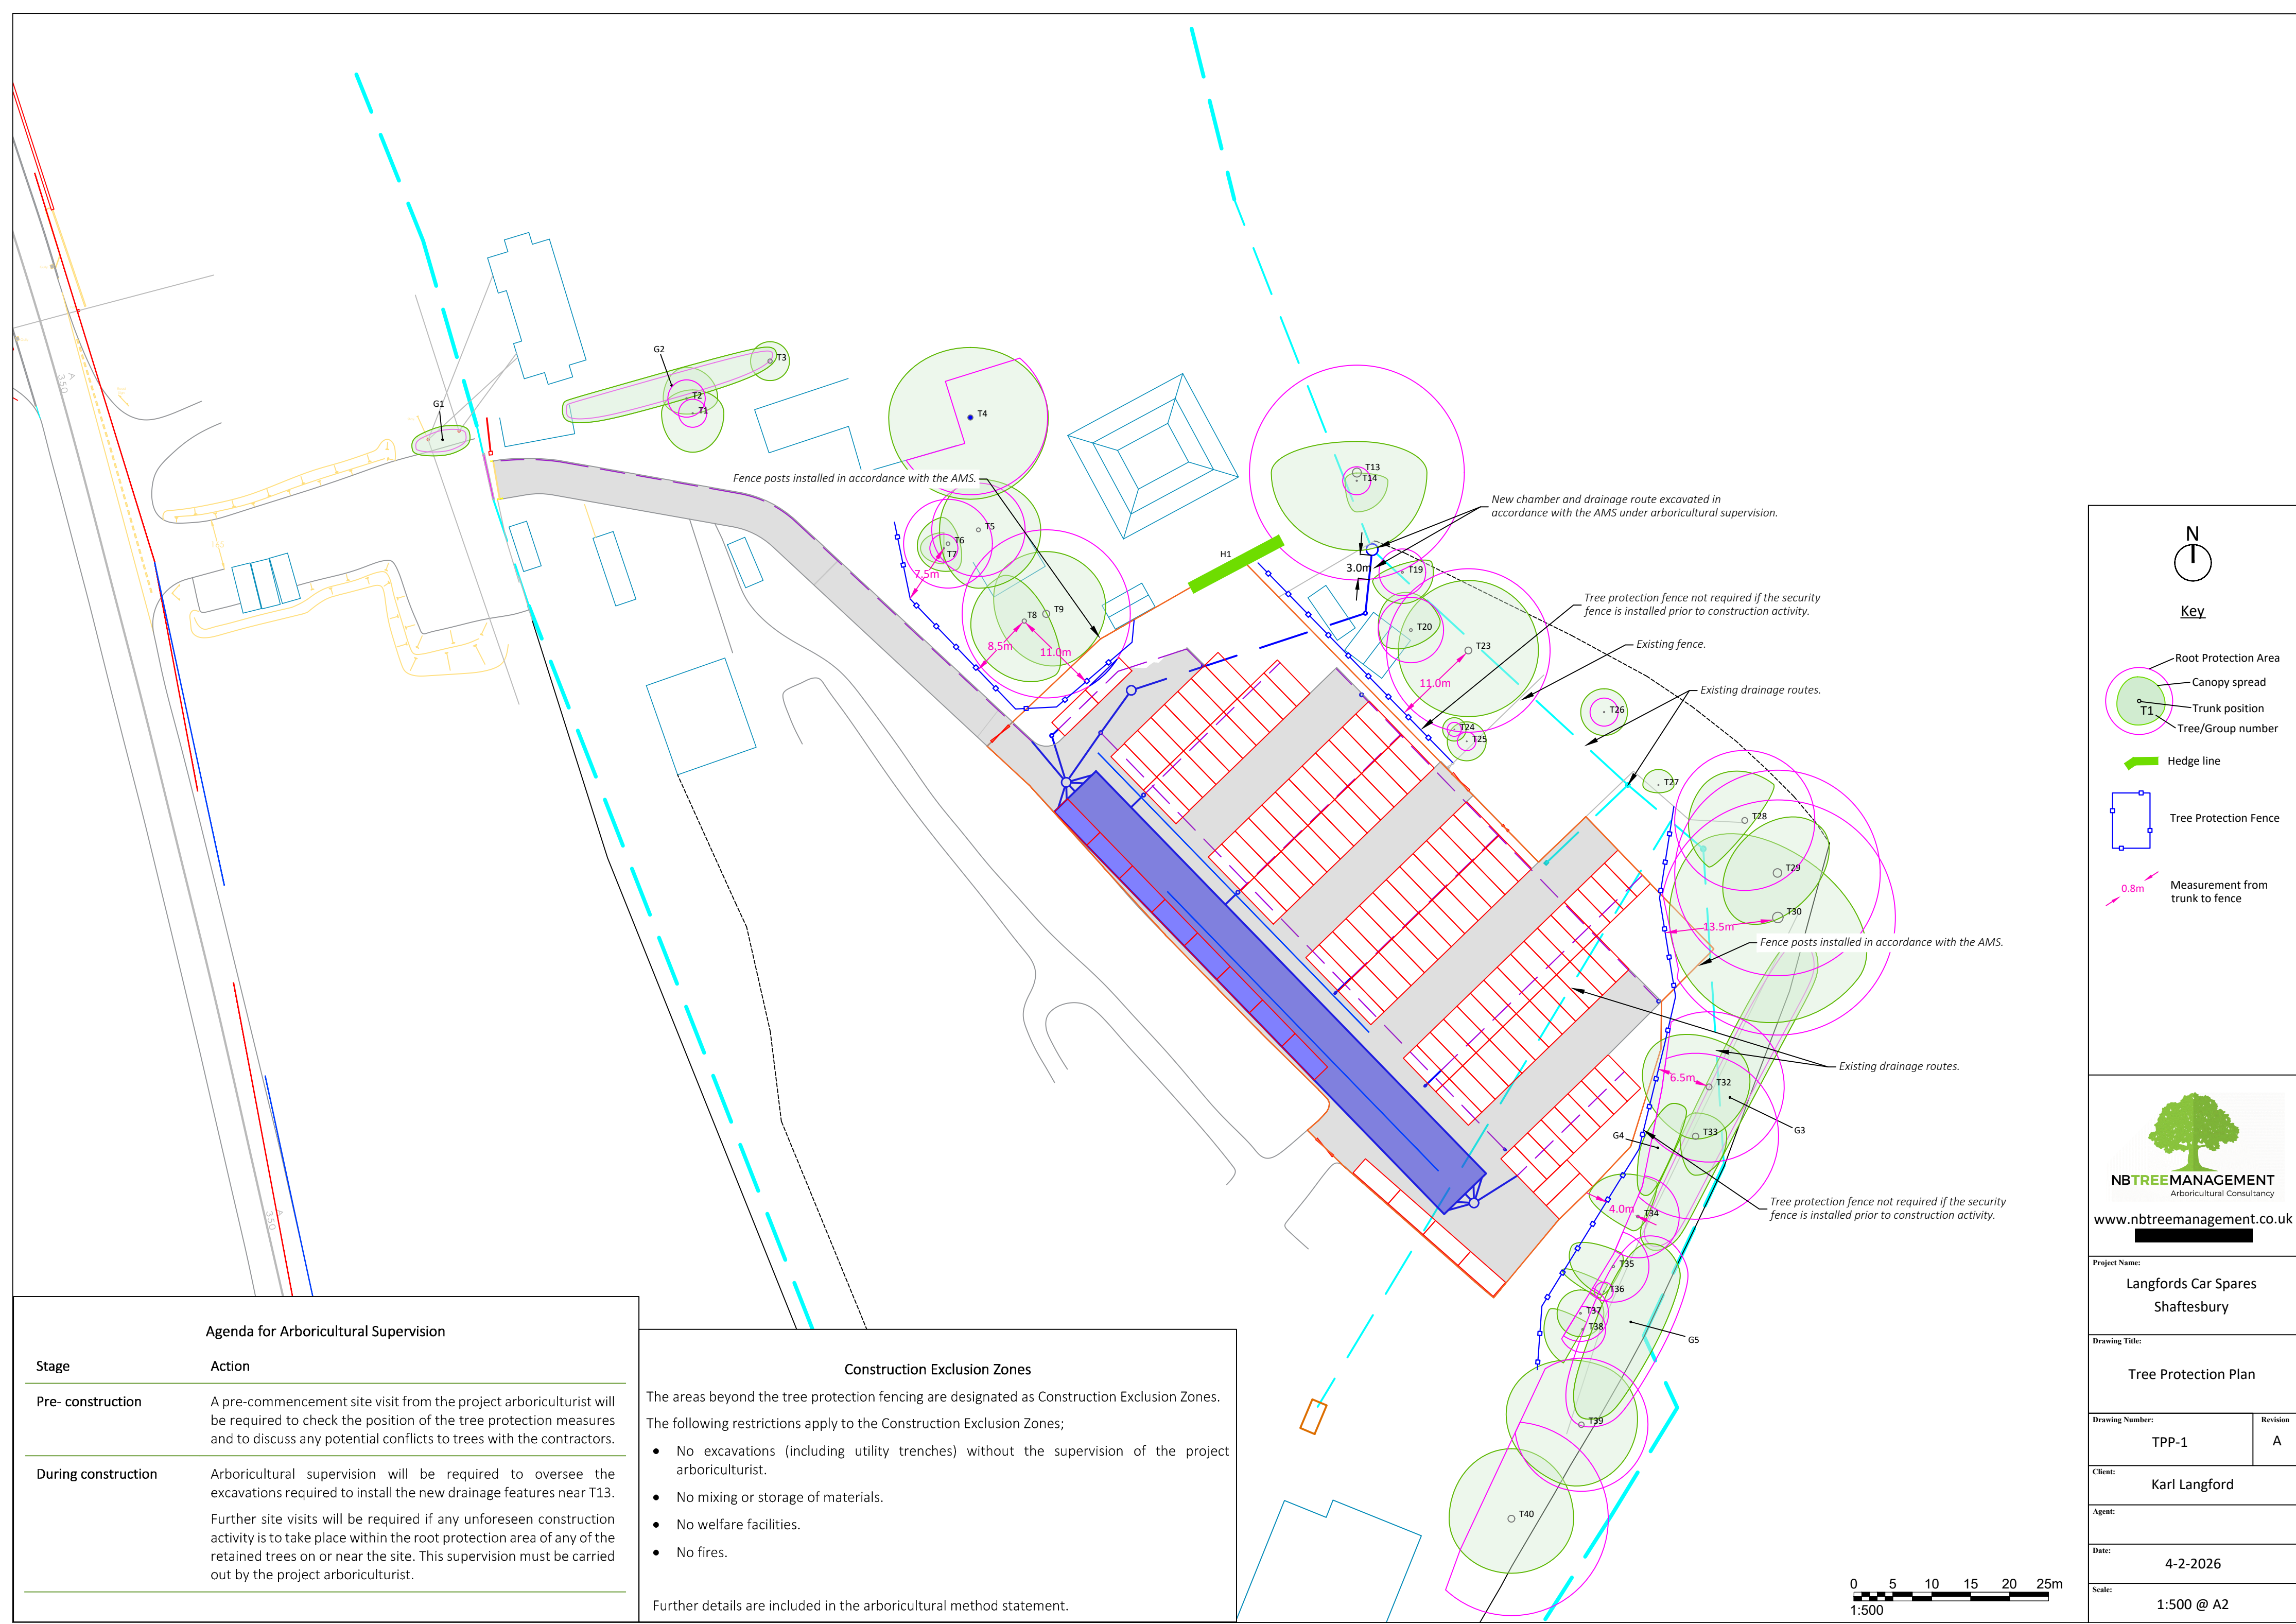
Appendix 3 Tree Protection Plan (TPP-1A)

**Tree Protection Plan (TPP-1A)** A plan which shows the retained trees on the proposed site layout and where protective measures are required during construction activities.

A new security fence is to be installed around the new site, and this will be within the RPA of two retained trees (T9 & T30) so care will be required when installing the fence posts. A method statement for the installation of fencing near trees accompany this report and will need to be followed when erecting the fence. This fence will need to be installed either at the start of the project (so some temporary tree protective fence won't be required) or once it is finished, when the tree protection fencing has been taken down.

The locations for new underground services have been designed to largely avoid the RPAs required by the retained trees. One chamber will be replaced, and a 3m section of new drainage pipe will be installed within the RPA of T13. The route has been positioned on the opposite side of the existing chamber to minimise the risk of root disturbance, as roots generally extend radially from the trunk. The excavations required to replace the chamber and install the new drainpipe will be carried out in accordance with the accompanying arboricultural method statement.

Temporary fencing and/or barriers must be used during construction activities to protect retained trees. The location of necessary tree protection is indicated on the tree protection plan at the rear of the report (TPP-1A). For effective tree protection it is crucial that the protective fencing is installed before any heavy plant machinery is used on the site. The fenced off areas will be construction exclusion zones.

There are two sections of temporary fencing that will not be necessary if the proposed security fence has already been installed. This is because the security fence will be more than adequate for tree protection during construction activity.
