# Stourhead MIOS Garden Lake - Arboricultural Impact Assessment

**Final**

Prepared for  
National Trust

Date  
December 2025

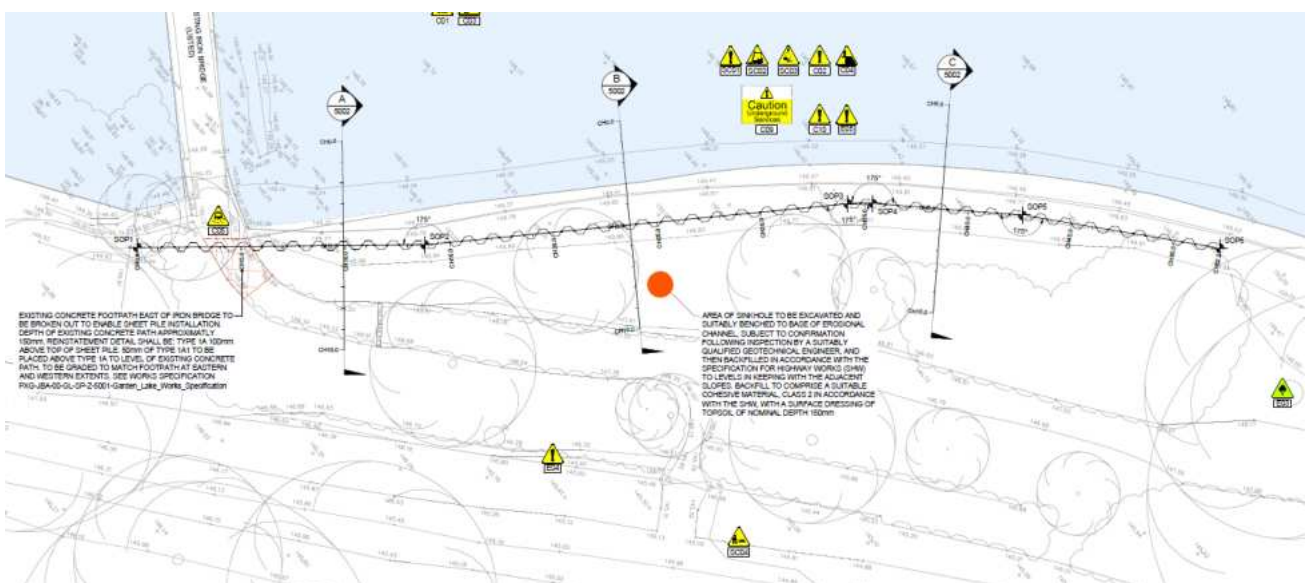
Figure 5-1 Image extracted from General Arrangement Drawing, location of soil stripping shown by annotated red dot.

The piling is proposed to be undertaken with an excavator from the waterside of the bund, by building a temporary granular working platform. Topsoil stripping will take place along the entire length of the sheet pile line. It is noted that the piling operations will occur within the rooting areas of T010 and T011. The piling line is indicated to run at the edge of the existing bund, parallel to the RPA of the trees. It is considered that the piling installation would intrude, but to a limited extent, within these two retained trees' root areas.

The movements of the plant are considered to be outside the rooting area of these two trees, with the exception of the piling line, due to being on the wet side of the piling line. However, soil stripping to form the platform to undertake the piling will be in close proximity to the RPAs of these two trees as indicated on the General Arrangement drawings, and the work zone remains within the rooting area of the trees. Therefore, the use of exclusion zones is proposed, using pin and ropes. Any intrusion will require the project's arboriculturist's approval. The use of pin and rope is proposed due to the relatively steep gradient, further restricting the potential for intrusion.

On balance, this approach results in a reduced number of tree removals and balances the requirement for load-bearing surfaces with the preservation of tree health by preventing long-term root compaction damage and enabling natural water and air flow to the roots.

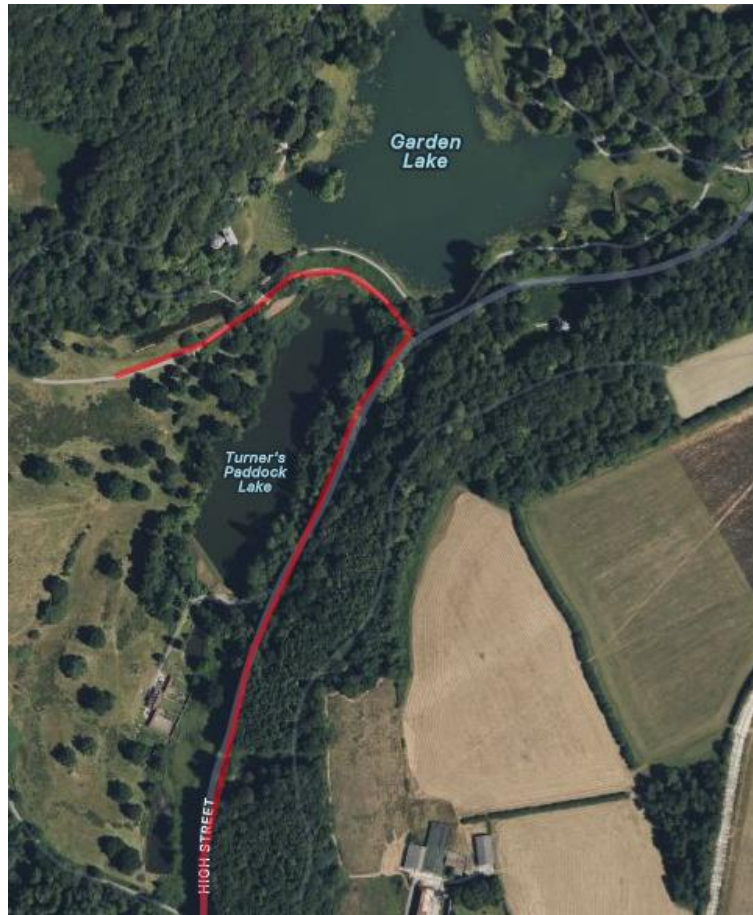
Figure 5-2 Site Access Route proposed to by-pass low structures

It is considered that the access to this location would be via the gravel/ stone access track which runs between Garden Lake and Tuners Paddock Lake.

It is considered that if this access route is used then there is limited potential for disturbance or additional compaction to the land.
