PROJECT:  
Former Weighbridge  
Chippenham  
SN15 1HW

# **The Weighbridge, Union Road, Chippenham SN15 1HW**

## **Condition Assessment Report**

WBC Document Ref: 3240643-WBC-XX-XX-RP-S-20001  
Revision: P01

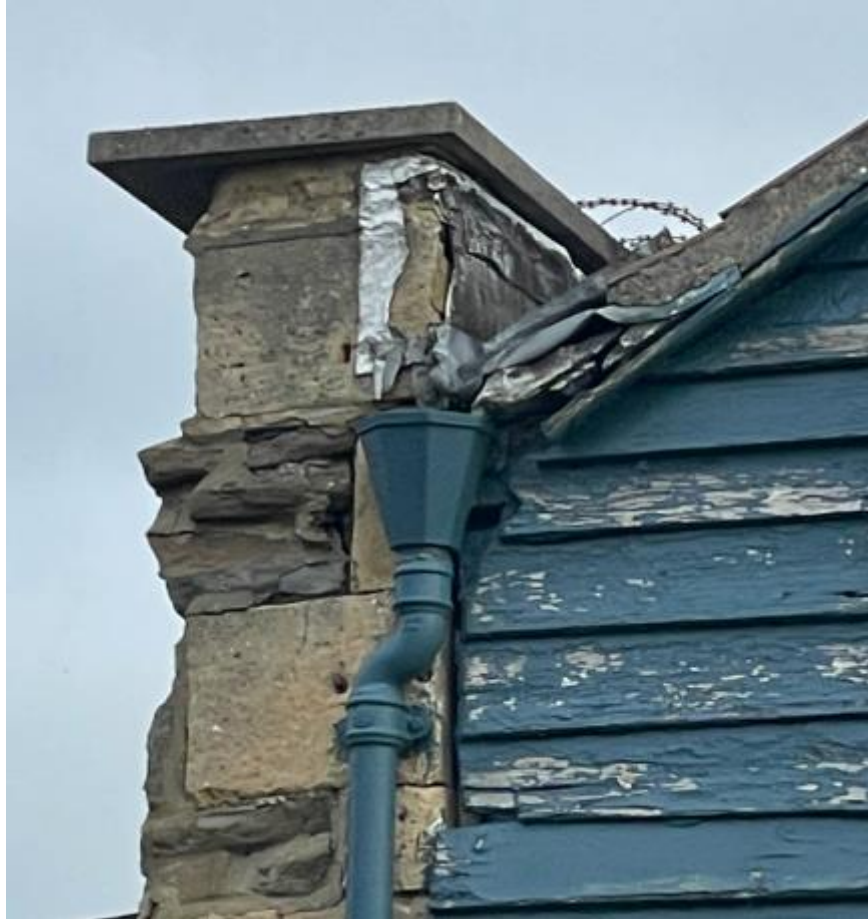
#### **2.2.1 North Elevation**

- 2.2.1.1 The north elevation wall consisted of a rubble stone formation, which was assumed to be the original boundary wall to the station. The wall is the party wall to the neighbouring property.
- 2.2.1.2 The neighbouring elevation wall was reviewed and was partially obscured by storage racking. The elevation was generally in good condition with some areas of mortar loss between the stone units.
- 2.2.1.3 At the junction between the wall and the roof, a hidden valley gutter detail was apparent, with the gutter discharging into a hopper to the West elevation.
- 2.2.1.4 Where observed, the flashing detail to the hidden gutter was poor and coming away from the masonry wall. Flash band

adhesive was noted to the east end elevation indicating that there have been historic repairs undertaken.

3.1.1.2 We would expect that works would be required to ensure pointing is complete and stone units are not loose, this is not urgent when compared to other areas and may be delayed until full refurbishment of the building.

3.1.1.3 It is imperative to repair and consolidate the hidden gutter system to reduce further ingress to the structural system below.

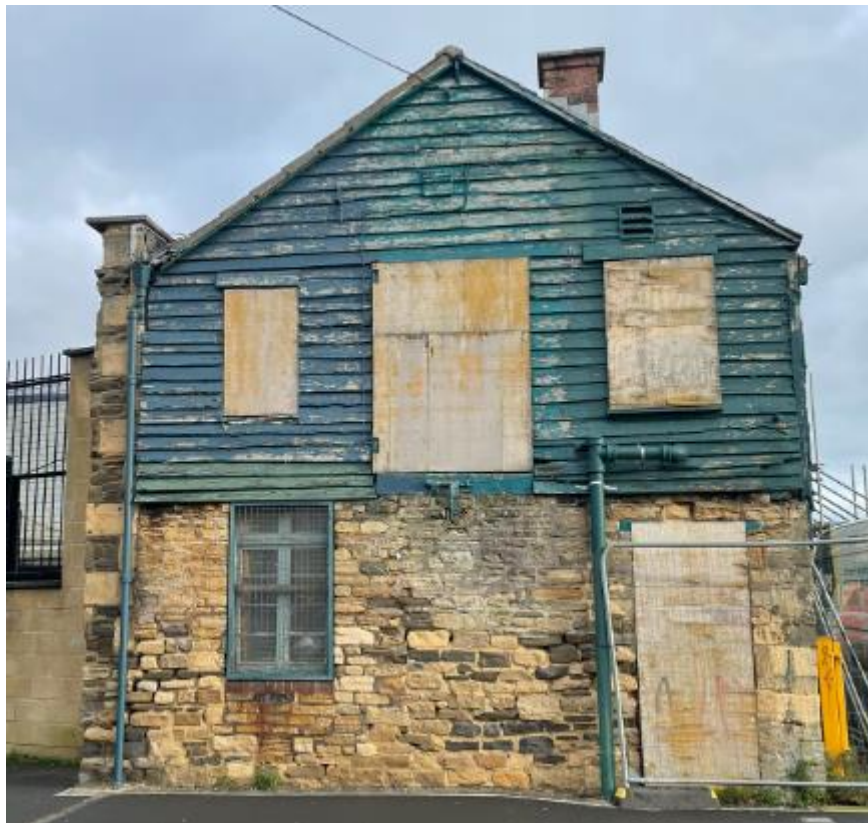
## 2.2.2 West Elevation

2.2.2.1 The first-floor area to the elevation was finished in horizontal timber cladding boarding.

2.2.2.2 There were 3No openings to the elevation which had been boarded over prior to inspection.

Bath stone masonry was evident to the external face of the ground floor. The exposed masonry had some delamination and section loss in close proximity of the timber cladding.

2.2.2.3 The timber cladding had some areas of slipped / broken timber, with finishes perished and severely weathered.

2.2.2.4 Where exposed, the timber frame around the window openings had perished.

3.1.2.2 It would be prudent to refurbish the cladding arrangement to the upper wall to reduce risk of further water ingress to the structural system internally.

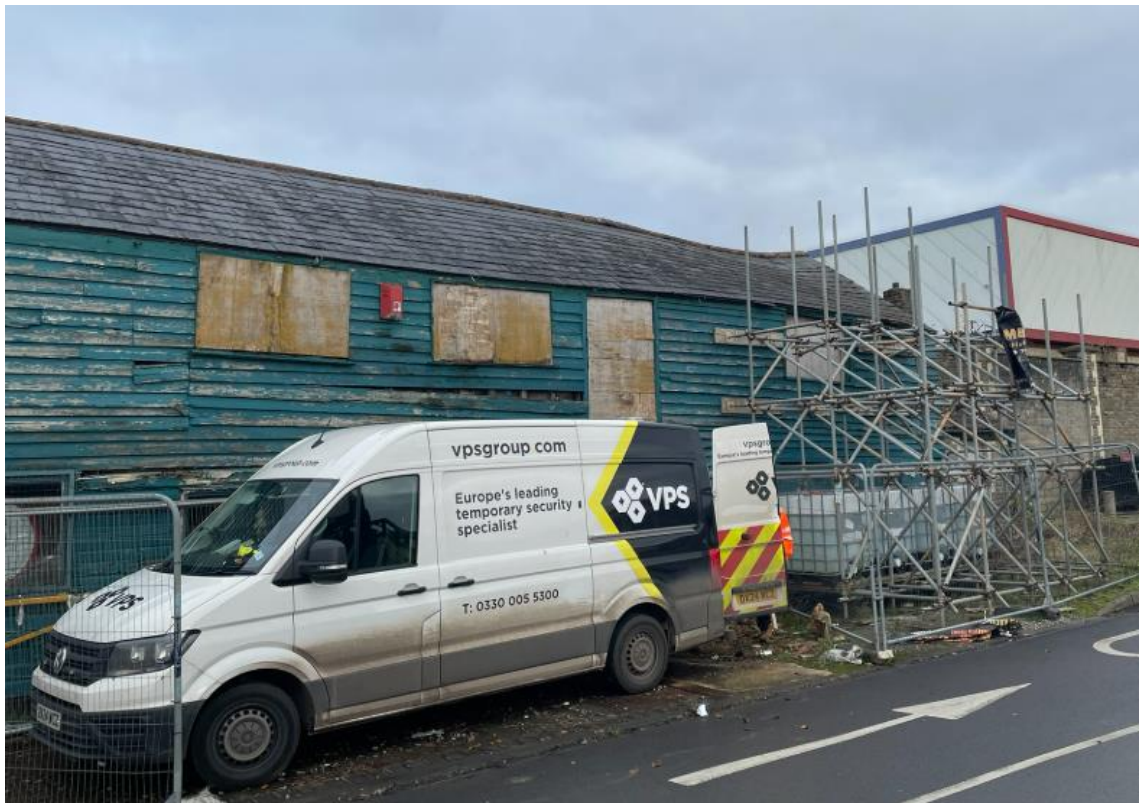
## 2.2.3 South Elevation

2.2.3.1 There was horizontal timber cladding to first and ground floor to this elevation, with several areas of slipped and broken timber exposing the structural arrangement behind.

3.1.3.3 It would be prudent to refurbish the cladding arrangement to the wall to reduce risk of further water ingress to the structural system internally.

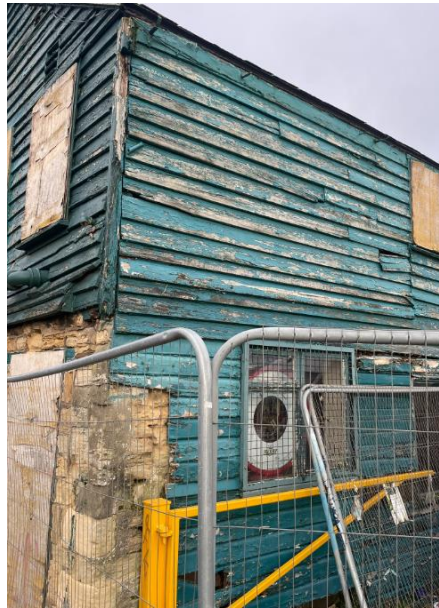
2.2.3.2 The remaining timber members had painted finishes which had perished and was in severely weathered condition, which may be close to end of working life.

2.2.3.3 Timber windows to the upper floor had been boarded with the exposed timber frame to window openings perished.

2.2.3.4 The original guttering arrangement was missing from the eaves.

2.2.3.5 The timber cladding to the lower level of the west elevation was missing with timber studs exposed at the junction with the ground floor of the elevation.

2.2.3.6 The timber stud wall to the first floor or the east end of the elevation had been severely deflected outwards away from the footprint of the building.

2.2.3.7 Towards the east end of the elevation the eaves level was deflecting downwards towards the ground.

3.1.3.2 The push out from Truss 5 has weakened the east end of the elevation. It would be prudent to unload the wall and repair the formation locally where possible.

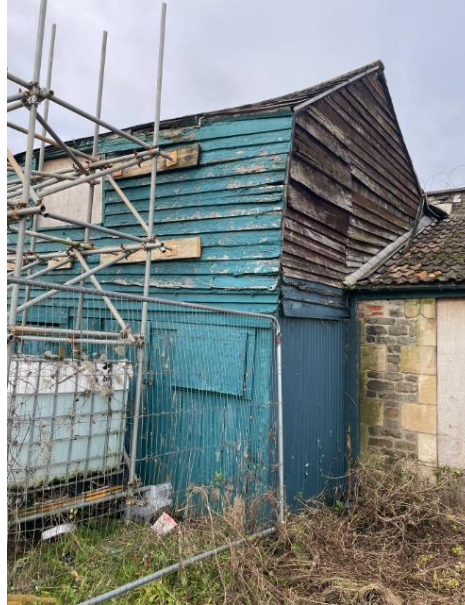
#### 2.2.4 East Elevation

2.2.4.1 The east elevation was obscured by a neighbouring building with the upper and south end of the elevation exposed. The elevation was clad with horizontal timber boarding to the first floor and vertical corrugated metal sheeting to ground level.

The neighbouring building was providing buttressing to the elevation.

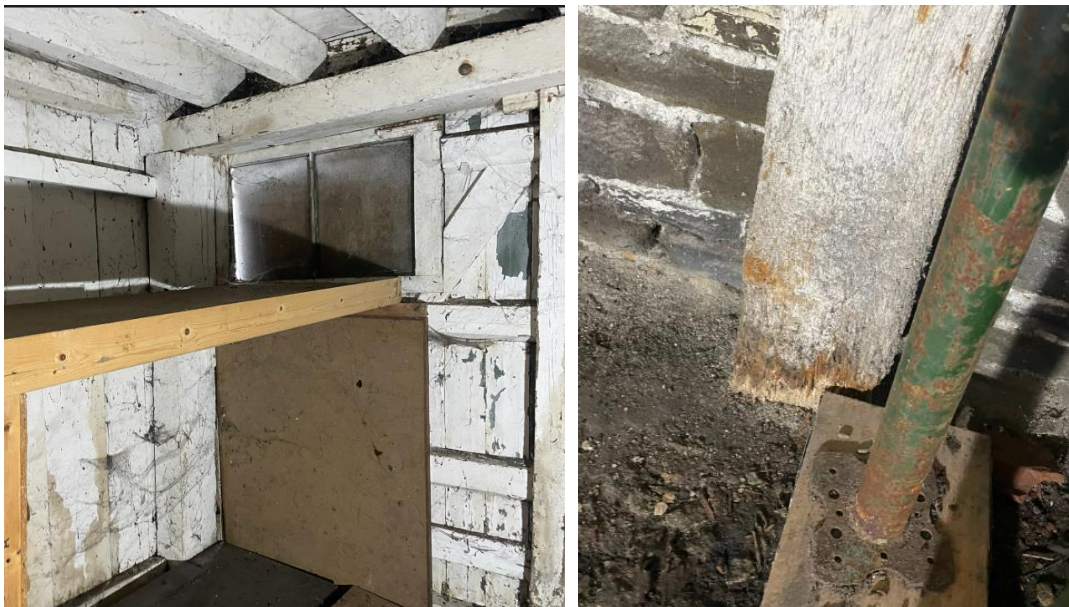
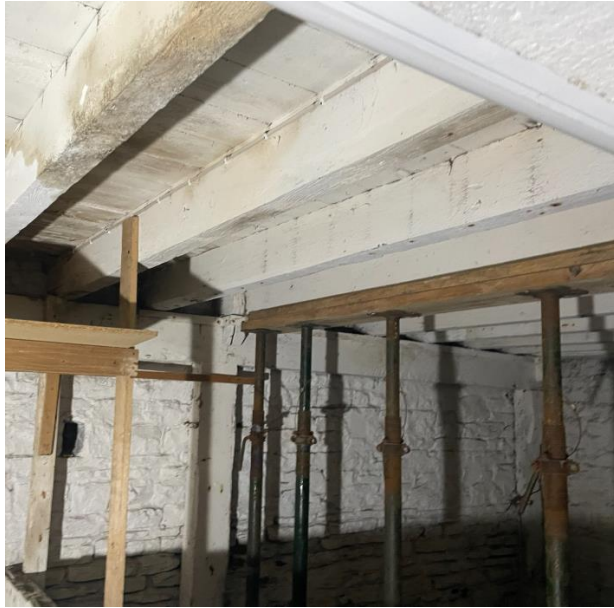
### 2.3.3 East Elevation Room

2.3.3.1 Exposed timber elements, post supporting beams to North elevation and centre of room. Columns supporting beams with some minor section loss at base of columns

2.3.3.2 South elevation beam has minor section loss at corner and deflection above window openings

3.2.1 Works are required within the East Elevation room. The existing bressummer beam over the window openings has section loss and requires splicing a new section into the formation to ensure suitable support for the floor above.

3.2.2 The existing timber posts bear directly onto the flagstone floor formation. Where section loss has been apparent on approx. 4No posts, it would

be prudent to install a new splice column section, with treated finishes to the bottom 150mm of the column.

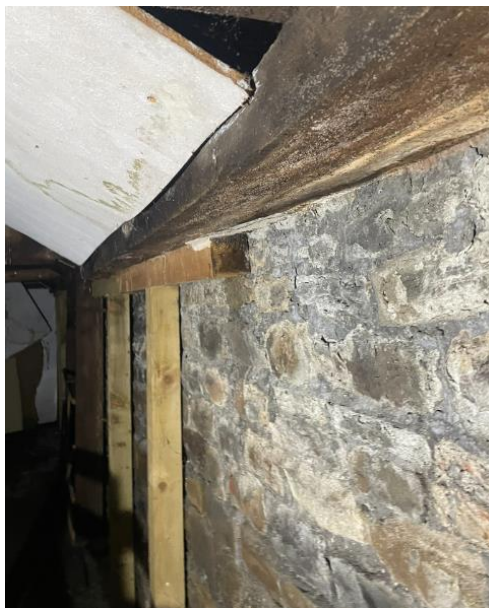
2.4.1.1 The elevation consisted of exposed rubble stone masonry wall with timber columns supporting a beam at ground floor ceiling level supporting the incoming timber joists. Columns continued up supporting a beam below the hidden gutter at eaves level, with incoming rafters fixed to the head of the beam.

2.4.1.2 The eaves beam supporting the incoming roof rafters and gutter had severe deflection in places, with rotation prevalent about the splice locations. The beam had been subject to modern repairs with softwood propping located about the centre of the elevation.

4.3.1.2 Install consistent support to the North elevation eaves beam.

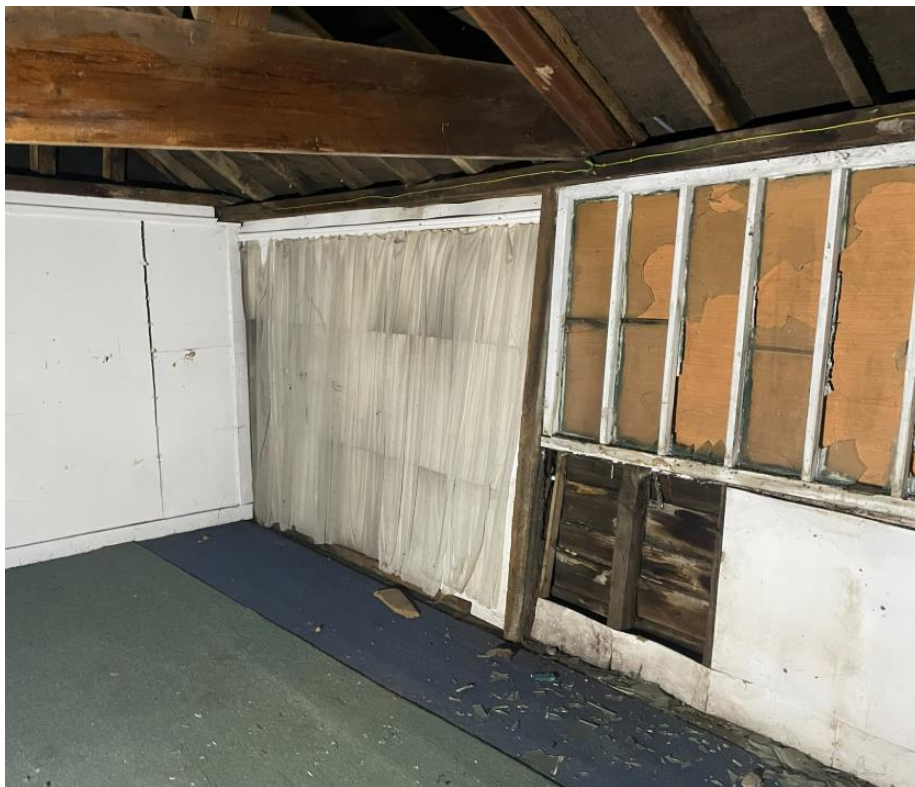
2.4.3.3 The East end of the elevation had been thrust outwards from its original position following the failure to Truss 5 bearing position. The flooring to this area deflects significantly towards the South East corner of the building.

- 3.3.2 Following removal of Truss 5, the South elevation wall should be reviewed fully, we anticipate that the timber stud wall will be removed fully and replaced with a similar system.

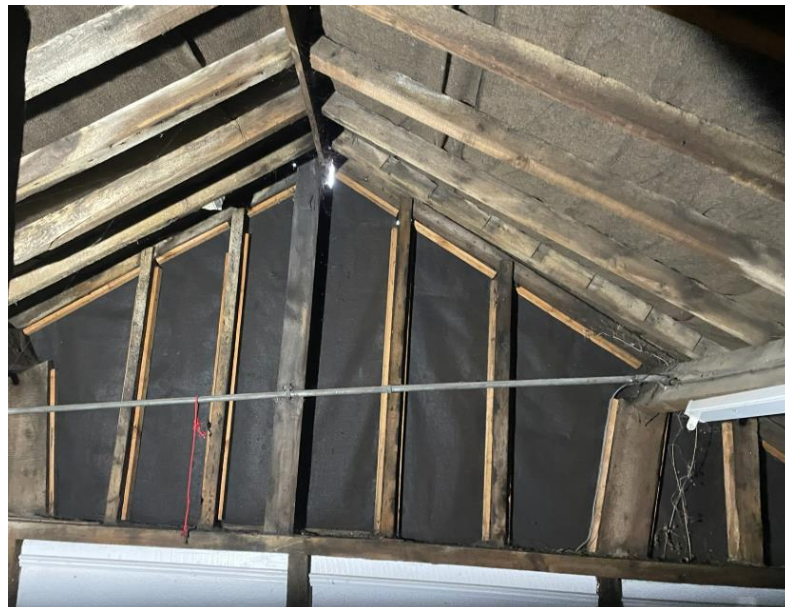
#### 2.4.4 East Elevation

2.4.4.1 Timber studwork exposed internally supporting timber purlin and ridge members with studs located approximately 600mm centres bearing onto a beam at eaves level.

2.4.4.2 No evidence of significant deviation to the internal face of the members.

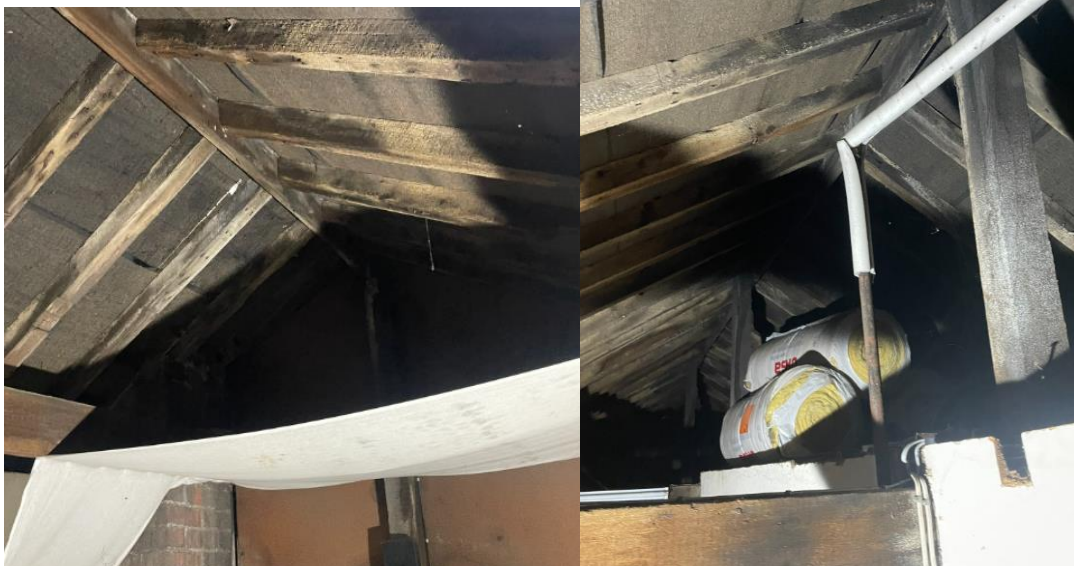
2.4.5.5 The rafters between Truss No1 and Truss No2 had minor section loss at the foot of the roof below the eaves beam. The eaves beam had suffered from historic water ingress and was deviating along its span.

2.4.5.6 The primary bottom chord and inclined struts to Truss No 2 were in good condition. The eaves beam at the North elevation bearing point was deflecting. Finishes obscured observation to the South elevation.

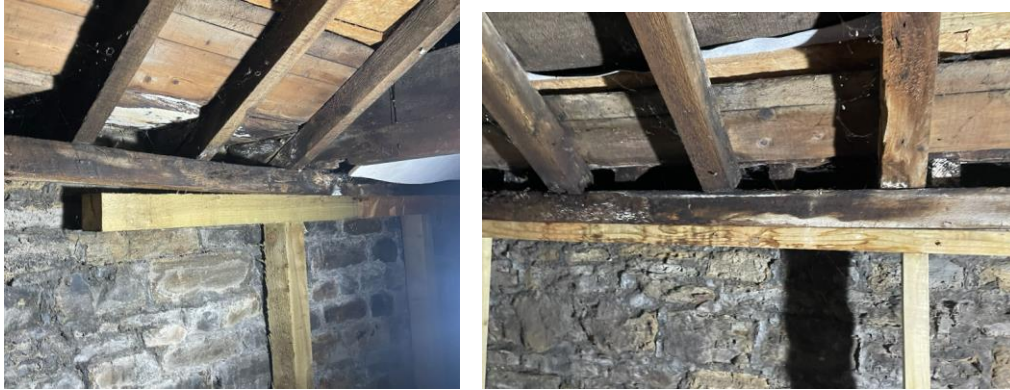
2.4.5.7 The rafters between Truss No2 and Truss No3 had minor section loss at the foot of the roof below the eaves beam. The eaves

beam had suffered from historic water ingress and had been subject to local repairs

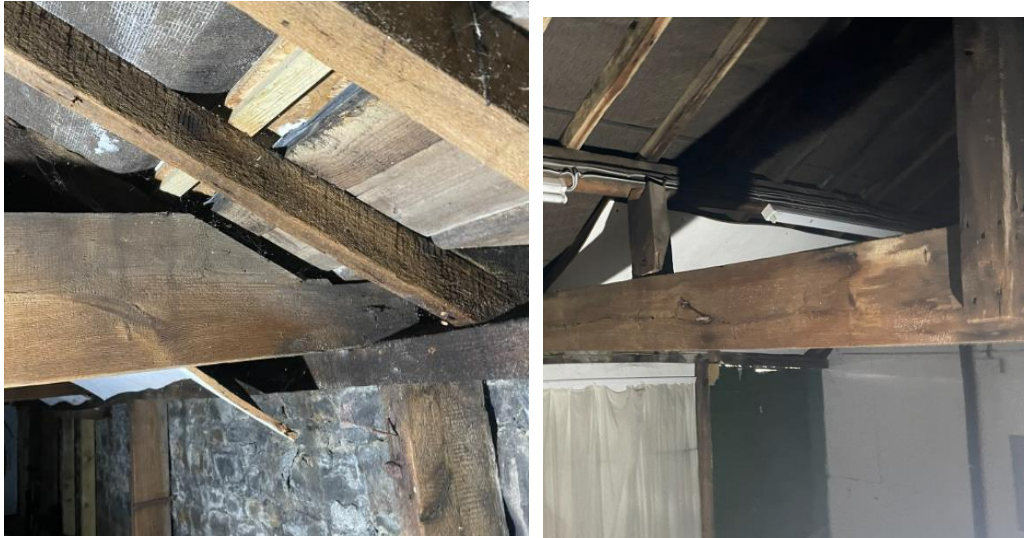
2.4.5.10 The truss bottom chord to Truss No 4 had slipped away from the timber eaves beam. There was minor separation of the supporting trusses over

4.3.2.2 Relocate slipped trusses and inclined support struts on neighbouring trusses.

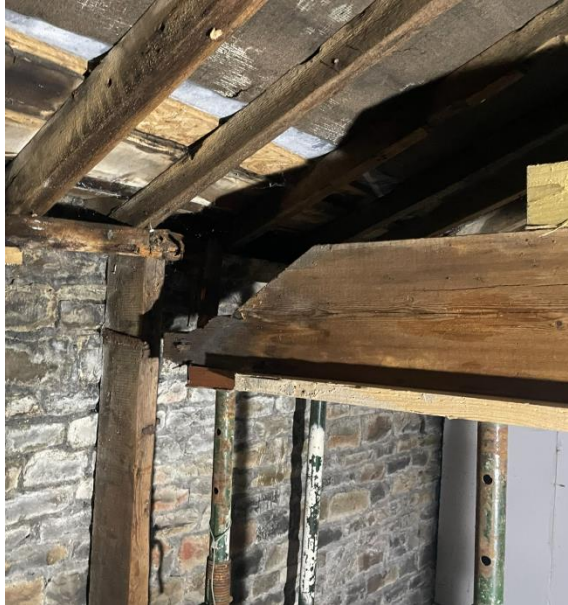
2.4.5.11 The timber eaves beam to the base of the North elevation rafters was deflected and suffered from water ingress. The rafters had suffered from deflection from the movement of the purlins and ridge caused by Truss 5 springing failure.

2.4.5.12 The bottom chord of the Truss No 5 had failed at the springing point from the North elevation eaves beam. The member was completely away from the support position and was propped prior to the visit. The supporting struts had pulled away from their position, resulting in the movement of the purlins, ridge board and local rafters downwards. The failure had also

caused thrust outwards to the timber stud wall to the South elevation.

4.3.2.1 Replace Truss 5 and supported deflected purlins either side.

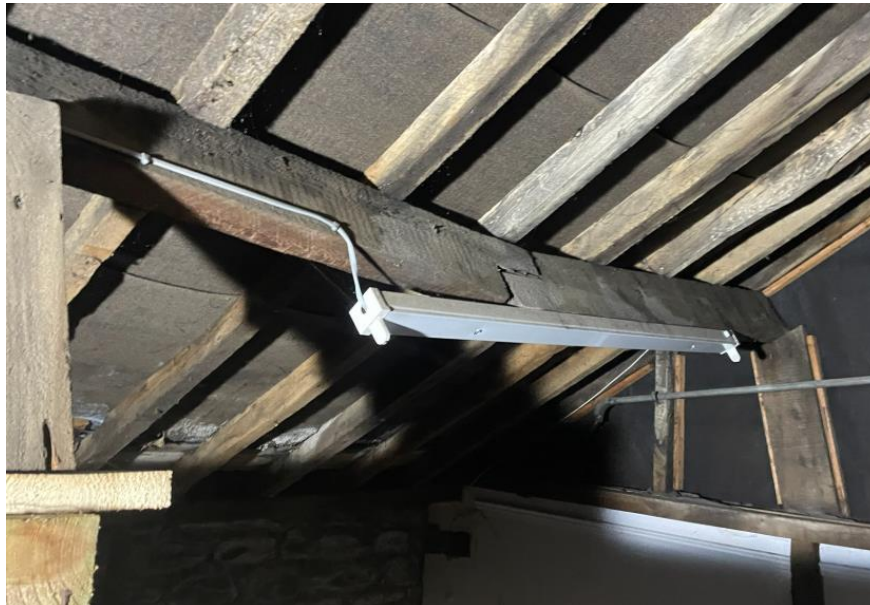
2.4.5.13 The rafters between the Truss No 5 and East elevation wall were supported by two purlins which had failed under deflection. The purlin to North elevation had failed at the splice position, which was poorly located at the centre of the span.
