**13 Whitehill Lane, Royal Wootton Bassett, SN4 7SB**

**Arboricultural Report containing:**

*Prepared by:*  
**Deb Randall BSc TechArborA**  
**Arboricultural Consultant**  
**March 2026**

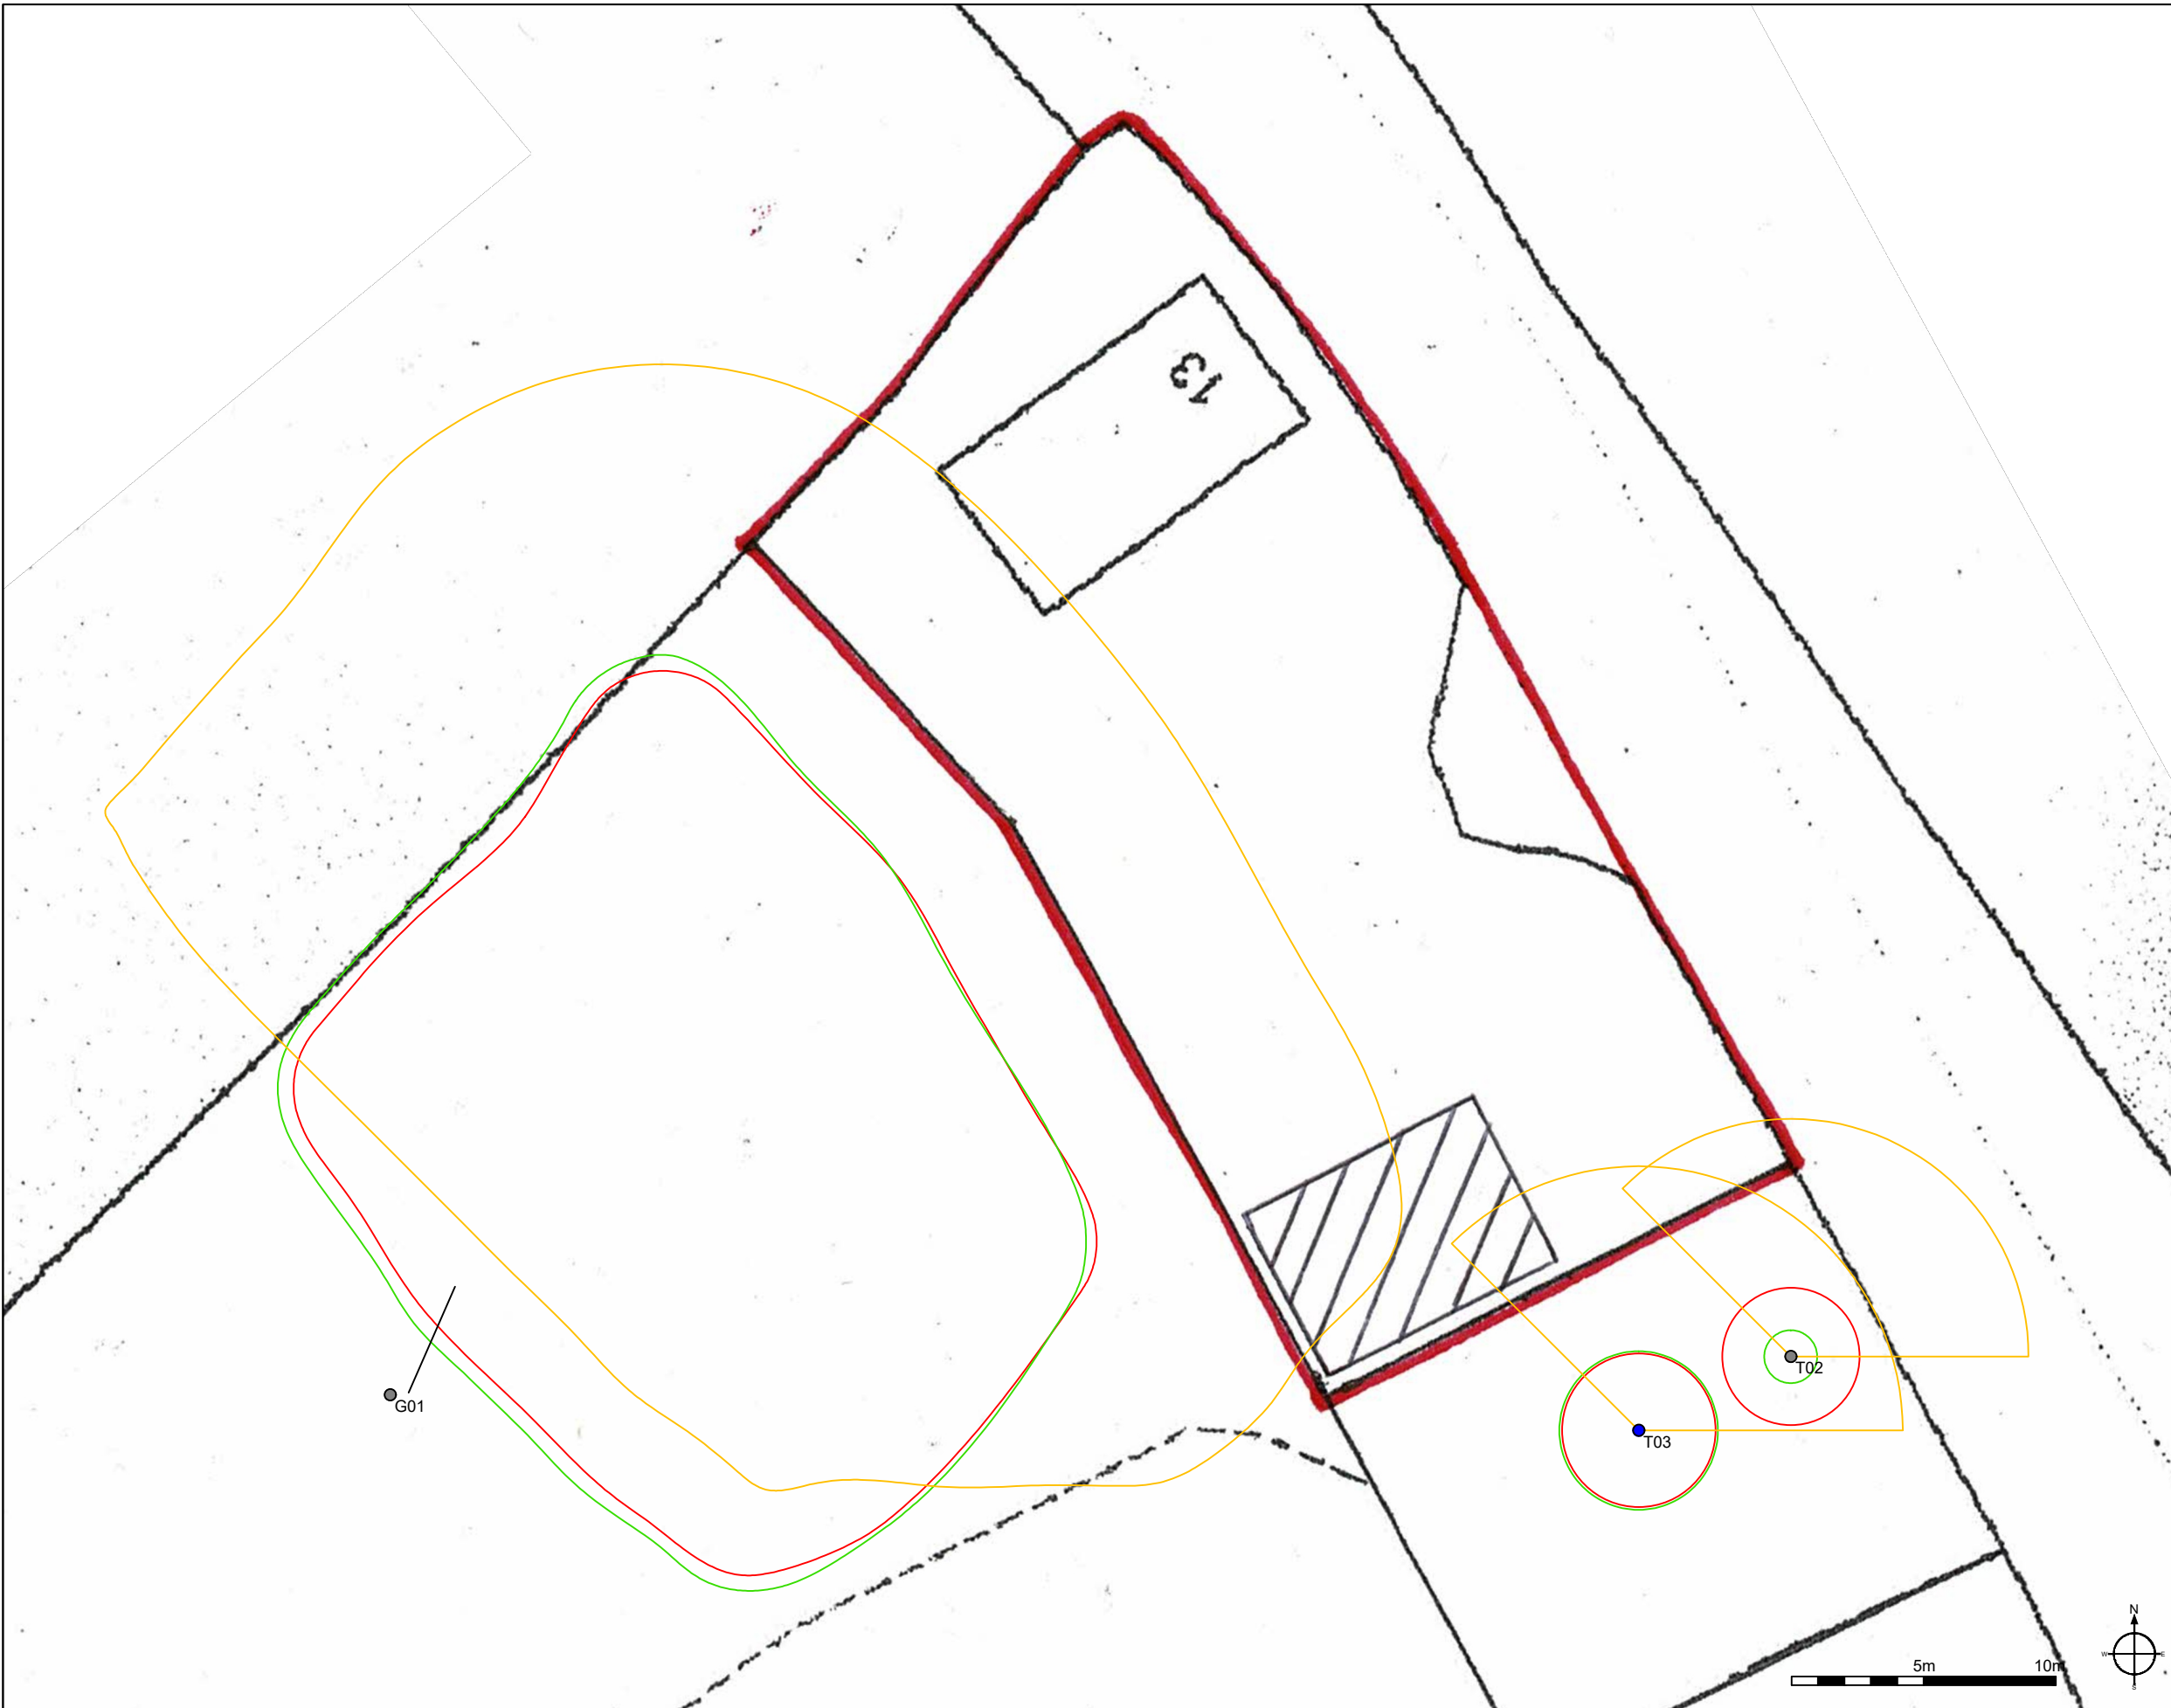
Drawing Title: Arboricultural Impact Assessment 1:250 at A3

**The approximate sweep of shadows cast by the retained trees, in midsummer, is plotted on the Arboricultural Impact Assessment Plan (260305-WL-AIA-SD), as described in BS5837: 2012. There are no shading issues associated with the proposed development.**

- 8.0.1 Below ground protection measures, based on the root protection areas (RPA), indicated in the Tree Constraints Plan, will involve the retention of the existing wooden boundary fence around the site. The existing boundary is illustrated in Arboricultural Impact Assessment Plan (Drawing Number 260309-WL-AIA-Rev A-SD) (appendix 3).
- 8.0.2 The potential position of tree roots as indicated in the Arboricultural Impact Assessment Plan are only guidelines based on calculations shown in BS5837:2012 'Trees in relation to design, demolition and construction – Recommendations'.

The Arboricultural Impact Assessment Plan indicates the location of the existing boundary and fencing. It is considered the fencing will be sufficient to prevent any unauthorised access into the RPA of the trees during the development works. These barriers will create a Construction Exclusions Zone (CEZ) around the retained trees. The fencing will be retained and maintained in position for the duration of the development.
