Beech House, Urchfont, SN10 4QN

## 1: Context

This application only relates to the existing brick boundary wall to the North East roadside elevation.

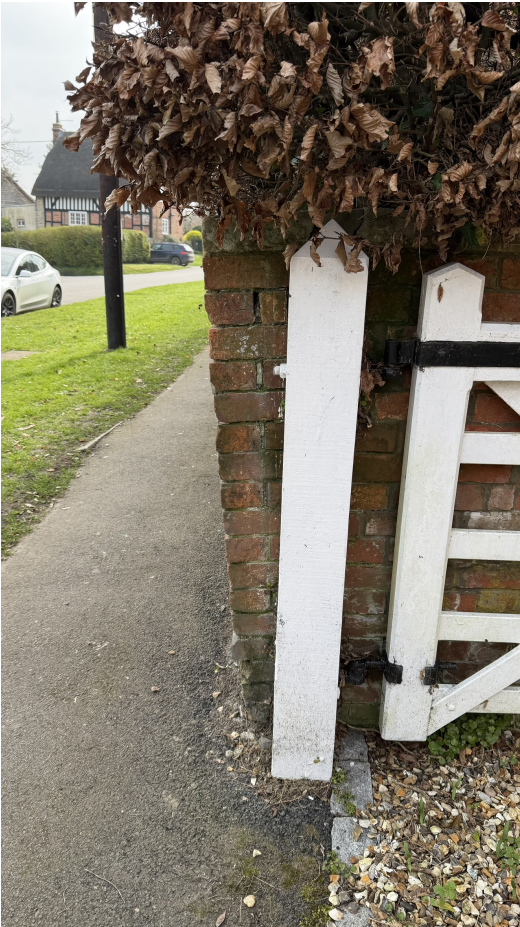
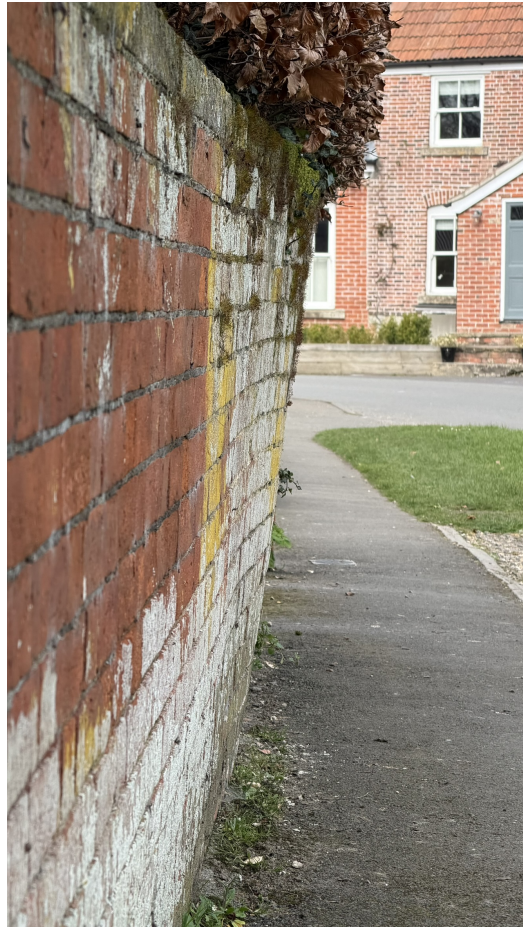
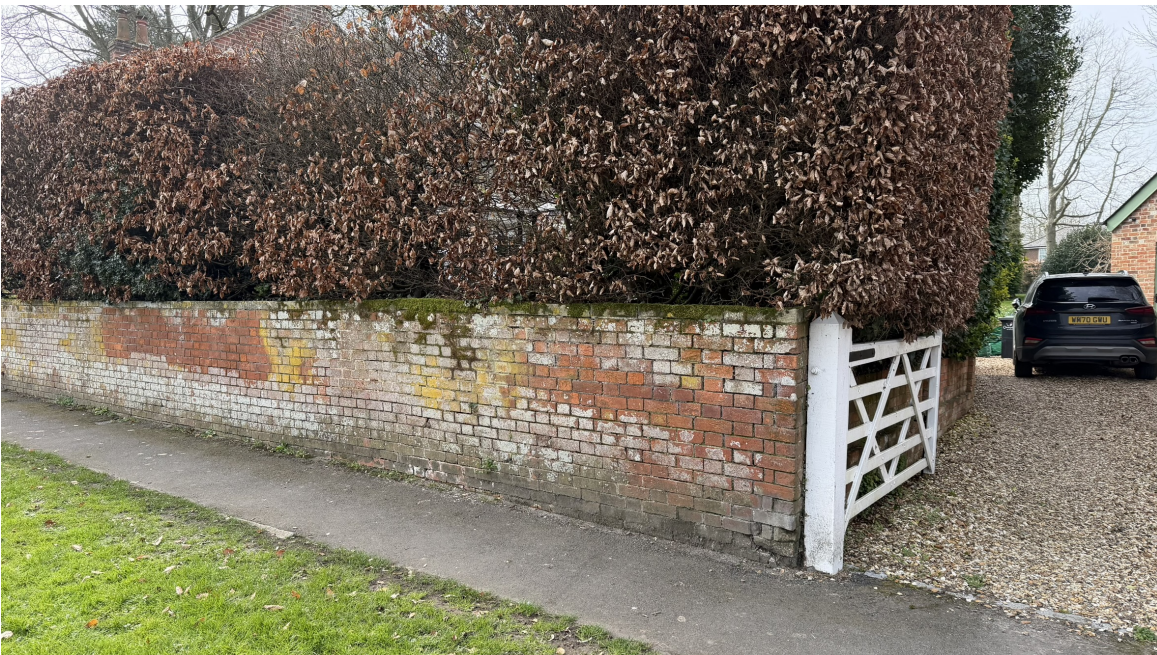
Existing photos.

The existing brick wall along the front boundary is a Flemish Bond double width brick wall with a stone coping and provides limited retaining to the garden level and hedgerow to Beech House.

The wall has bowed and leaning towards the roadside close to the driveway entrance and is now at an angle that needs attention.

The existing wall as shown, will be carefully taken down to ensure as many bricks are reclaimed as possible. Excess lime will be carefully removed whilst protecting the front face to maintain the aged patina.

The wall will be taken down to path level and any excess spoil and roots removed to provide a working space behind. The wall will be rebuilt using traditional lime mortar and the reclaimed bricks. Further reclaimed bricks to match will be sourced if required and used on the back face. Any recess behind the rebuilt wall is to be backfilled with pea shingle.
