Planned removal of secondary trunk of Beech Tree to the South West of 8 Foscote Cottages, Grittleton.

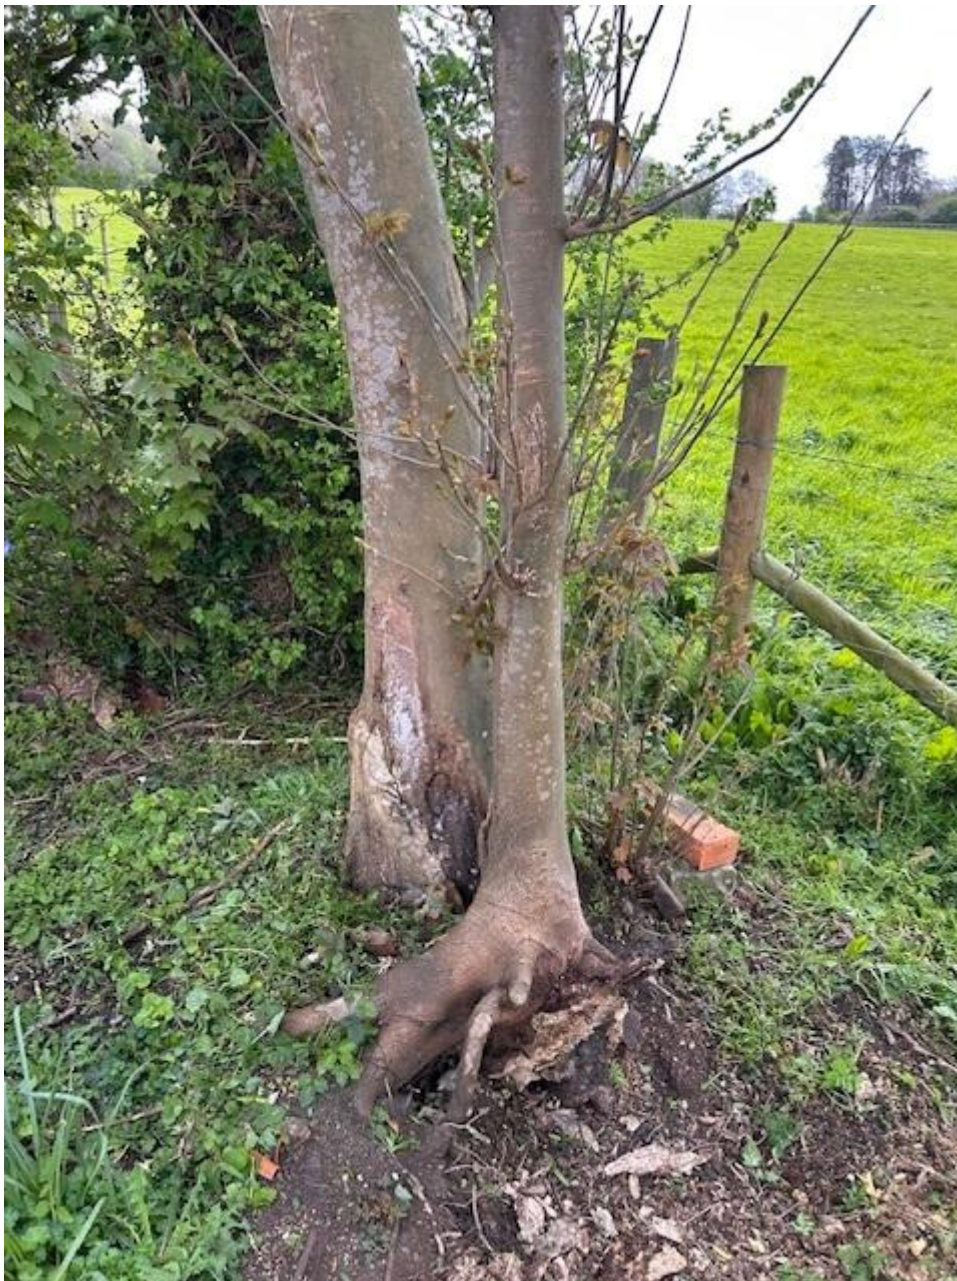
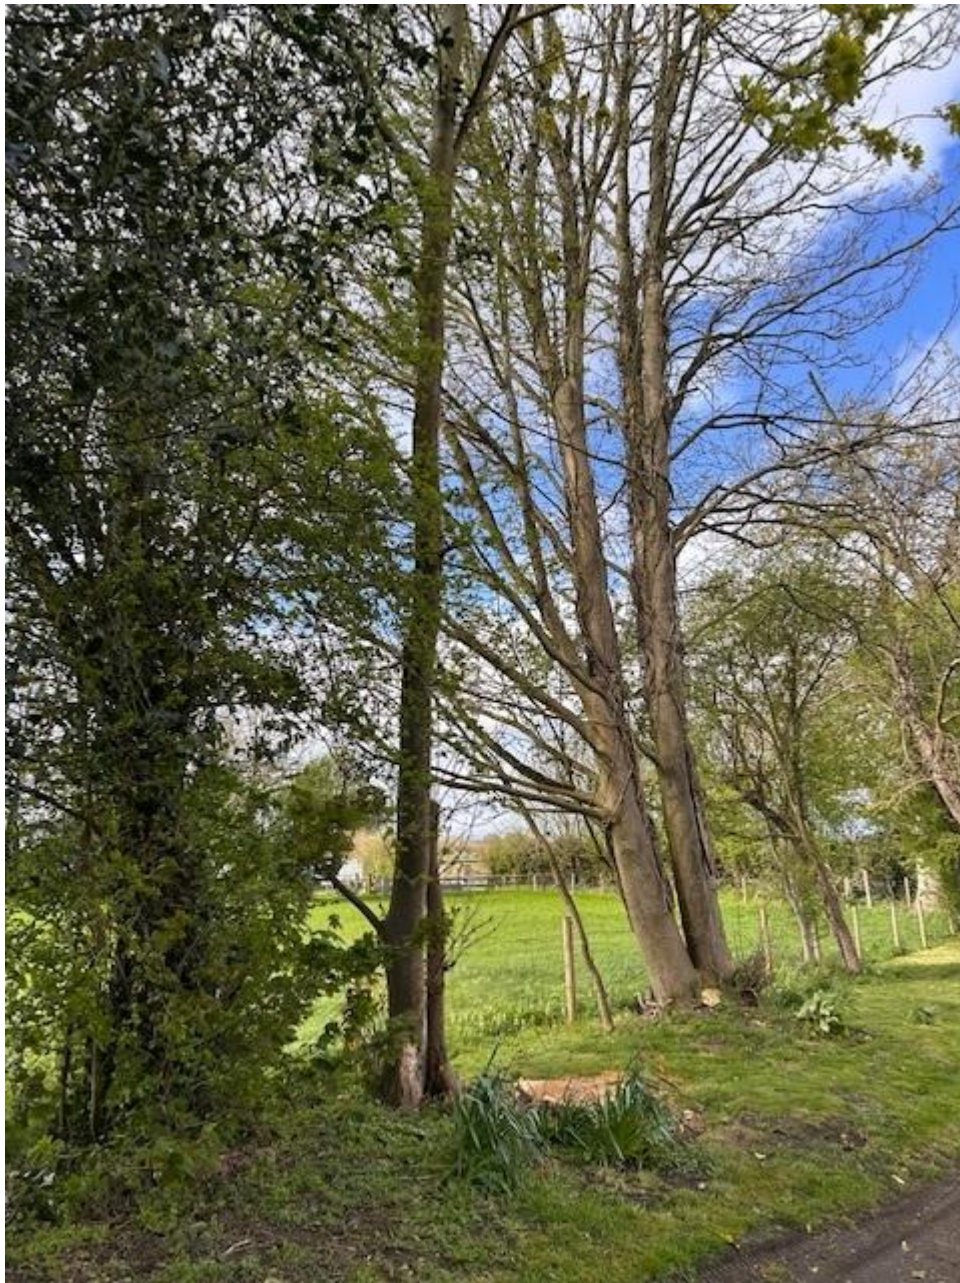
The attached images show the remaining section of a beech tree at 8 Foscote Cottages, that the applicants Mr & Mrs J Wilding seek permission to have cut down and removed from the property entirely.

The tree is recommended for removal by a qualified tree surgeon on safety grounds. The primary trunk has previously died and has already been felled/ storm damaged, leaving behind a secondary stem that is structurally compromised.

This residual growth is not adequately anchored into the ground, as it originates from the weakened and decayed base. The root system has likely been destabilized following the loss of the main trunk, reducing the tree's overall structural integrity. Visible signs of

decay and poor attachment at the base further indicate that the remaining section is unlikely to withstand adverse weather conditions such as strong winds.

Due to these factors, the tree presents a foreseeable risk of failure, which could result in damage to nearby property, fencing, or pose a hazard to people in the vicinity.

Removal of this section is therefore justified as a necessary risk mitigation measure to ensure safety and prevent potential harm.
