# ***Design and Heritage Statement***

Roof repairs, window repairs, replacing the front doors, and  
foundational works

2-4 Pewsey Road

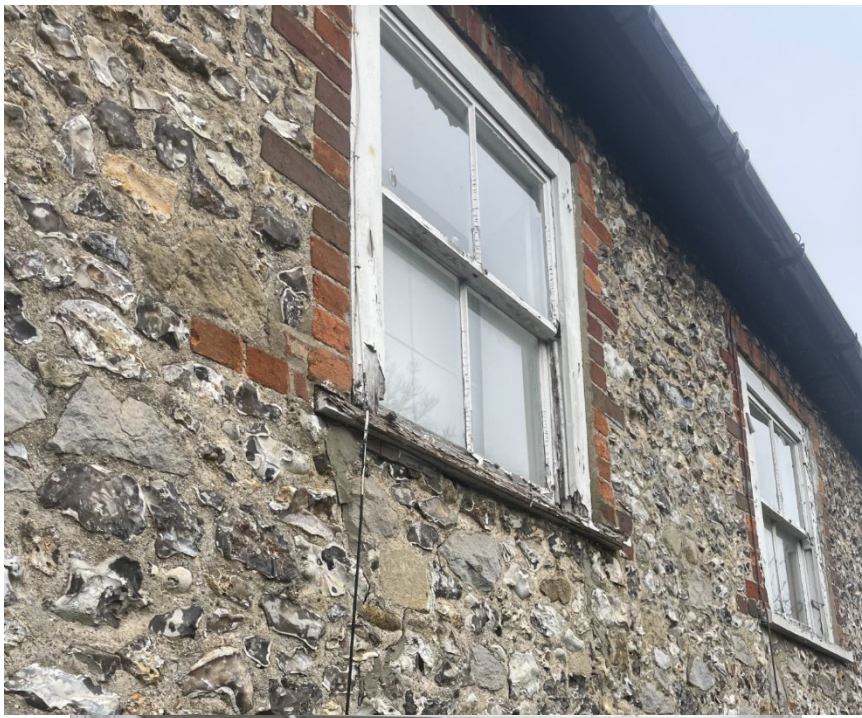
At 2, 3 and 4 Pewsey Road, there are several sash and casement windows that require localised timber repairs and redecoration; some of the window sills are in poor condition and require remedial works and redecoration. Refer to image 1(below), drawing MC/PR/NSED/01 Pewsey Road North & South Elevations and drawing MC/PR/EWED/01 Pewsey Road West & East Elevations.

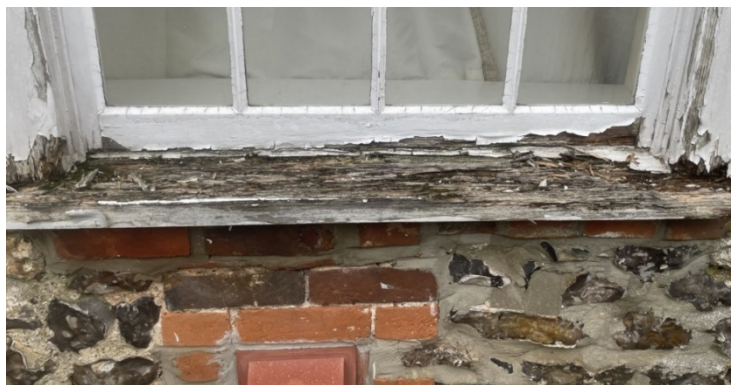
The sash window that is located top left of the southern elevation on 2 Pewsey Road is considered irreparable due to the extent of timber decay. It is proposed that this window be replaced on a like-for-like basis, replicating the existing glazing pattern, moulding profiles, sections and detailing. Refer to Image 2(below). Please refer to drawings MC/2PR/SWD/01 & MC/2PR/SWD/02. Sash Window Detail & Sash Window Section Detail.

*Image 2: Sash window to be replaced.*

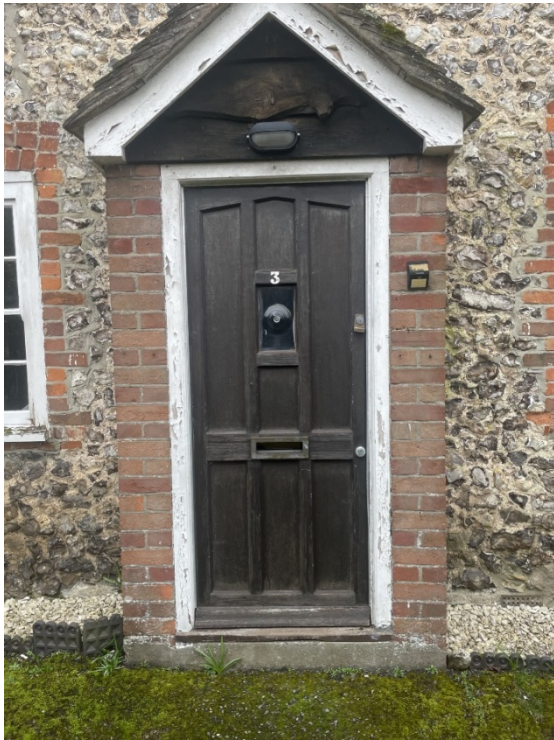
As mentioned on the Historic England listing, 2 and 3 Pewsey Road have modern doors set inside porch structures. Refer to Images 3 and 4(below).

*Image 3: Front door of 3 Pewsey Rd*

It is proposed to replace the existing modern-style entrance doors at Nos. 2 and 3 Pewsey Road with cottage-style six-panel glazed timber doors. The proposed doors will be of traditional design, constructed in painted timber, and detailed to reflect the character and appearance of the historic cottages. Refer to images 5 & 6. Please refer to drawing MC/PR/FDD/01 Pewsey Road Front Doors.

We will carry out minor repairs to the frame of 3 Pewsey Road, but not 2 Pewsey Road, as it seems to be in good condition. Ironmongery will be upgraded. Hinges to polished brass, handles will be antique black Tudor euro lock; these match the existing style that is on 4 Pewsey Road. We will reuse the existing night latches that are already in place. Refer to image 5.

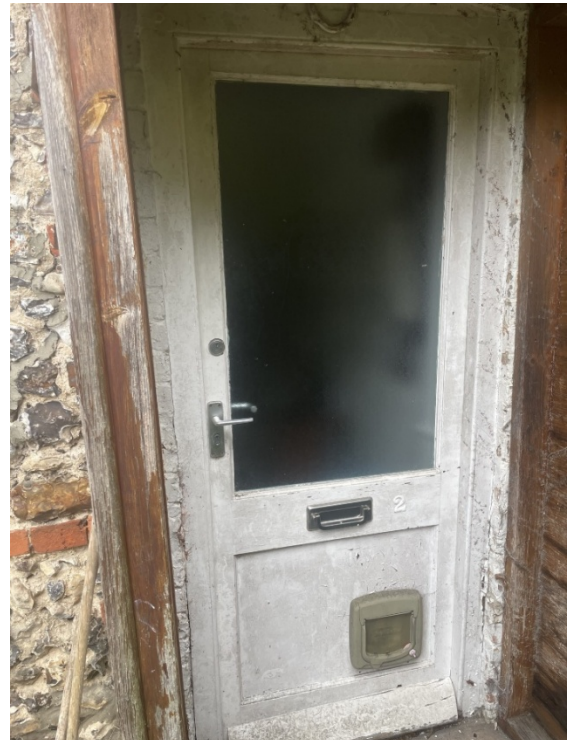
*Image 4: Front door of 2 Pewsey Rd*

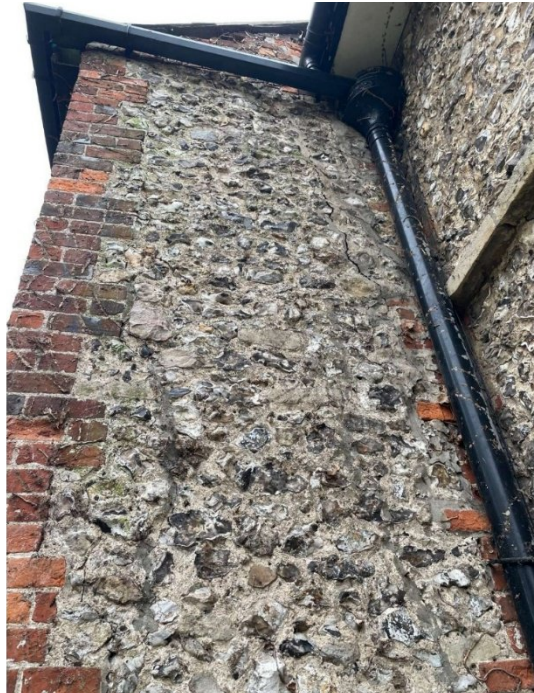
In 2024, a survey was carried out by Perega, an independent civil and structural engineering consultant, as signs of subsidence were quite visible on the Pewsey Road cottages. There are historic cracks on the walls of 2 and 4 Pewsey Road, which have been infilled with mortar in the past. Refer to images 7 & 8(below). Internally, these cracks are also visible. As identified in image 9.

The historic cracks have further developed in recent years. The structural engineer who carried out the survey suggested the use of underpinning. The method suggested was traditional hit-and-miss concrete. This is quite a labour-intensive method, which also presents risks as significant excavation is required. It can potentially damage the properties even more, affect landscaping, and create noise pollution.

*Image 7: Crack on 2 Pewsey Road flank return*

After some consideration, we feel that the non-invasive solution of resin injection would be a better option to pursue, rather than the traditional concrete underpinning. Major excavation will be eliminated, which in turn minimises risk to the properties, residents, general public and the landscape.

The external cracks can be repaired using a sand lime mortar.

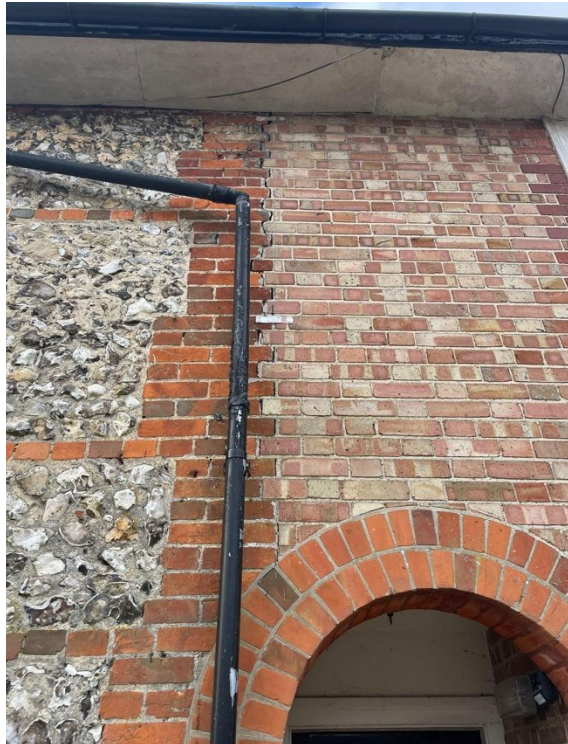
*Image: 8 External crack on 4 Pewsey Road*

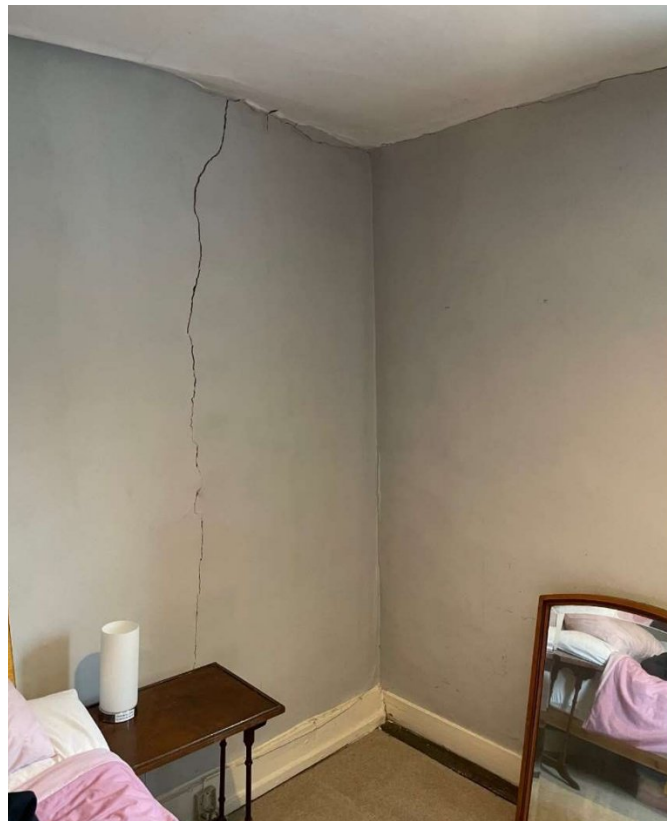
*Image 9: Internal crack on 2 Pewsey Road*

We haven't completely dismissed the first report; we feel the wall stitching aspect suggested could be beneficial. We propose to install helifix stitching bars. This is done by cutting 10mm

wide slots into the base masonry, via the mortar bedjoints of the brick courses, fitting the steel bars at a spacing of 300-450mm(4-6 brick courses) from the base of the wall to the top, mortaring the bars in place and then re-plastering.
