PROJECT 3 Northgate Street

DRAWING STATUS Listed Building Consent

DRG TITLE Existing Ground Floor Plan  
Showing Repairs

JOB/DRG No. 496/102

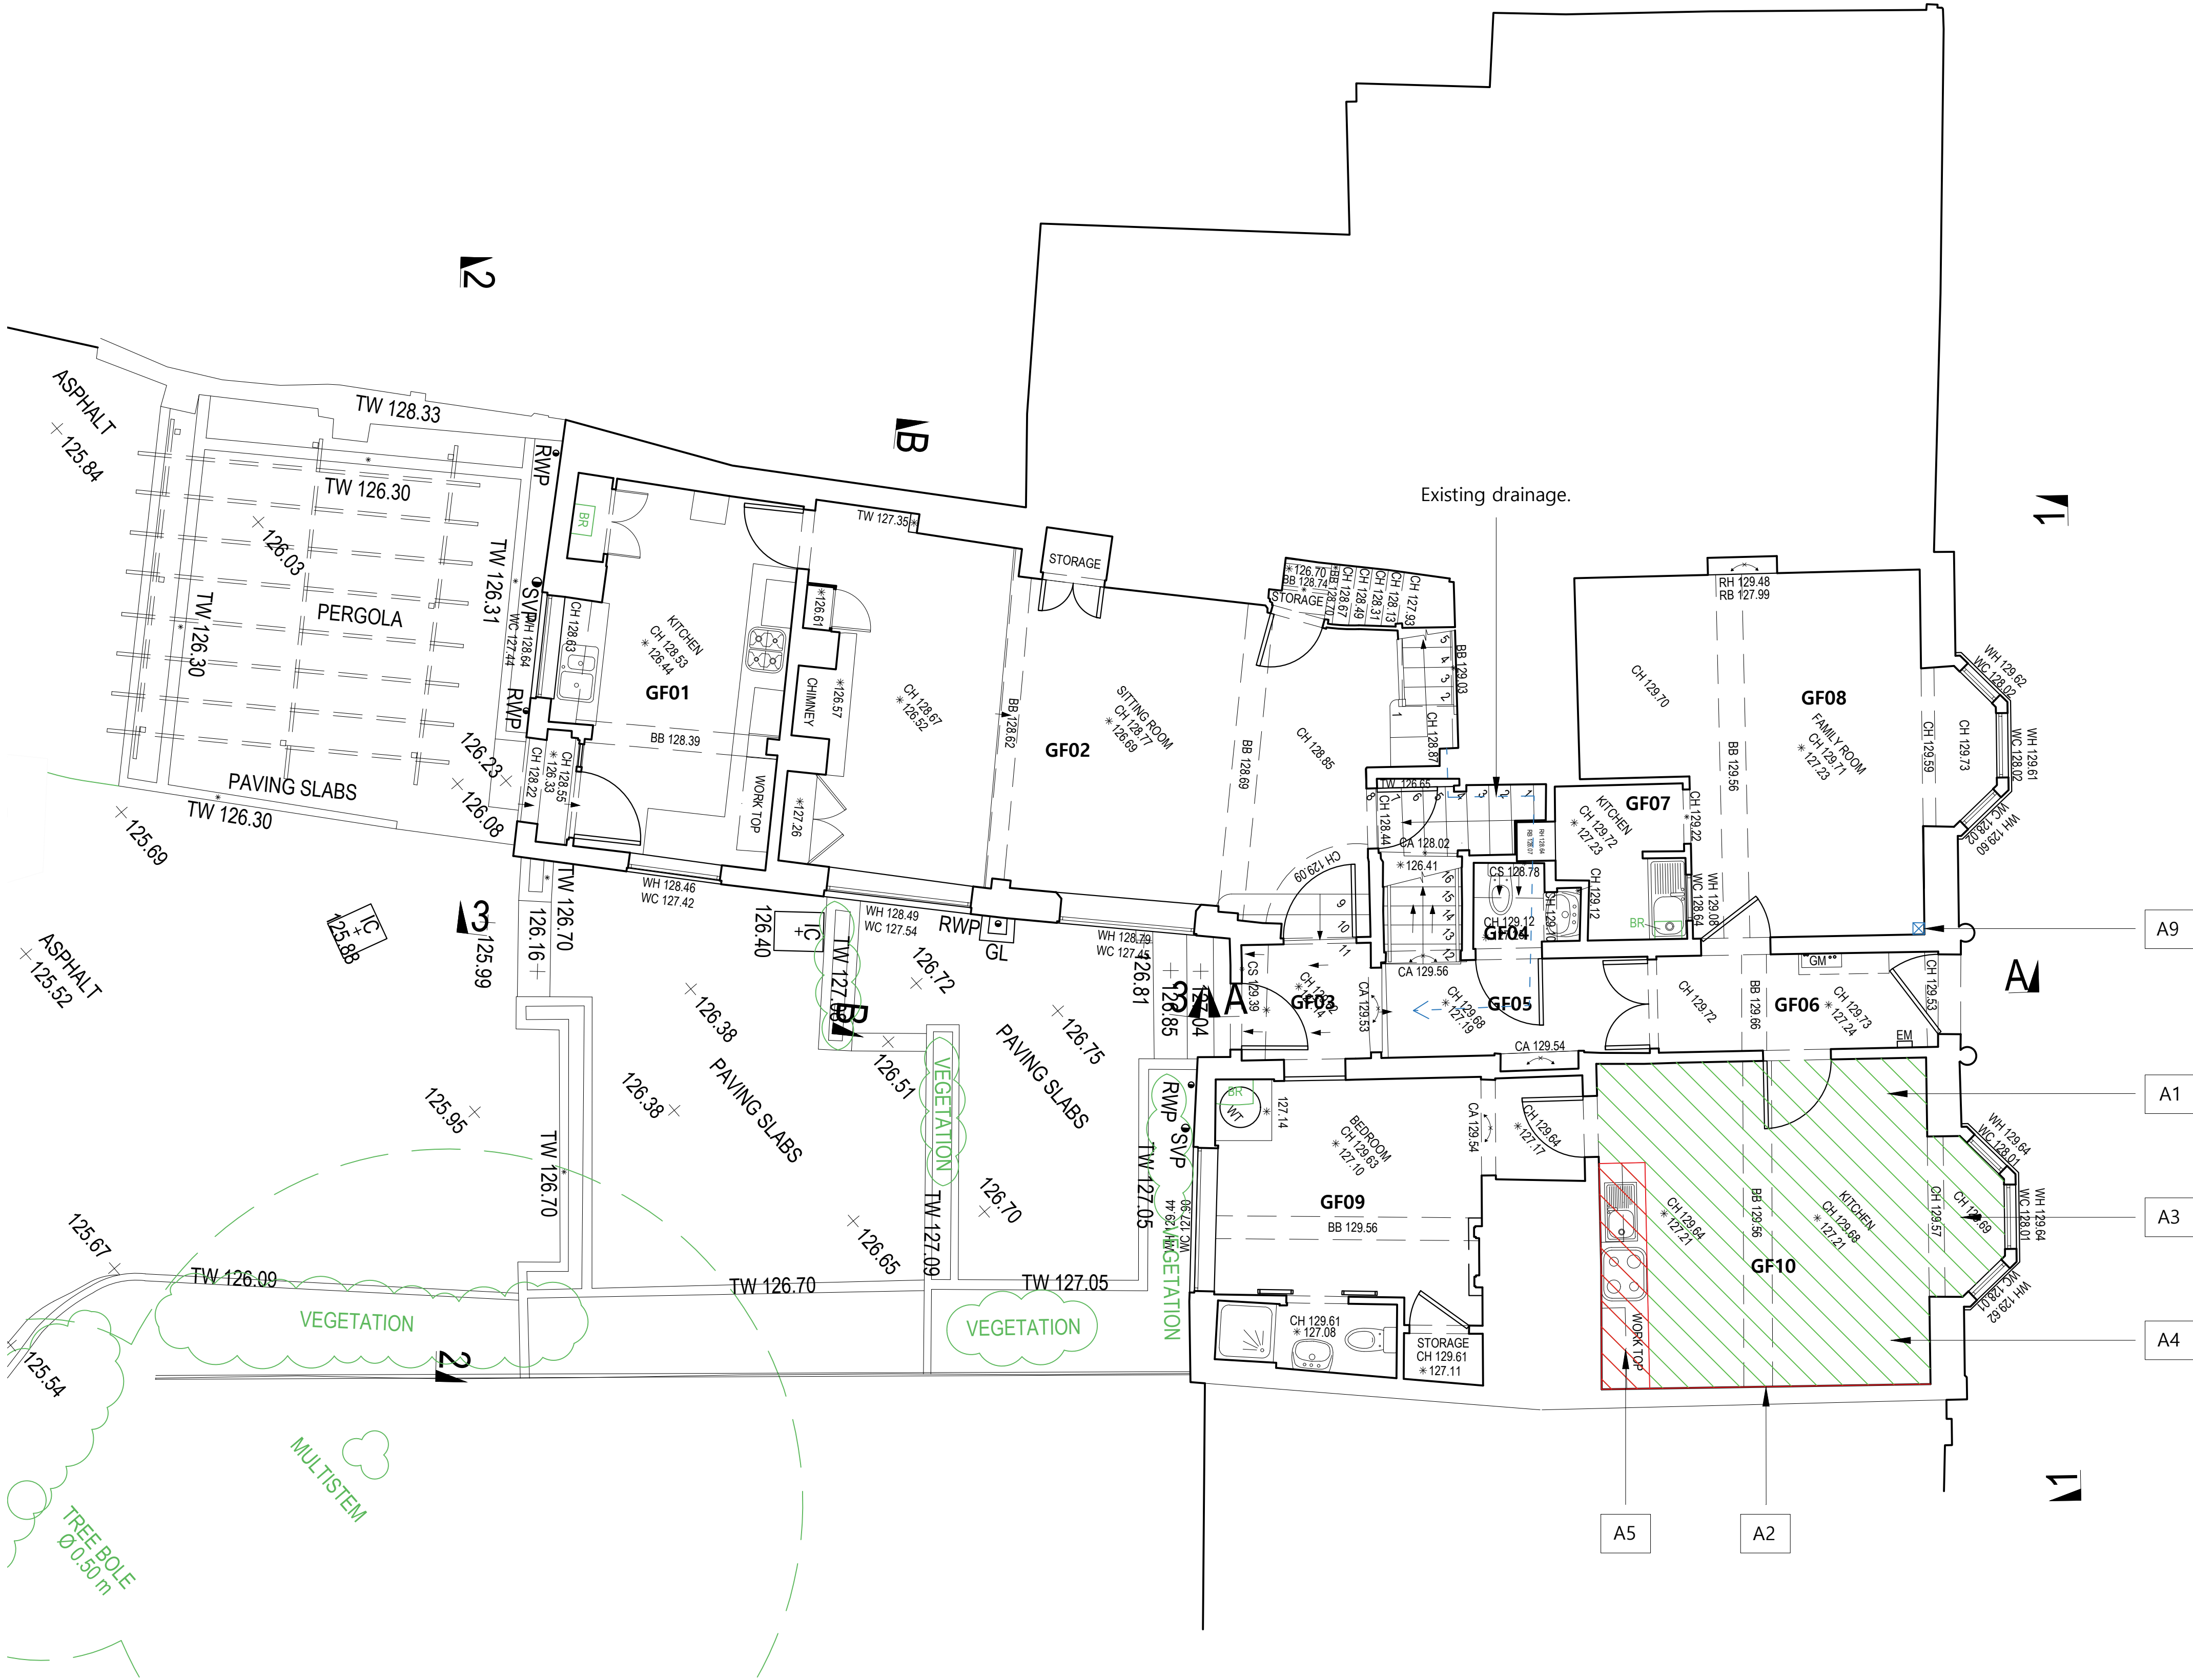
1.0 Existing Ground Floor Plan Showing Repairs

Repair water damaged floorboards.
- A2

Remove plaster and existing laths to wall to inspect timber frame for repairs. Replace laths and replaster in lime.
- A3

Remove plaster and existing laths to ceiling and failed sections of cornice. Replace laths and replaster in lime.
- A4

Mould to be taken of all existing cornice. All cornice to be repaired following repairs to ceiling.
- A5

Remove kitchen units.
- A9

New soil and vent pipe from SF to connect to existing drainage. To vent to roof above.
