| <b>PROJECT</b> | 3 Northgate Street | <b>DRG TITLE</b> | Existing Second Floor Plan<br>Showing Repairs |
| <b>CLIENT</b> | Private Client | <b>JOB/DRG No.</b> | 496/104 |
| <b>DRAWING STATUS</b> | Listed Building Consent | <b>SCALE</b> | 1:50@A1 1:100@A3 <b>REVISION</b> C |

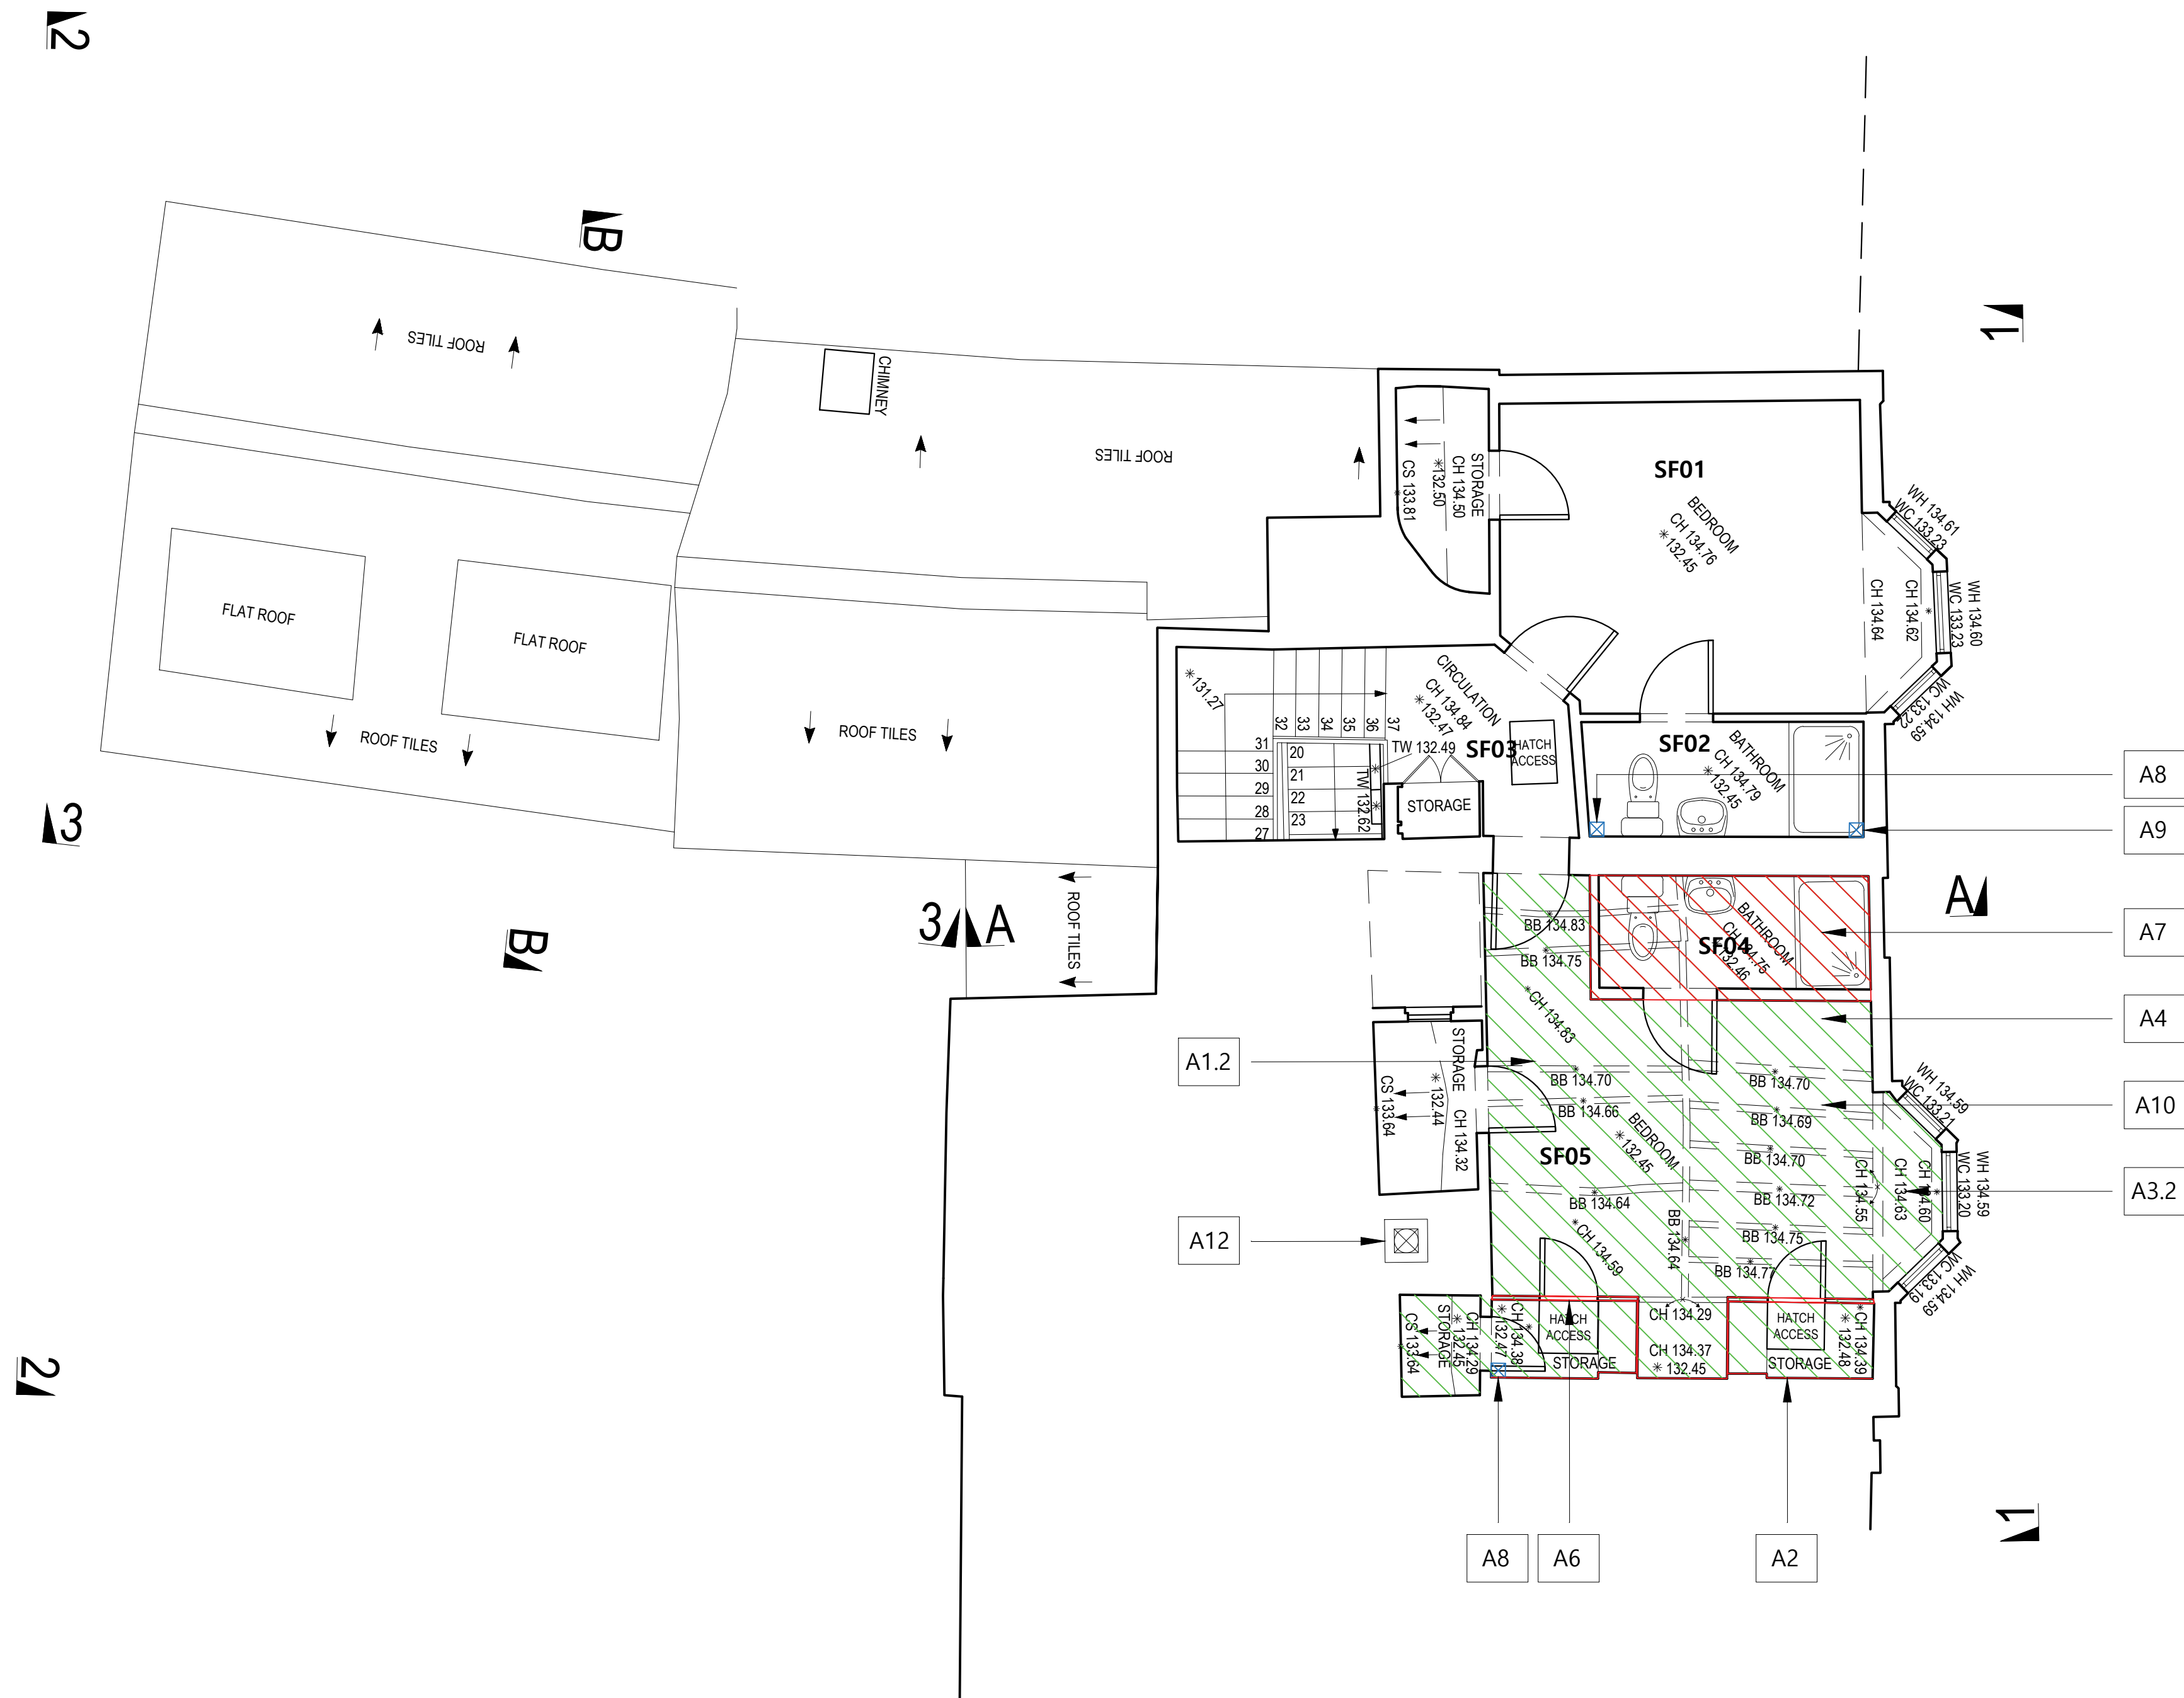
| A1.2 | Replace 100% water damaged floorboards owing to prolonged exposure to water ingress. Boards to be replaced like for like i.e. from evidence of surviving boards or boards to match the floor below. |
| A3.2 | Repair existing ceiling structure including reinstatement of existing ceiling joists to structural engineer's details. Provide new lath and plaster to underside of ceiling. |

| A2 | Remove plaster and existing laths to wall to inspect timber frame for repairs. Replace laths and replaster in lime. |
| A4 | Mould to be taken of all existing cornice. All cornice to be repaired following repairs to ceiling. |
| A6 | Remove cupboards. |
| A7 | Remove bathroom partition and sanitaryware. |
| A8 | Provide new vents in ceiling. To vent to roof above. |
| A9 | New soil and vent pipe. To vent to roof above. |
| A10 | For structural alterations to roof see drawing 501. |
| A12 | Existing flue to be reused and reinstated. |
