**URCHFONT GARAGE, URCHFONT, DEVIZES,  
WILTSHIRE, SN10 4QH**

**TREE SURVEY, ARBORICULTURAL IMPACT ASSESSMENT  
AND TREE CONSTRAINTS PLAN  
FOR  
PROPOSED RESIDENTIAL DEVELOPMENT**

**On behalf of  
GAIGER BROS LTD**

**REF: 23.1742**

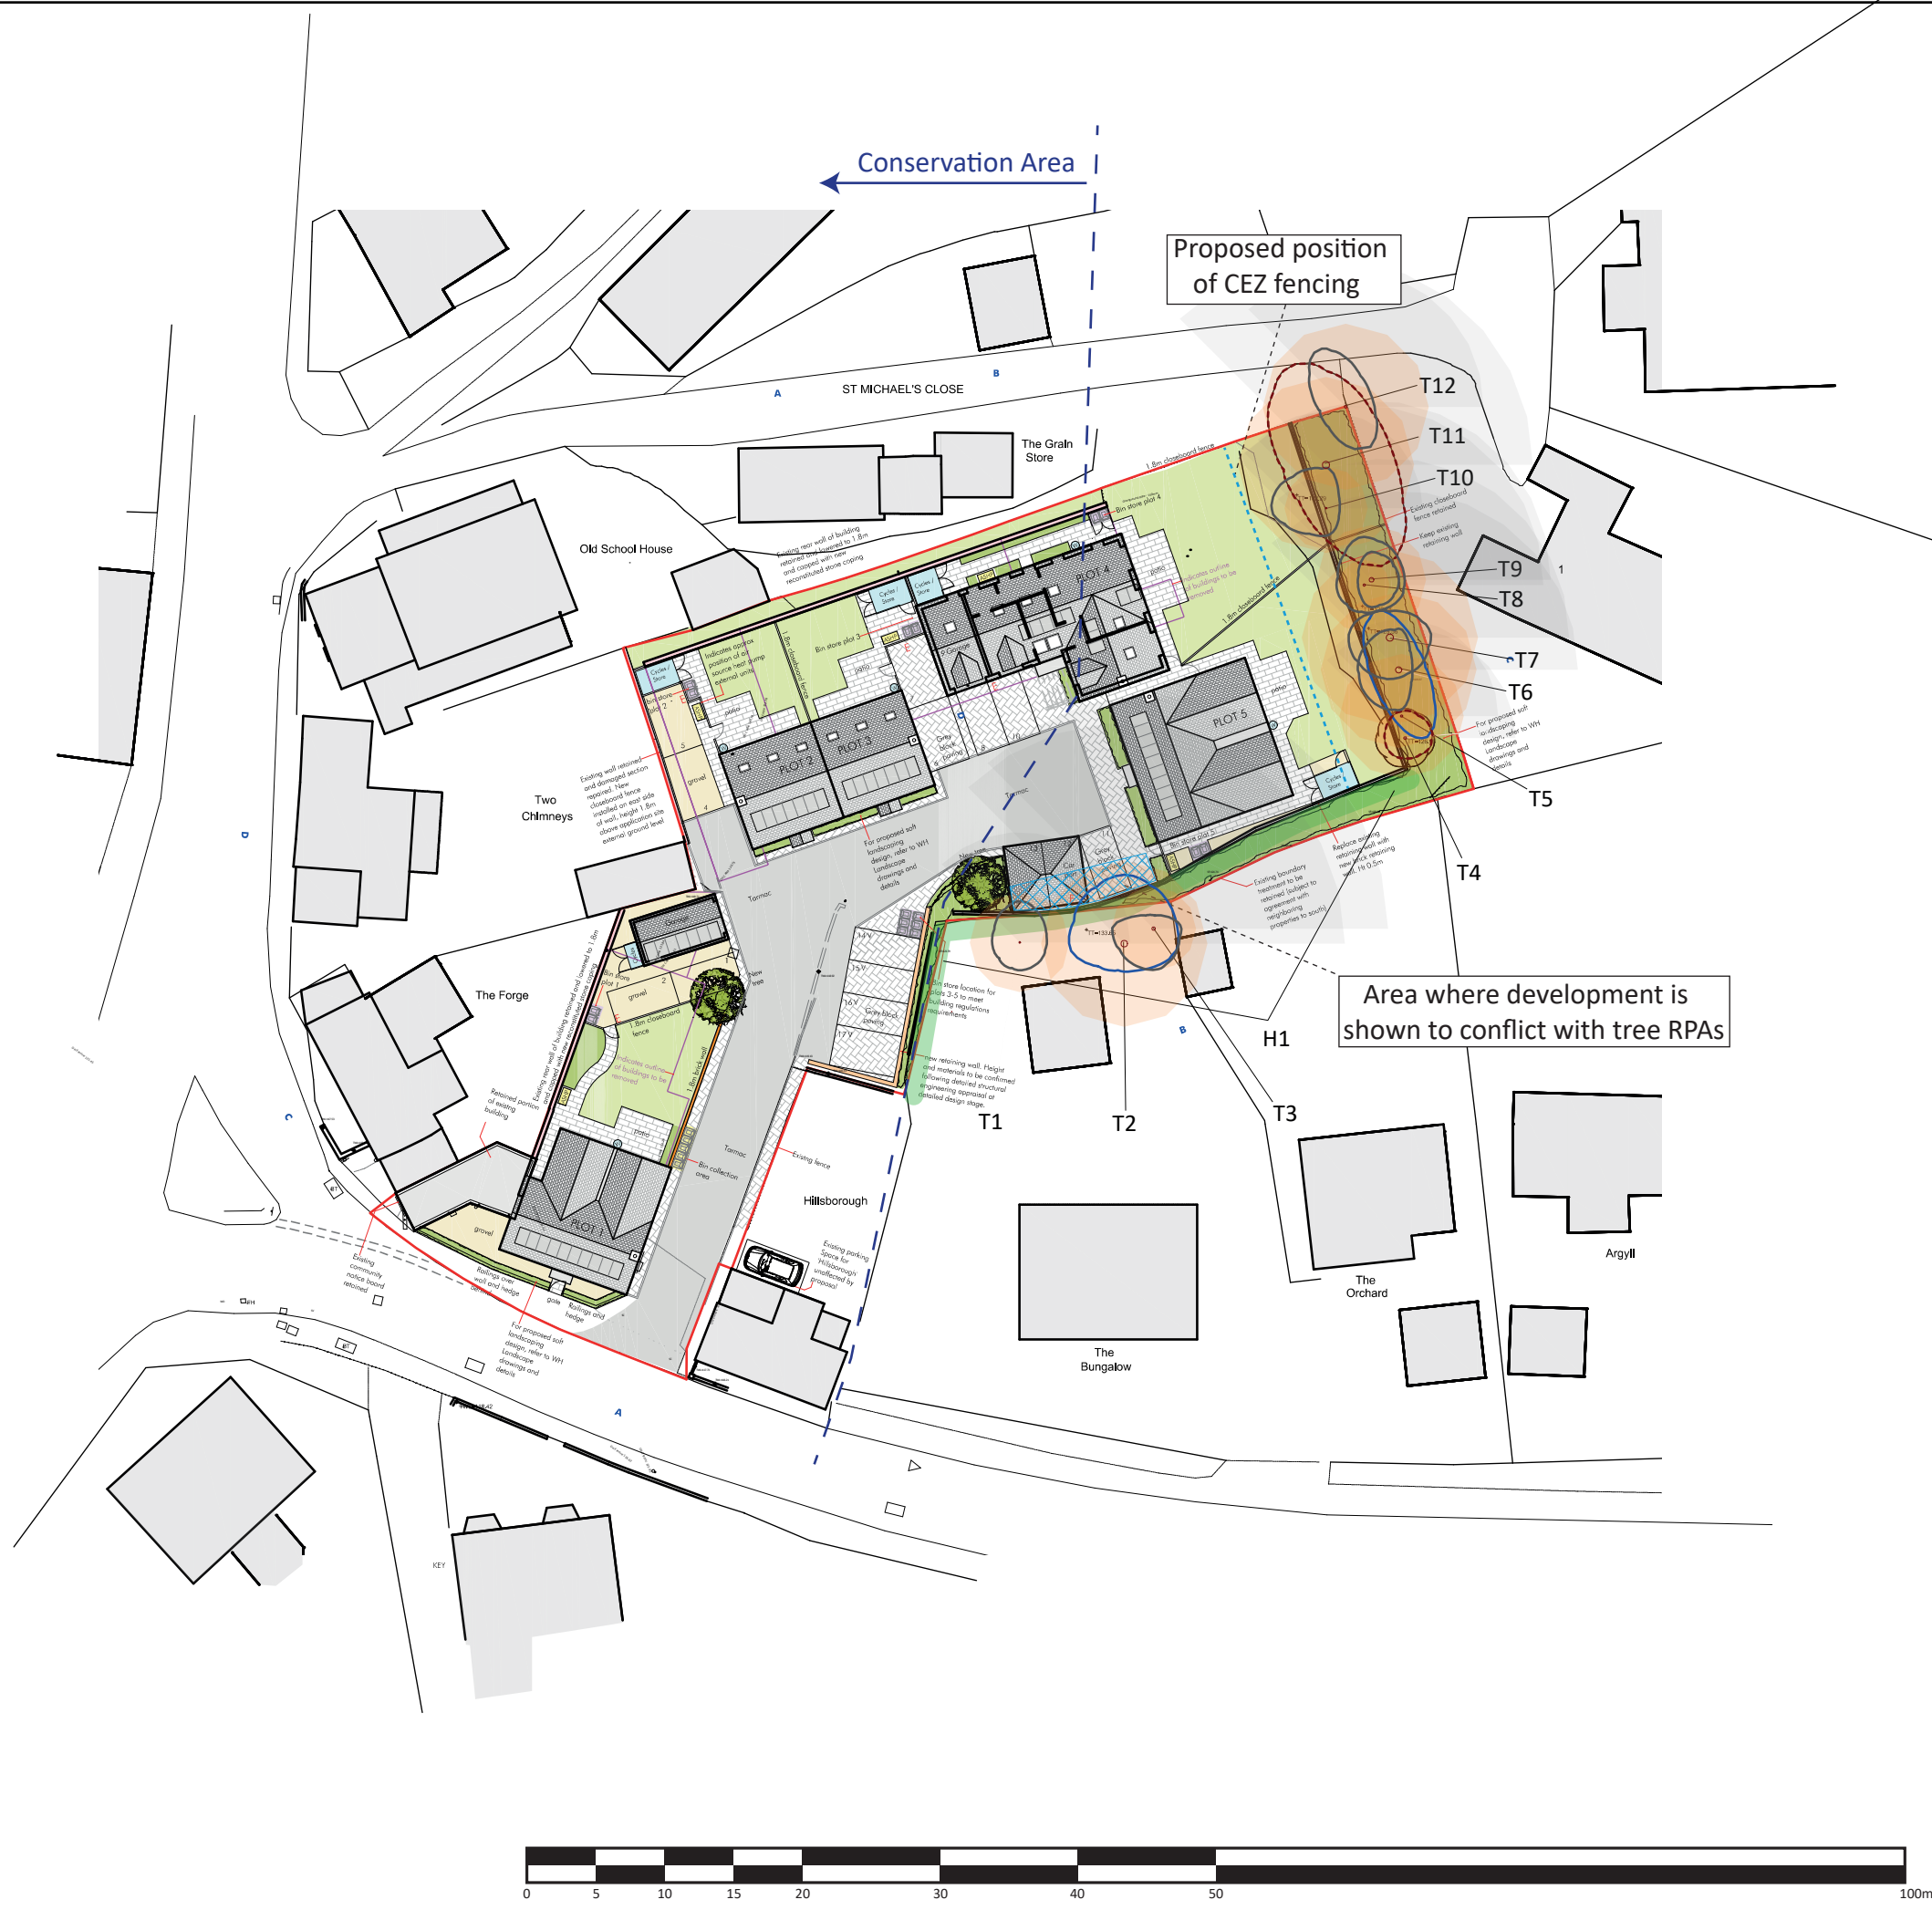
ARB-1742-02: TREE CONSTRAINTS PLAN (DESIGN OVERLAID)

**6.6** It is assessed that conflict between the proposed replacement of hardstanding with block paving to the west of plot 5 and the construction of a car port does not conflict with the RPAs of off-site trees T1 & T2. However, the recommendations in para 5.7 will need to be followed during the replacement of the retaining wall in proximity to trees T1-T3 to reduce potential negative impacts to be inflicted on these trees.

**5.6** The replacement of the section of retaining wall that runs through the RPAs of T1-T3 on adjacent land will need to be undertaken to a methodology which reduces the potential for the root systems of these trees to be damaged during the construction process. Ground beyond the southern profile of the wall must remain intact and not be excavated during this process once the existing wall is removed. An impervious membrane will also need to be established between the new wall and the ground to the south within the RPAs of these trees to ensure that concrete leachate resulting from the works do not contaminate the ground within the RPAs of the adjacent trees.
