# Heritage Statement: Units 2, 3 and 4

47 Blue Boar Row,  
Salisbury

April 2026 | Project Ref 10630A

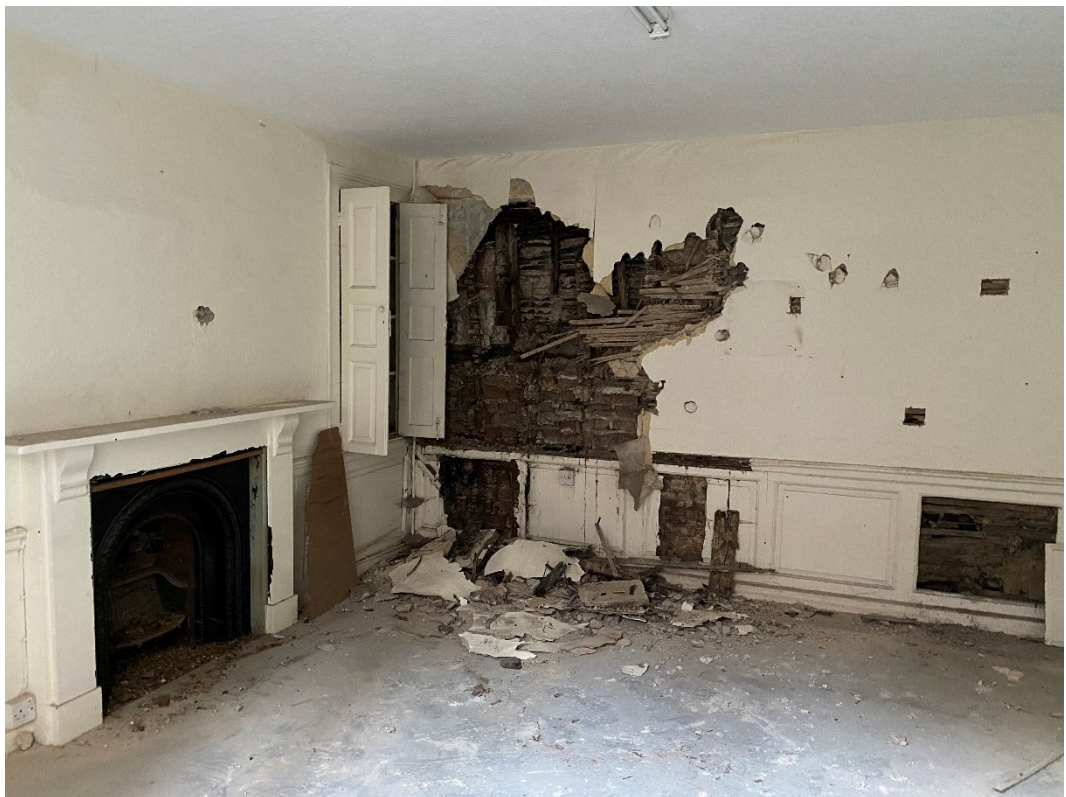
*Figure 15: First floor central room off stair half landing with 18<sup>th</sup> century dado panelling but older timber frame visible in damaged wall (the result of vandalism).*

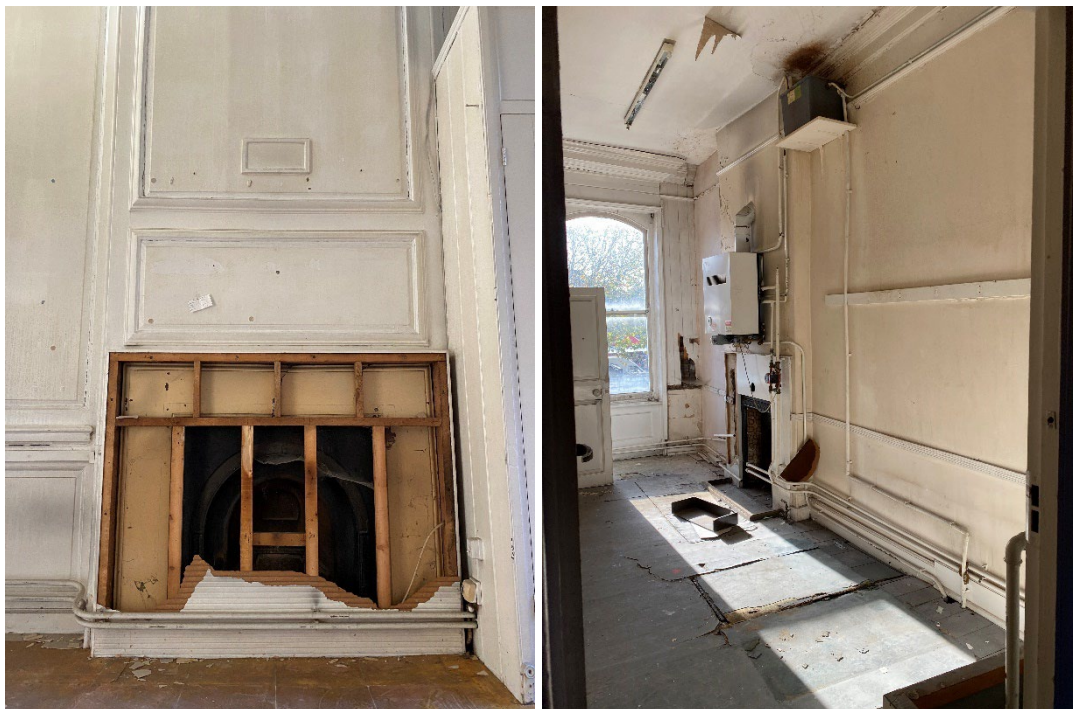
*Figure 18-19: first floor spaces, retained fireplaces, panelling, joinery and cornices but run down with unsympathetic later insertions of services.*

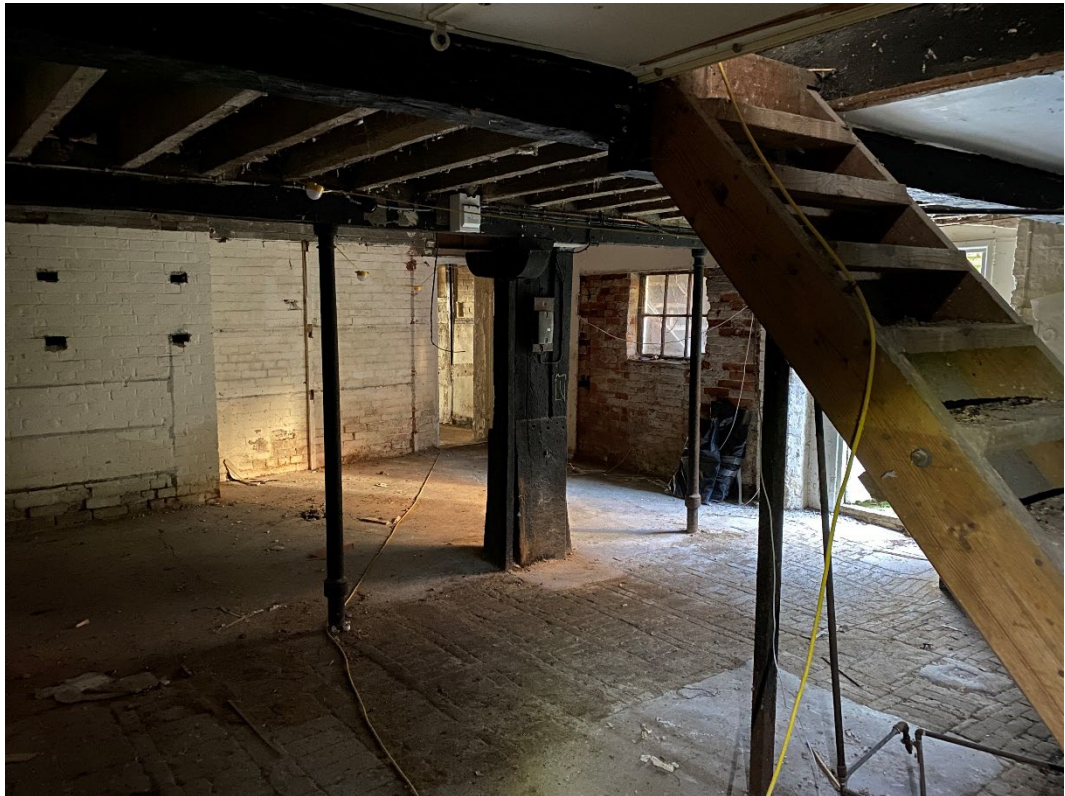
*Figure 21: ground floor area under older and 19<sup>th</sup> century structures. Some historic flooring survives but partitions and structural lines eroded.*

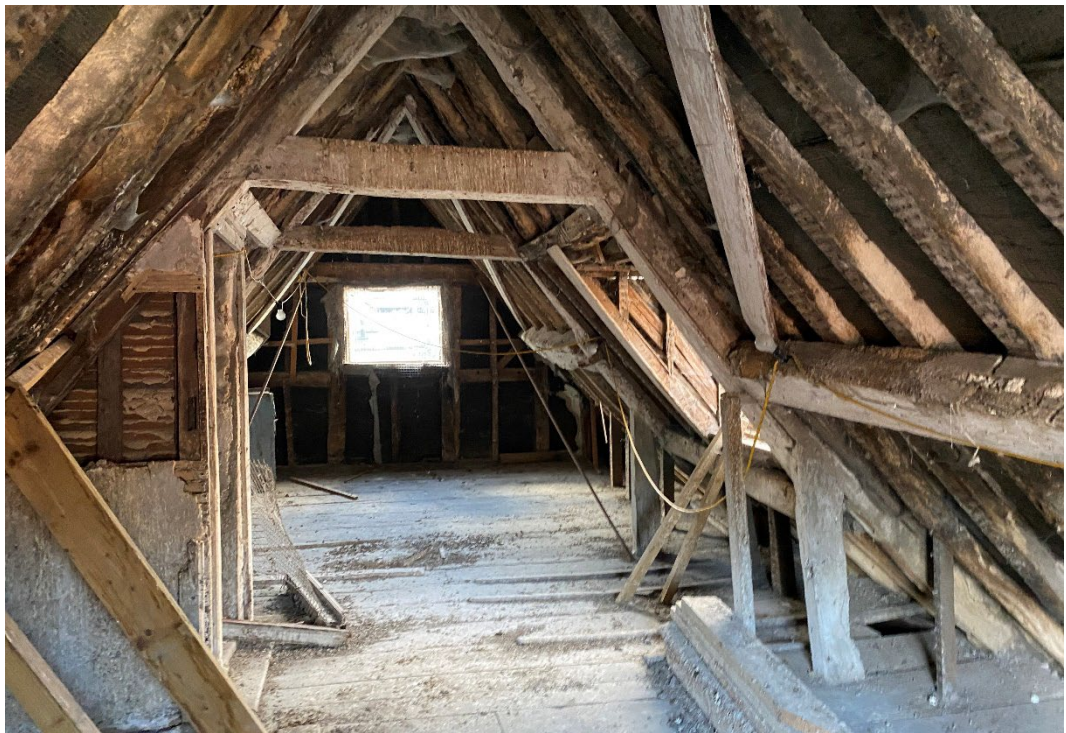
*Figure 24: 16<sup>th</sup>/17<sup>th</sup> century roof structure, frequent later bracing of several periods suggests long structural issues.*

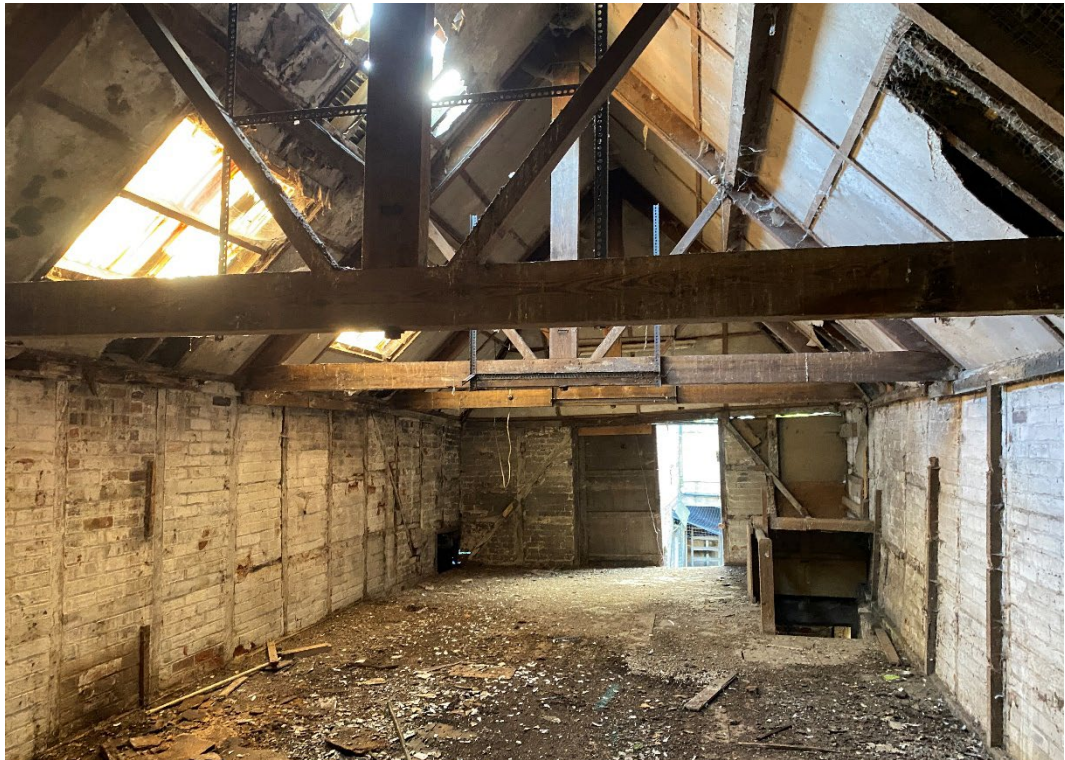
*Figure 29: first floor area, a single space with 20<sup>th</sup> century roof structure and covering, post 1916 fire.*

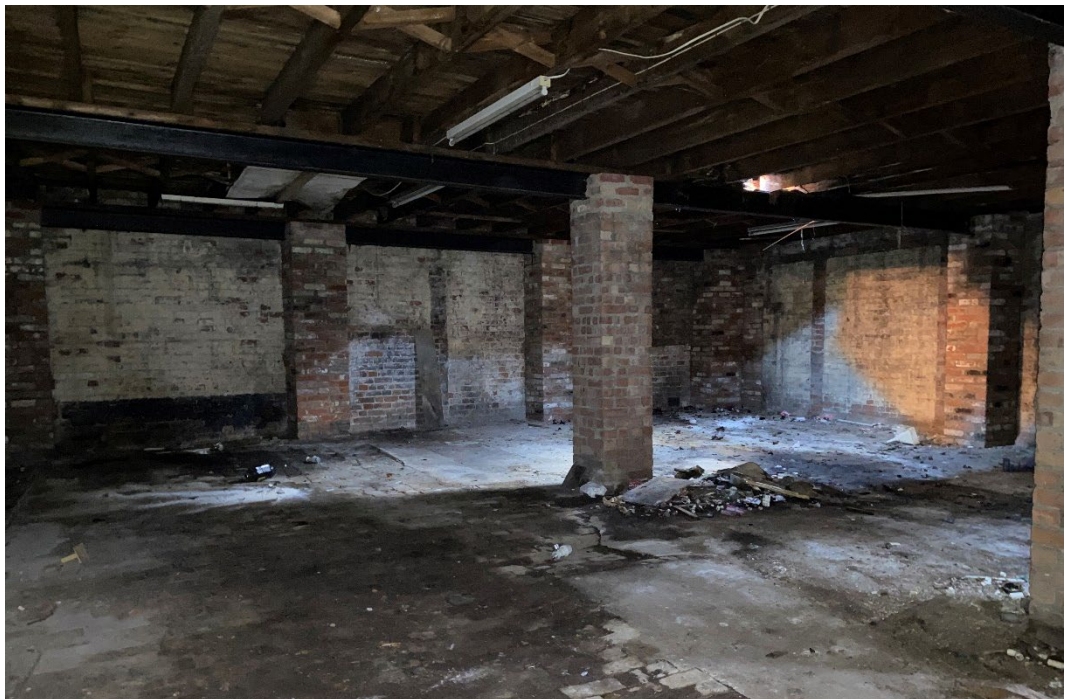
*Figure 30: The north east structure, heavily altered and rebuilt with flat roof.*

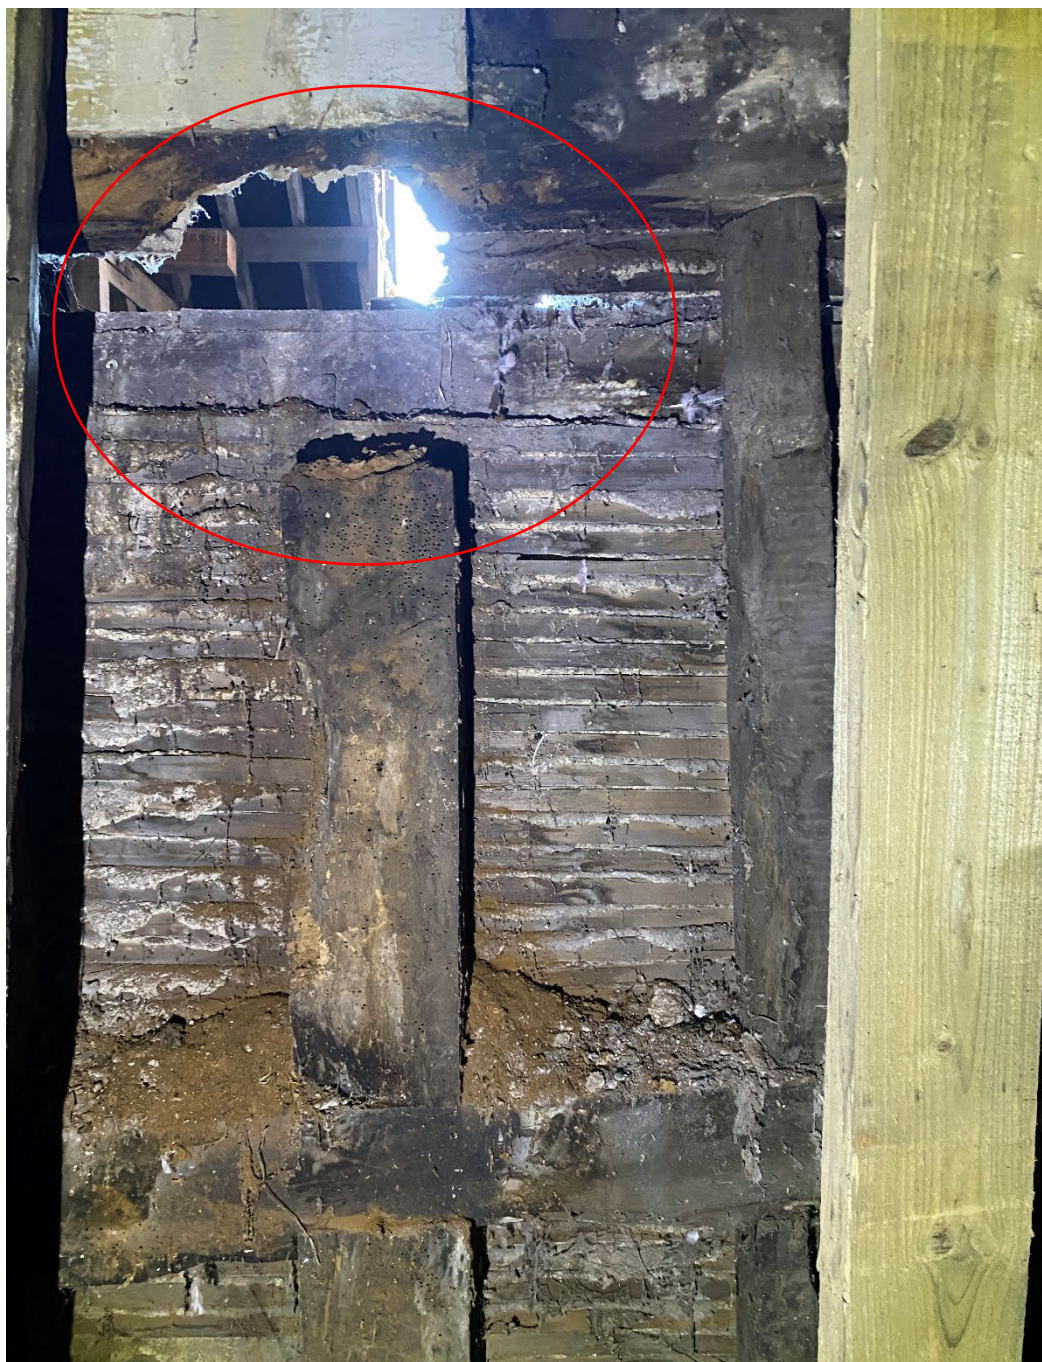
**4.11** It is noted, however, that the structures in the centre and rear of this building are in exceptionally poor condition after many years of no use, water ingress and lack of maintenance. Though the fabric retains architectural and historic values, it is in many instances no longer viable as structure, elements of timber frame crumble at the slightest touch, the structure's walls are only held up by scaffold and props, there is exceptionally little structural integrity within the building. Andrew Waring's Structural report details this. For any degree of future function a substantial proportion of the building's historic fabric would be replaced and thus the historic authenticity of any fabric would be impacted. While condition is not normally a consideration of significance, it is relevant when that condition has proceeded to the point of near collapse such that the evidential and illustrative values are lost through active decay and timber details, or finishes are corroded and rotted away.

*Figure 32: Detail from exposed timber frame showing complete loss of structural detail at joint – the architectural evidence and illustration of this structural element is gone, the timber shown here has since collapsed fully out of the wall. Other similar examples of this level of decay are found throughout the central building.*

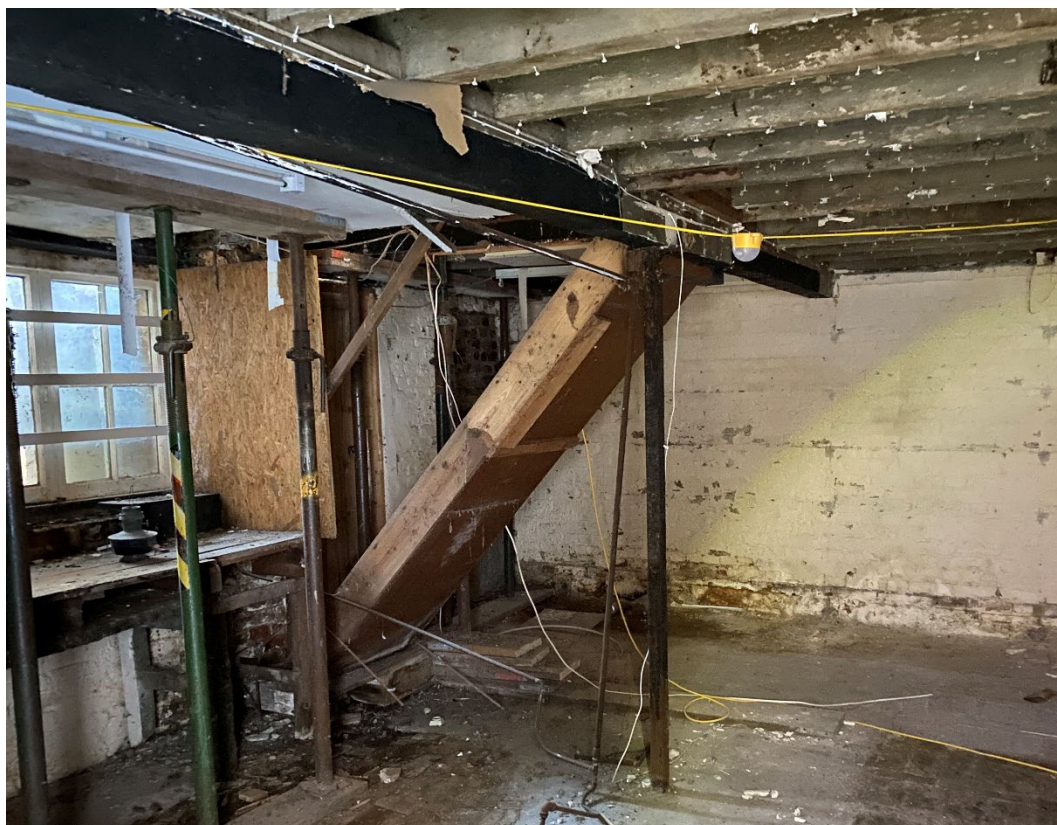
*Figure 33: recent ladder stair inserted in the 19<sup>th</sup> century stair. Note also extensive propping of northern floor structure linked to adjacent façade decline and collapse.*

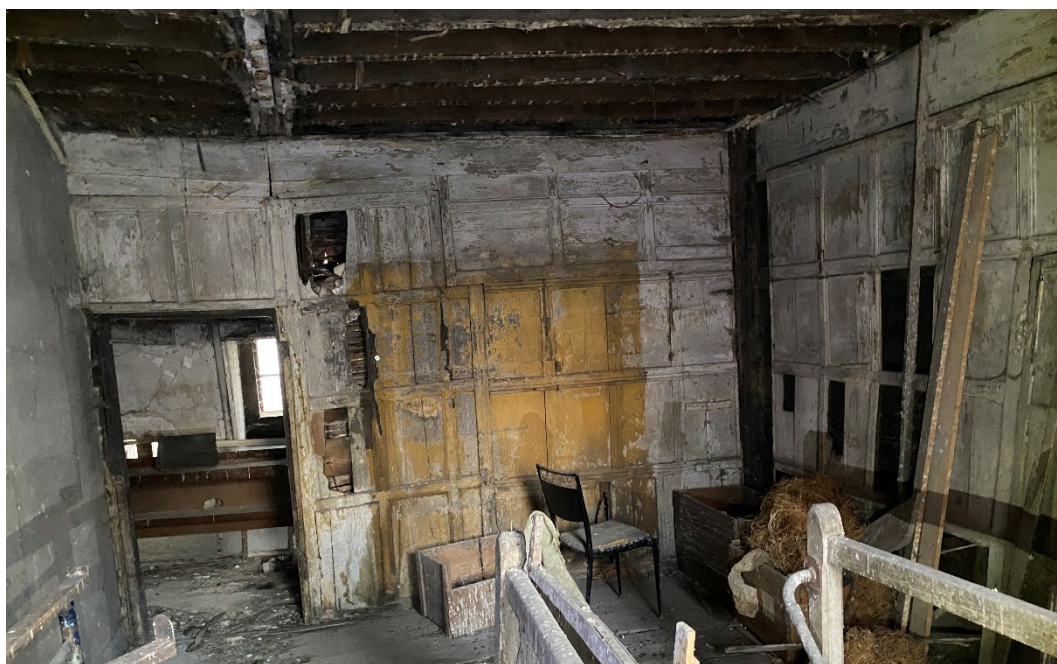
*Figure 36: Panelling in situ, but much cut about to fit this wall suggestive of it not being made for this space originally.*

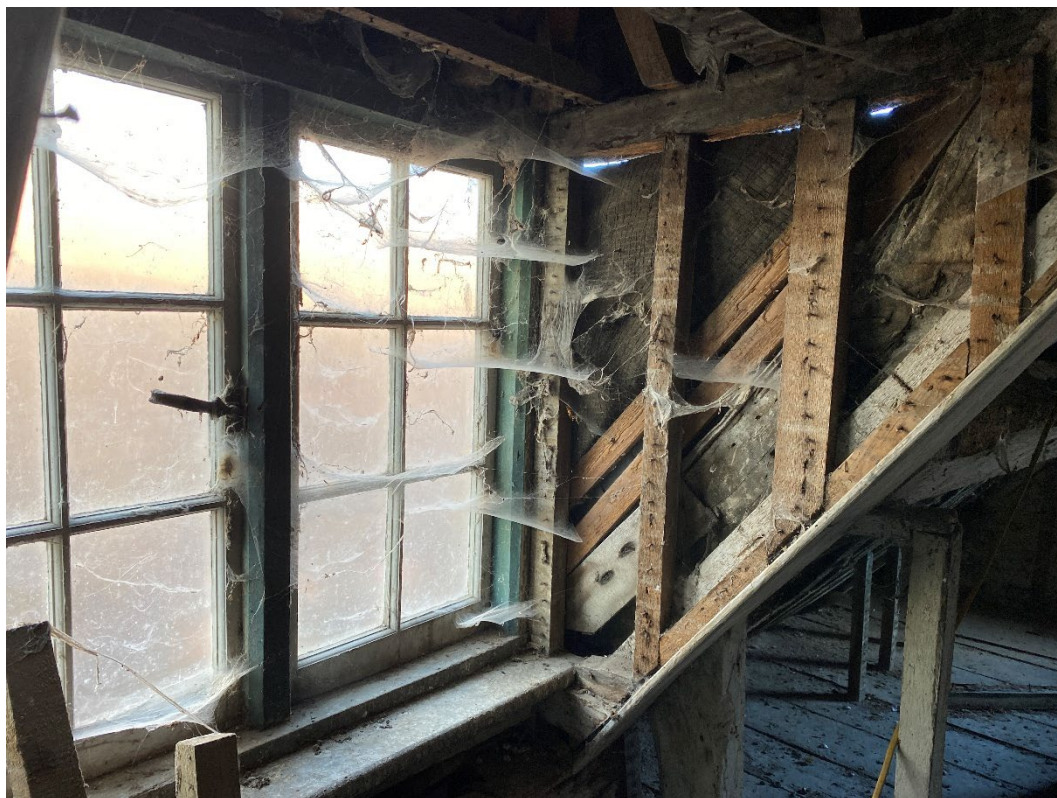
*Figure 39: Dormer in attic of oldest core, dormer frame may be 19<sup>th</sup> century but window has been replaced in the 20<sup>th</sup>.*

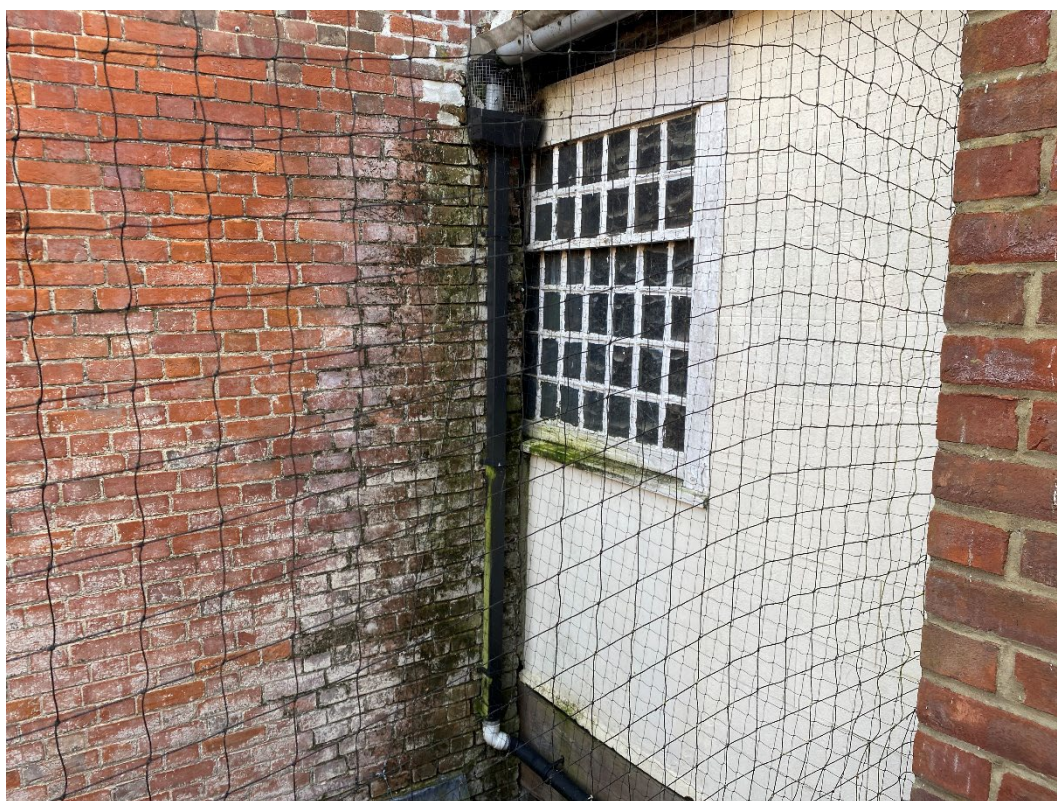
- 5.11** Room 1.9 also retains a significant early multi-pane window and, along with room 1.10 a substantial quantity of small square panelling which is typical of the 16<sup>th</sup> century. This panelling is, for the most part, not in situ but stacked loose against the walls. It will be removed from the building, cleaned and dried out prior to being assessed for repair and reinstatement within the building. The multipaned window will also be restored, Georgian wired glass removed, and the whole frame relocated so that it is no longer overlapped by the adjacent structure.

*Figure 41: Multi pane 16 over 32 sash to be repaired and relocated so that it is not overlapped by the adjacent brickwork and drainage.*

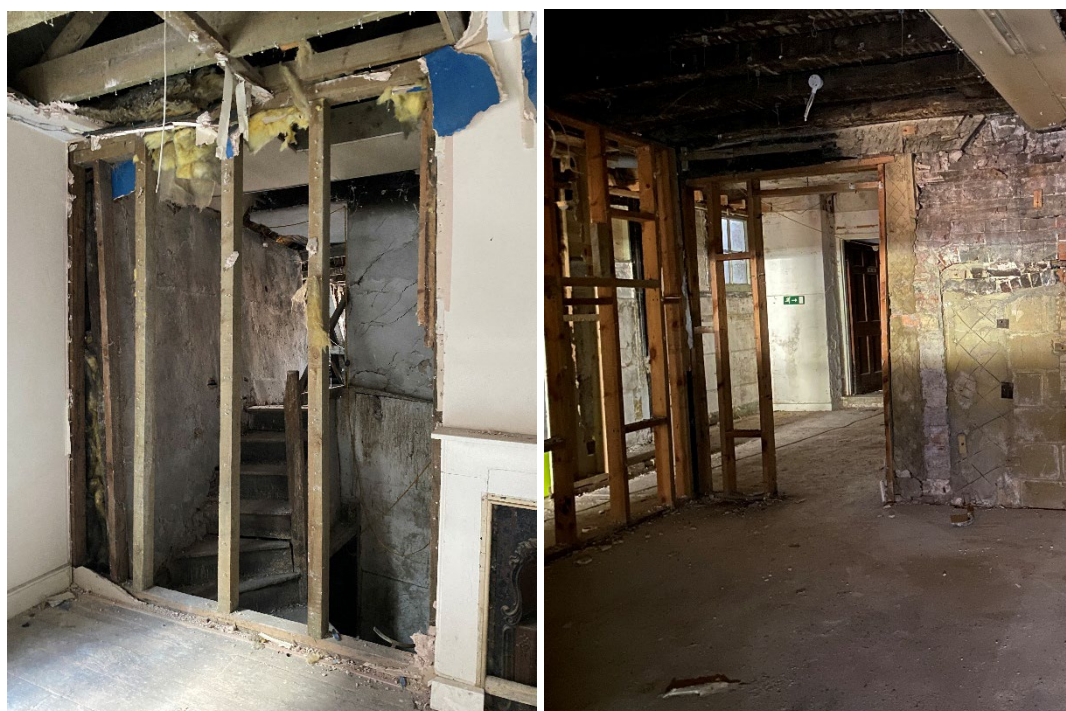
*Figure 42-43: areas of extant fabric removal in modern period where fire rated partitions will be installed between units 6/7 in the front of the building and unit 2.*

- 5.15** Fire and acoustic insulation is necessary for building control to sign off the proposals as the building's use will change. The drawing package illustrates the proposed location of wall linings in the new units and change here is actually constrained to areas already affected by consented works to the front half of the building, or to the most damaged area of wall which requires comprehensive reconstruction in any case and can thus be fire rated from the outset.

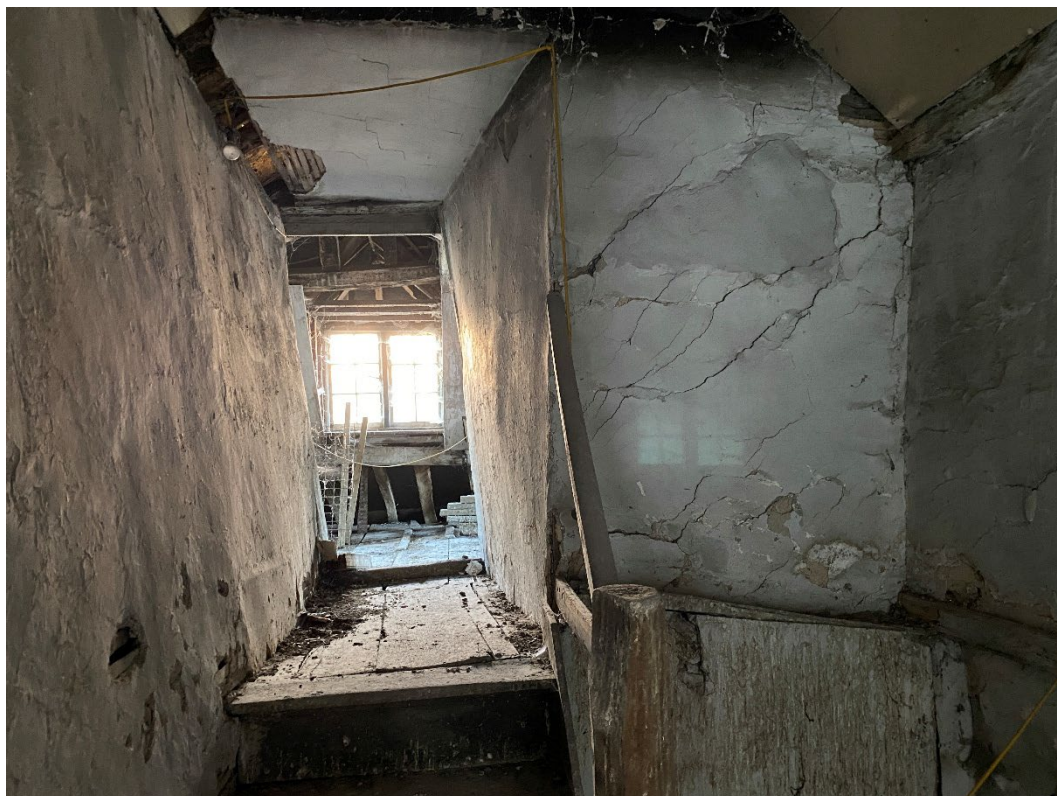
*Figure 44: second floor passage from stair to attic, floor will be repaired and levelled, and stair rebuilt, but the misaligned walls will be retained and repaired without straightening to vertical.*

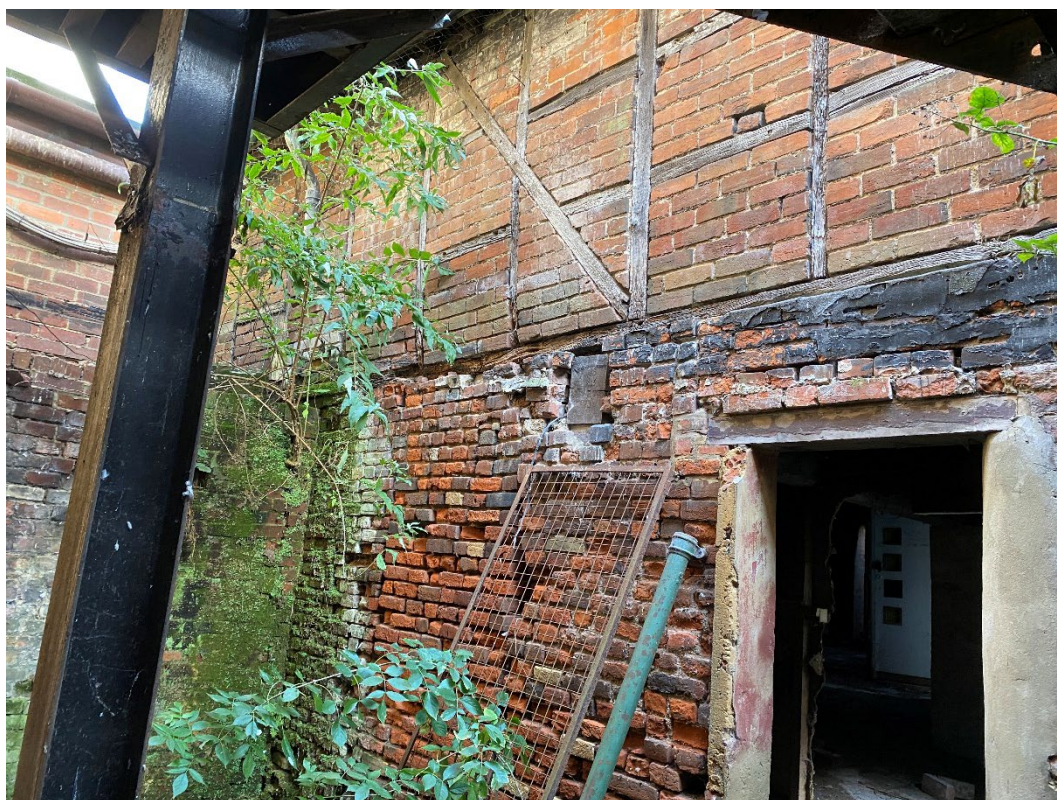
**5.27** The existing structure is not viable to adapt, It is a structure of only modest interest in the overall spectrum of the listed building. It is heavily altered with substantial areas of reconstruction dating to the 20<sup>th</sup> century post fire period (see Appendix 2), the later fabric is not of innate interest. It retains some late 18<sup>th</sup> century brickwork, and likely more substantial areas of 19<sup>th</sup> century brick and timber frame of only a single skin thickness. Though assessed as forming a stable there are no surviving stalls, mangers or troughs that directly illustrate this use, it is simply an open structure with some traditional fabric. Adjacent buildings have been built hard against its western wall making it impossible to easily maintain or observe one of the longer structural sides placing it at further risk.

*Figure 45: the ground floor possibly 18<sup>th</sup> century brickwork much corroded and fragmenting with almost no pointing surviving. Note concrete/cement inserted door on the right, and later brickwork in slender timber frame above – probably 19<sup>th</sup> century.*

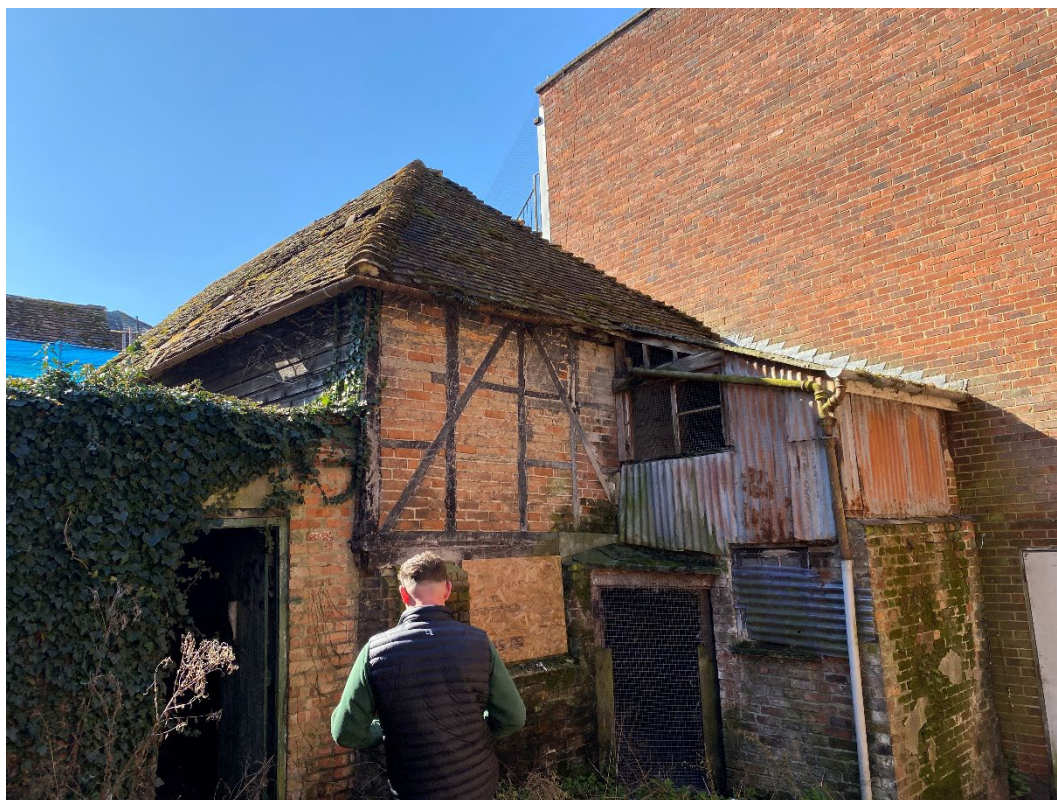
*Figure 46: northern end of the structure, modern additions and modern next door structure hard against the slightly older building with its hipped roof. Timber siding visible on the long elevation.*
