**MANTON PARK FARM, MANTON PARK,  
MARLBOROUGH, WILTSHIRE, SN8 4HB**

**TREE SURVEY, ARBORICULTURAL IMPACT  
ASSESSMENT & TREE CONSTRAINTS PLAN**

**PROPOSED TRAINERS HOUSE**

**Project Reference: 25.2079**

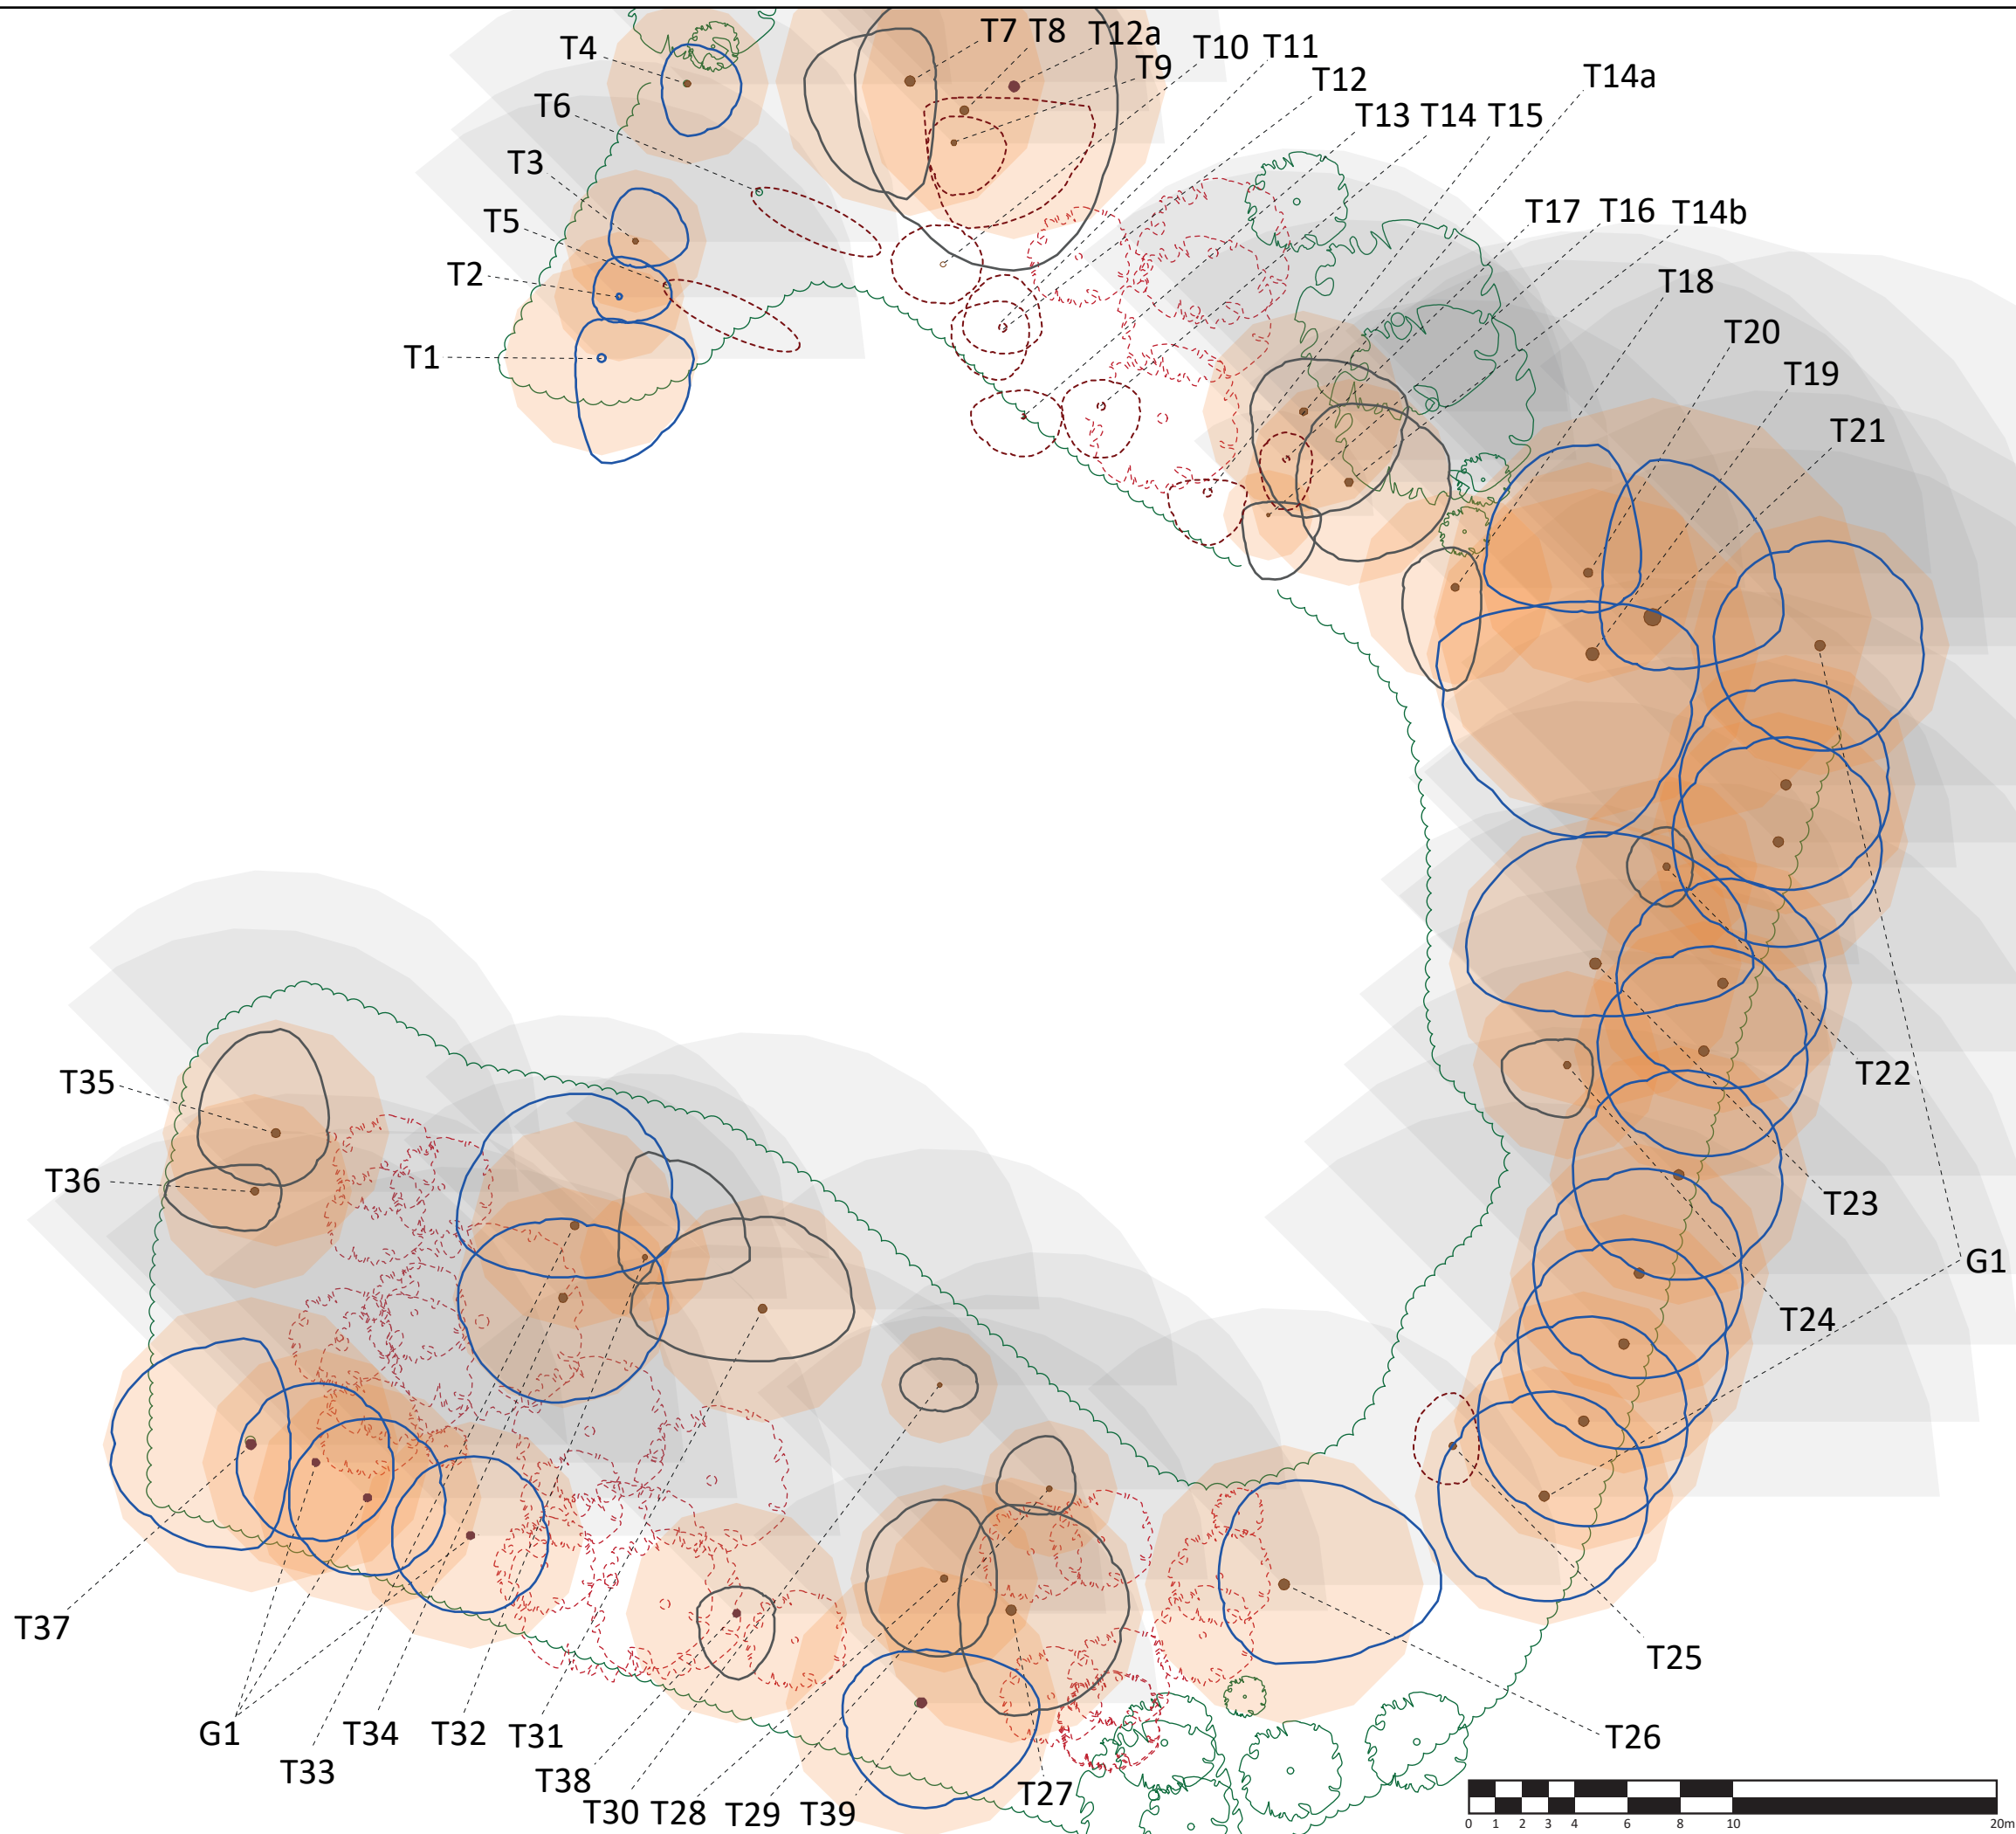
ARB-2079-01: TREE CONSTRAINTS PLAN (EXISTING)

**4.6** The beech (T8) located on the northern side of the clearing showed very poor, suppressed form as a result of competition from adjacent trees. The stem was heavily affected by canker, with areas of stripped bark, exposed deadwood and evidence of squirrel damage throughout its primary stem structure, rendering stems and branches vulnerable to failure. Consequently, T8 was assessed as U grade retention category.

**5.1** A significant proportion of the trees assessed are composed of Scots pine that are either dead or in poor physiological condition, principally due to the soil conditions that they were planted in being unsuitable for the species type which prefer more acidic soil. Those which have not already failed to establish and remain alive are considered unlikely to reach full maturity and more likely to succumb to poor physiological condition as a result of unsuitable growing environment.

**5.2** The U grade trees that are either dead or moribund are composed largely of Scots pine but also include a very poorly formed beech (T8). These do not pose any significant threat by failure to the current use of the site and its apparent very low occupancy of use. These U grade trees are not likely to pose any significant hazard to the future use of the site as they are set some distance from the proposed position of the new dwelling. In most cases U grade trees are recommended to be removed to address potential hazards that they pose. However, if a small element of risk by failure can be accepted it would be considered more beneficial, from a wildlife habitat and conservation perspective, to retain these trees as standing deadwood as opposed to removing them.

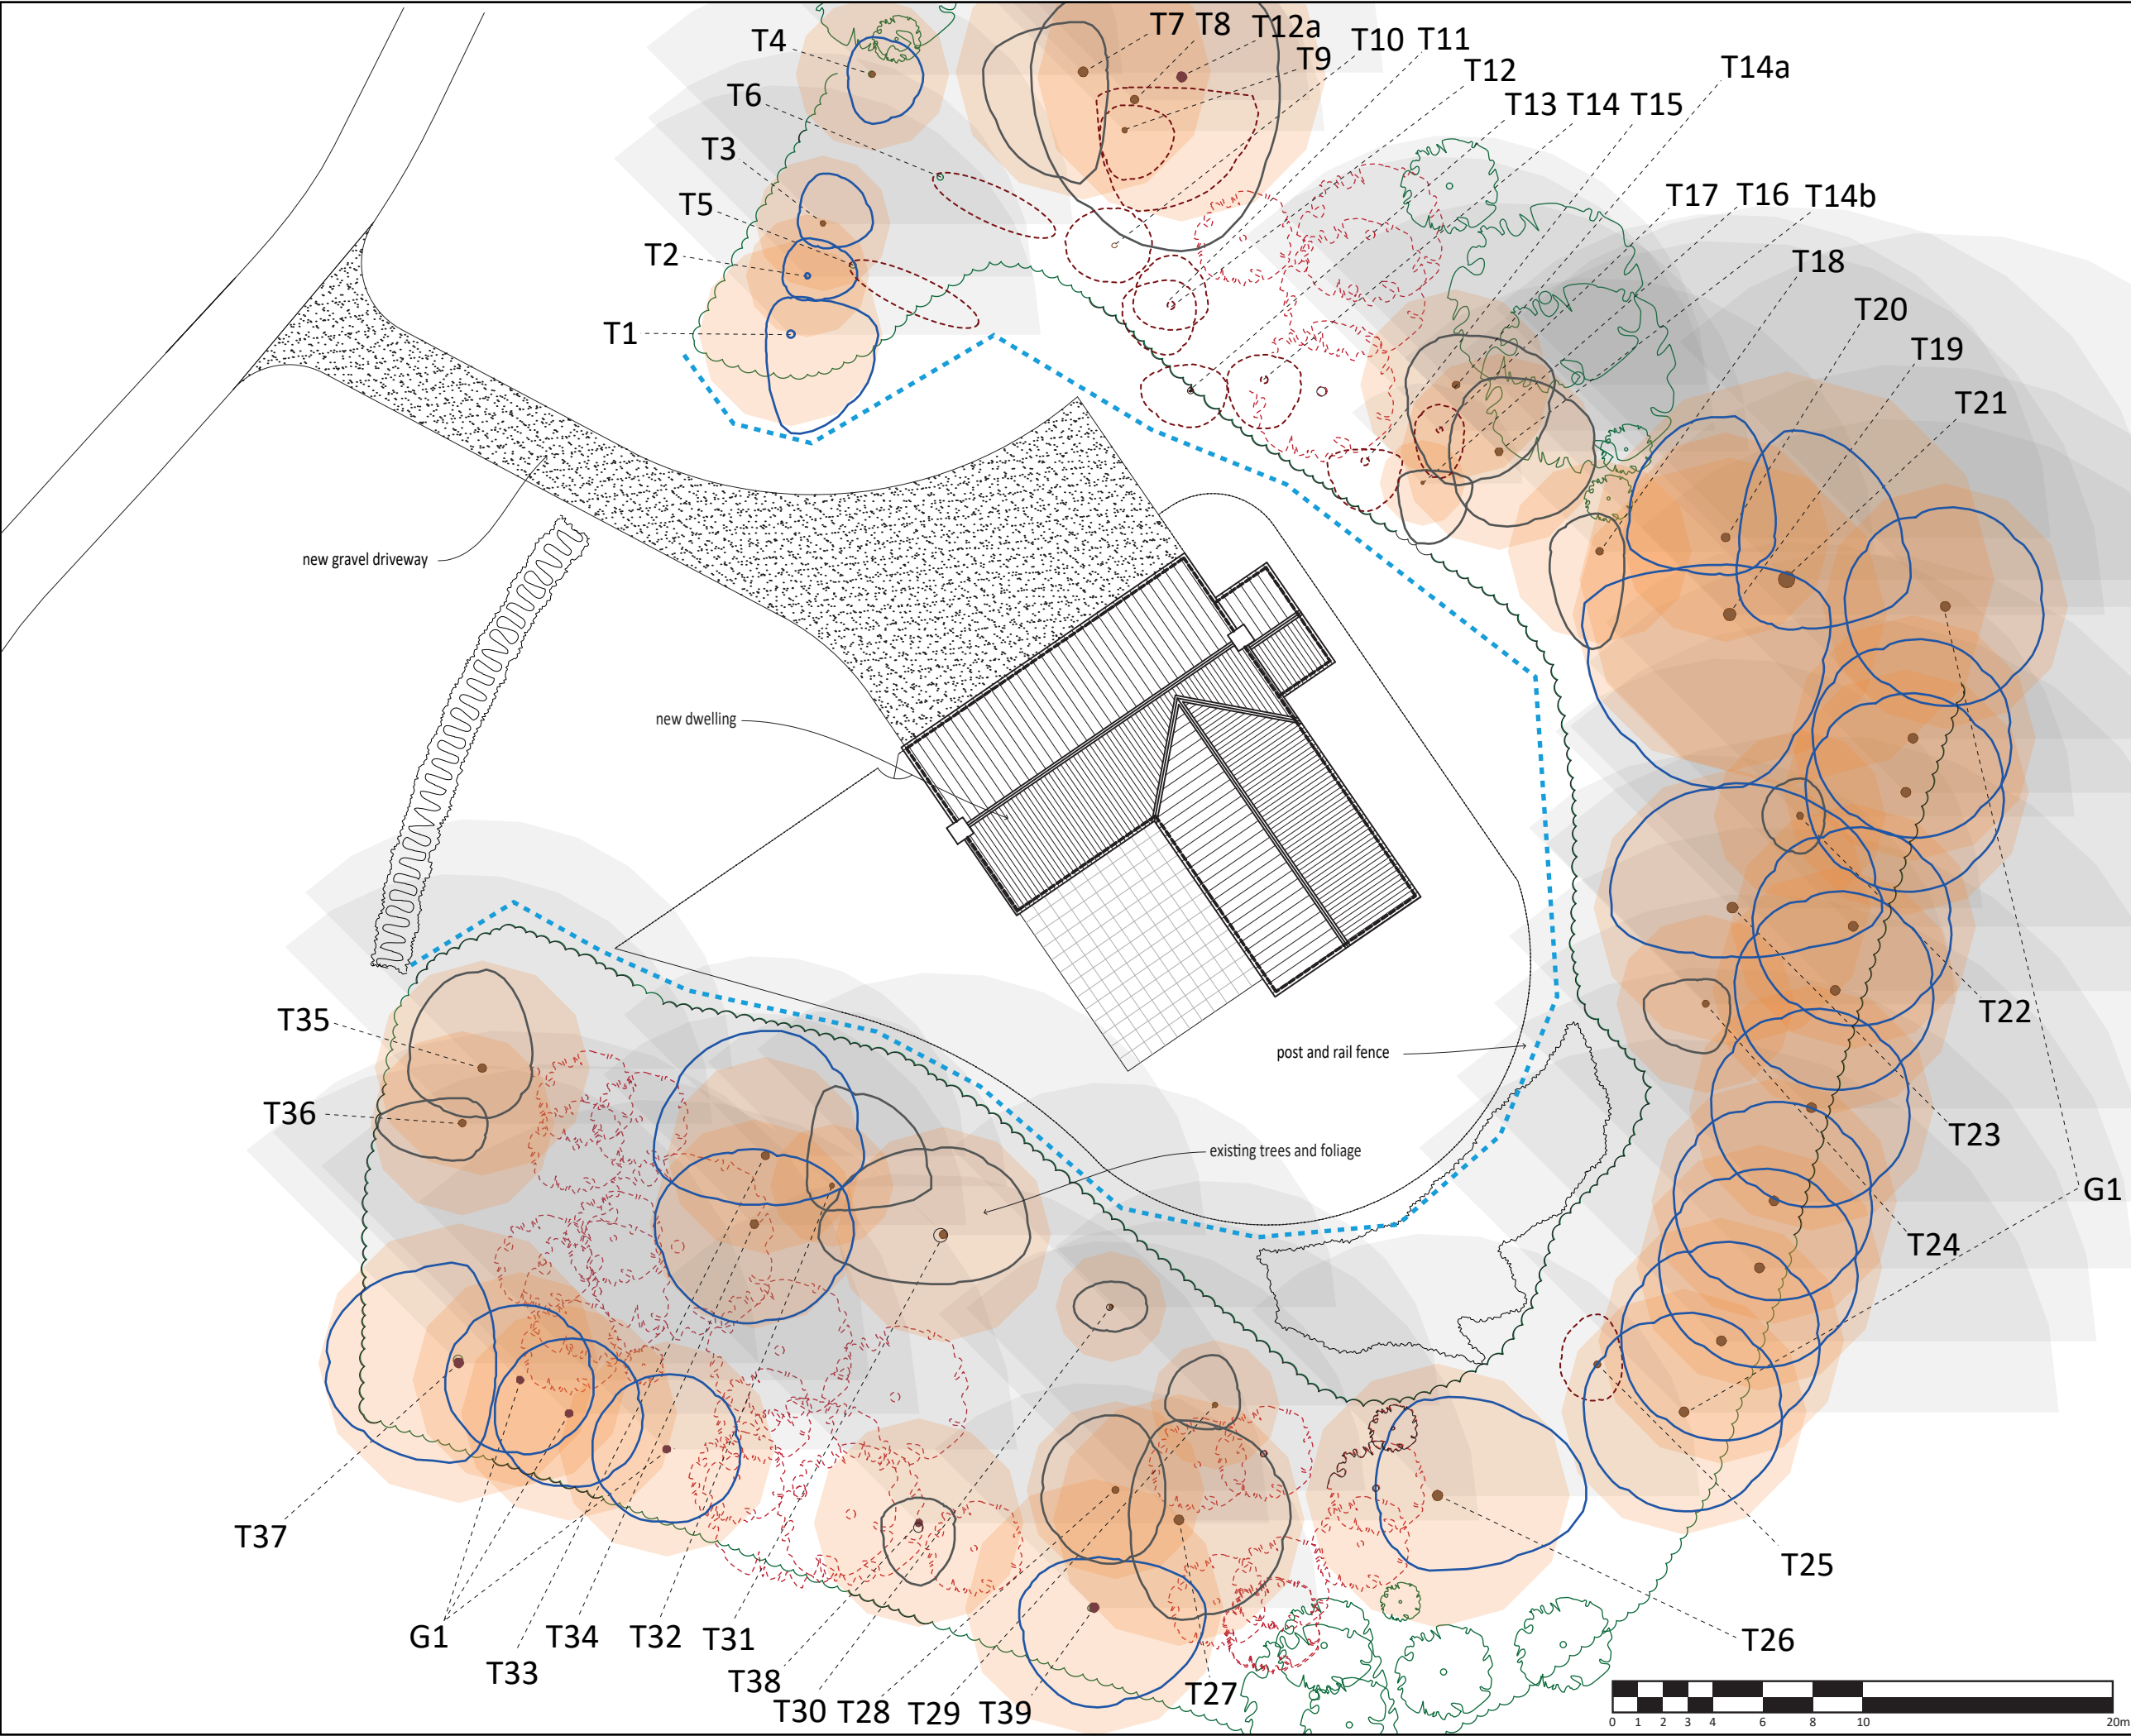
ARB-2079-02: TREE CONSTRAINTS PLAN (PROPOSED)

**5.5** The only potential conflict that exists between the proposed development and adjacent trees relates to inadvertent damage during construction. This may arise from site vehicles or plant causing soil compaction within RPAs, or from direct impacts to tree stems and crowns. Other risks include the potential for the storage of site materials or siting of site cabin/toilets within RPAs, leading to root damage, or for the spill from the mixing of materials to leach into RPAs.

**6.6** There is a minor risk that the stems, crowns, or root systems of the trees assessed could be inadvertently damaged during the construction process, either through direct impact by vehicles or plant, or via soil compaction within the RPA caused by vehicle movement, material storage or the siting of cabins/toilets. This potential for such damage will be mitigated by the establishment of a fenced off CEZ as specified in section 5.6.
