## Peregrine Bryant Architects

### Further opening-up works required to Ramsbury Manor House to Facilitate Repair, Reservicing, and Asbestos Removal (HE-RMI 263: Issue V1: 30.04.26)

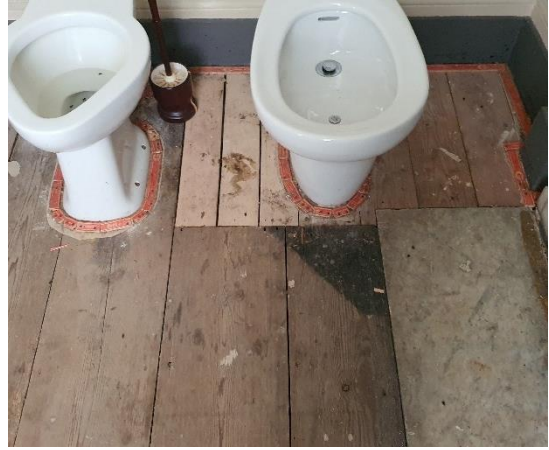
*Figure 6: Timber floor old repairs - Blue Bathroom  
FR01*

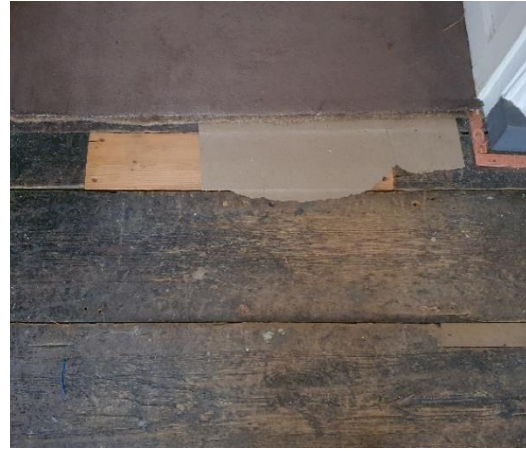
*Figure 30: Old repair to floor - Pink Bedroom FR05*

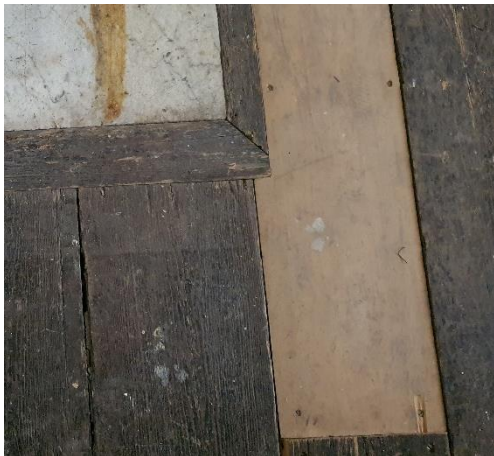
*Figure 31: Old repair to floor - Pink Bedroom FR05*

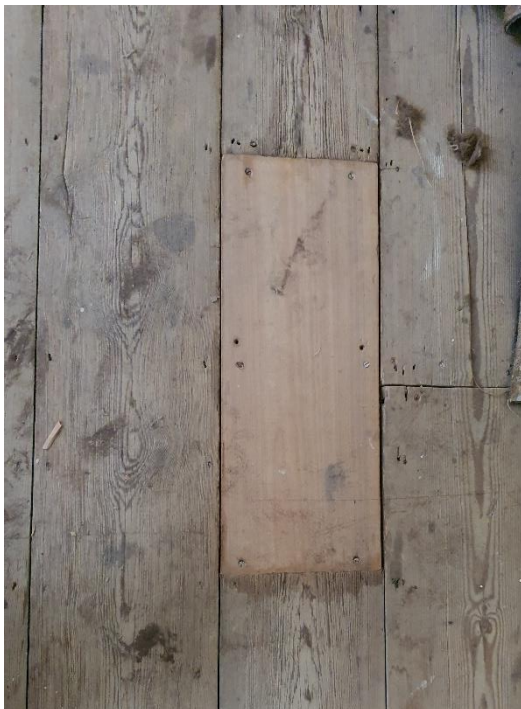
*Figure 57: Old timber repair to floor - Yellow Bedroom FR09*

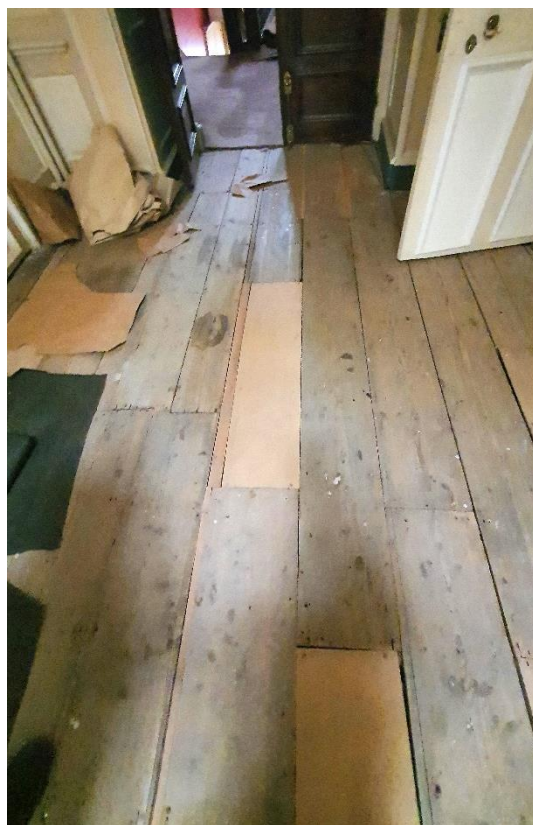
*Figure 63: Timber boards and visible old repairs, post carpet removal - Corridor FR11*

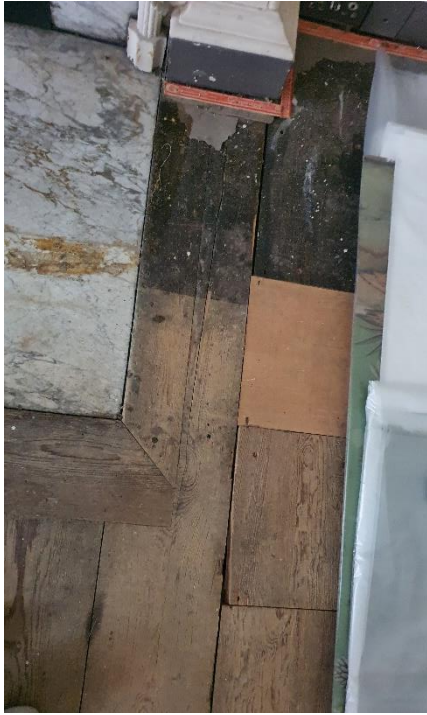
*Figure 75: Old floor repairs - Mrs. Hyams  
Bedroom FR12*

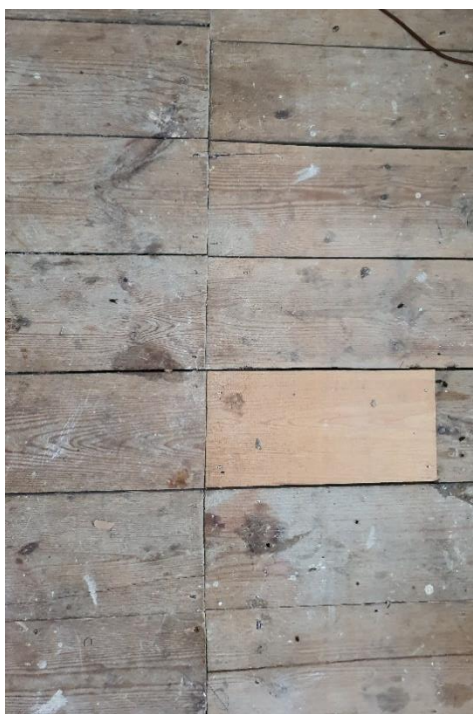
*Figure 89: Old timber repair to floor - Mr. Hyams Bathroom FR14*

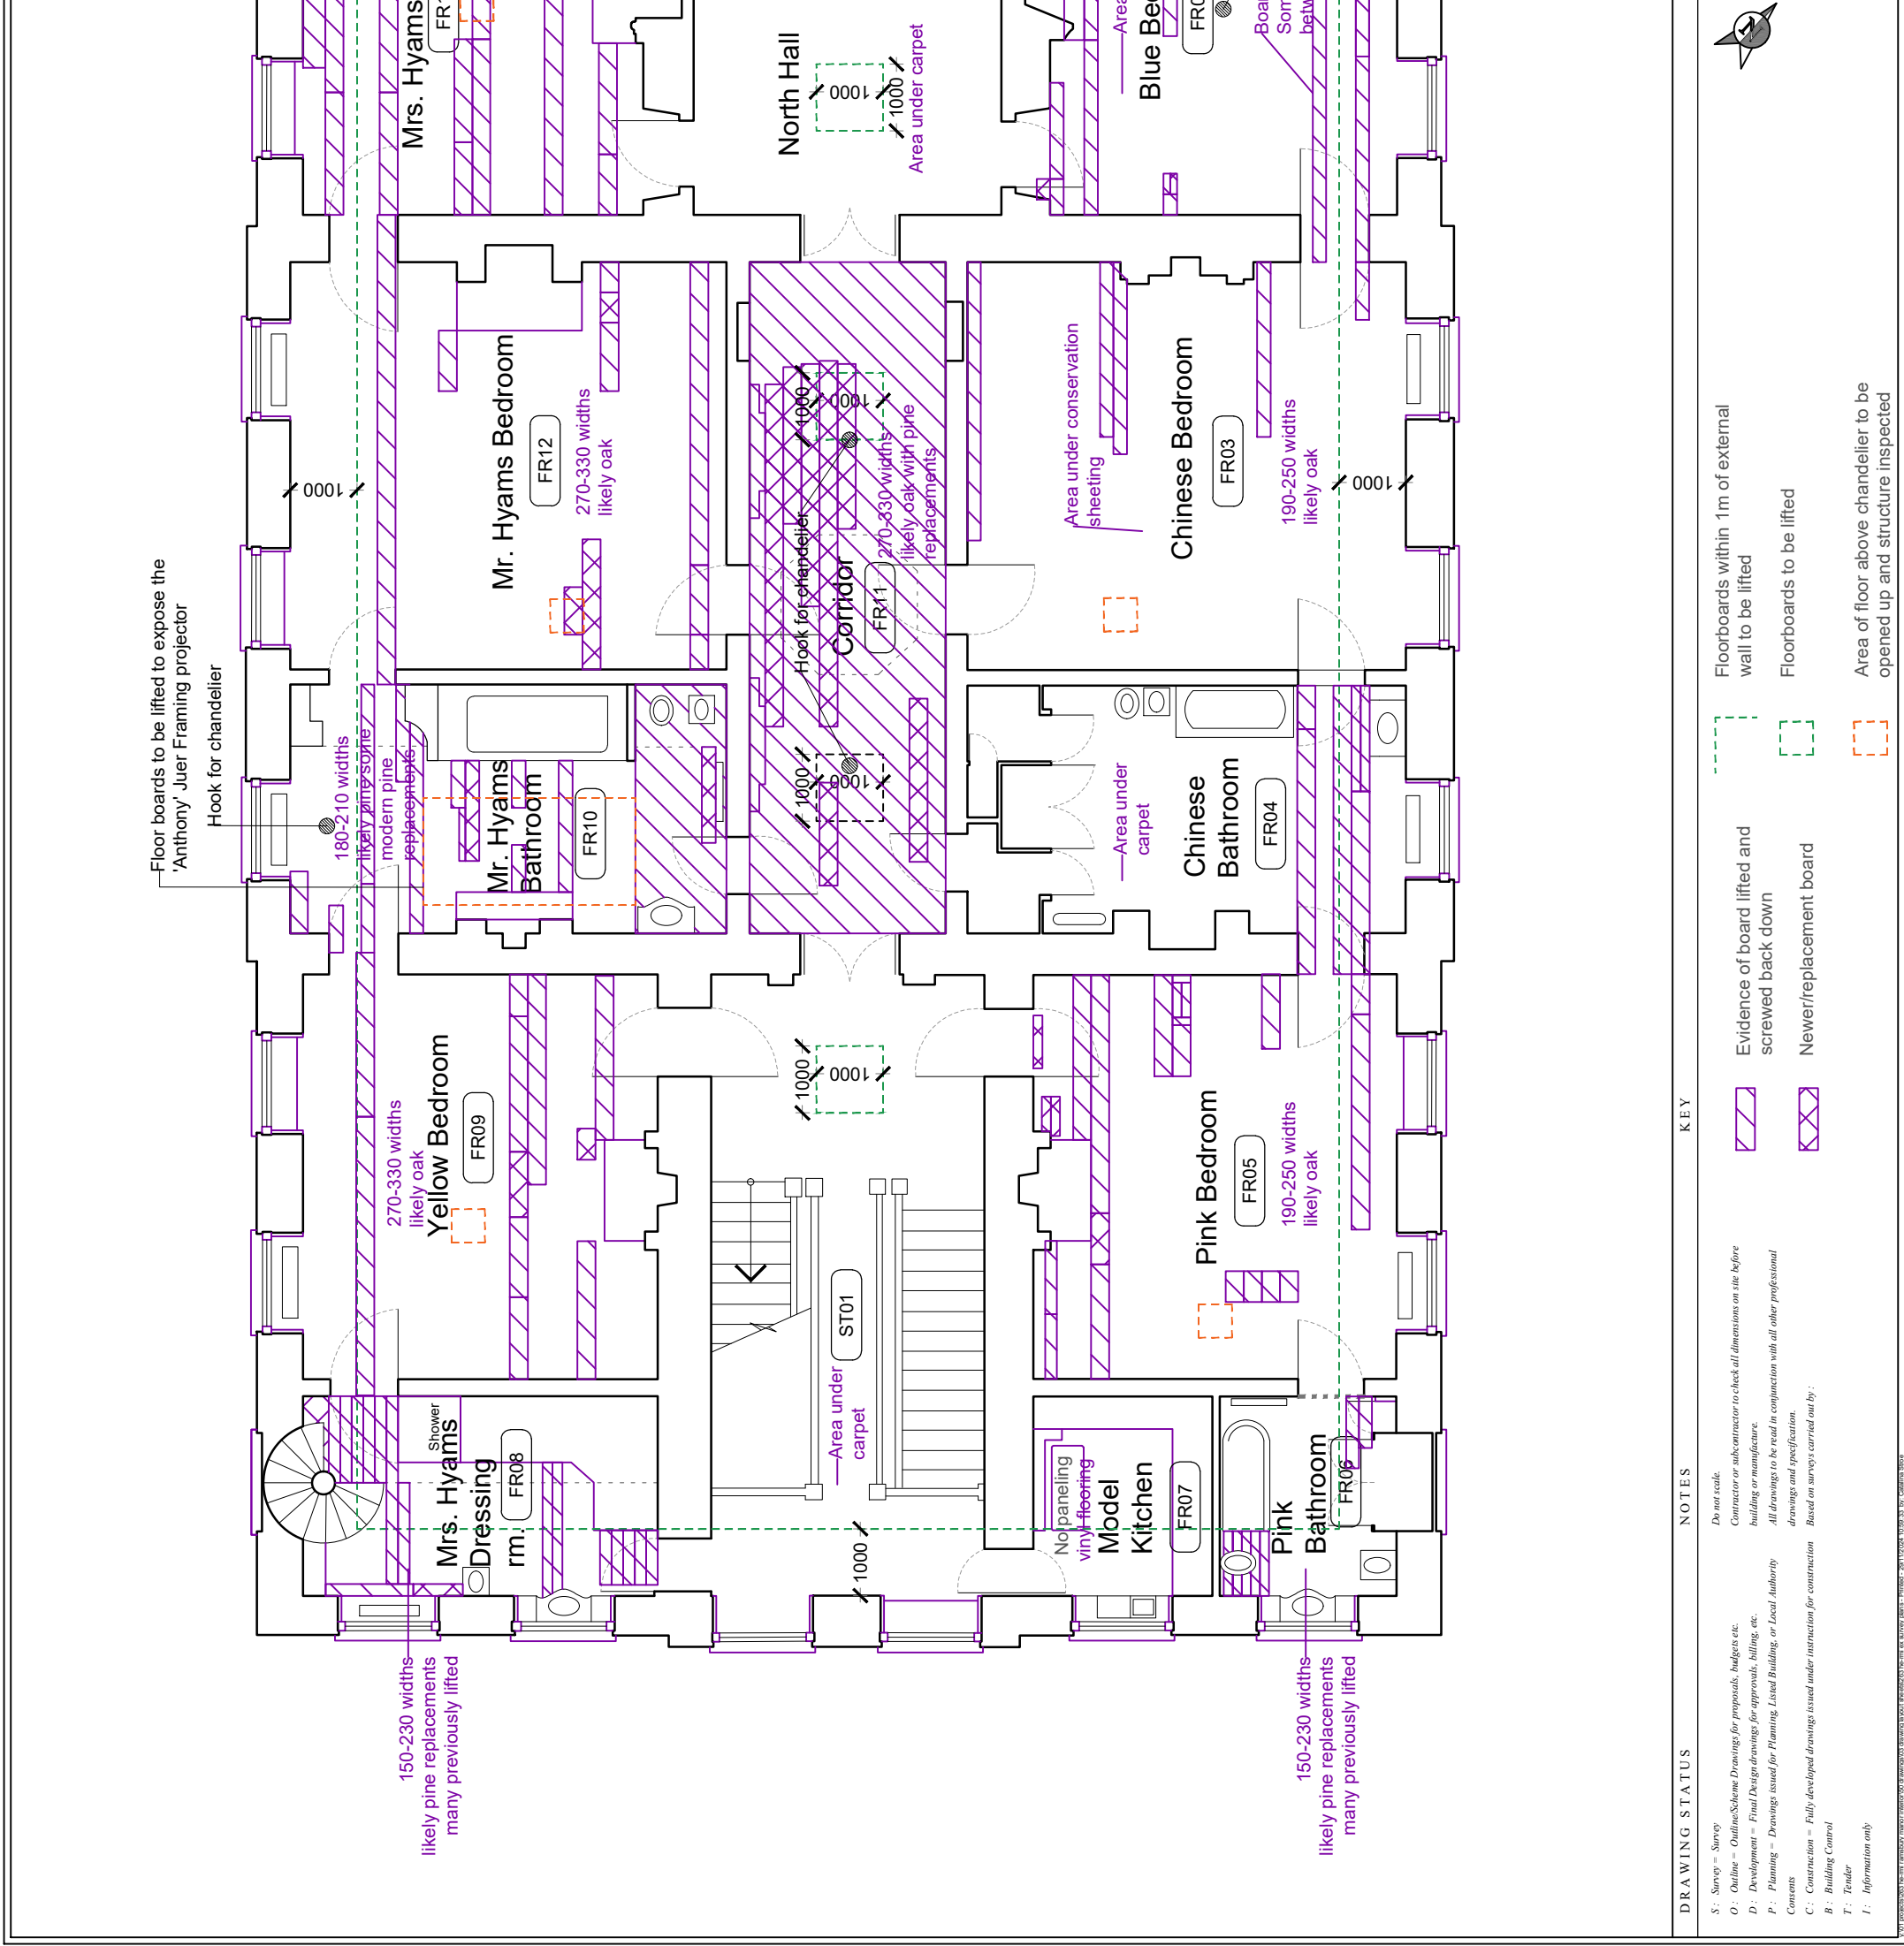
Area of floor above chandelier to be opened up and structure inspected
