# LAND EAST OF SOUTHAMPTON ROAD, ALDERBURY

## Arboricultural Impact Assessment

JSL4528\_771  
Land northeast of  
Southampton Rd, Alderbury  
Arboricultural Impact  
Assessment  
Rev .  
April 2026

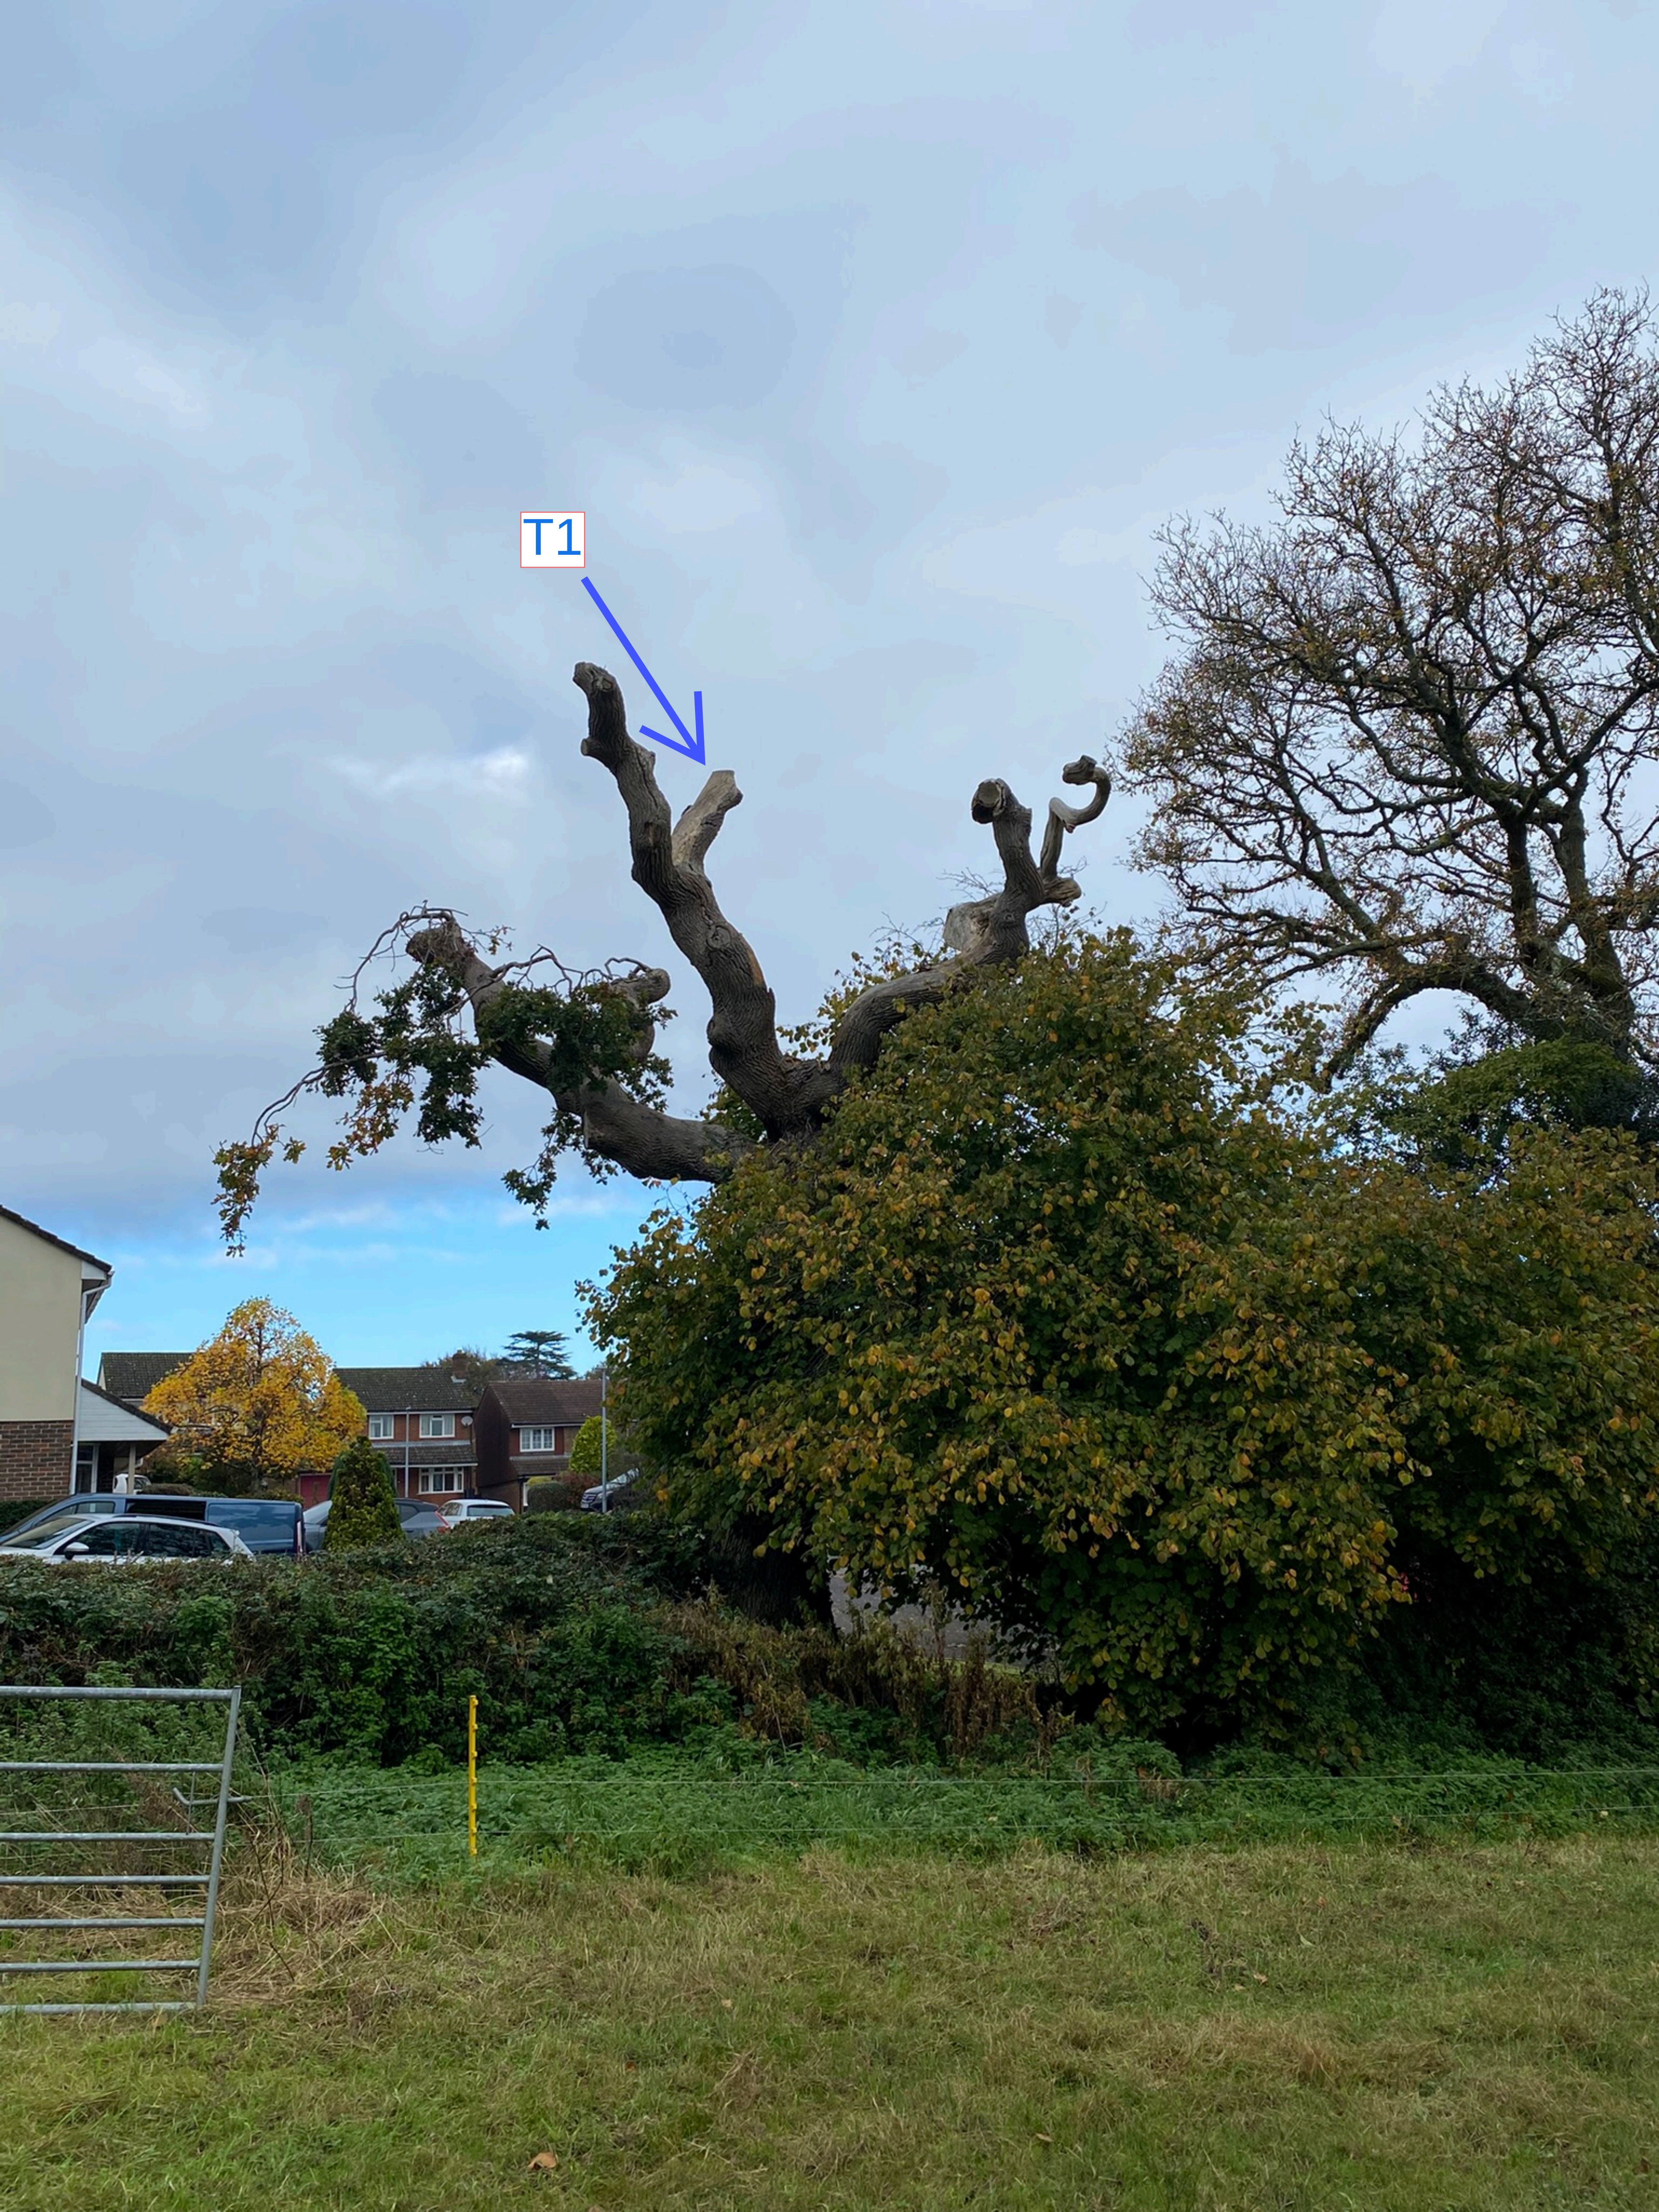
| Alderbury Rd | Type | Impact m2 | RPA | Percentage | Level |
|---|---|---|---|---|---|
| | <p>T1 is in a significantly compromised condition, with its actual rooting area likely much smaller than the British Standard guidance. Two trial trenches, approximately 2m long and 800mm deep, were excavated under arboricultural supervision at the edge of the proposed road. No evidence of small or large roots was found in either trench. This supports the prediction that T1's root system has declined over many years, mirroring the tree's overall decline.</p> <p>Furthermore, the tree is practically dead, with only a few small live branches remaining. The root system required to support such minimal live growth is negligible. Another consideration is the impact of the excavation required to construct the road and whether it will affect the tree's structural integrity. The results from the trial trenches indicate that no loss of structural integrity is expected from the road construction. Please see appendix A for further detail.</p> | | | | |

| Ref. no | Species | Height (m) | Ht. Can. | Crown spread (m) | | | | Canopy area (sqm) | Stem dia. (mm) | Stem no. at 1.5m | FSB Hgt | Age class | Structural Condition | General Observations | Management Recommendations | Estimated remaining contribution (yrs) | Tree Quality Category (BS5837) |
|---|---|---|---|---|---|---|---|---|---|---|---|---|---|---|---|---|---|
| T1 | Quercus robur (Common Oak) | 10 | 7 | 7 | 7 | 5 | 7 | 132 | 1,000 | 1 | 7(W) | OM | Poor | Off site tree. Poor shape & form. Low vitality. Declining. Not Plotted on original survey. Decay present on stem. Fungal brackets visible on stem. 80% of canopy is dead. Canopy has been reduced significantly back to stumps of approx. 20cm diameter. Most of the remaining stems are dead with no signs of reactive growth at stumps or within central canopy. Bark loss extensive. | Fell/reduce canopy | <5 | U |
