**13 Whitehill Lane, Royal Wootton Bassett, SN4 7SB**

**Arboricultural Report containing:**

*Prepared by:*  
**Deb Randall BSc TechArborA**  
**Arboricultural Consultant**  
**March 2026**

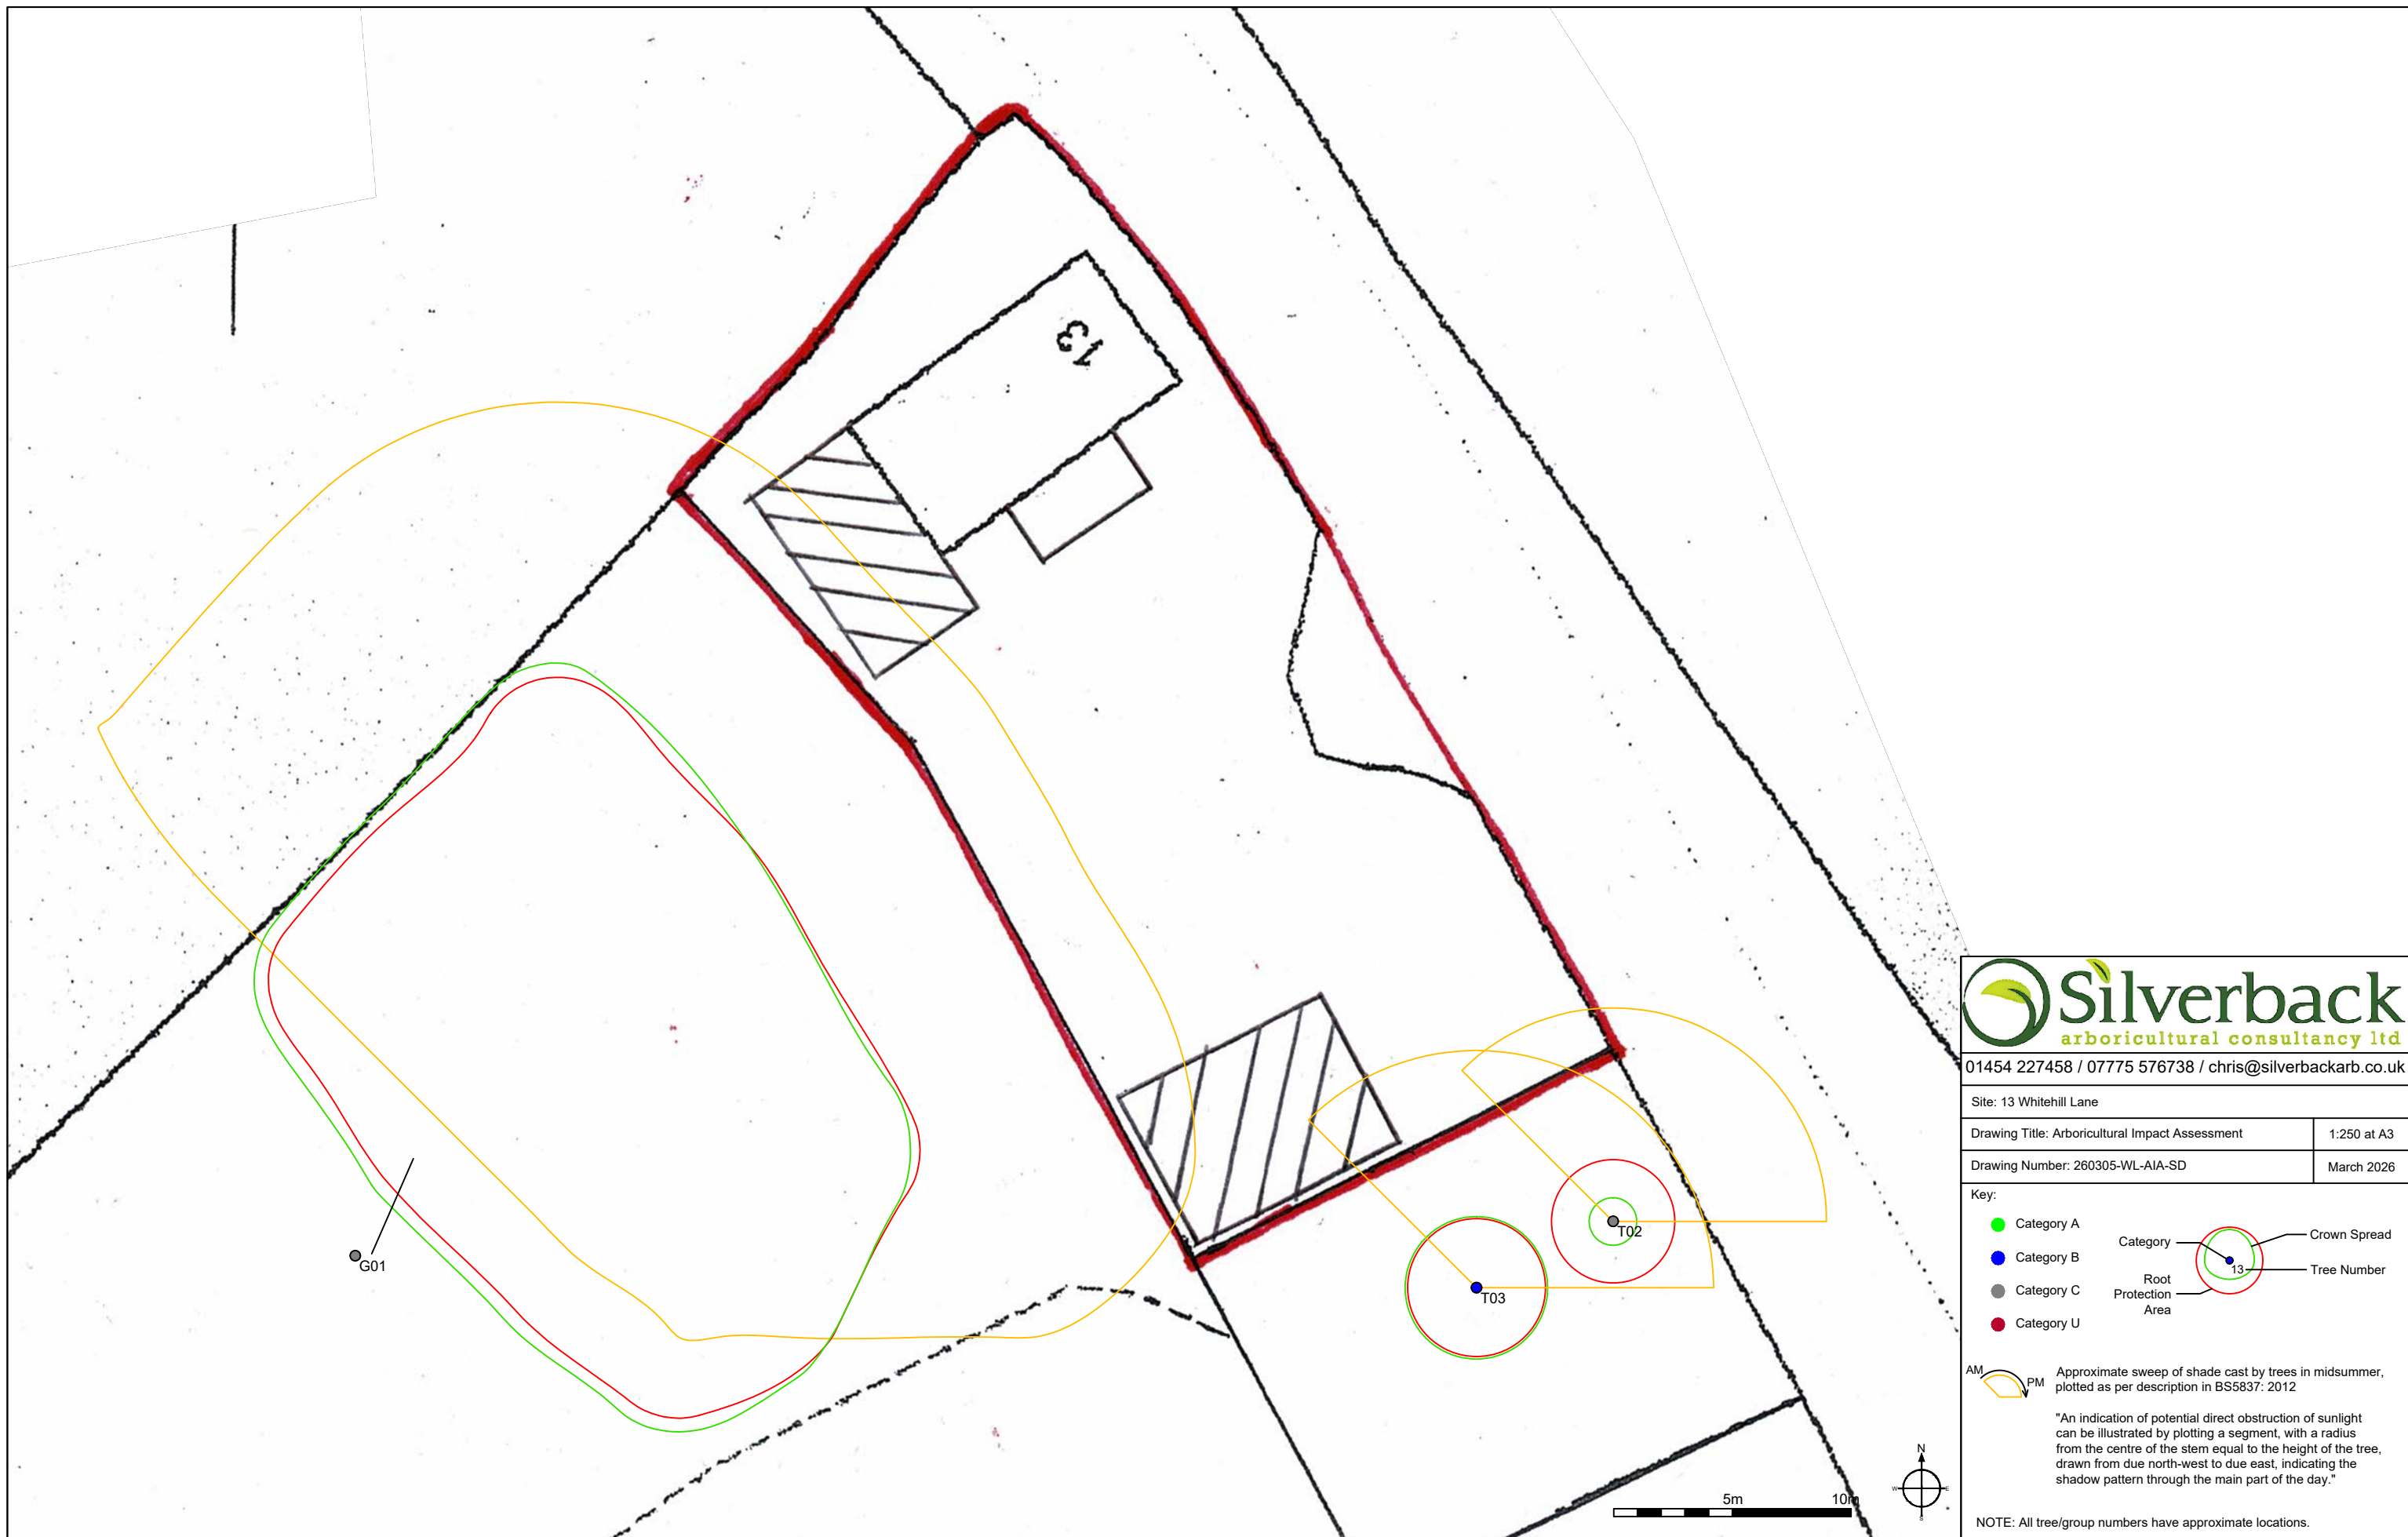
| Drawing Number: 260305-WL-AIA-SD | March 2026 |

**The approximate sweep of shadows cast by the retained trees, in midsummer, is plotted on the Arboricultural Impact Assessment Plan (260305-WL-AIA-SD), as described in BS5837: 2012. There are no shading issues associated with the proposed development.**

- 8.0.1 Below ground protection measures, based on the root protection areas (RPA), indicated in the Tree Constraints Plan, will involve the retention of the existing wooden boundary fence around the site. The existing boundary is illustrated in Arboricultural Impact Assessment Plan (Drawing Number 260305-WL-AIA-SD) (appendix 3).
- 8.0.2 The potential position of tree roots as indicated in the Arboricultural Impact Assessment Plan are only guidelines based on calculations shown in BS5837:2012 'Trees in relation to design, demolition and construction – Recommendations'.
