An Arboricultural Method Statement on Trees at

13 Buryfields  
Lydiard Millicent  
Swindon  
SN5 3NF

16<sup>th</sup> April 2026

Prepared for Mr R Huntington

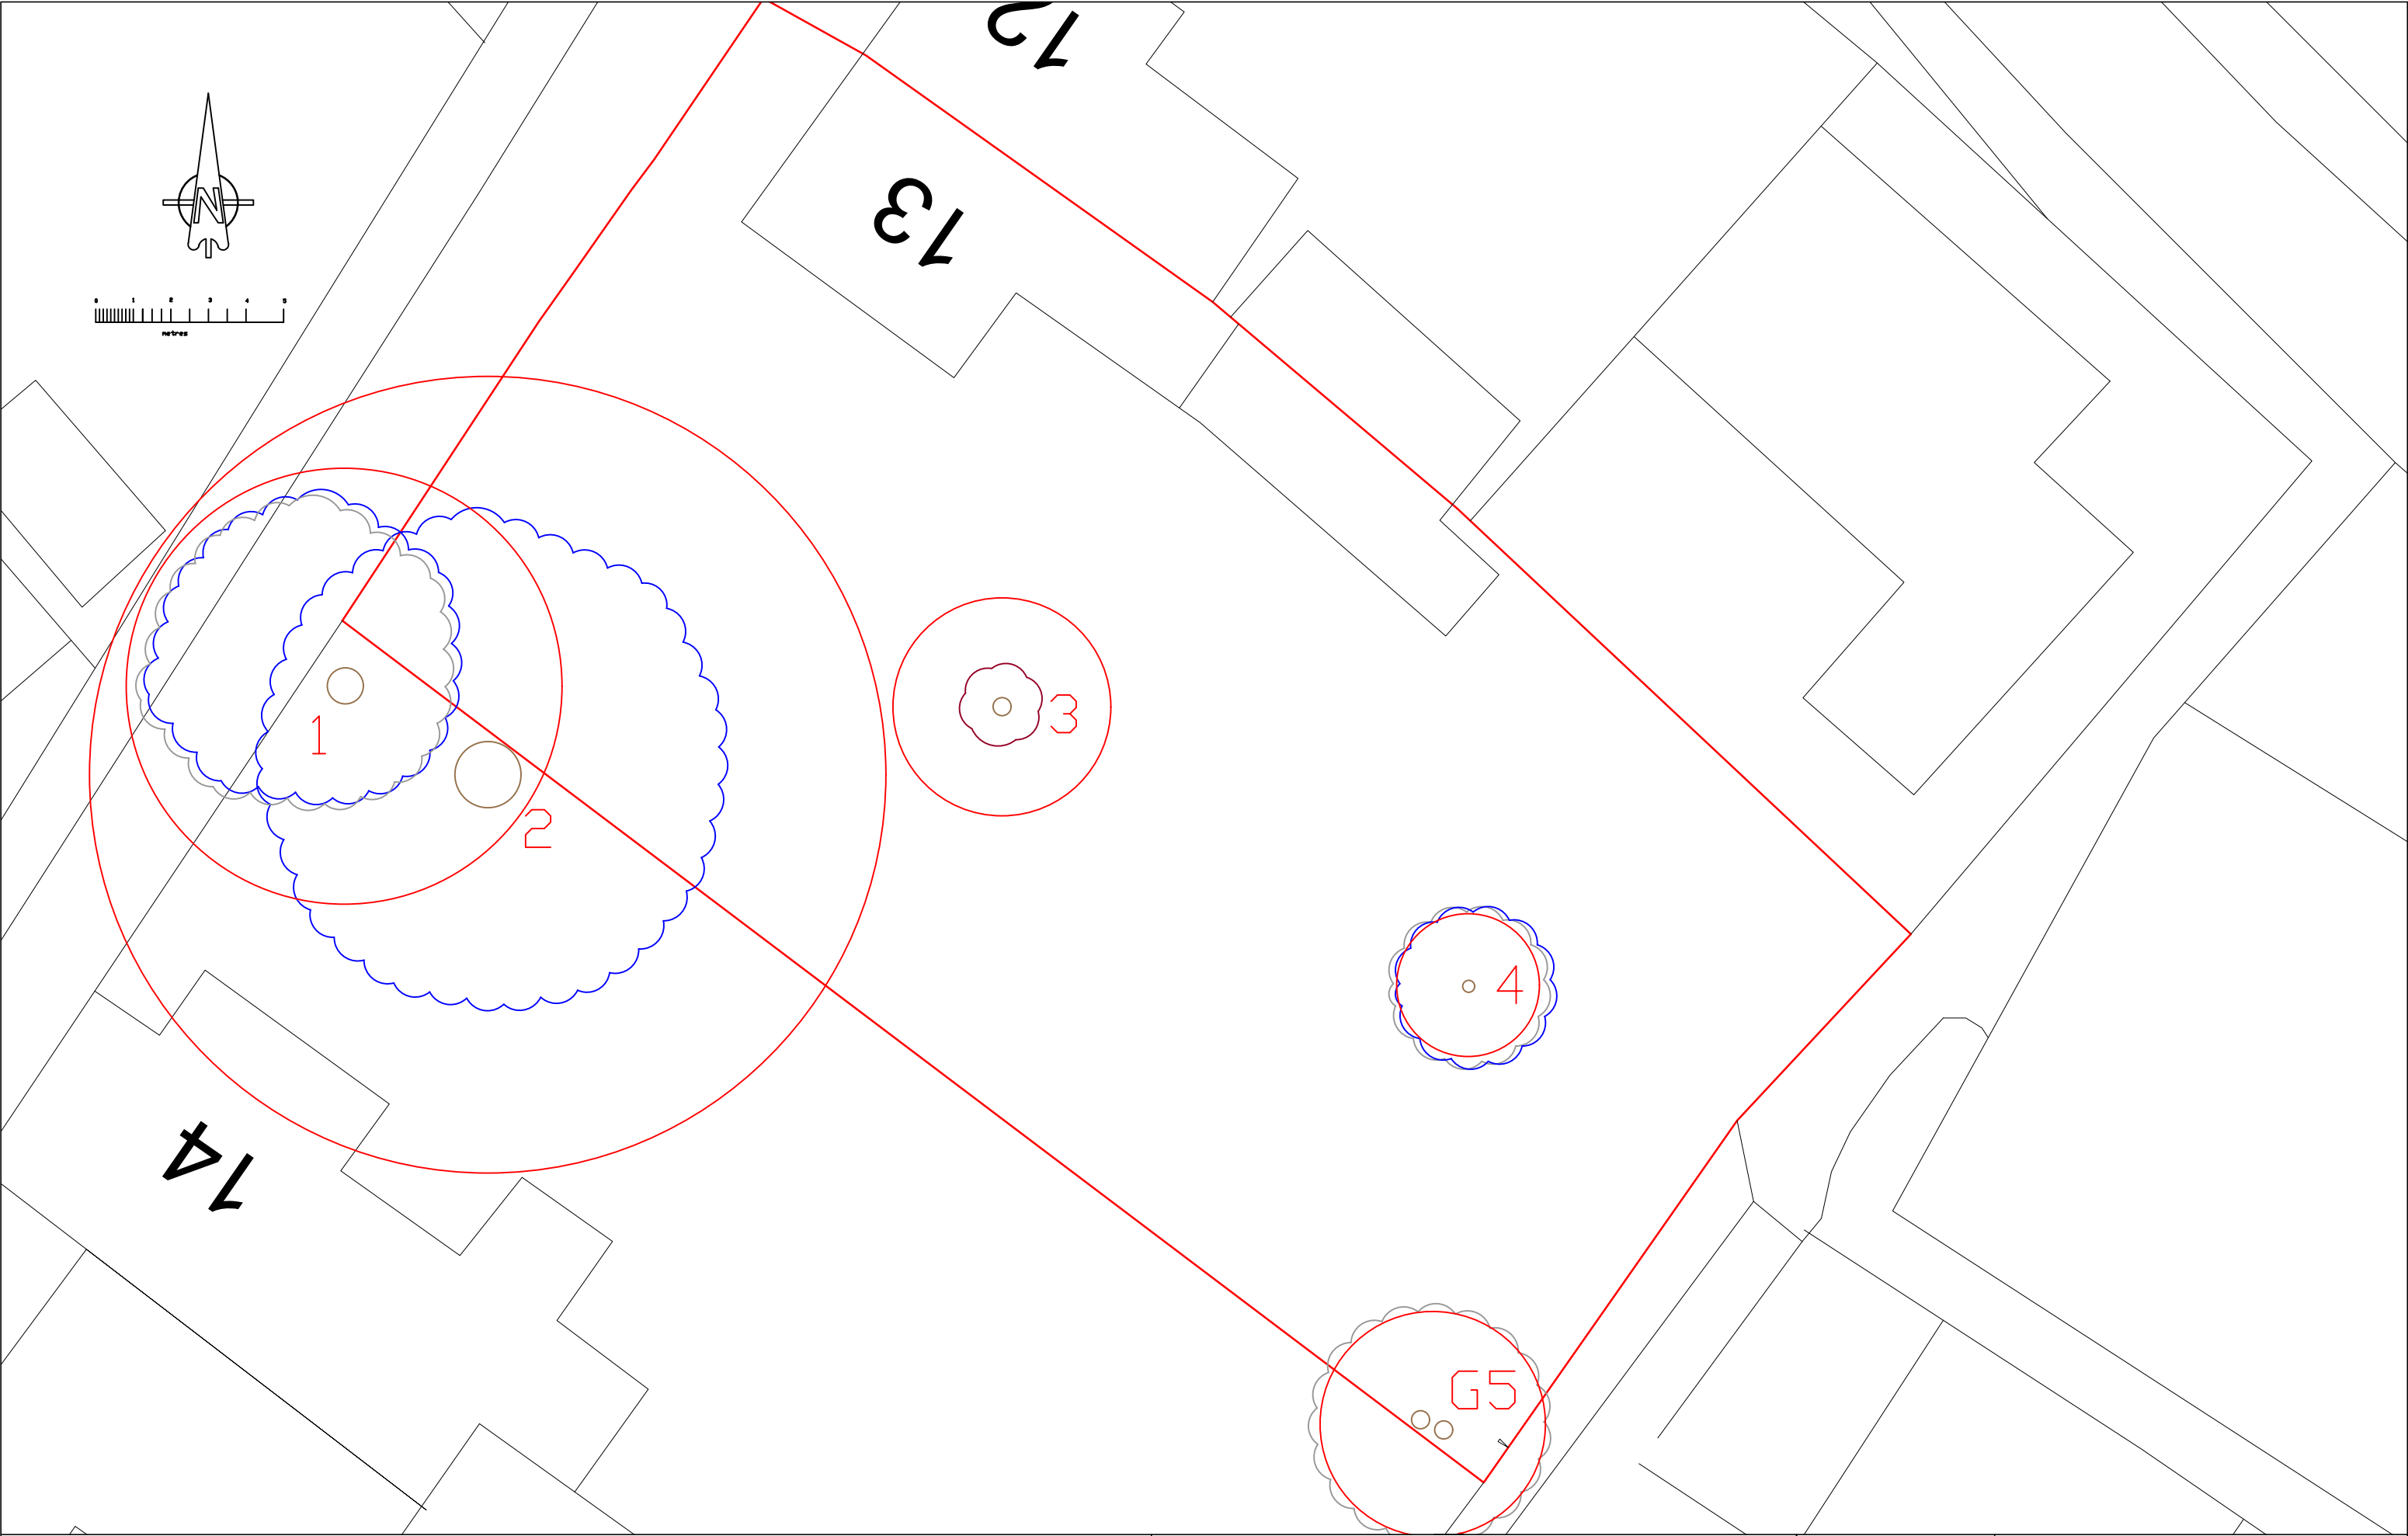
- 3.1 Drawing:** The included Tree Constraints Plan, 13B/TCP, illustrates the above and below ground constraints that the trees pose to the development.
- 3.2 Root Protection Area (RPA):** These are calculated in accordance with the criteria in annex C and D of the British Standard 5837 *Trees in relation to design, demolition and construction 2012*. The table calculates the radius of a circular area of soil to be protected prior to the commencement of any works in order to ensure the trees long term survival, adjustments can be made to this according to the soil topography and pre-existing soil conditions.
- 3.3 Canopy Spread:** This is measured at the 4 cardinal compass points and plotted accordingly.
