| <b>BOLINGBROKE DESIGN</b><br>6 The Slipway, Staverton, BA14 8UP<br>Mobile 07860 491800<br>bolingbroke.design@gmail.com | <b>LEGEND:-</b><br>[Pattern] Exy Walls<br>[Pattern] New Stone<br>[Pattern] New Brick<br>[Pattern] New Block<br>[Pattern] New Stud | <b>NOTES:</b><br>A Window / Door B Door. © All copyright Reserved 2025 | Client <b>Peter Hood</b><br>Job Title <b>"Big Barn" Beanacre Manor Beanacre SN12 7PT</b> | Scale <b>1:50</b><br>Drawn by <b>[Signature]</b><br>Date <b>July 2025</b> | Drawing Title <b>Main Barn Prop. North Elevation</b><br>Drg No. <b>3209/B/10</b><br>Rev <b>C</b> |

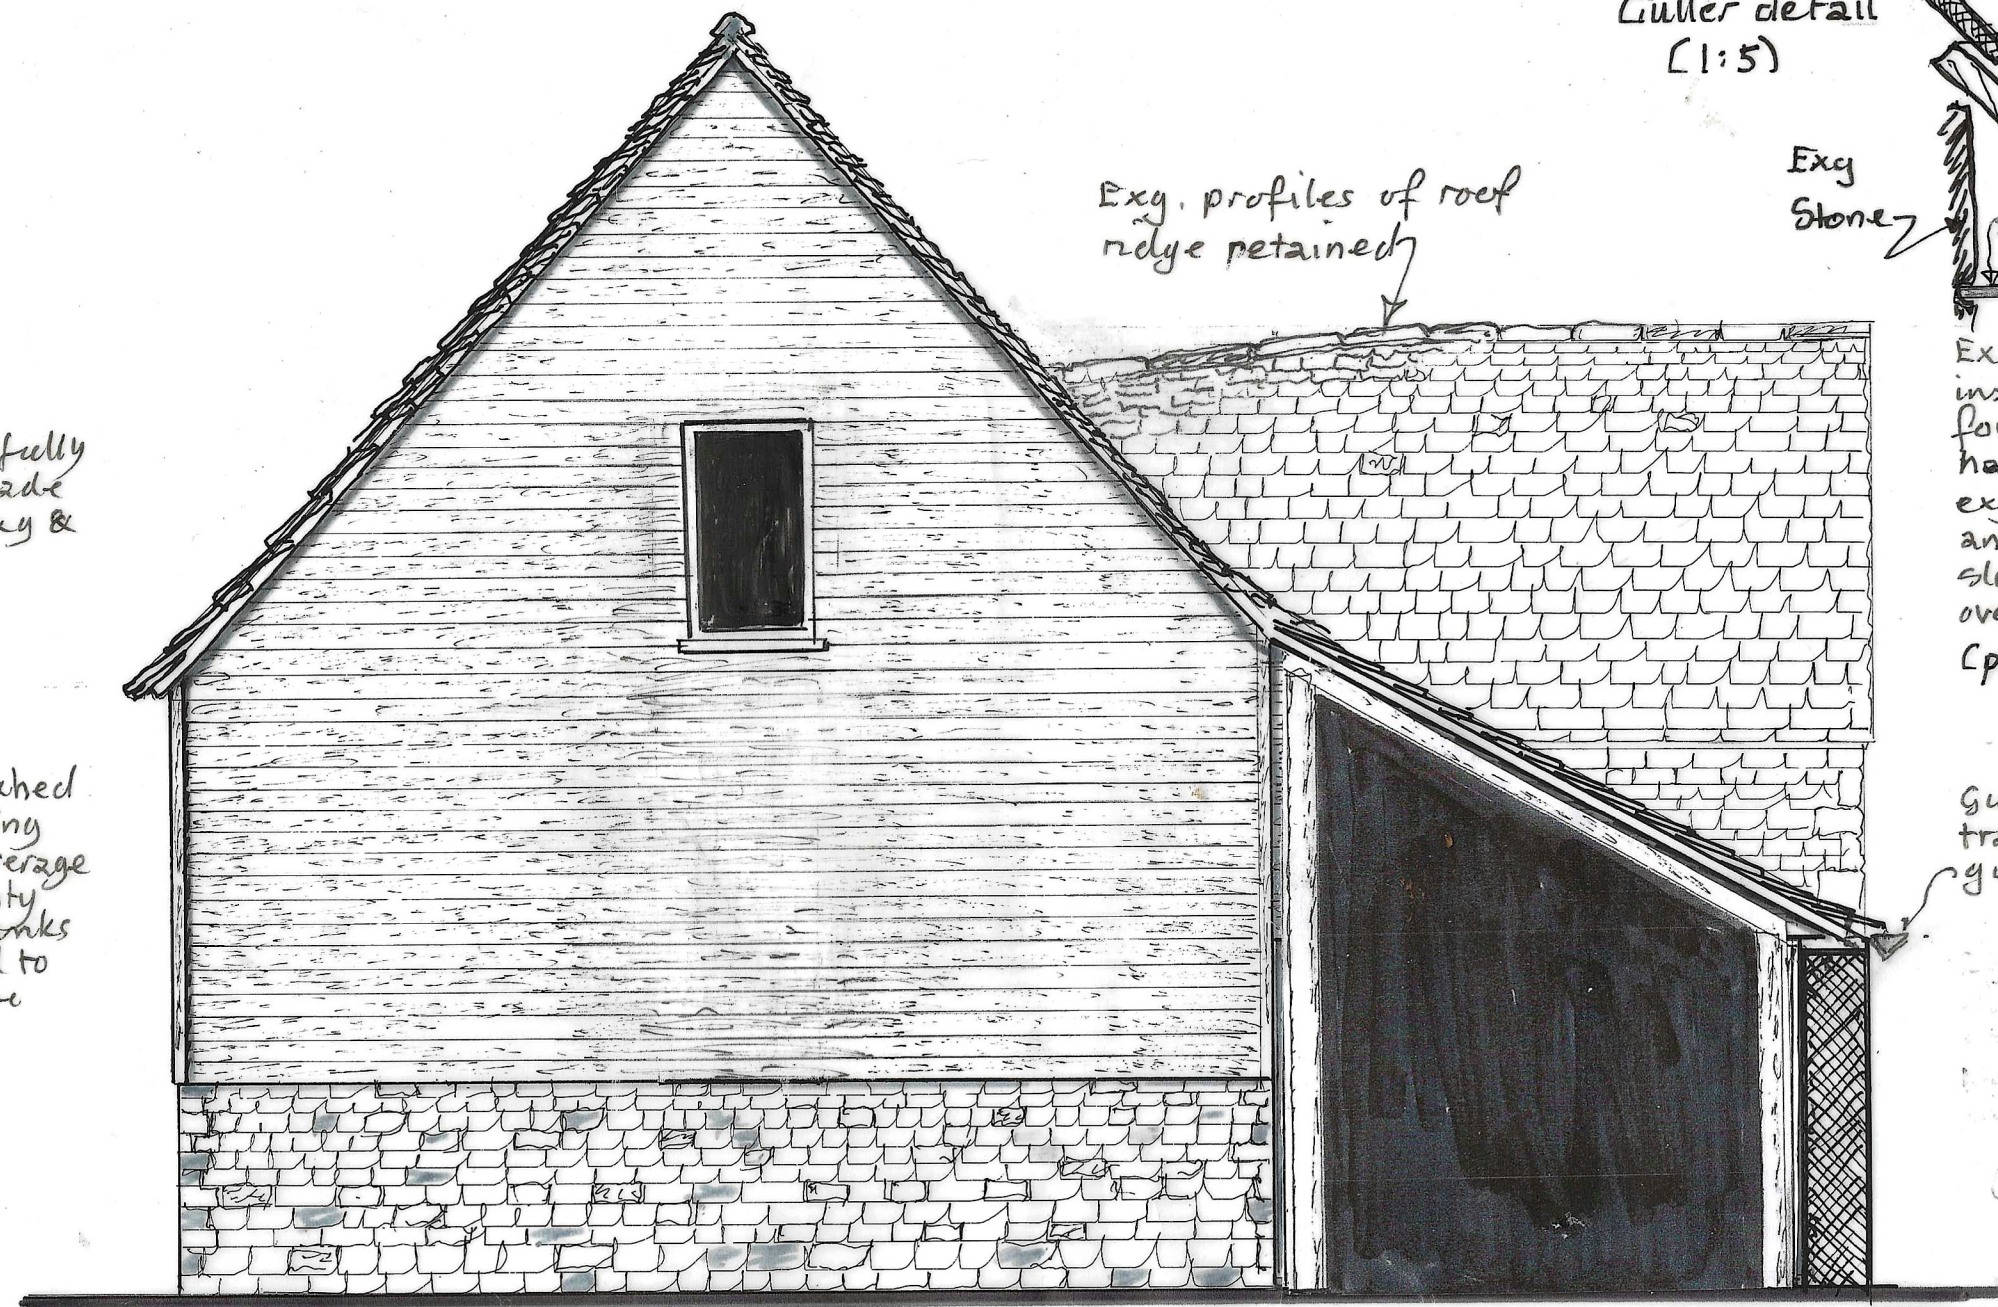
Replace defective / ill matched cladding with larch boarding approx 170 mm to match average original & create uniformity. Any intact / suitable planks to be retained and used to repair / replace defective planks elsewhere

Existing window to be carefully removed & overhauled / made good, single glazed as exy & re-installed

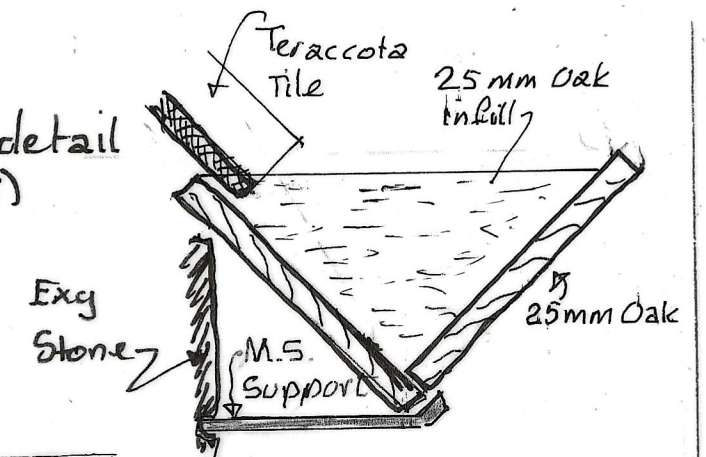
Gutter detail (1:5)

Gutters replaced with traditional oak plank gutters (see above)
