THE OLD RECTORY, MERE,  
WILTSHIRE, BA12 6DS

HERITAGE IMPACT STATEMENT  
June 2026

Adrienne Ridler-Lee MSc  
The Heritage Consultancy  
[www.theheritageconsultancy.co.uk](http://www.theheritageconsultancy.co.uk)

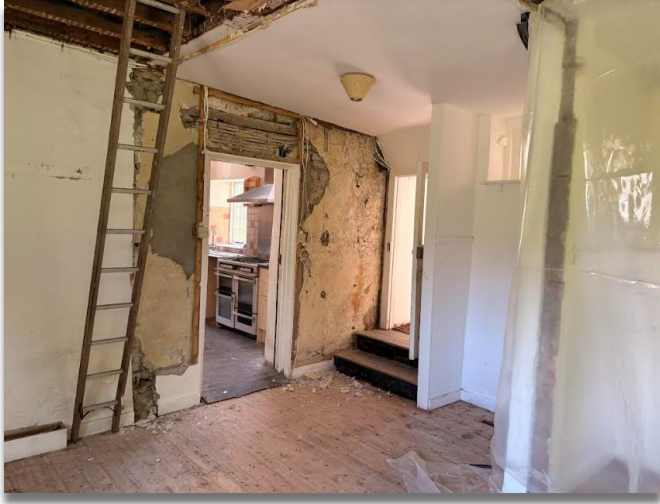
8.11 The west, north and east elevations are in fair condition, however it is intended to remove the unkeyed plaster (with sections of cement repair) from the historic stone wall (Fig.25) to the south elevation, which is most likely a former exterior wall based on the depth of the elevation. A section of C20 plaster has been removed from the wall to investigate the historic fabric underneath to identify the most appropriate approach to the works. The stone beneath the cement and plaster is intended to be left revealed with the existing cement mortar raked out and replaced with lime, however, should it be found that the stone is not viable to remain exposed, then the elevation will be plastered with a lime mortar.

8.24 The widening of the opening will require the removal of a modest amount of C19 material comprising stone; the joint of which is seen in Figure 25, to the right of the door. The proposed finish depends on the historic fabric beneath; if the stonework is in a materially and structurally viable condition, then it is intended to leave it revealed with repairs to the joints with a lime-based mortar. If it is not appropriate to reveal the stone, then it will be repaired with lime mortar before the application of a lime-based plaster. It is intended to retain the existing timber lintel, however once the surrounding material is removed, should it be identified as not being structurally able to support the load above, then it will be replaced with a suitably sized lintel of corresponding material to maintain the character of the dwelling.

*Fig.25. Existing utility looking south west. Note lintel above door.*

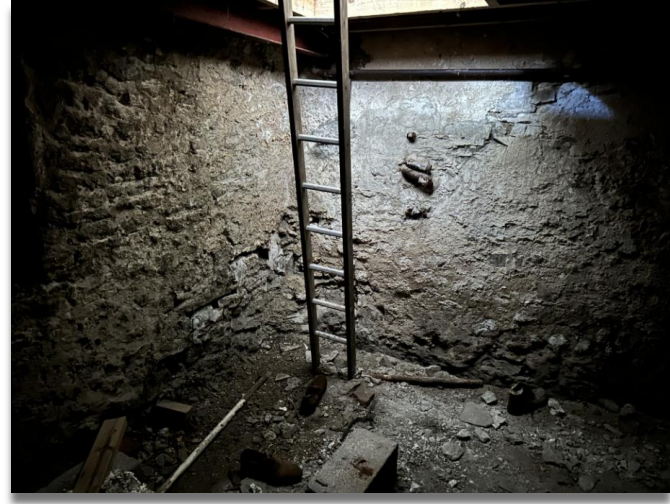
8.15 At present, there is no safe access into the cellar (Figs.26 and 27) which reduces the ability to carry out routine checks or maintenance. The existing access is achieved via a ladder through a hatch in the existing utility floor. It is proposed to install a new timber stair from the kitchen (via the floor hatch) following the line of a previous stair (to the south east corner, seen in Fig.26) to reinstate access. The stair will cause minimal disruption to historic fabric, comprising a largely free-standing, lightweight structure with open treads and a hand rail, with any fitting points utilising any C20 elements if possible.

*Figure 26. Cellar, note C20 steels and historic stair line.*

8.14 In addition to the joists, a new C20 steel beam is intended to aid the support of the proposed kitchen floor (beneath the Aga). The 3 existing steel beams are to be repaired and conserved, with rust removed; the members being re-coated with an appropriate protective treatment as advised by the engineer. The beams will be strengthened at each end where they are inserted into the wall if and where necessary; further supported by existing (and additional) brick pillars which are to be repaired and retained. These discreet works will allow for the existing, temporary uprights to be cleared, reinstating the original cellar proportions.

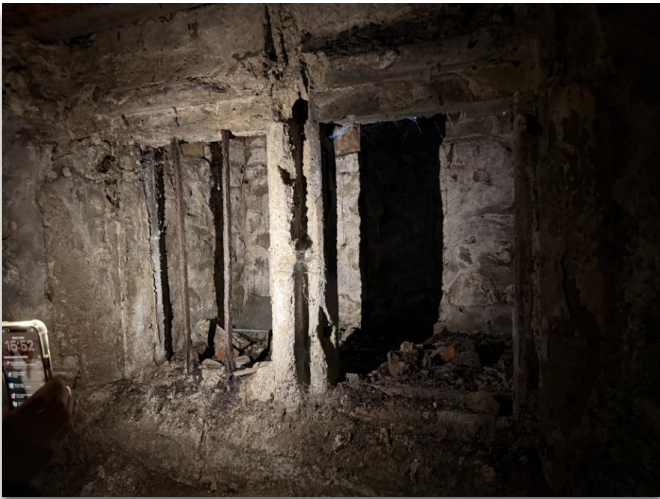
*Figure 27. Cellar; opening with mullion and iron ferramenta.*

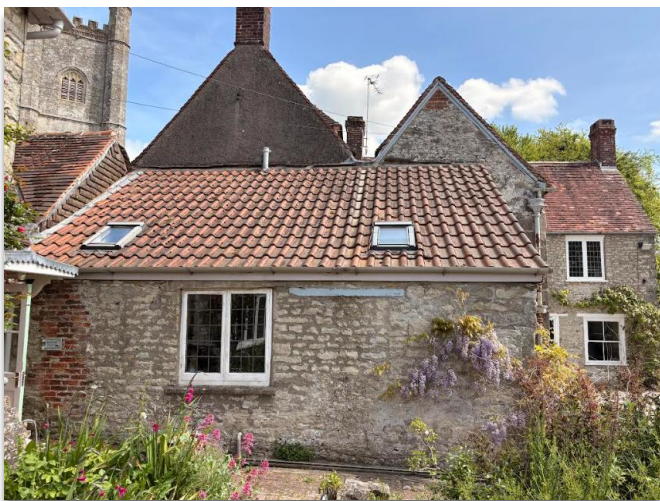
8.35 With reference to the former door opening, the Applicants wish to reintroduce ingress and egress into this area of the house via a new opening. The reinstatement of the door opening to the south has been considered, however the Applicants have concerns that an additional door leading off the parking area in such close proximity to the existing front door (leading to the entrance hall) may result in the elevation appearing visually over-busy, and may cause confusion to visitors as to the principal entrance. Instead, the Applicants wish to expand upon the existing window in the west elevation (Fig.33) to create a double door flanked by side lights. The proposed

*Figure 33. West elevation of existing kitchen; evidence of former opening (beneath lintel); anomalies in stone, evidence of straight joint.*

**8.36** The proposed double doors would require the removal of a limited section of historic stonework; however, this part of the building appears to have undergone significant alteration over time. As previously noted, the window opening within the south elevation has been inserted within an earlier doorway demonstrating that this section of the house once comprised access. A section of the west elevation contains a timber lintel positioned beneath the eaves, together with a visible straight joint within the masonry below, likely indicating the presence of a blocked opening. The proposal therefore responds to an area of the elevation that has already experienced historic alteration, rather than resulting in the loss of a wholly intact section of primary fabric. The proposed door would require the removal of stone below a section of the lintel, below the existing window, and a minimal amount to either side. The introduction of the doors would enhance the functionality and long-term viable use of the building by improving physical and visual connectivity between the proposed dining room and the surrounding grounds. In addition, the opening would increase levels of natural light and ventilation within the space, contributing positively to the quality and usability of the interior, whilst remaining proportionate and sympathetic to the established character and evolution of the building.

**8.37** In addition to the current rooflights (Fig.33) over the existing kitchen, it is proposed to insert an additional 2 to increase ventilation and light. The existing rooflights are comparatively small for the scale of the slope and the room below, that is not fitted with a suspended ceiling, instead the historic truss being exposed. The existing rooflights do not fit flush to the roof and will instead be replaced with Conservation rooflights (with lead flashing) to match the new. No historic material will be removed to accommodate the lights; the existing roof comprising machine manufactured red clay pantiles appearing to be C20 replacements that are proposed to be replaced (see para.8.23 below). Neither the proposed rooflights or the double door would be visible from the public realm or from the Church tower, resulting in a discreet intervention that enhances the living space whilst respecting the historic character of the house as observed from the west and south.

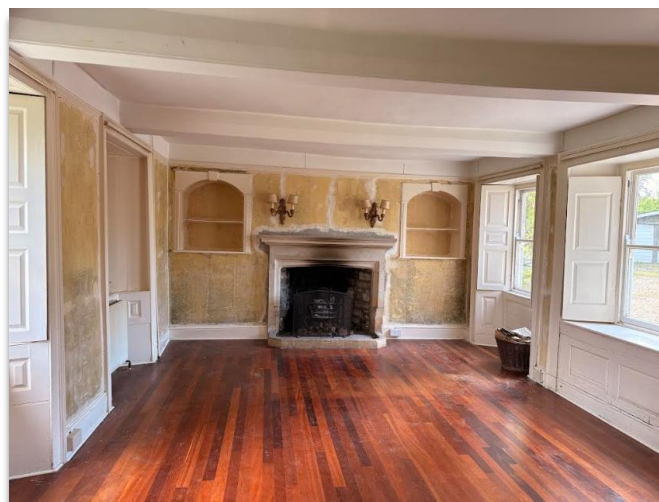
**8.56** The drawing room (Figs. 36 and 37) is in need of general maintenance and repair in order to conserve and enhance the surviving C18 fixtures and fabric. An original Georgian arched doorcase survives to the west side of the room, providing a historic connection to the entrance hall, however, this feature is concealed by a later, lightweight insertion forming a small lobby (Figs.37 and 38), likely introduced to reduce draughts from the entrance hall beyond. The lobby disrupts the original proportions of this principal room and diminishes the visual and physical relationship between the historic doorcase and the space it was designed to serve. The proposal intends to remove this lightweight lobby, with no harm to any historic fabric in order that the original room proportions can be reinstated, which will reveal the arched doorcase and reestablish the connection to the drawing room. To the north of the lobby is a C20 bookshelf (Fig.38); not comprising a historic or original fixture or fitting. Along with the removal of the lobby, it is intended to remove the bookshelf (the securing of which has not altered any historic fabric) to further reveal the original form of the interior west elevation. Book cases will instead be fitted to the east (see accompanying detailed drawing).

8.60 It is evident that the C18 fireplace surround has at some point in time been removed. The existing replacement (Fig.36) comprises a cast cement piece, which is incongruous to the period, character and status of the room. The Applicants wish to source an appropriate, Georgian piece (salvaged, not replica if at all possible) that will be fitted along with a slate hearth.

*Figure 36. Looking south in drawing room.*

8.66 The proposed replacement of a C20 cast cement fireplace surround, and the replacement with a heritage appropriate, salvaged piece seeks to reinstate the originally intended character of the drawing room, providing enhancement and a positive impact upon significance.

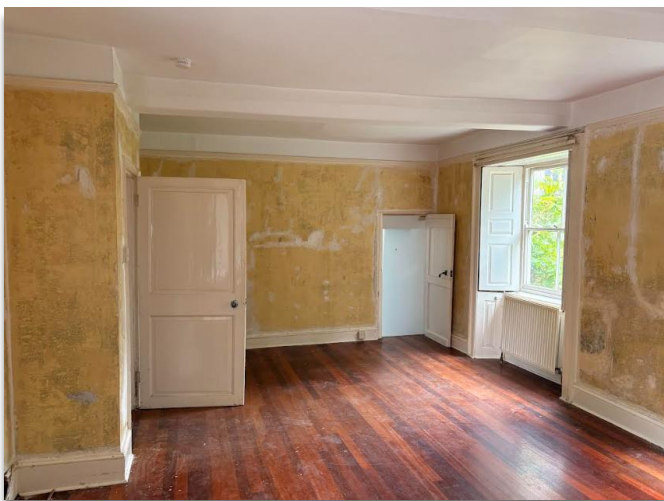
Figure 37. Looking north in drawing room. Note lobby to west (left).

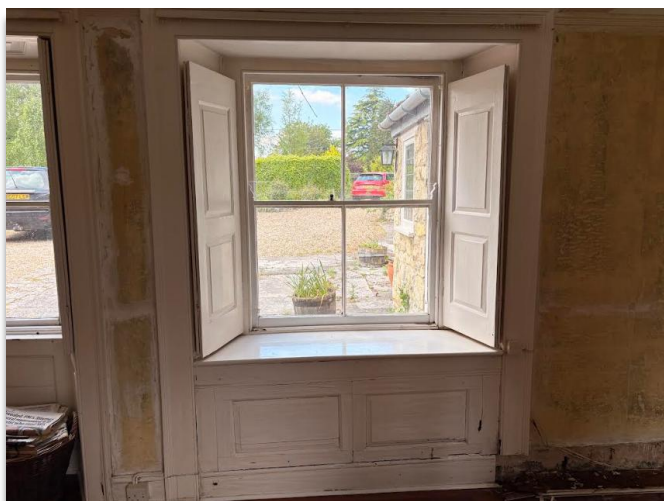
**8.57** The drawing room retains historic skirting boards, picture rails, and a window seat with panelling beneath (Fig.39) which are all of historic and architectural value, however, defective rainwater goods have resulted in inadequate disposal of rainwater, allowing the external stone elevations to become saturated and leading to moisture ingress within the internal walls. This has adversely affected historic timber elements, resulting in localised decay and areas of rot.

Figure 39. West window; panelling and skirting damp, suffering rot.

**8.58** The Applicants are committed to retaining historic fabric wherever possible, however sections of skirting board to the west elevation, the window seat and its associated panelling below are now beyond repair (Fig.40) and require replacement on a like-for-like basis to match the existing profiles and materials. This represents a necessary intervention to conserve the character of the room.

8.59 It is also intended to remove the damp, unkeyed plaster where necessary in this room, and to replace with lime plaster. In addition to this, it is intended to install French drains to the exterior to mitigate the issues with water ingress and damp that are currently causing harm to the original fabric of the house.

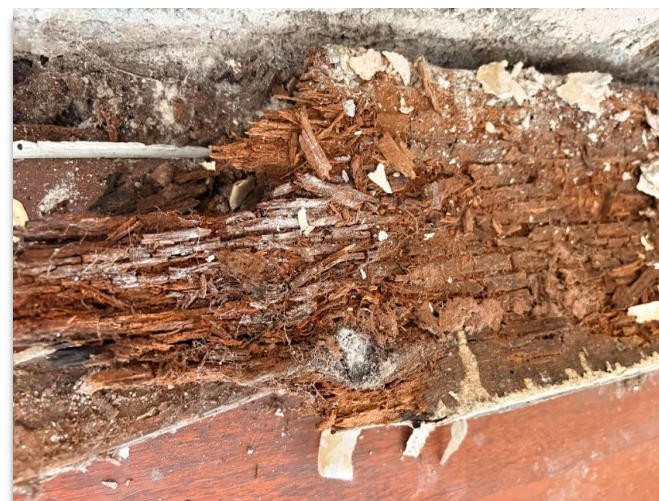
8.62 The Applicant's overall approach to the conservation works is one of "repair rather than replace". However, in relation to the timber fixtures within the drawing room, namely the skirting boards, window seat, and wall panelling, extensive decay has rendered the material too fragile for effective repair, and replacement is therefore the only viable option.

Figure 40. Section of drawing room skirting board, demonstrating level of decay.

8.63 The replacement elements will be manufactured by a suitably experienced heritage joiner to match the existing detailing, ensuring continuity in design, materiality, and character. The proposals will reinstate the quality and coherence of the interior fabric within the room and will not result in further loss of surviving historic material beyond that already compromised. Other surviving timbers within the space will be retained, appropriately conserved, and treated to ensure their long-term preservation.

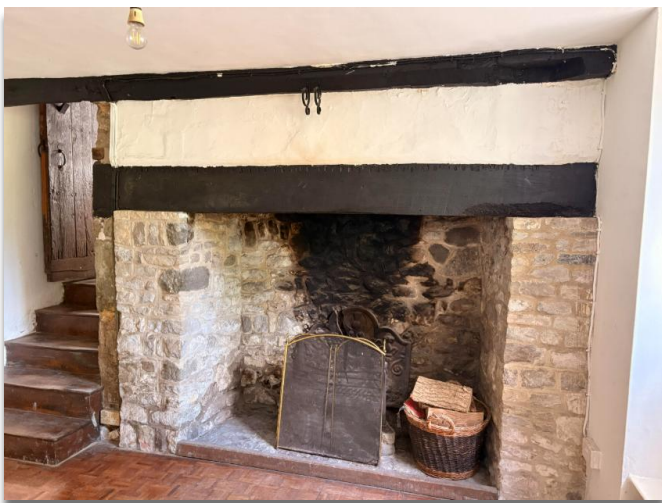
8.69 The space that comprises the existing snug, once formed the original kitchen/service quarters, comprising surviving fabric of the building that pre-dated the C18 fire. The stonework within the inglenook (Fig.41) does not pre-date the fire, instead appearing to be an C18 insertion. The timbers above the opening appear to be C18, however the raised stone hearth appears to later; its condition not commensurate with centuries of use.

Figure 41. Snug inglenook. Steps to existing kitchen, proposed dining room. Note parquet floor.

8.70 The Applicants wish to insert a wood burning stove set upon the existing hearth (and associated flue/liner) so that the opening and stack can continue to safely operate in its originally intended purpose.

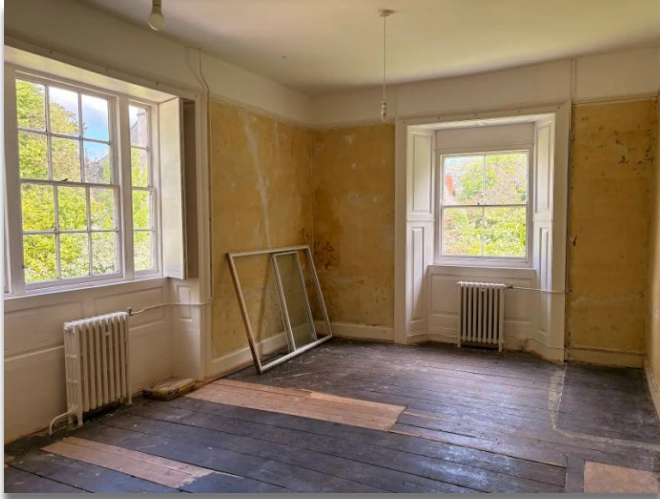
Figure 49. Bedroom 1. Note ad hoc timber replacement.

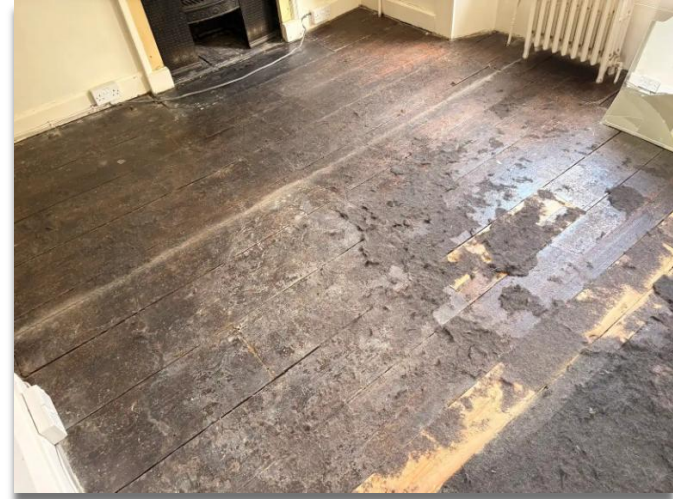
Figure 50. Bedroom 2. Ad hoc timber replacement.

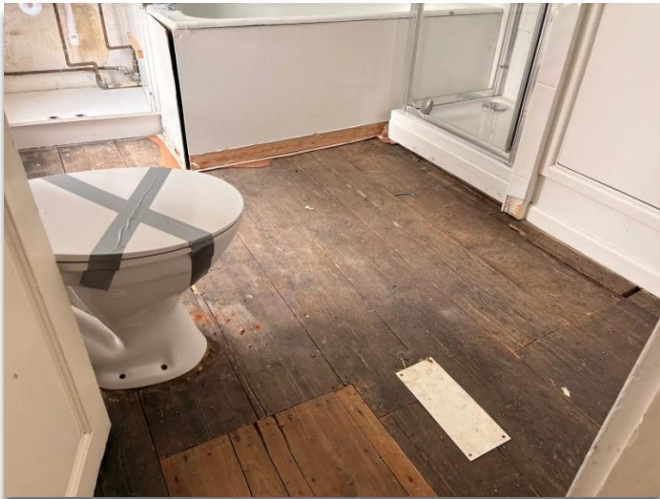
Figure 51. First floor bathroom. Ad hoc timber replacement.
